PHOTO DOCUMENTATION

Appendix no. 2

to the Final Report on implementation of measures determined in EMP
for the Contract 3A.4

Odra-Vistula Flood Management Project

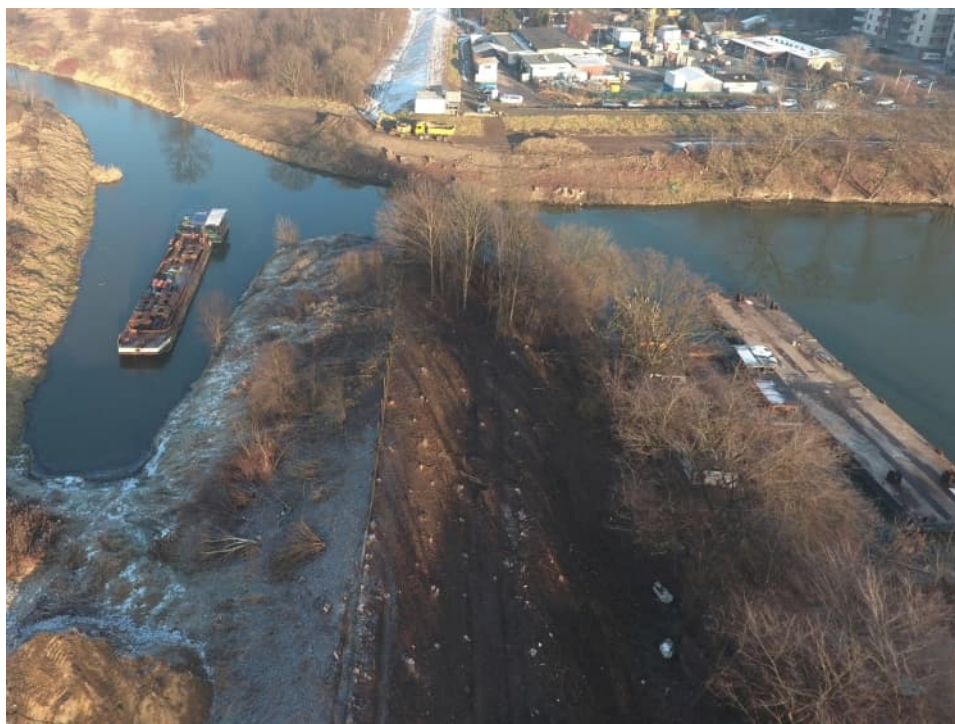
Fig. 13. Tree felling
– the right Vistula embankment upstream of the Płaszów port,
status in the second decade of December 2021 (view towards the east).

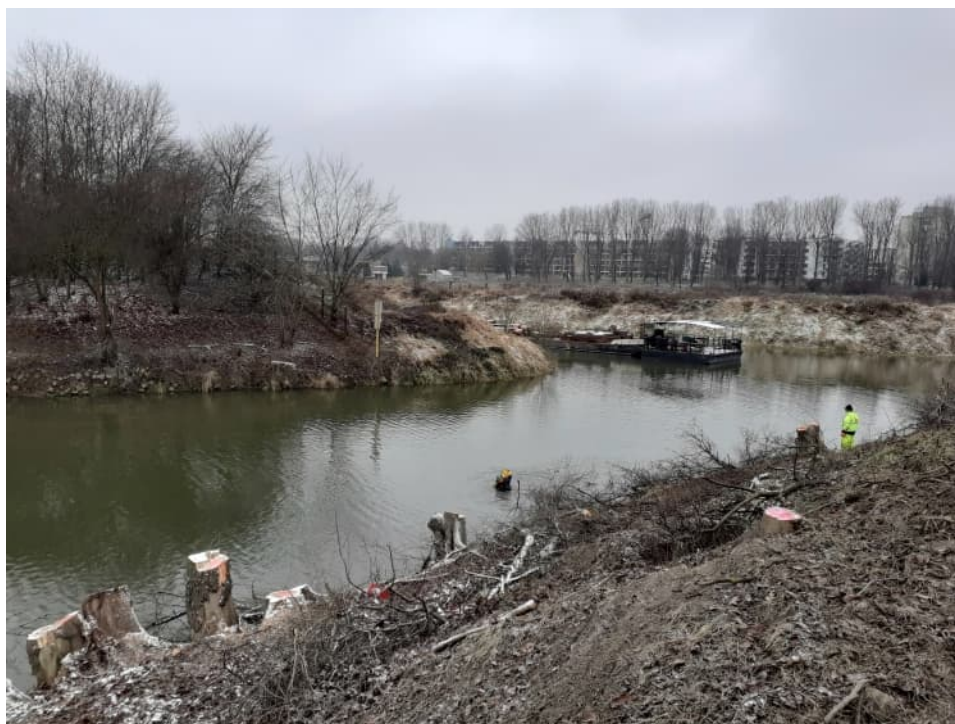
Fig. 15. Sapper supervision inspection before the commencement of works, status in the first decade of December 2021 (view towards the west).

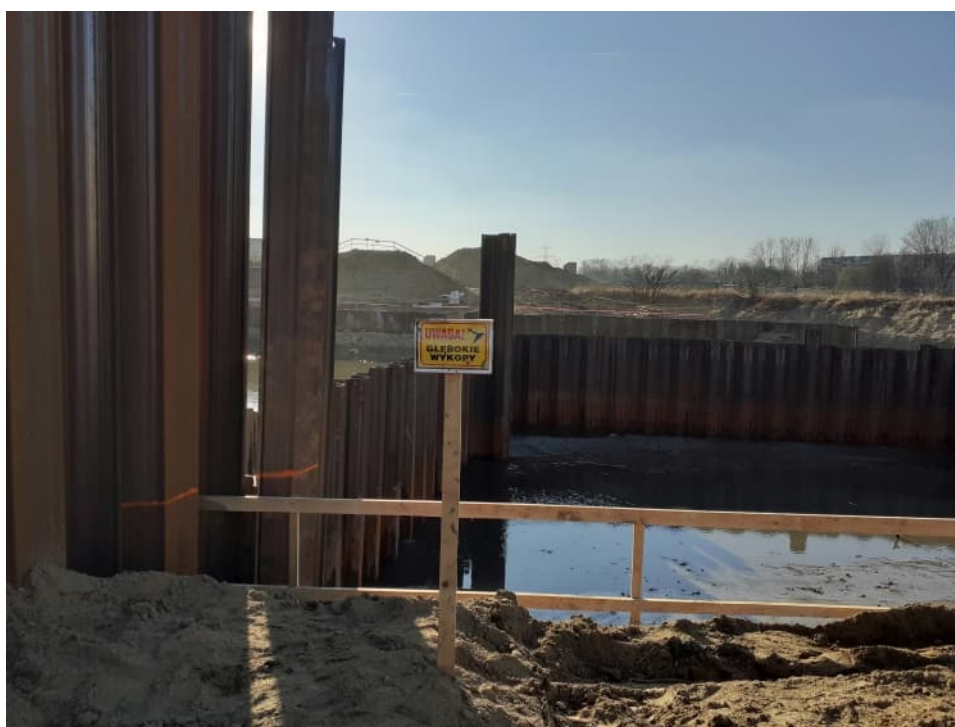
Fig. 23. Protection of hazardous sites,
status in the first decade of March 2022 (view towards the west).

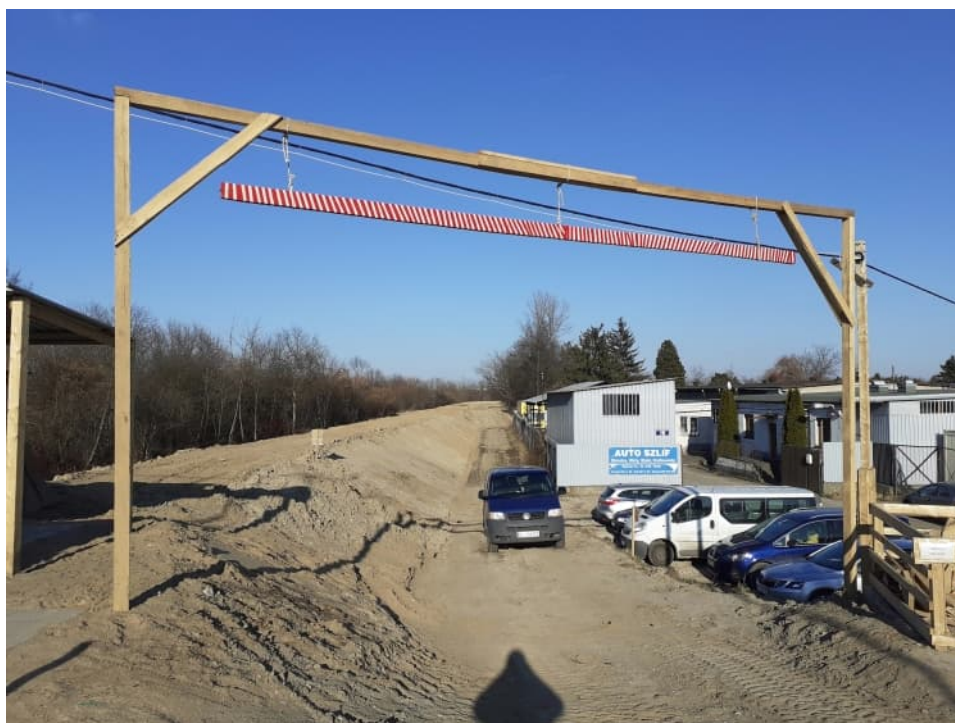
Fig. 24. Protection of hazardous sites,
status in the first decade of March 2022 (view towards the east).

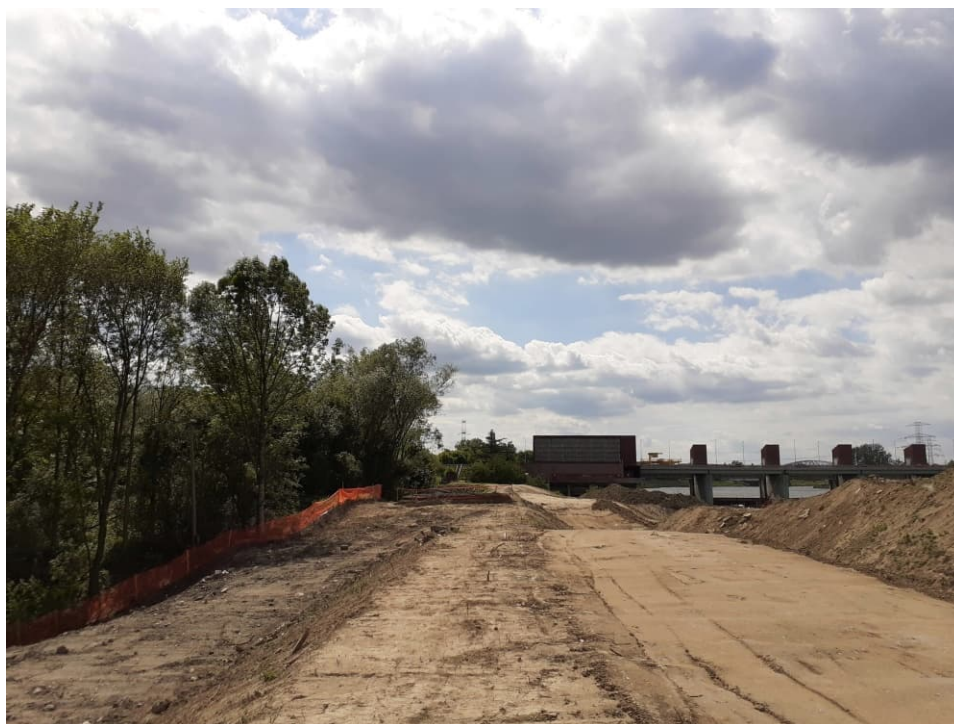
Fig. 25. Protection of trees not intended to felling,
status in the third decade of May 2022 (view towards the west).

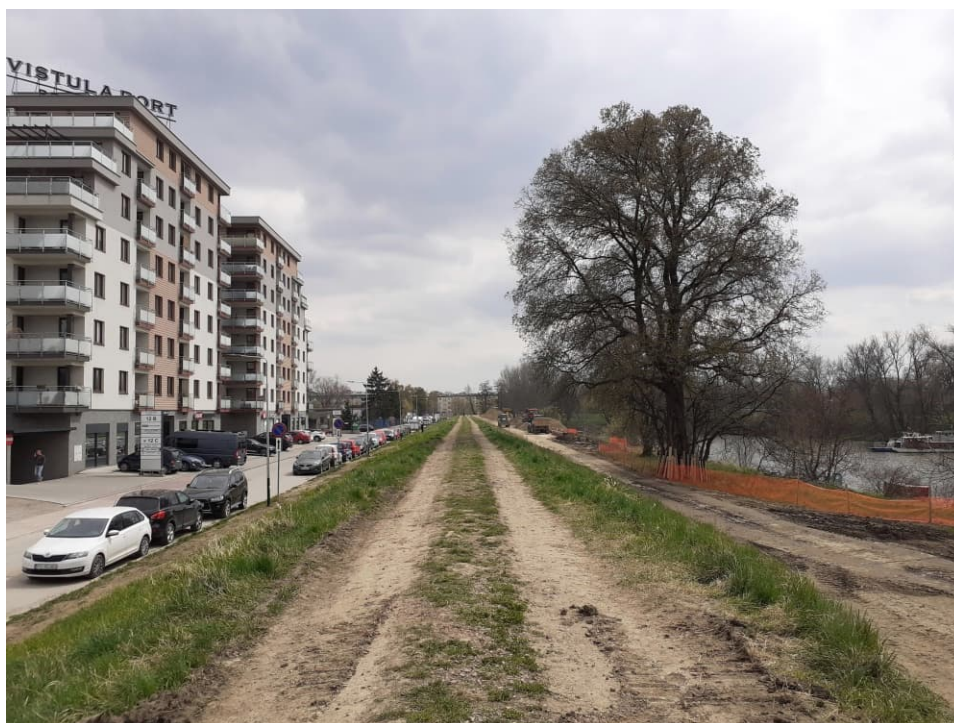
Fig. 26. Protection of trees not intended to felling,
status in the second decade of April 2022 (view towards the south).

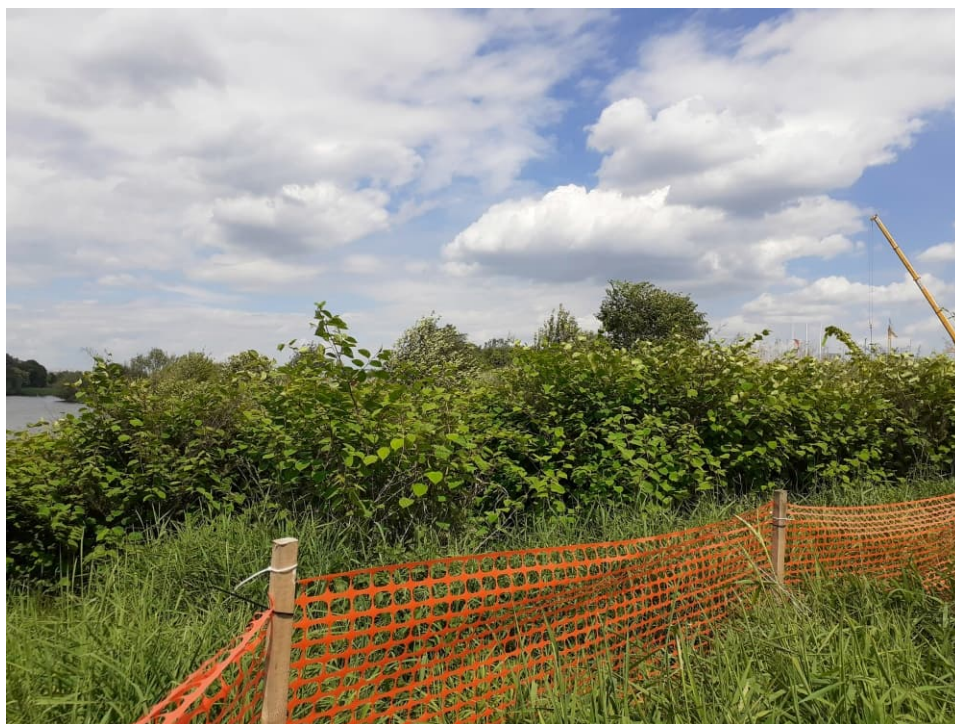
Fig. 27. Preventing the spread of foreign invasive plant species
– fencing off knotweed site in the right embanked area of Vistula,
status in the third decade of May 2022 (view towards the east).

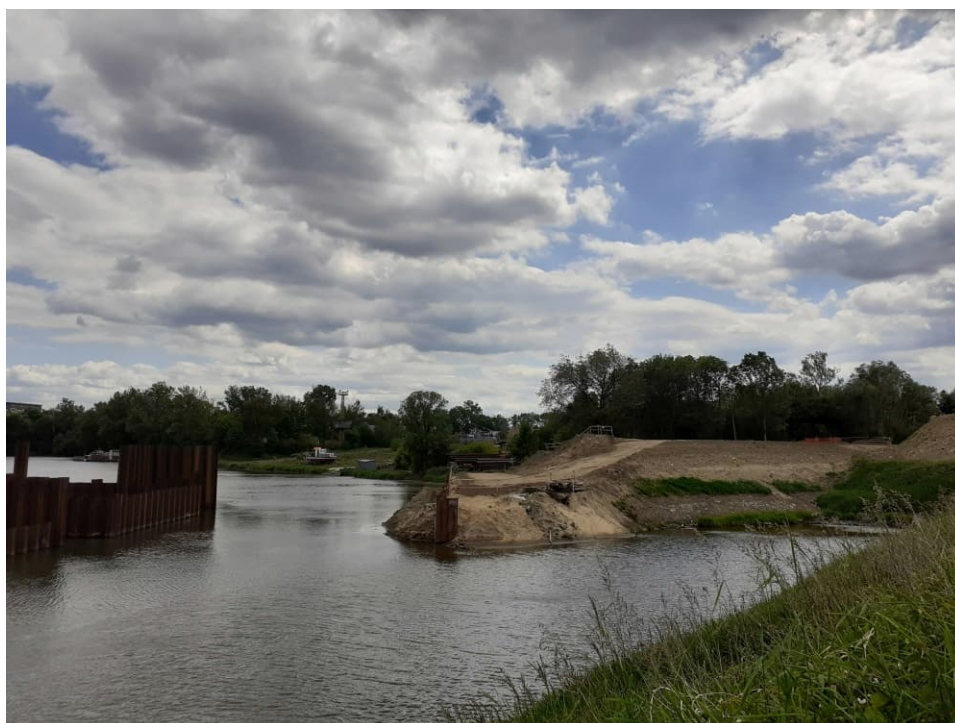
Fig. 28. Maintaining the patency of the Płaszów port channel during works,
status in the third decade of May 2022 (view towards the south).

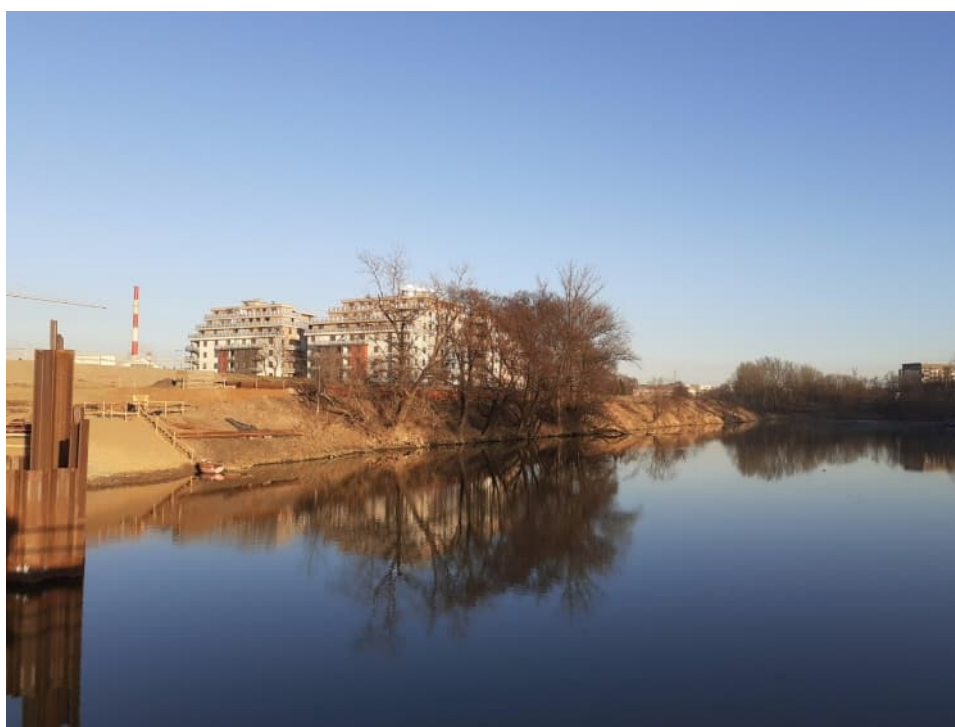
Fig. 29. No impact of works on water environment in the Płaszów port channel, status in the third decade of March 2022 (view towards the south).

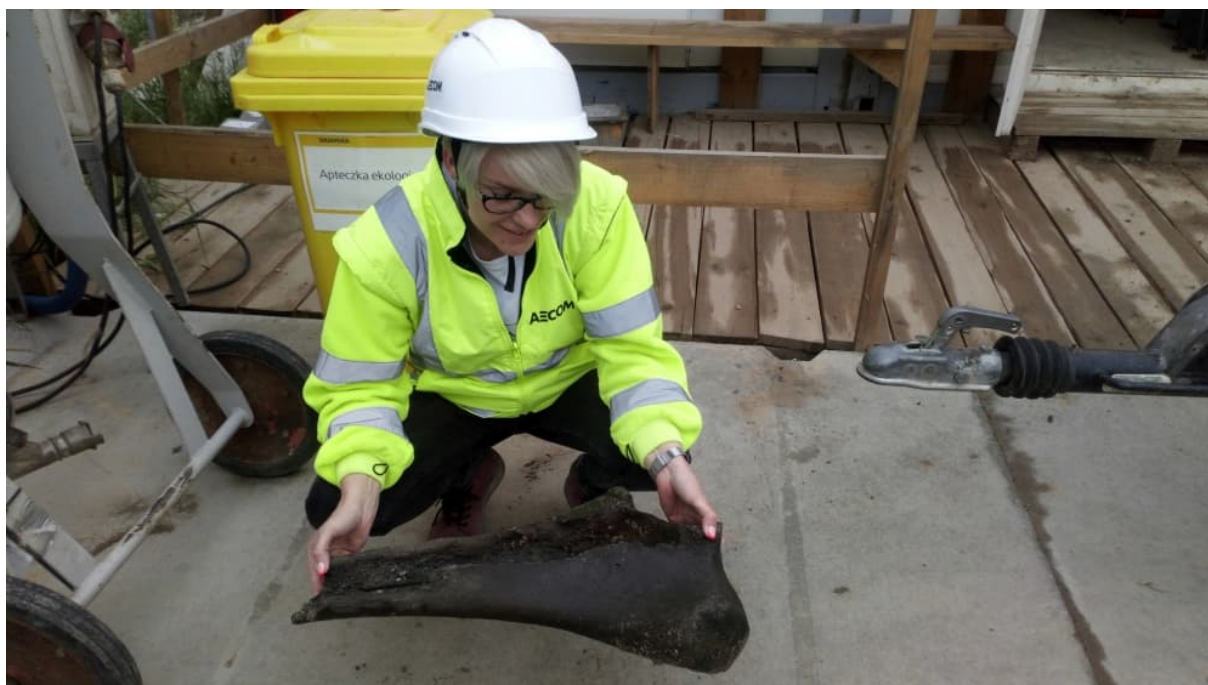
Fig. 30. Archaeological find – a mammoth bone excavated during earthworks and secured by archaeological supervision, status in the third decade of May 2022

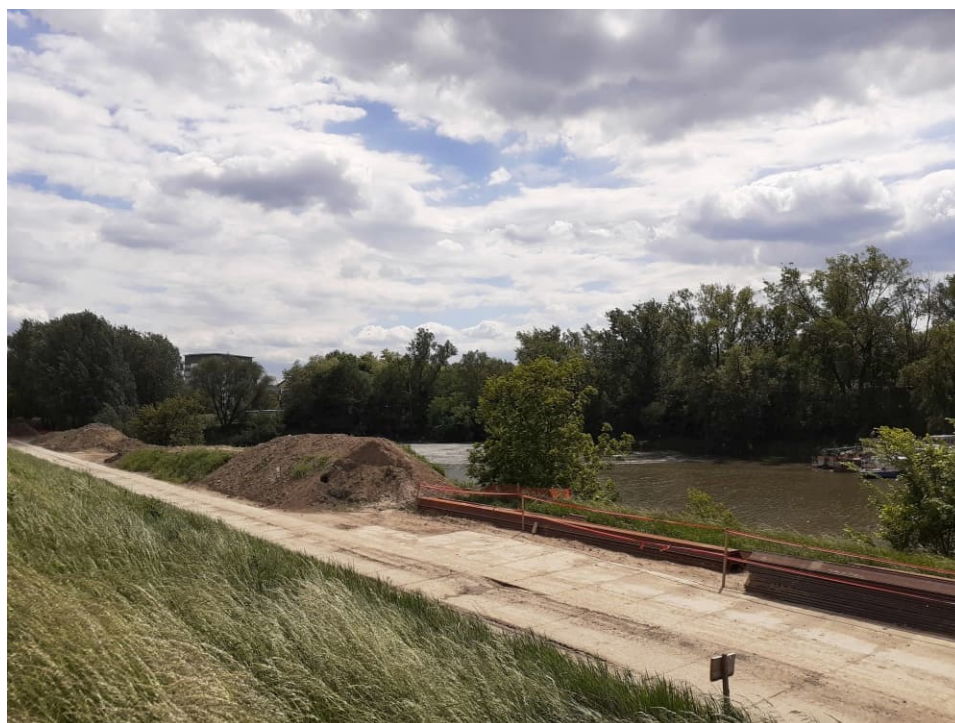
Fig. 32. Protection of top-soil piles,
status in the third decade of May 2022 (view towards the south).

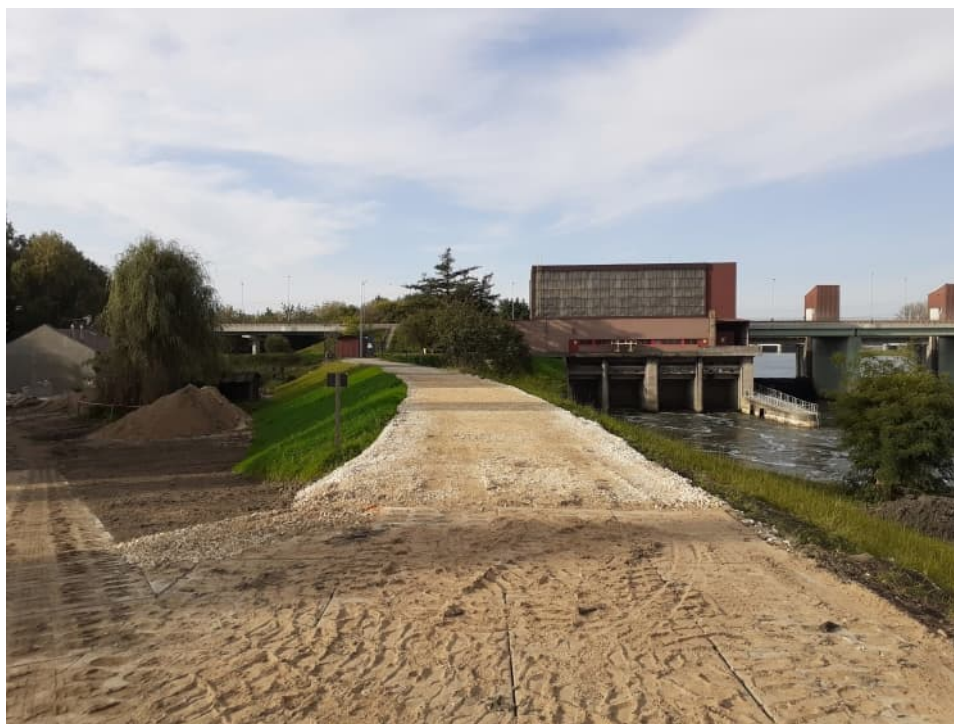
Fig. 57. Growth of grasses sown on the slopes of the Vistula flood embankment, status in the second decade of October 2023 (view towards the west).

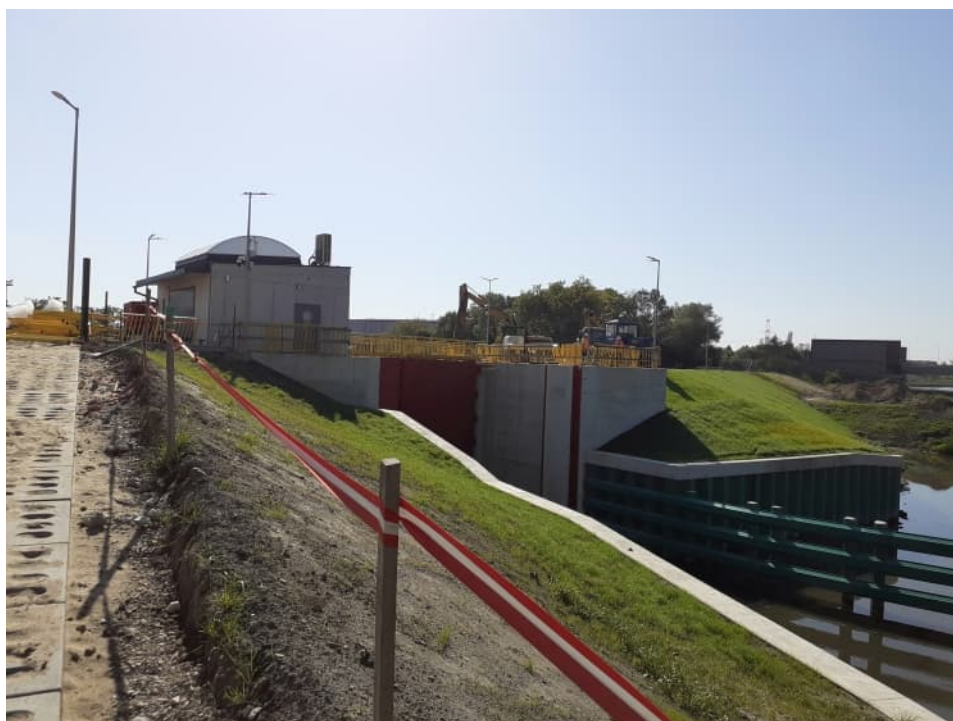
Fig. 58. Growth of grasses sown on the slopes of the Vistula flood embankment and on the bank slope of the Płaszów port channel, status in the third decade of September 2023 (view towards the west).
