STATE COMMISSION ON RAILWAY ACCIDENT INVESTIGATION

ANNUAL REPORT 2022

FROM ACTIVITIES STATE COMMISSION ON RAILWAY ACCIDENT INVESTIGATION

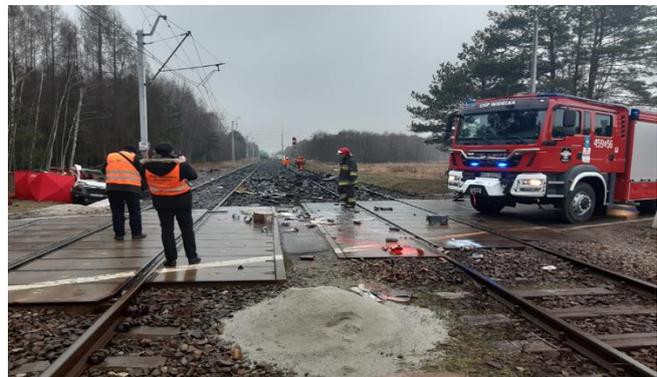
- As a result of the occurrence, the driver of the road vehicle died at the scene. Five train passengers were injured. Four people received medical attention at the scene, one person was taken to the hospital in serious condition and died as a result of his injuries.
- A delivery truck and the first section of rail vehicle No. EN63B-108 were destroyed.

Photo 1 - View of the site of the occurrence (PKBWK's own material)

Occurrence at a level crossing of category C. The occurrence involved the RAJ 33506 passenger train owned by railway undertaking POLREGIO S.A., consisting of an EN63B-108 electric multiple unit and a Citroen Jumper van. The occurrence consisted of the train hitting the side of the vehicle, whose driver entered the crossing despite the signals on the traffic lights prohibiting entry behind these signals and the sound signals emitted by acoustic devices.

- 1) Introduction of a speed limit of up to 50 km/h on road No. 1214R on the approaches to the crossing due to non-compliance with the provisions of the Regulation of the Minister of Infrastructure and Development of October 20, 2015 *on the technical conditions to be met by the intersections of railway lines and railway sidings with roads and their location*, Annex No. 3, paragraph A, 1 as an implementing regulation of Article 7 of the Construction Law,
- 2) Mark the intersection (on the side of Road No. 9 - the left side of the intersection) with an A-10 sign in accordance with regulations,
- 3) Mark the crossing with P-14 horizontal signs.

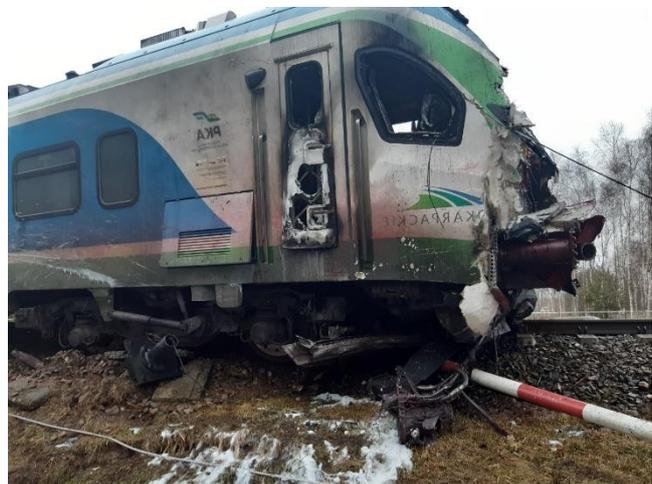
Photo 2 - Consequences of the occurrence (material of the railway commission)

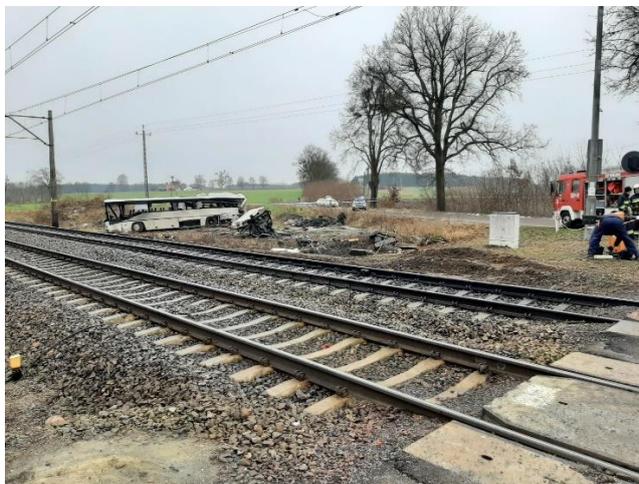
- As a result of the incident, the driver of the bus was killed on the spot.
- The bus was destroyed, and the EU07A-002 locomotive and two passenger cars were damaged.

Photo 3 - Consequences of the occurrence (PKBWK's own material)

An occurrence on a category B level crossing involving the passenger train IC 5600/1 of PKP Intercity S.A., consisting of locomotive EU07A-002 and seven coaches, and a Mercedes INTEGRO bus of PKS Grudziądz. The occurrence consisted in the train hitting the right rear of the bus, which was in the rolling stock gauge between the closed half-barriers and was trying to leave the crossing. After the impact, the bus was thrown to the right side of track no. 2, in the direction of the train, at about 100 meters from the axis of the crossing.

1. The Infrastructure Manager PKP PLK Railway Line Department in Bydgoszcz will reassess the significance of the change, considering local conditions, in connection with the implementation of post-accident recommendations.

3. The road manager will develop a new traffic organization project in the area of the cat. B railway crossing, taking into account the topographical conditions of the intersection of the railway line and the road, in such a way that the vehicles coming from the direction of Bąkowski Młyn will have priority in passing through the crossing.

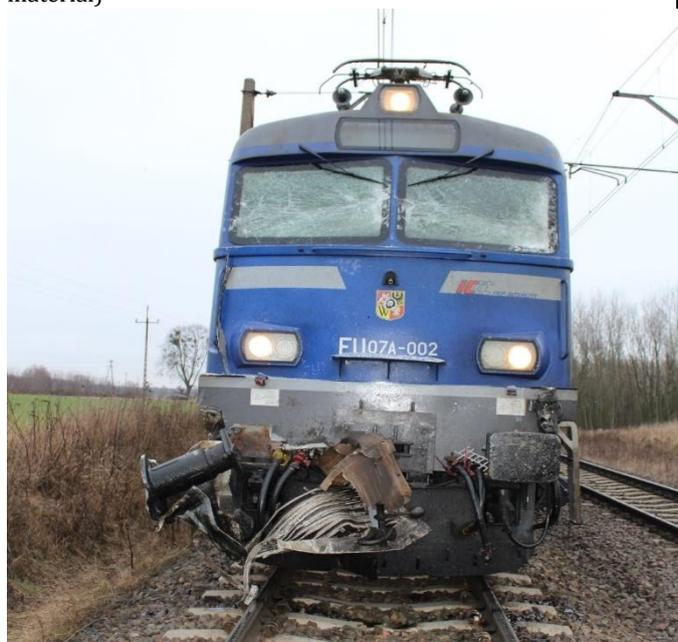
Photo 4 - Consequences of the occurrence (PKBWK's own material)

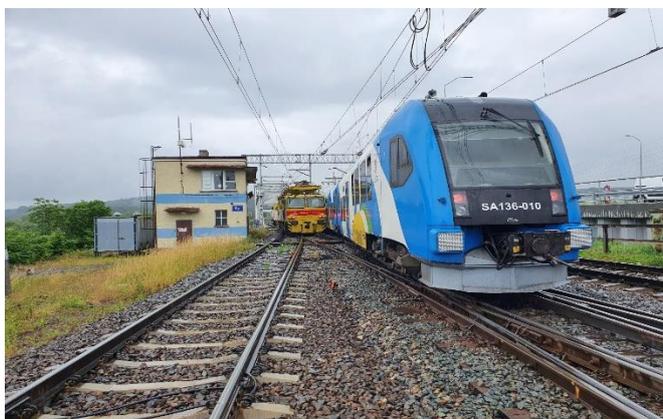
- As a result of the occurrence, two rail vehicles were damaged: ROM train 88628/9 led by rail bus type 219M and network train Rob.1 led by motorized car WM15P.00/HB-19.
- There were no casualties as a result of the occurrence.

Photo 5 - View of the vehicles after the occurrence (source: materials provided by the railway commission)

While the train ROM 88628/9 (POLREGIO Spółka Akcyjna) of line Szczecin Główny - Kołobrzeg was running on track no. 2 from Szczecin Port Central SPA station in the direction of Szczecin Zdroje junction post, at Regalica junction post in the area of turnout no. 3, a collision occurred with a network train Rob. standing on turnout no. 1.

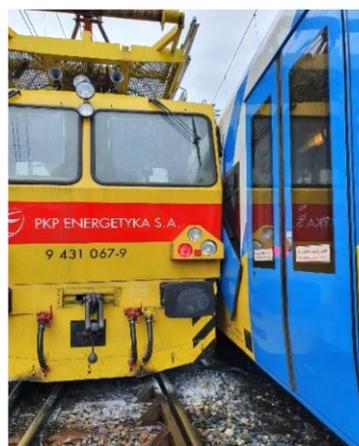
Photo 6 - View of the site of the vehicle clash (source: materials provided by the railway commission)
