**STATE COMMISSION ON RAILWAY ACCIDENT INVESTIGATION**  
**Ministry of Interior and Administration**

**REPORT No. PKBWK 01/2025**

**on the investigation of a serious railway accident occurring on  
10 January 2024 at 7:58 AM  
on the Rogóżno Wielkopolskie-Budzyń section, track No. 1, km  
56.055, of railway line No. 354, Poznań Główny POD-Piła Główna,  
level crossing of category D  
area of infrastructure operator PKP PLK S.A. Maintenance-of-Way Department in  
Poznań**

**WARSAW, 3 January 2025**

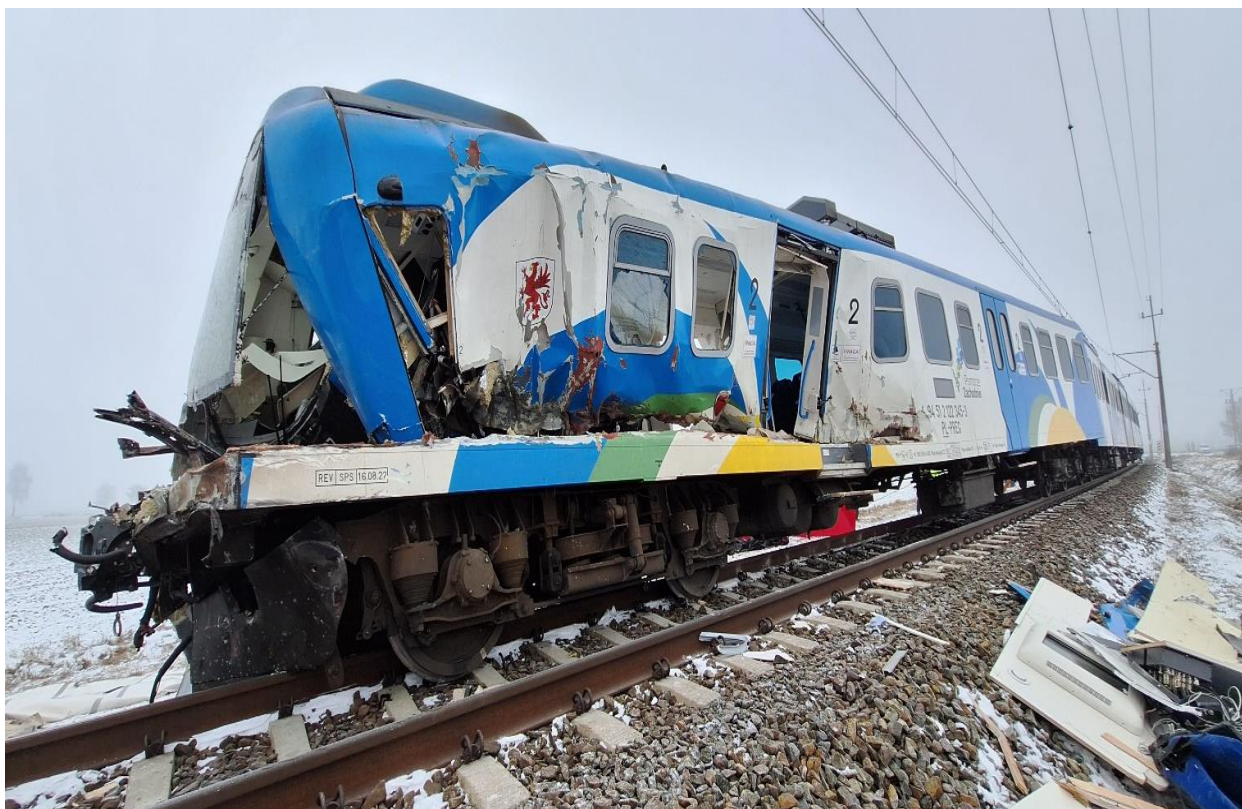
**Photo 1** – Consequences of the occurrence for the railway vehicle (source: PKBWK)

The train consisted of the EN57AL-1527 electric multiple unit whose carriage B was damaged and derailed (photos 1 and 2).

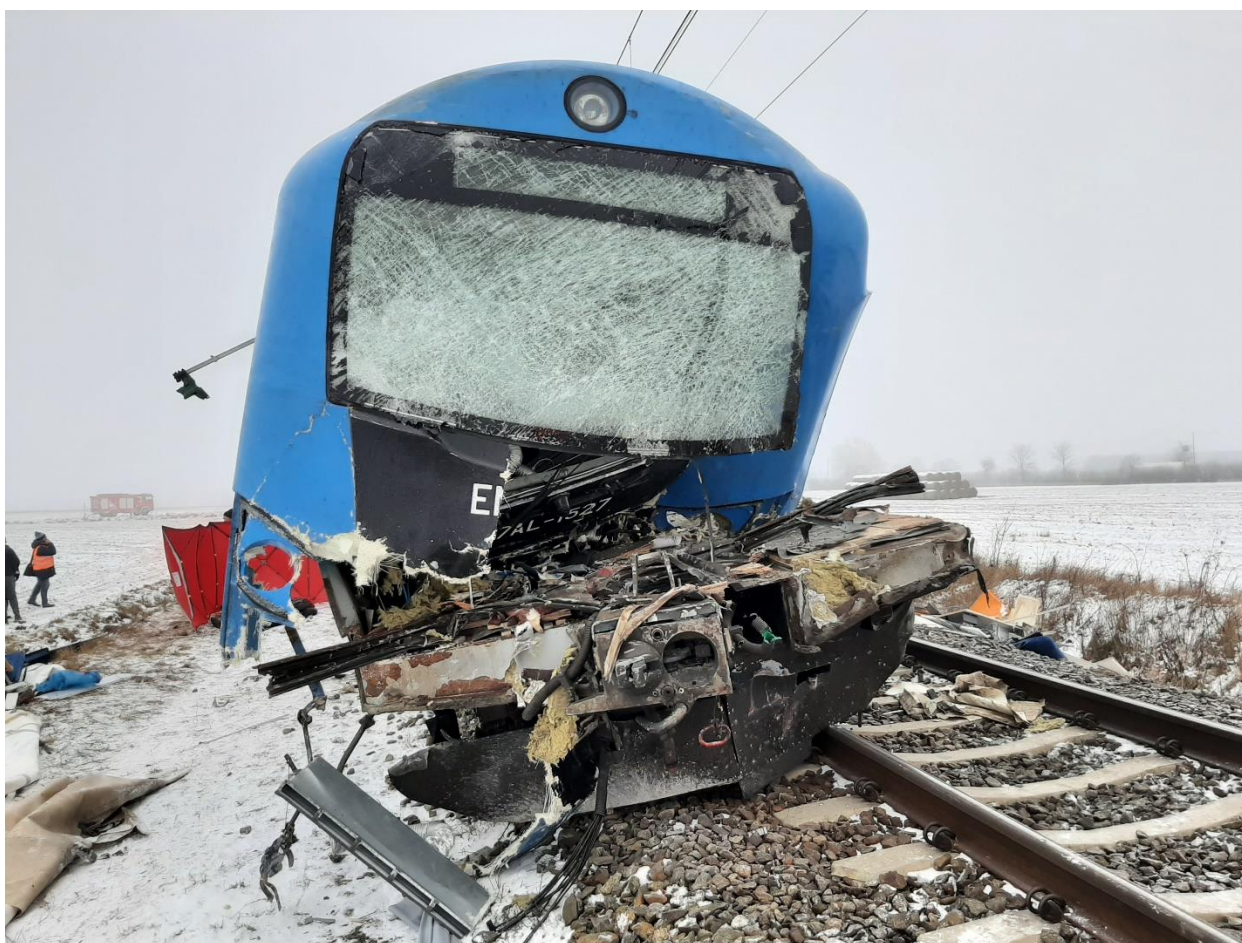
**Photo 2** – Consequences of the occurrence for the railway vehicle (source: PKBWK)

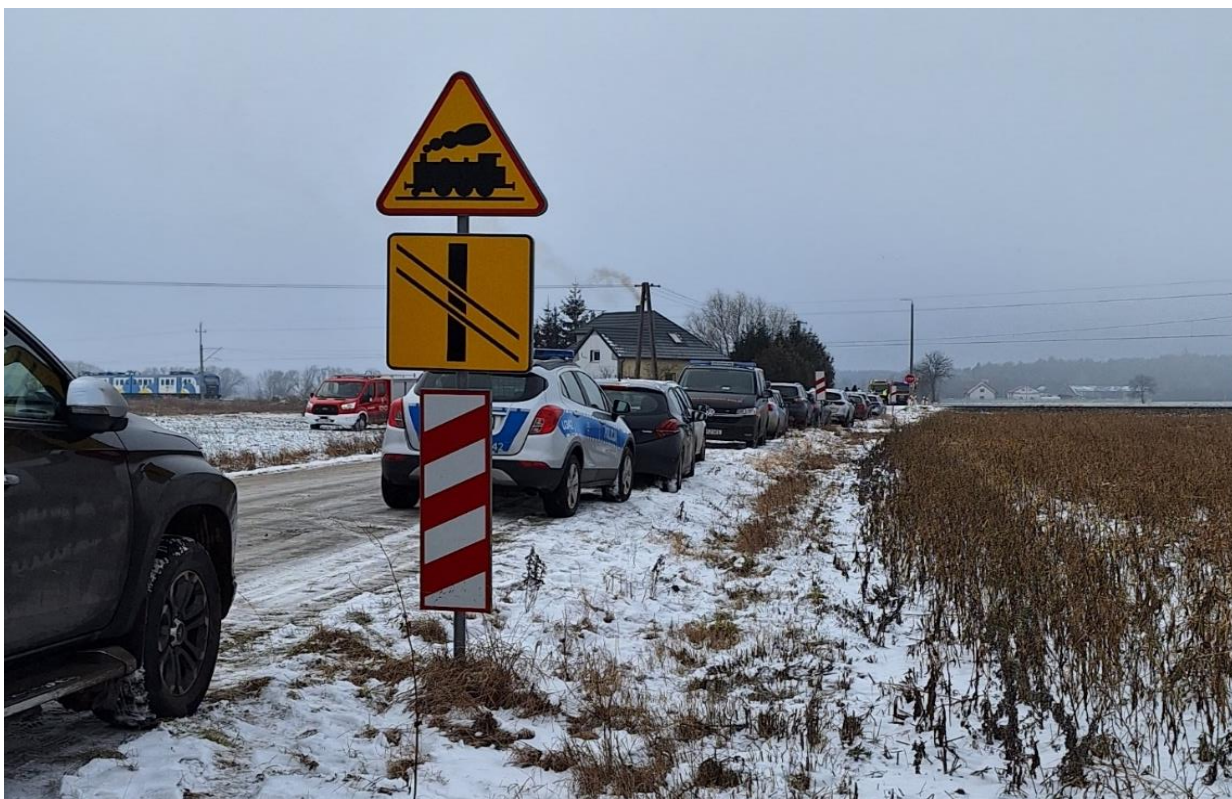
**Photo 3** – Marking of the road leading to the crossing (source: PKBWK)

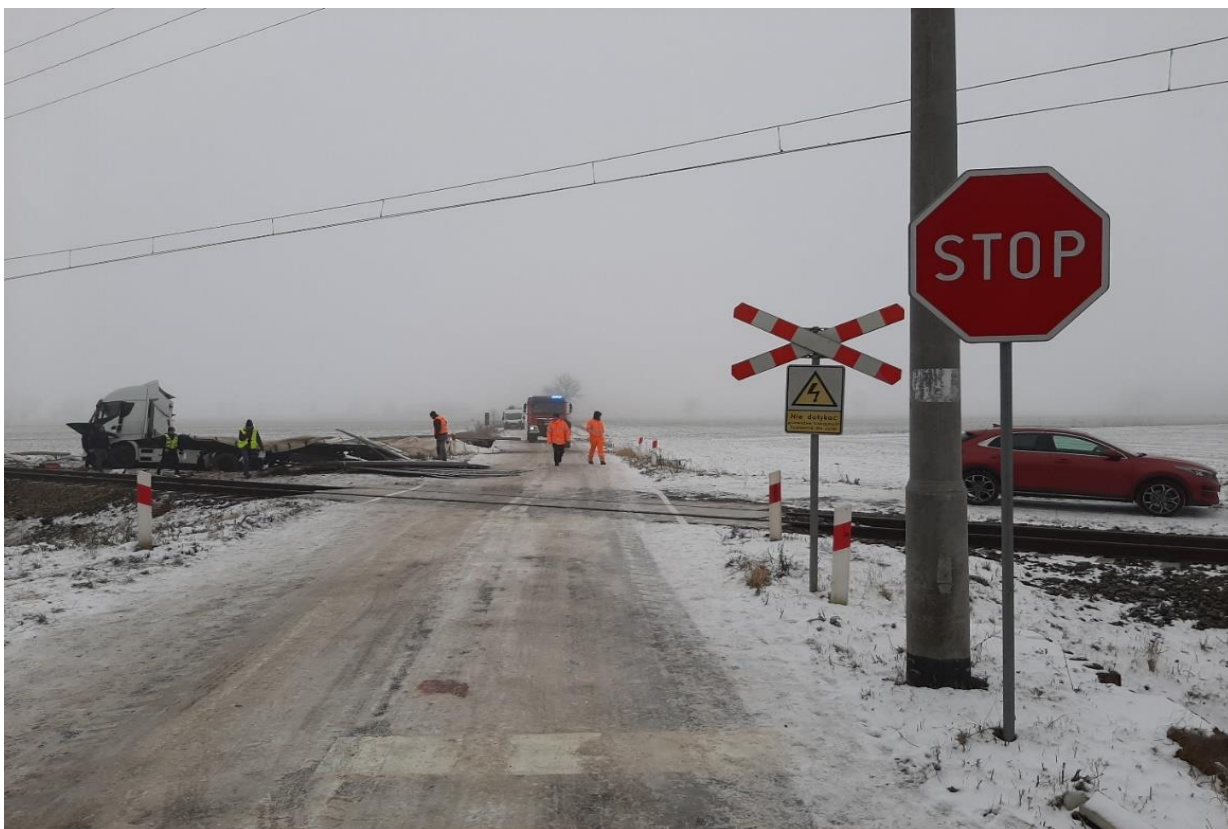
**Photo 4** – View of the crossing from the direction of travel of the road vehicle (source: PKBWK)

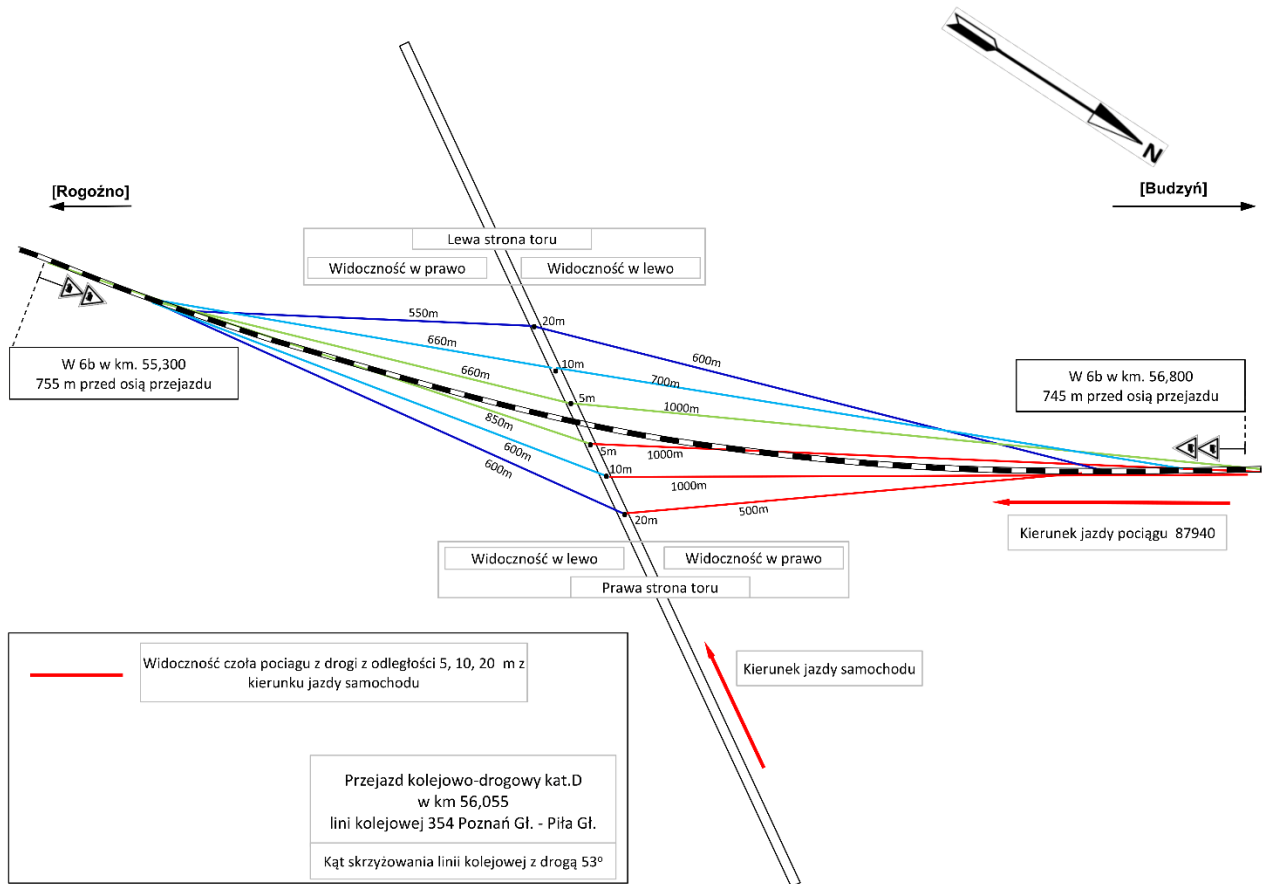
**Figure 2 – Sketch of visibility based on the crossing certificate (prepared by PKBWK)**

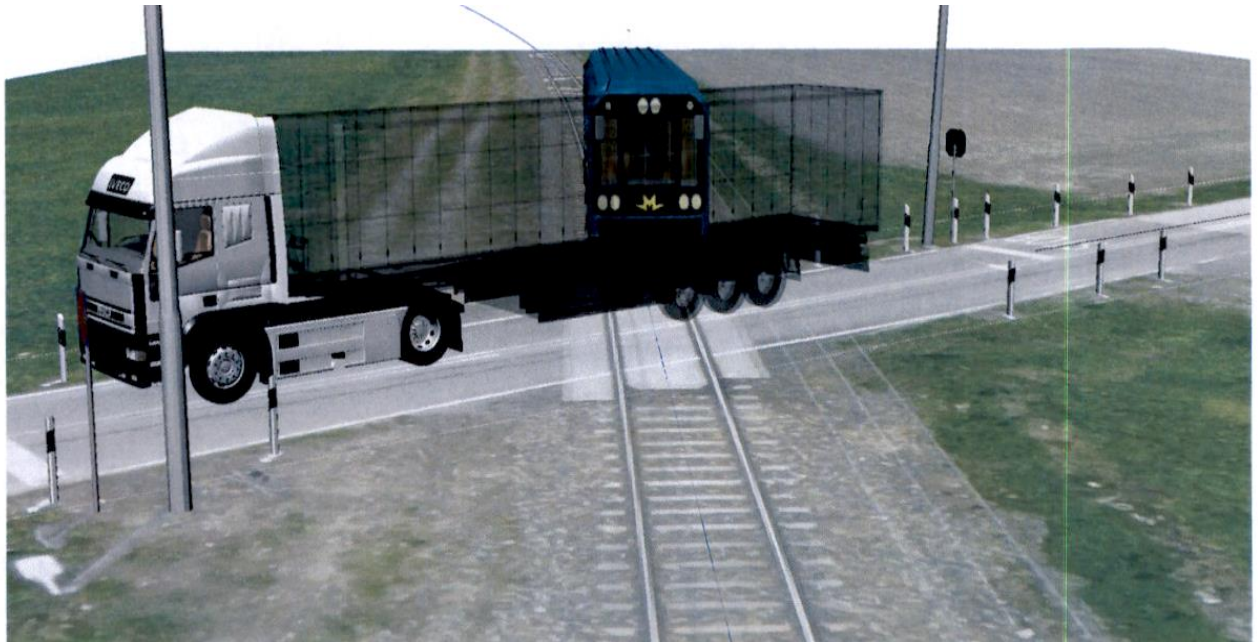
**Figure 3** – Relative positions of vehicles at the time of their collision (source: Opinion of a forensic expert)

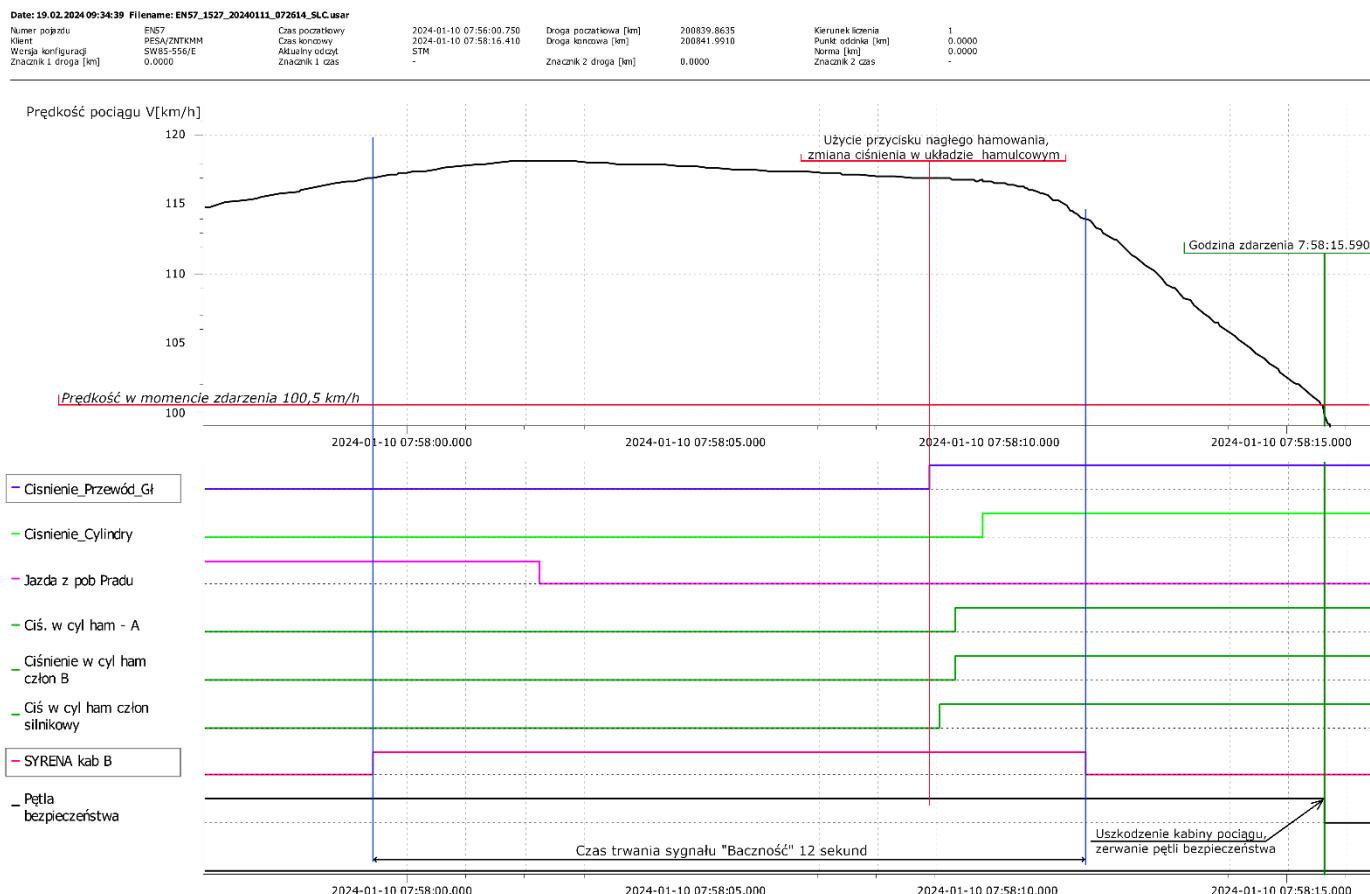
Figure 4 – Chart of the running data of the MOJ 87940 train (prepared by PKBWK)

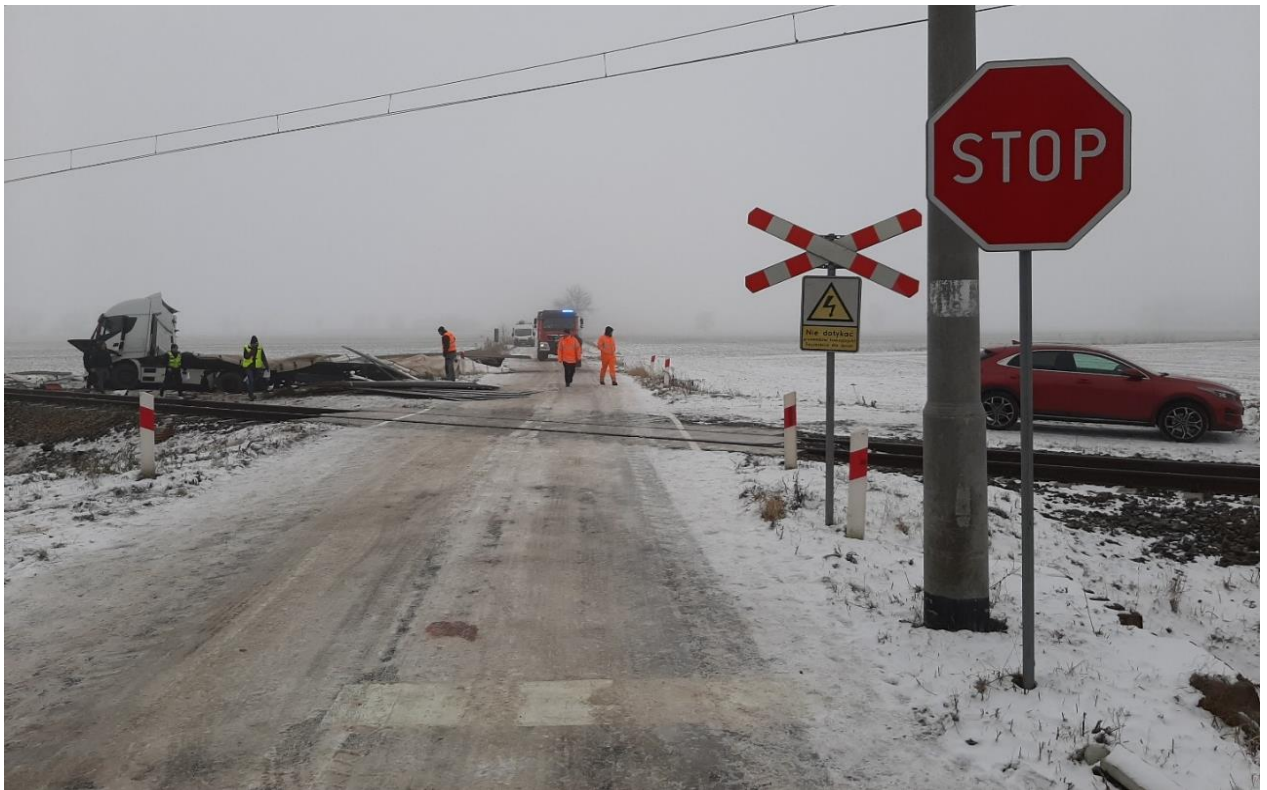
The approach road to the crossing from the direction of the moving road vehicle rises along a distance of 25 m and has a slope of 2.3%. The angle of intersection between the railway line and the road is 53°.

**Photo 5** – View of the crossing from the direction of travel of the road vehicle (source: PKBWK)

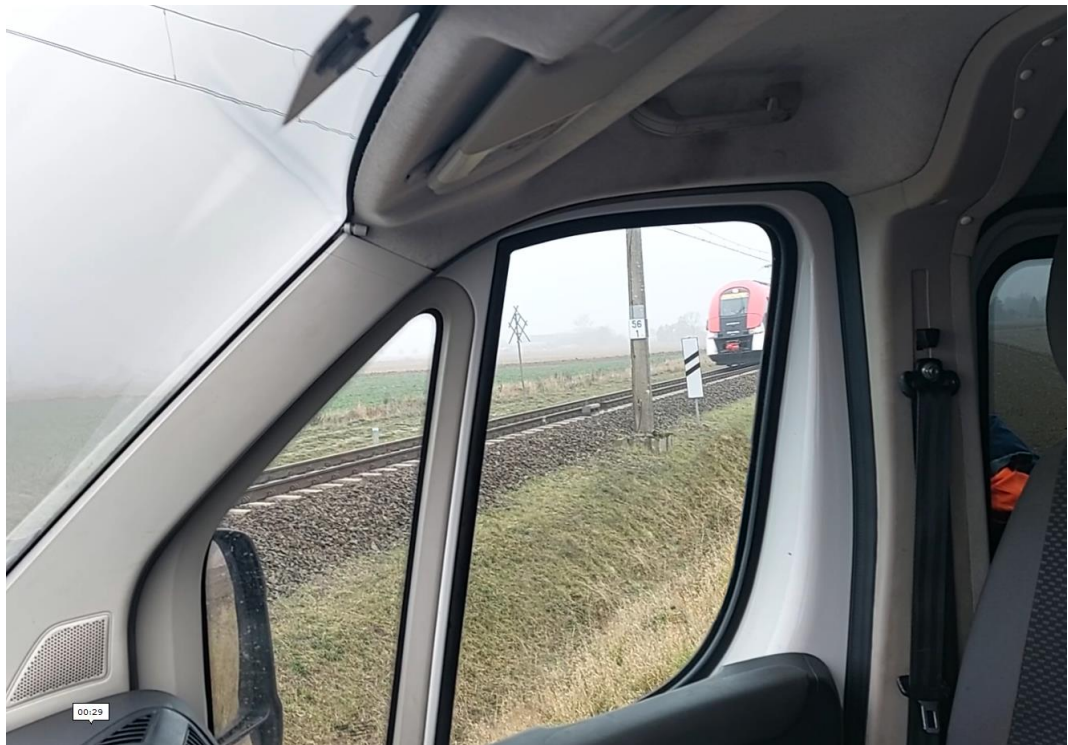
In order to verify the visibility of the front of the train from the road in conditions similar to those experienced by road users, the Investigation Team carried out a check from a Citroen Jumper road vehicle. When the car was stopped in front of the P-12 line, the visibility of the front of the train, with the driver leaning forward as much as possible, is shown in Photo 6. After taking measurements, the visibility of the front of the train from the van, taking into account the design of the cab, was found to be between 45–50 metres. A visibility measurement taken at the same location (ahead of the P-12 line) but from the height of a pedestrian confirmed the values in the level crossing certificate (photo 9). The difference in visibility of the train front from the car and from the observation point according to the rules of the Regulation is between 950–955 m. As can be seen from the measurements, checking visibility only from a height of 1–1.2 m above the

centreline of the lane, as envisaged by the legislator, cannot – in the opinion of the Investigation Team – be considered representative of the conditions similar to those experienced by road users. Differences in measurements amounting to up to 2000% are too large to be considered representative. The visibility of the train front

**Photo 6** – View from the driver's position in the Citroen Jumper car (source GDPWK).

In light of the foregoing, the Investigation Team recommends that the Minister of Infrastructure analyse the *Regulation of the Minister of Infrastructure and Development of 20 October 2015 on the technical conditions to be met by crossings of railway lines and sidings with roads, and on their positioning* (Journal of Laws of 2015, item 1744, as amended) to determine if it is necessary to add specific requirements to check the visibility of the train front from the road and account for conditions similar to those experienced by road users (e.g., drivers of various road vehicles).

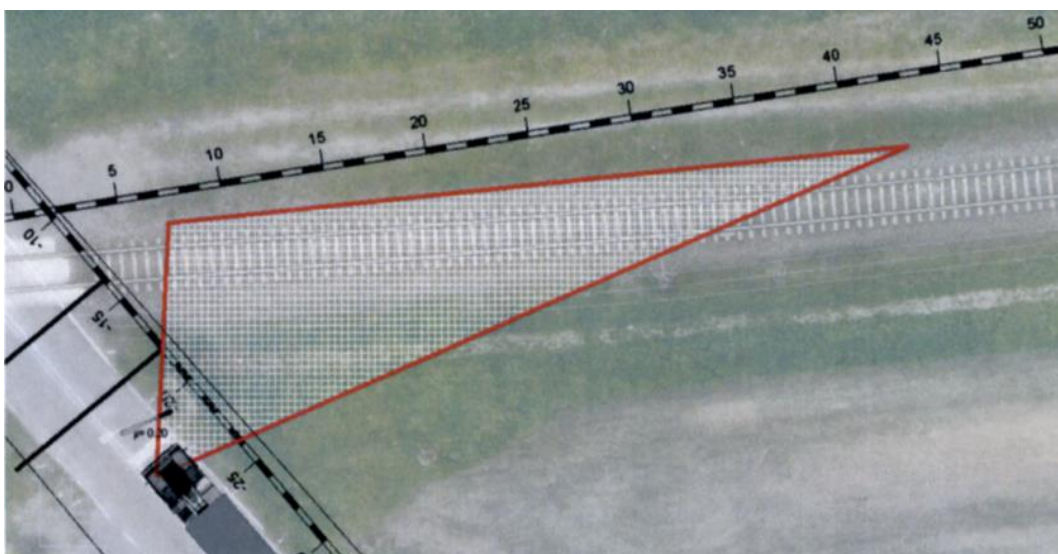
**Photo 8** – Determined field of view from the position of the truck driver (source: Opinion of a forensic expert)

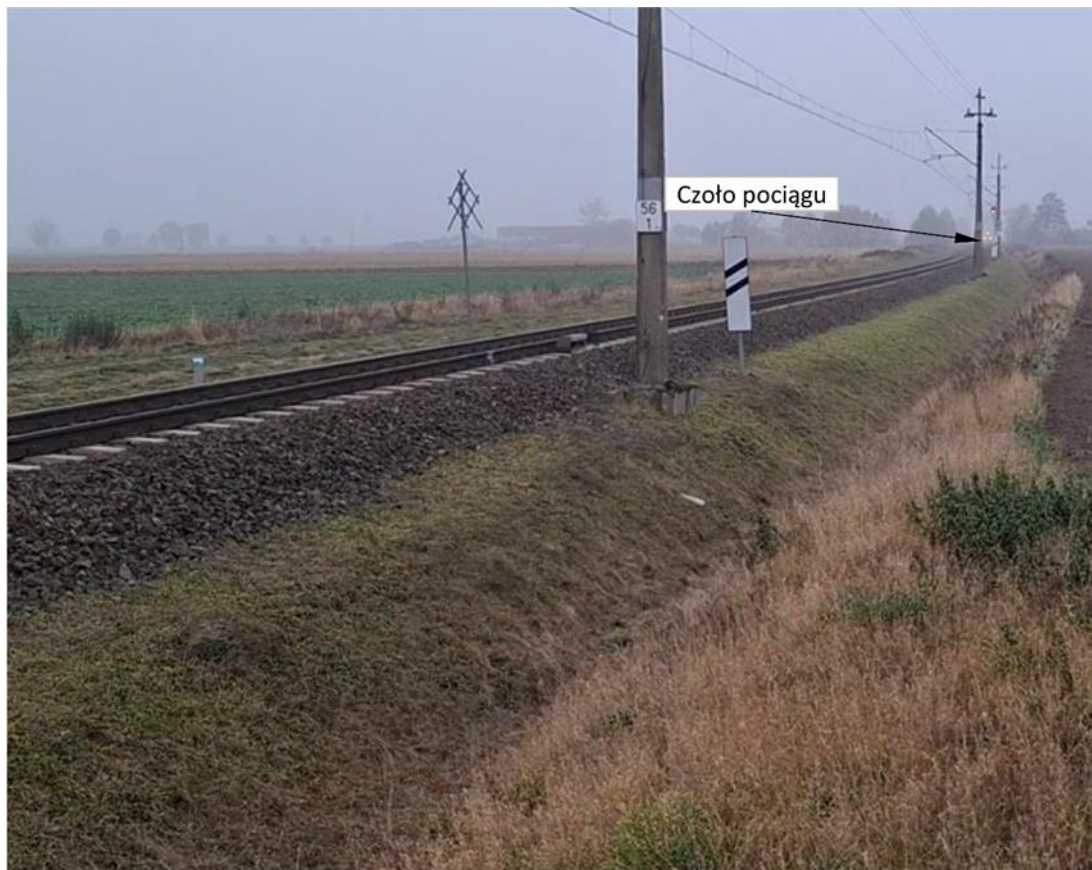
**Photo 9** – Visibility of the train front from the pedestrian’s position (source: GDPWK)
