PHOTO DOCUMENTATION

Appendix no. 2

to the Final Report on implementation of measures determined in EMP
for the Contract 3A.1 – Works Contract 3A.1/1

Odra-Vistula Flood Management Project

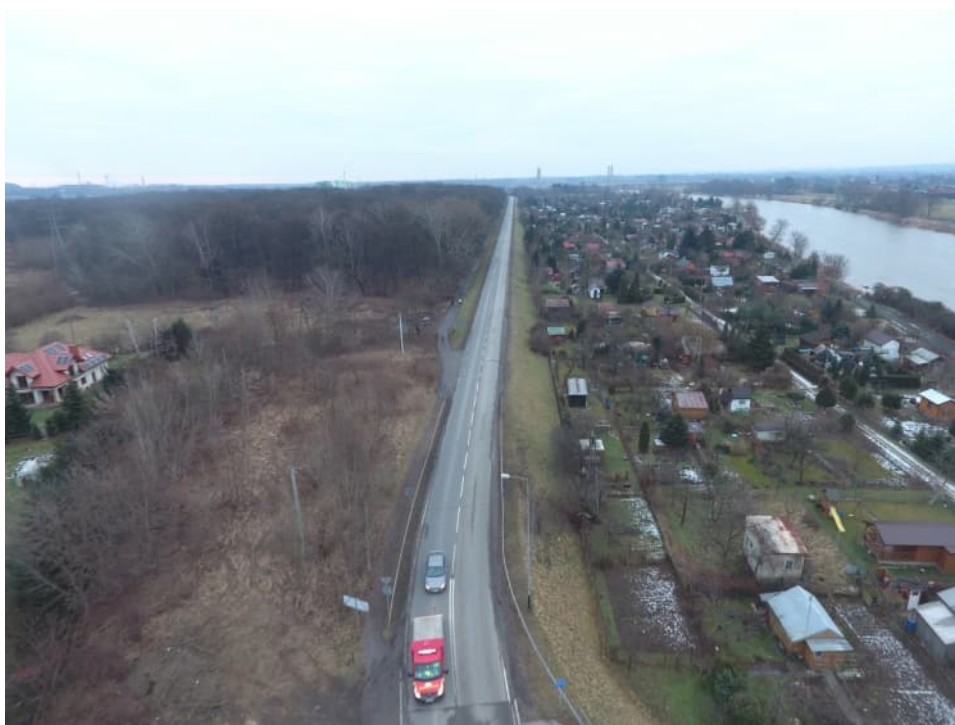
Fig. 1. Site condition in the first quarter of the works implementation period – the left Vistula embankment within *Section 1.1*, status in the first decade of February 2021 (downstream view).

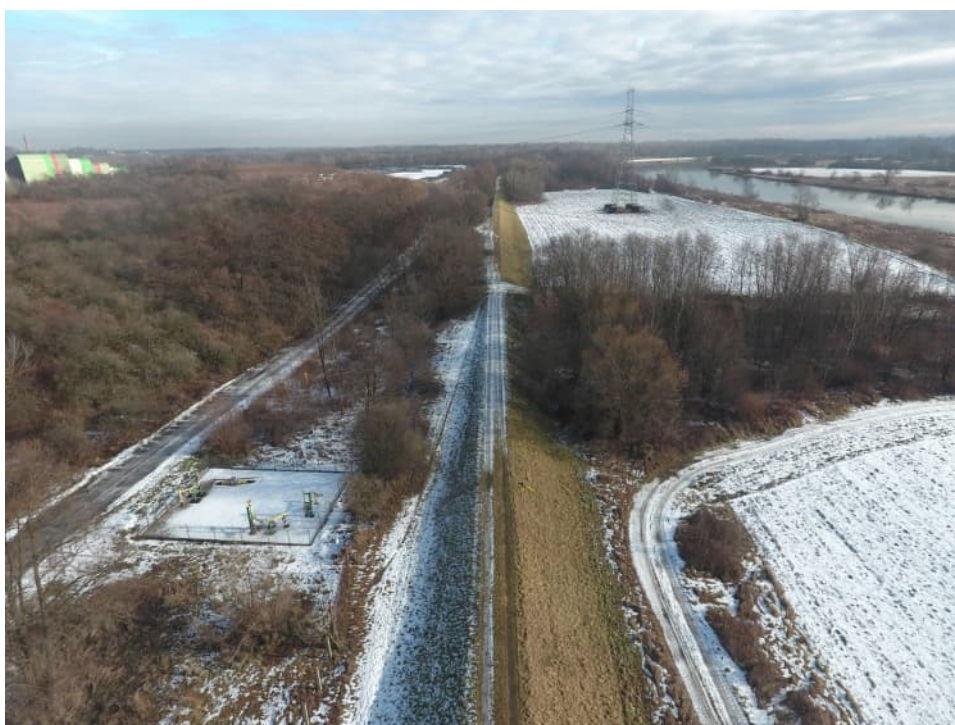
Fig. 2. Site condition in the first quarter of the works implementation period – the left Vistula embankment within *Section 1.2*, status in the first decade of February 2021 (downstream view).

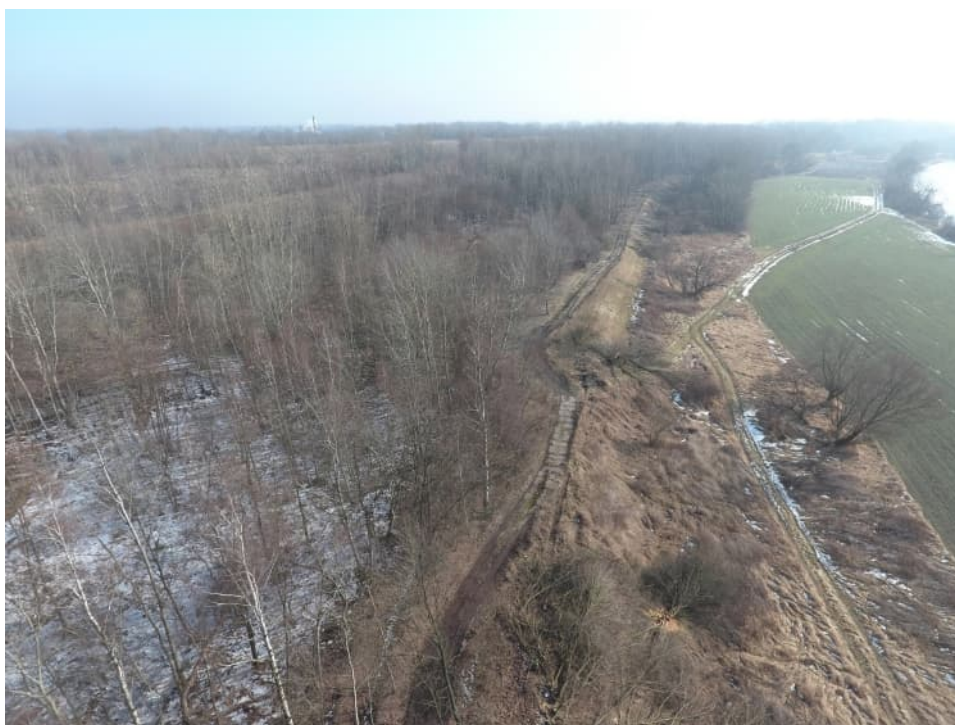
Fig. 3. Site condition in the first quarter of the works implementation period – the left Vistula embankment within *Section 1.3*, status in the third decade of February 2021 (downstream view).

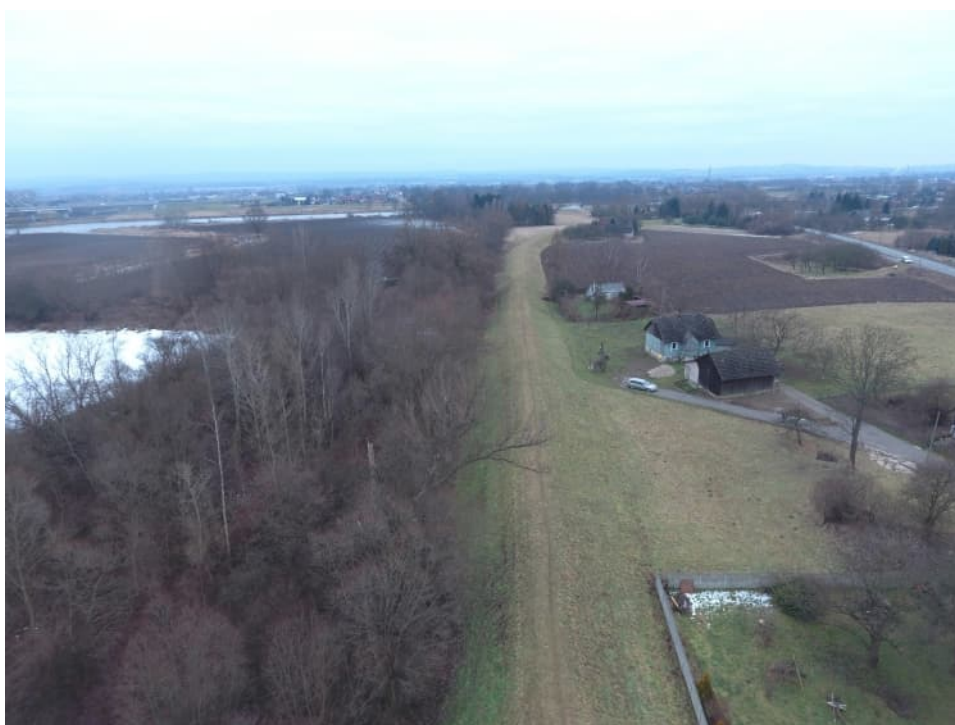
Fig. 4. Site condition in the first quarter of the works implementation period – the right Dłubnia embankment within *Section 1.4*, status in the first decade of February 2021 (downstream view).

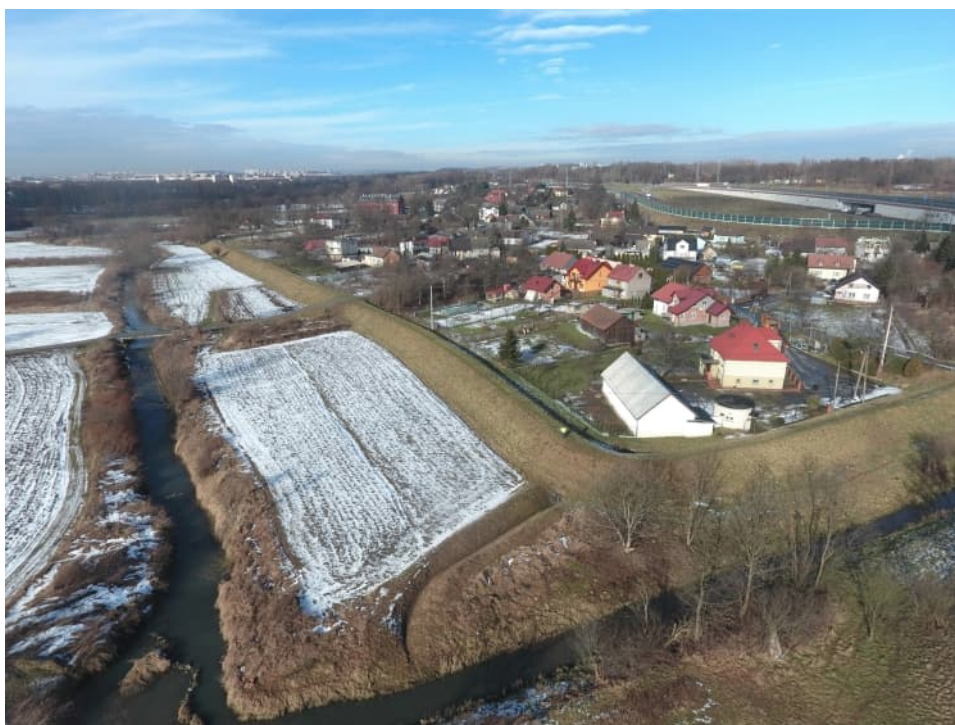
Fig. 5. Site condition in the first quarter of the works implementation period – the left Dłubnia embankment within *Section 1.5*, status in the first decade of February 2021 (upstream view).

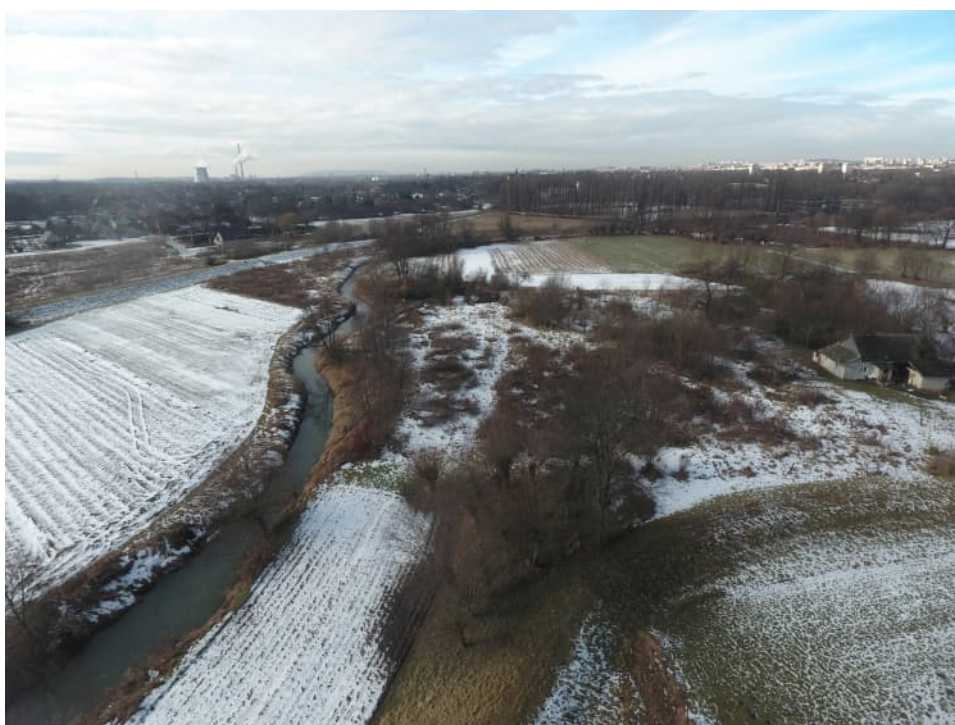
Fig. 6. Site condition in the first quarter of the works implementation period – area of the planned left Dłubnia embankment within *Section 1.6*, status in the first decade of February 2021 (upstream view).

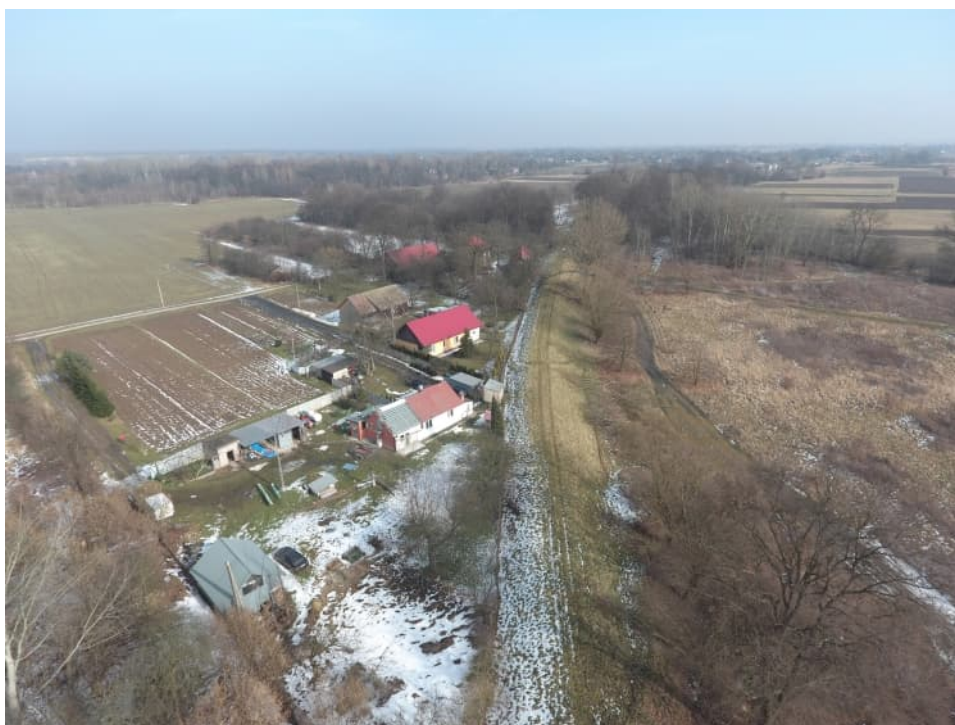
Fig. 7. Site condition in the first quarter of the works implementation period – the left Vistula embankment within *Section 2* – upper part, status in the third decade of February 2021 (downstream view).

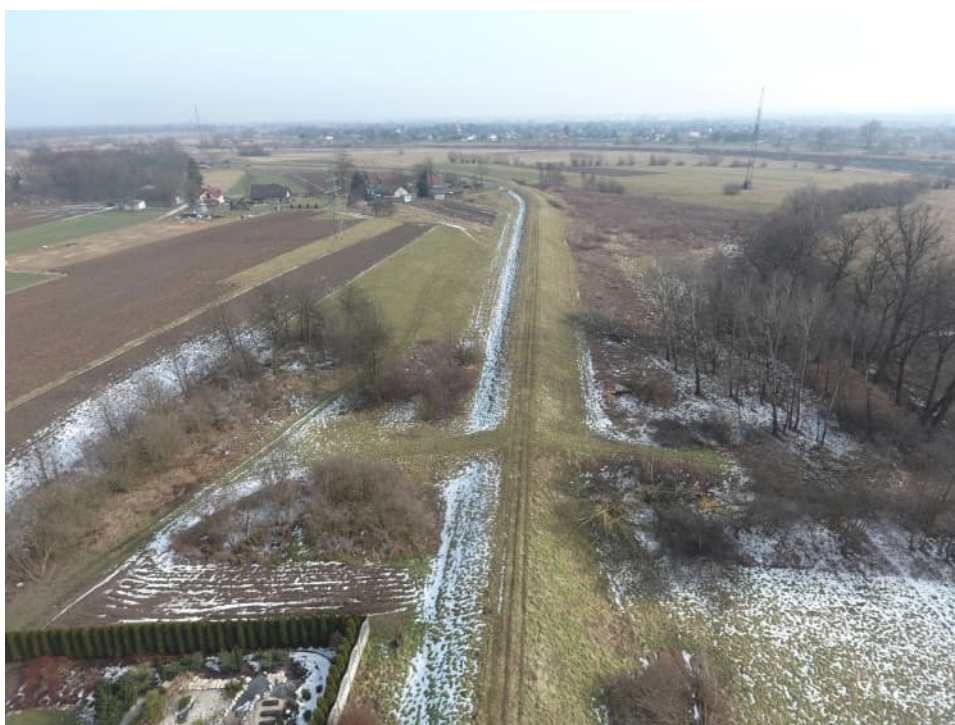
Fig. 8. Site condition in the first quarter of the works implementation period – the left Vistula embankment within *Section 2* – lower part, status in the third decade of February 2021 (downstream view).

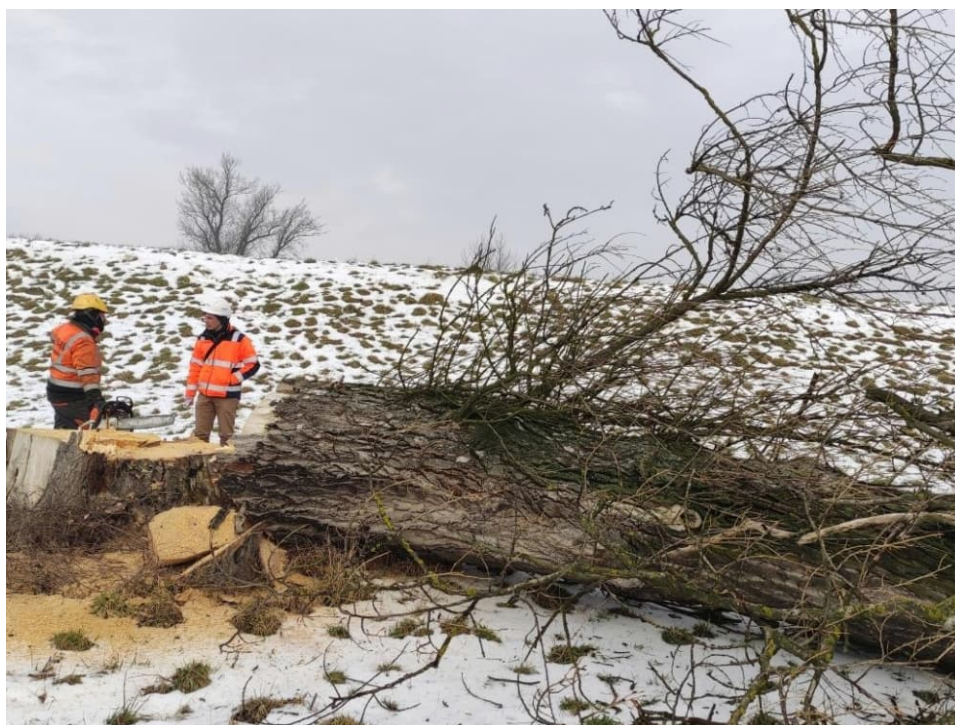
Fig. 9. Tree felling
– the left Vistula embankment within *Section 2*,
status in the second decade of February 2021 (downstream view).

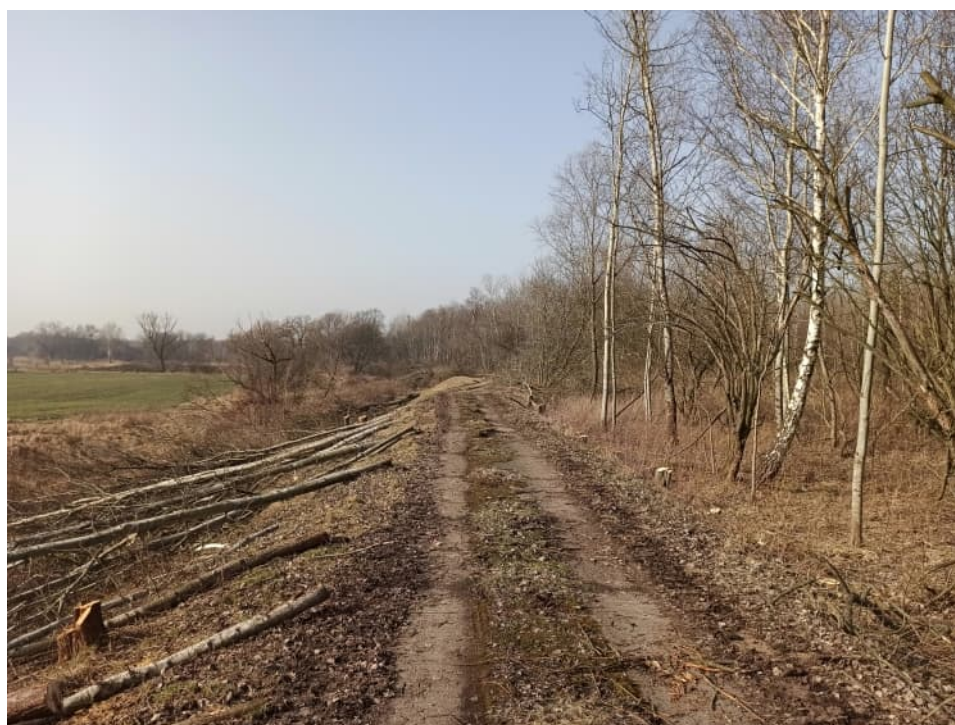
Fig. 10. Construction site after tree felling
– the left Vistula embankment within *Section 1.3*,
status in the third decade of March 2021 (upstream view).

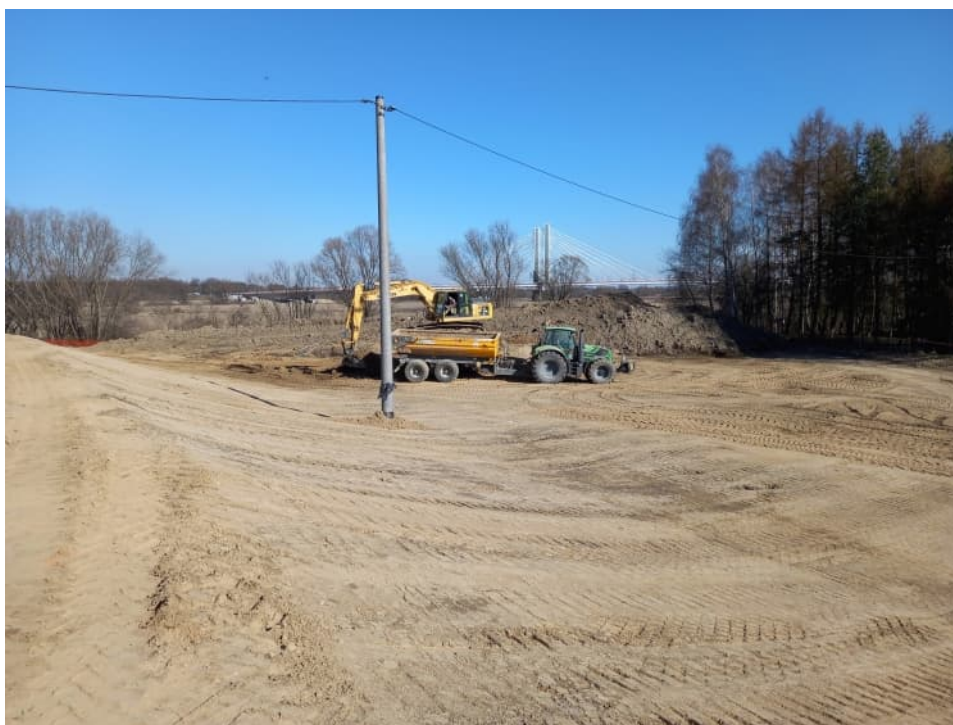
Fig. 11. Storage yard in the right embanked area of Dłubnia
– the right Dłubnia embankment within *Section 1.4*,
status in the third decade of March 2022 (upstream view).

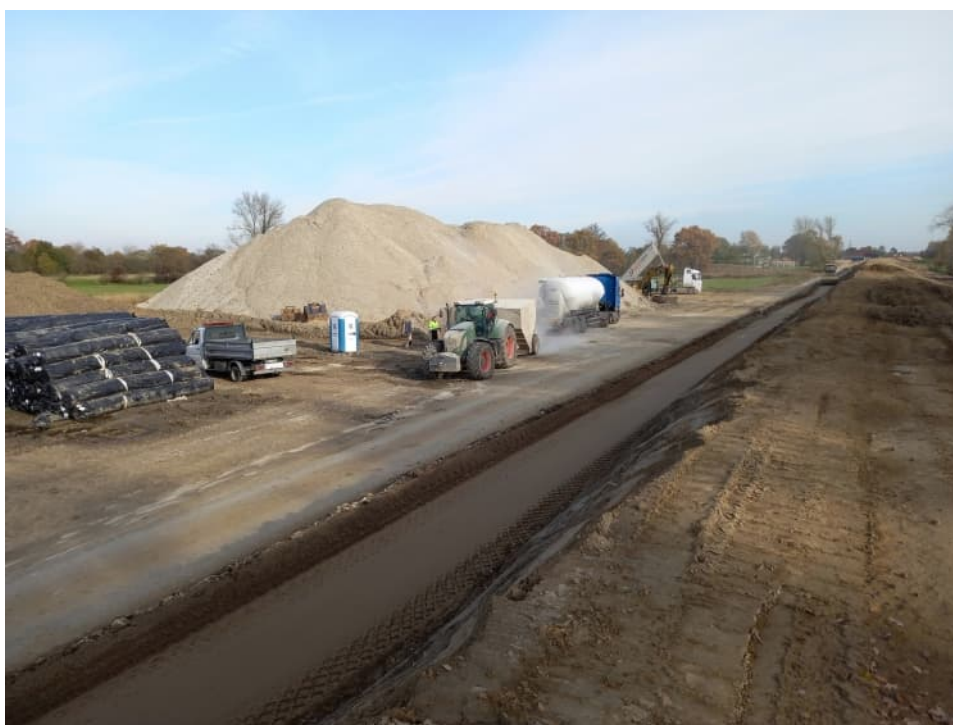
Fig. 12. Storage yard in the area beyond the left Vistula embankment
– the left Vistula embankment within *Section 2*,
status in the third decade of October 2021 (downstream view).

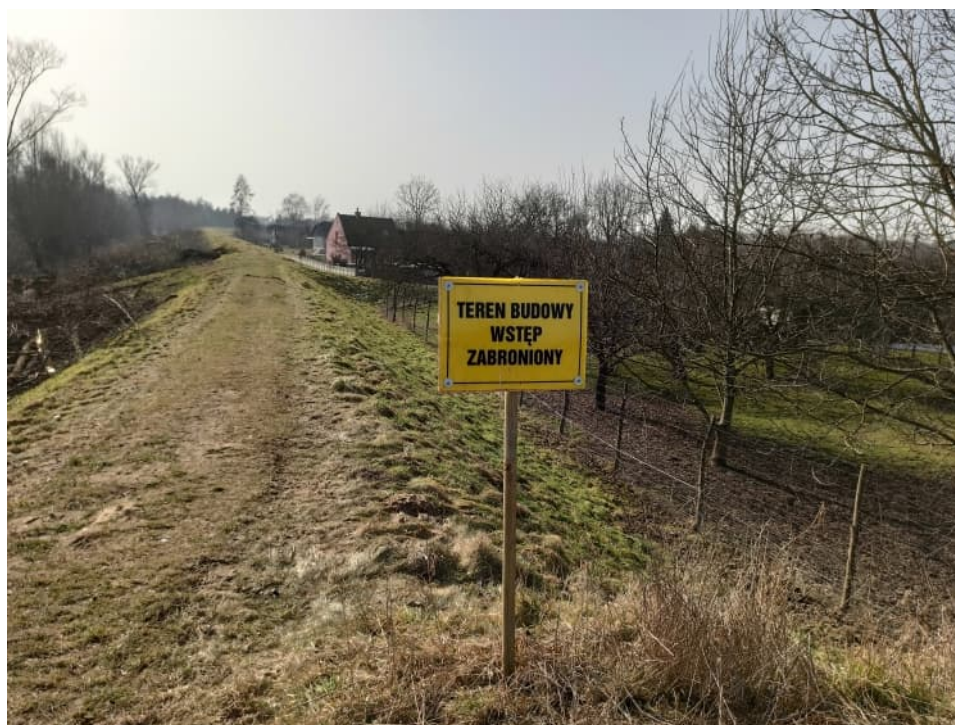
Fig. 13. Marking of the construction site
– the right Dłubnia embankment within *Section 1.4*,
status in the third decade of February 2021 (downstream view).

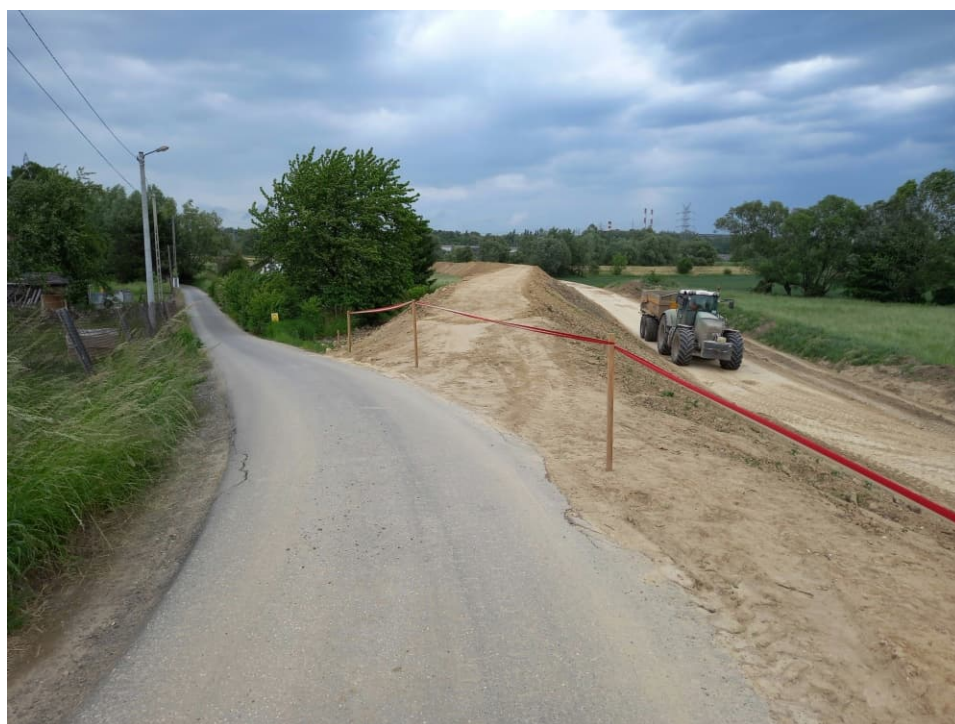
Fig. 14. Marking of the construction site
– the right Dłubnia embankment within *Section 1.4*,
status in the third decade of May 2022 (upstream view).

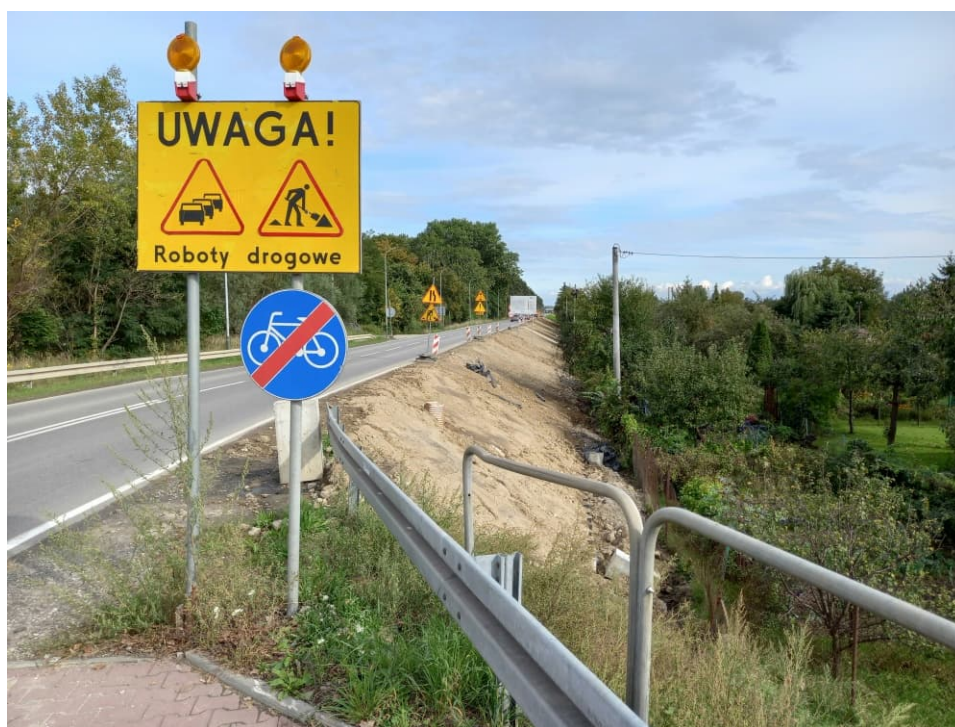
Fig. 15. Marking of public road in the vicinity of the construction site
– the left Vistula embankment within *Section 1.1*,
status in the third decade of September 2022 (downstream view).

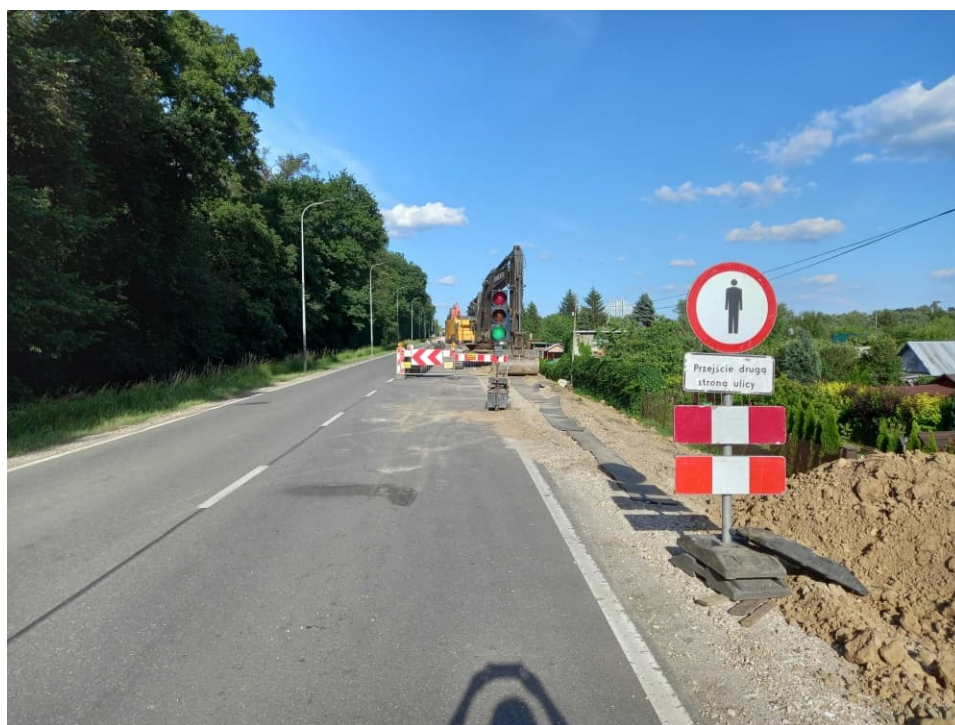
Fig. 16. Marking of public road in the vicinity of the construction site
– the left Vistula embankment within *Section 1.1*,
status in the third decade of June 2022 (upstream view).

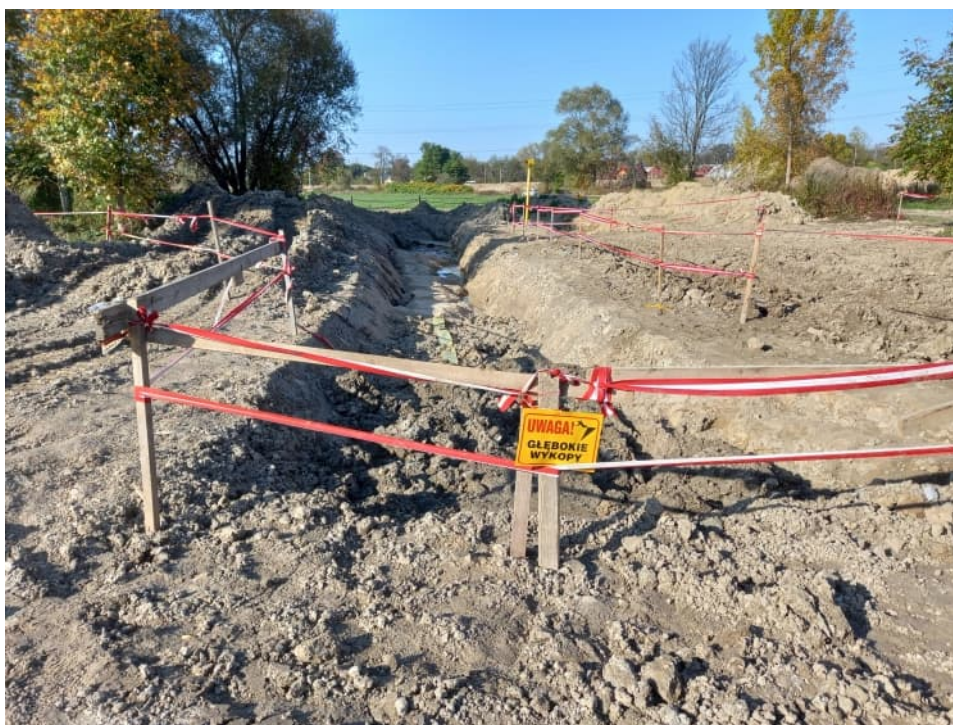
Fig. 17. Protection of hazardous sites
– the right Dłubnia embankment within *Section 1.4*,
status in the second decade of October 2022 (downstream view).

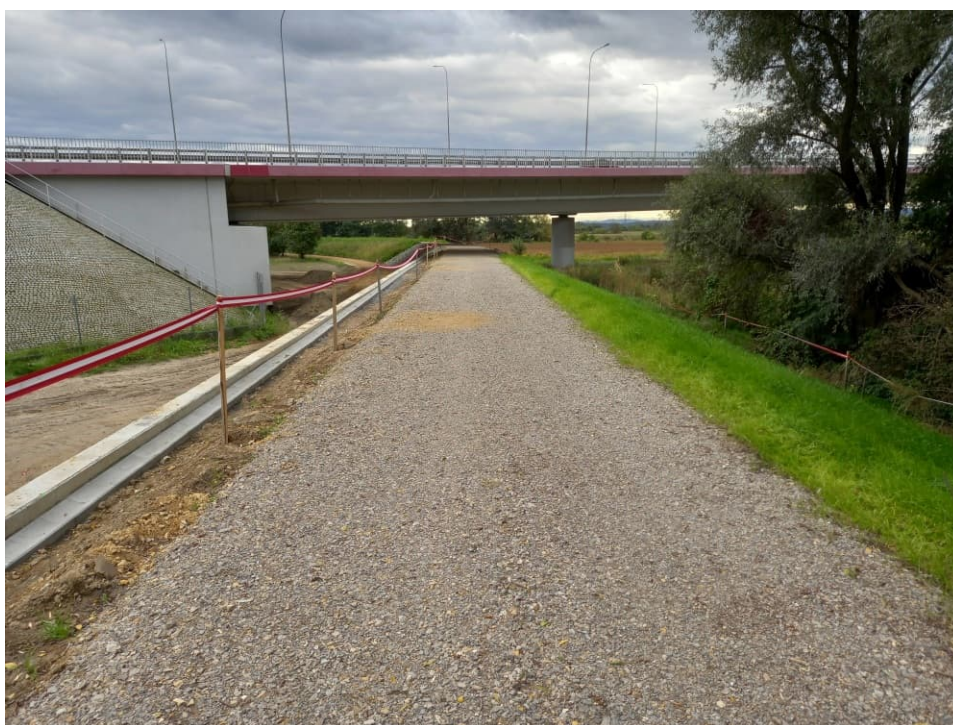
Fig. 18. Protection of hazardous sites
– the left Dłubnia embankment within *Section 1.5*,
status in the third decade of September 2022 (downstream view).

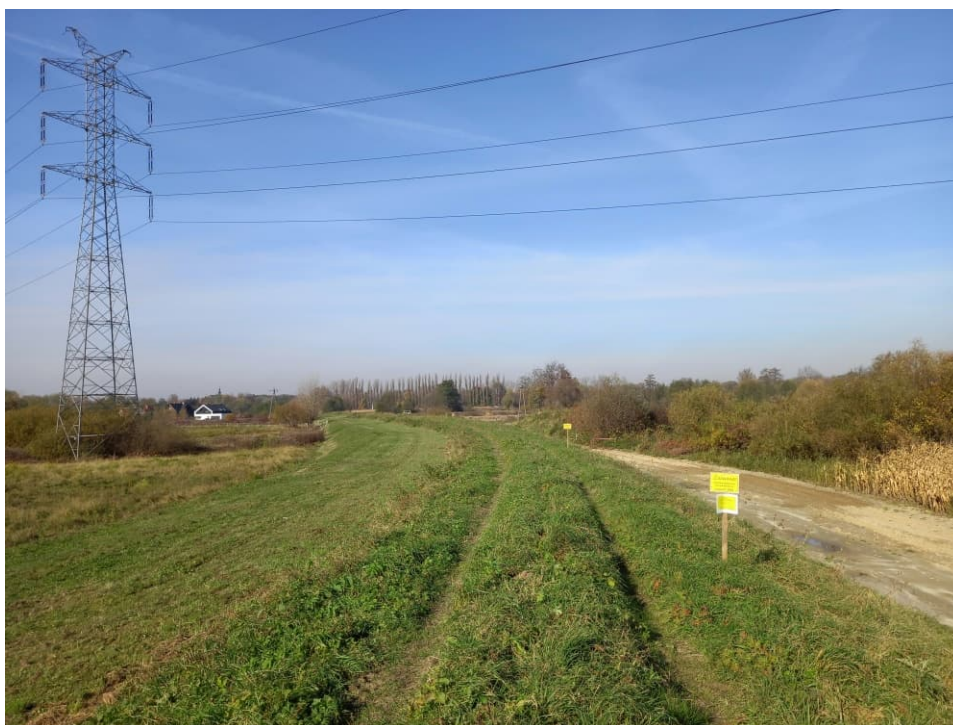
Fig. 19. Protection of hazardous sites under the power line
– the right Dłubnia embankment within *Section 1.4*,
status in the third decade of October 2021 (upstream view).

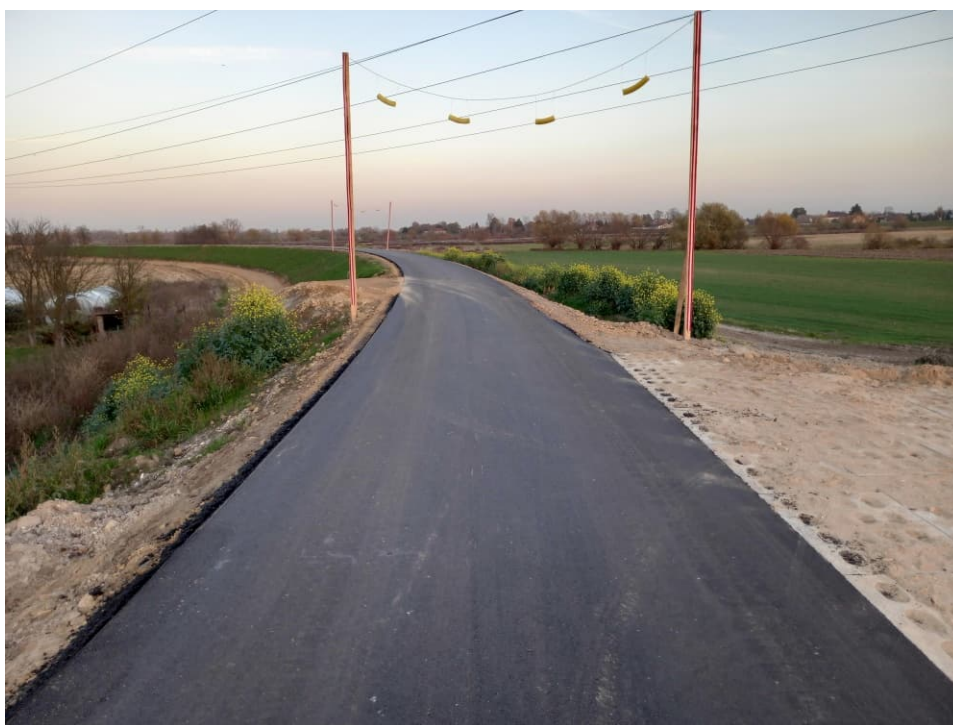
Fig. 20. Protection of hazardous sites under the power line
– the left Vistula embankment within *Section 2*,
status in the third decade of October 2022 (downstream view).

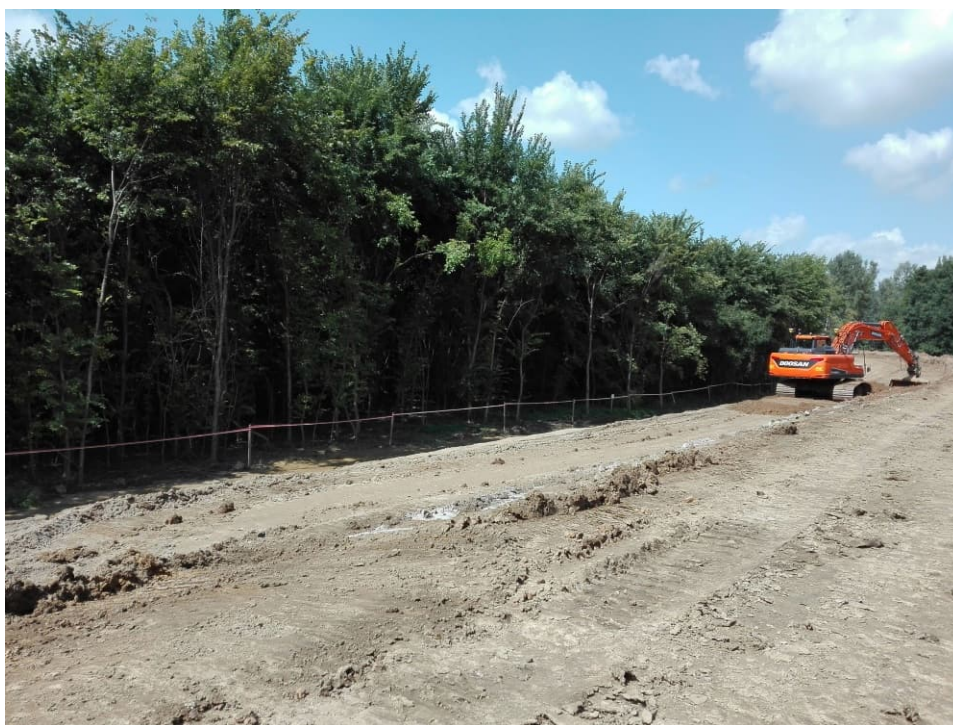
Fig. 21. Protection of trees and shrubs not intended to felling
– the left Vistula embankment within *Section 1.3*,
status in the second decade of August 2022 (upstream view).

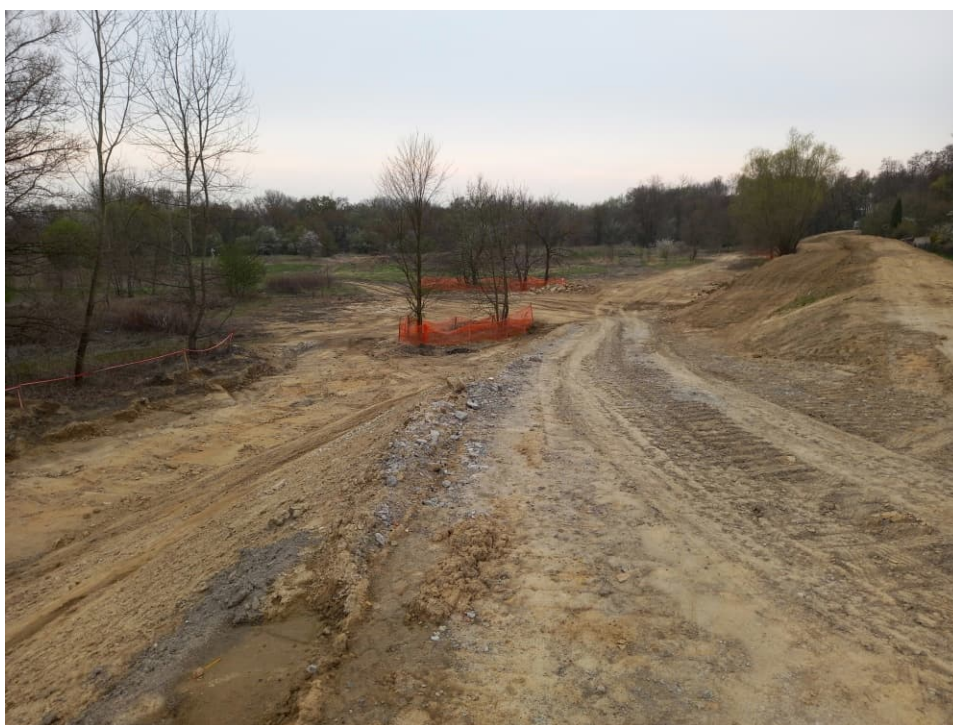
Fig. 22. Protection of trees and shrubs not intended to felling
– the left Vistula embankment within *Section 2*,
status in the second decade of April 2022 (upstream view).

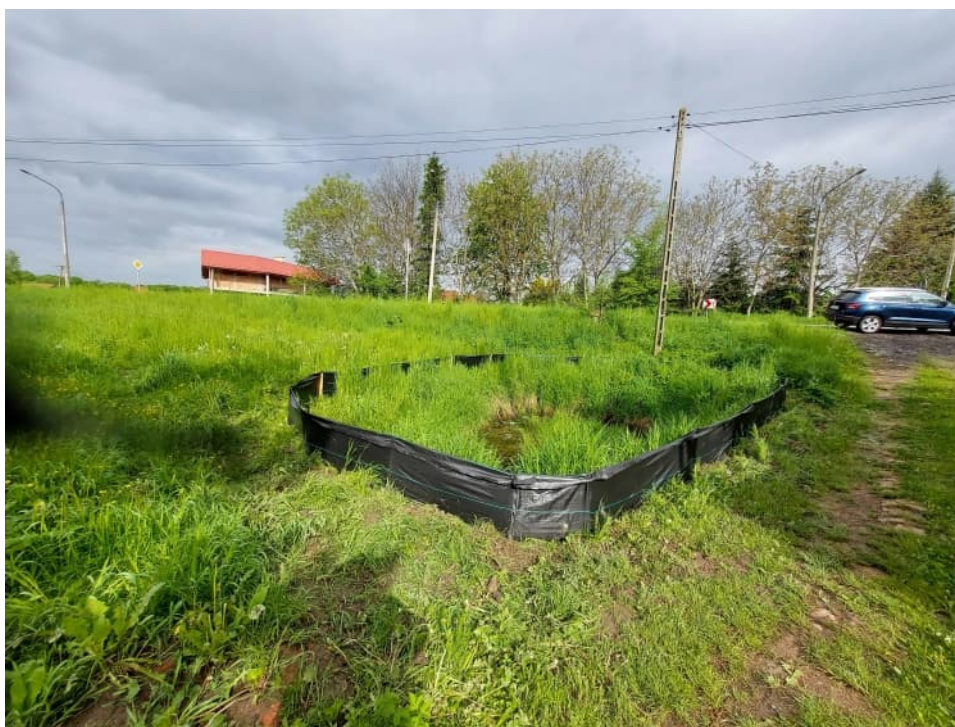
Fig. 23. Securing the breeding site of protected amphibian species
– access road to the storage yard on *Section 1.4*,
status in the second decade of May 2021 (upstream view).

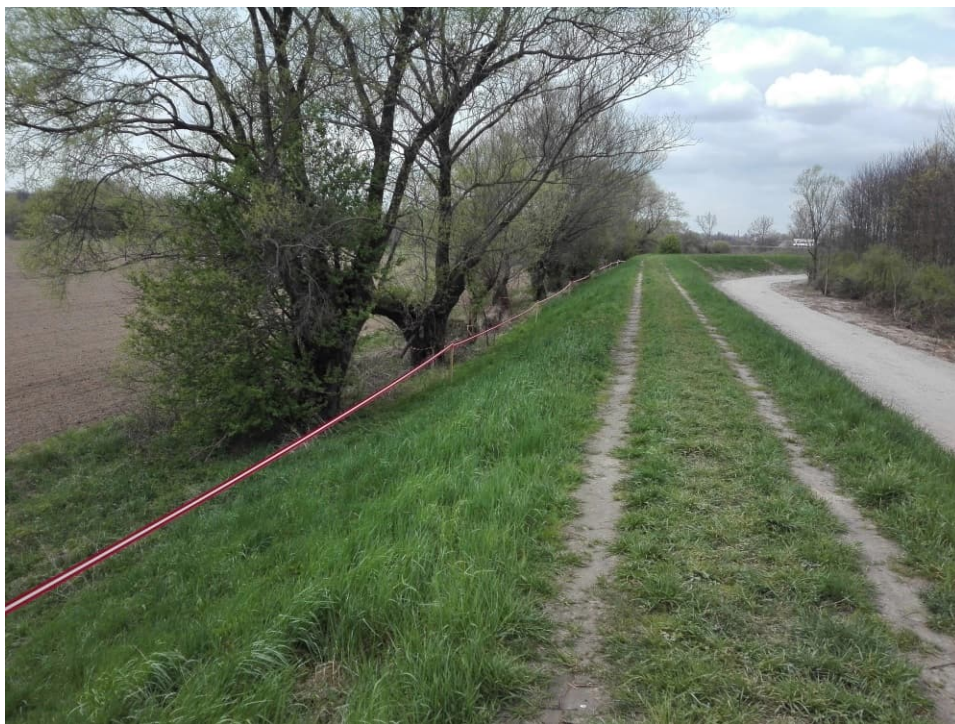
Fig. 24. Securing the breeding site of a protected beetle species
– the left Dłubnia embankment within *Section 1.5*,
status in the third decade of April 2021 (upstream view).

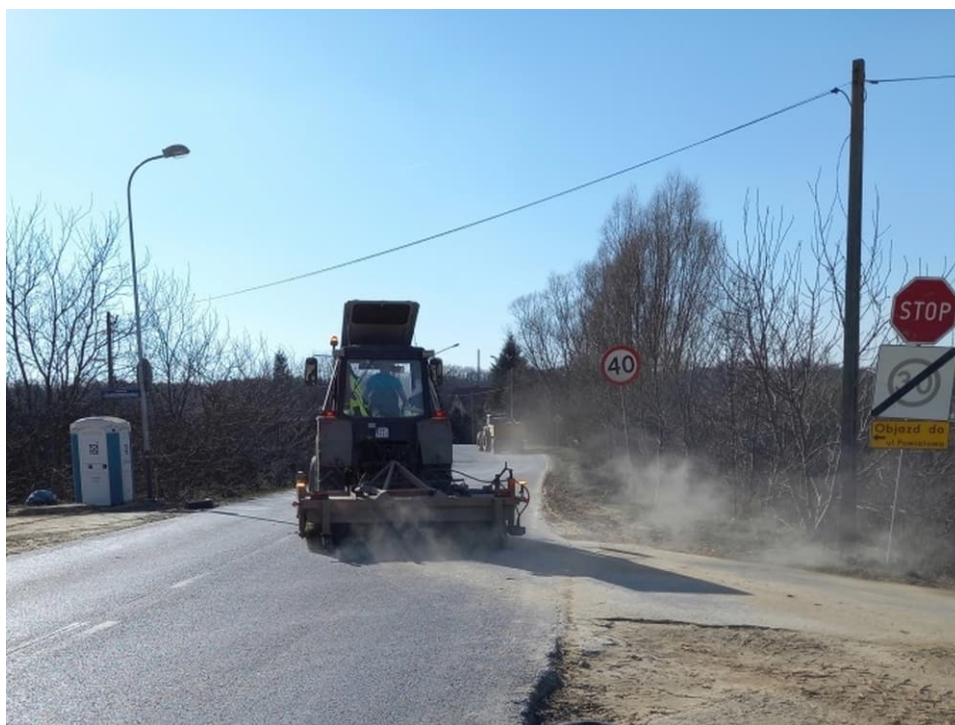
Fig. 25. Keeping public roads clean in the vicinity of the construction site – the right Dłubnia embankment within *Section 1.4*, status in the third decade of March 2022 (view towards the west).

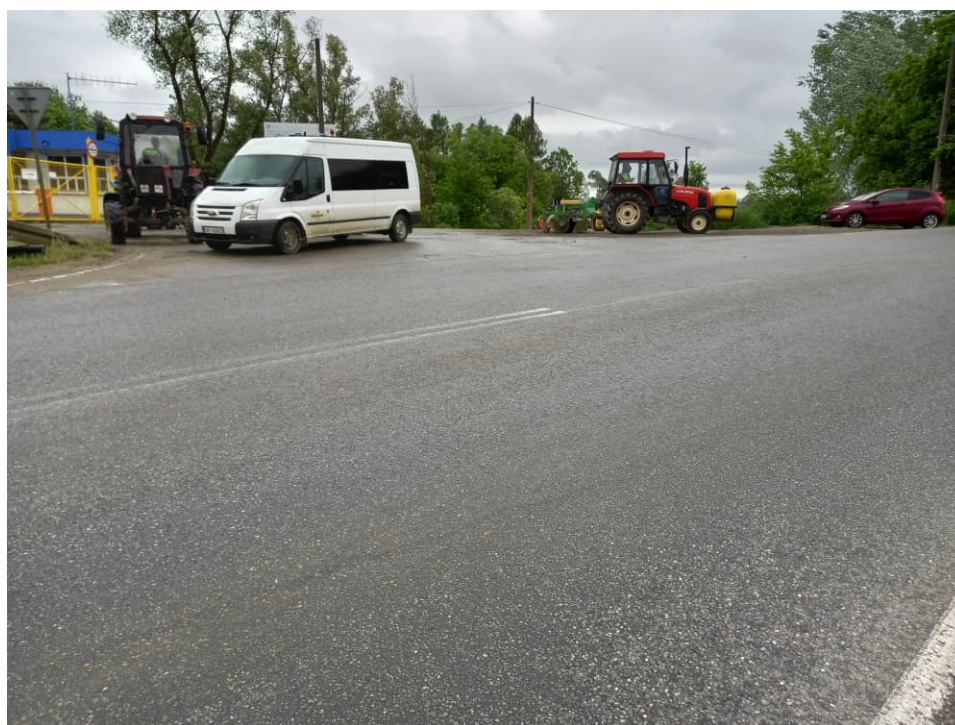
Fig. 26. Keeping public roads clean in the vicinity of the construction site – the left Dłubnia embankment within *Section 1.5*, status in the third decade of May 2022 (downstream view).

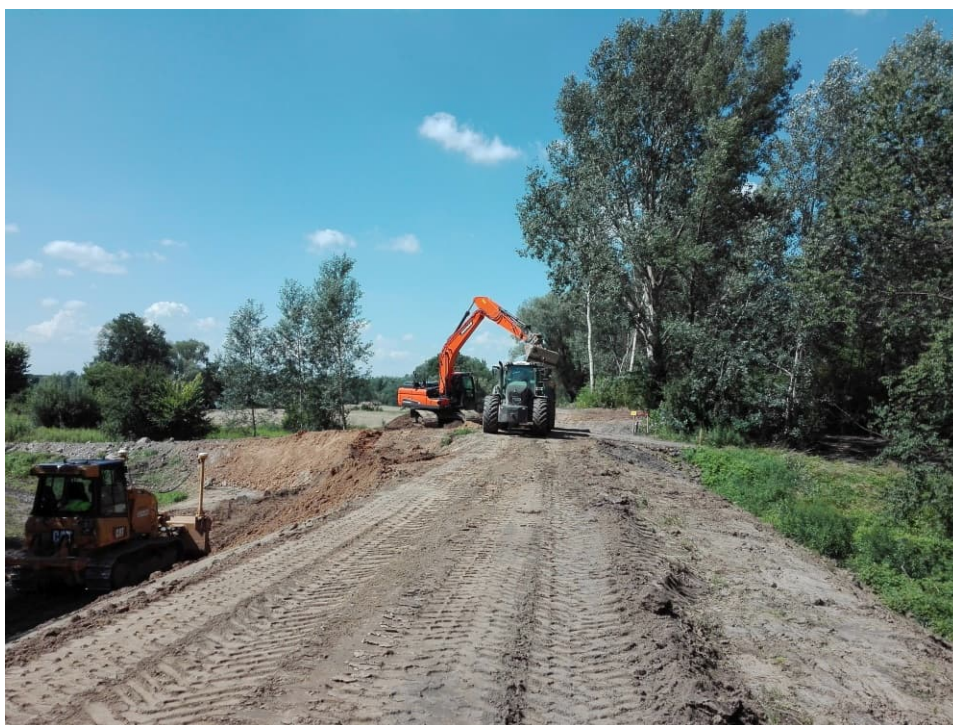
Fig. 27. Removal of a top soil layer
– the left Vistula embankment within *Section 1.3*,
status in the third decade of July 2021 (upstream view).

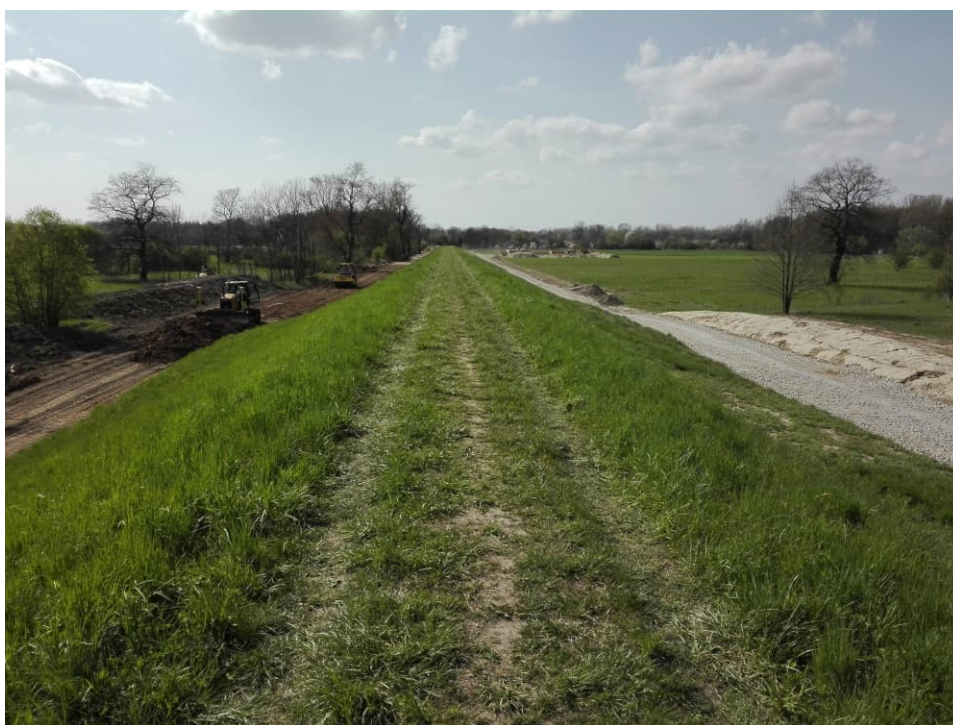
Fig. 28. Removal of a top soil layer
– the left Vistula embankment within *Section 2*,
status in the third decade of July 2021 (upstream view).

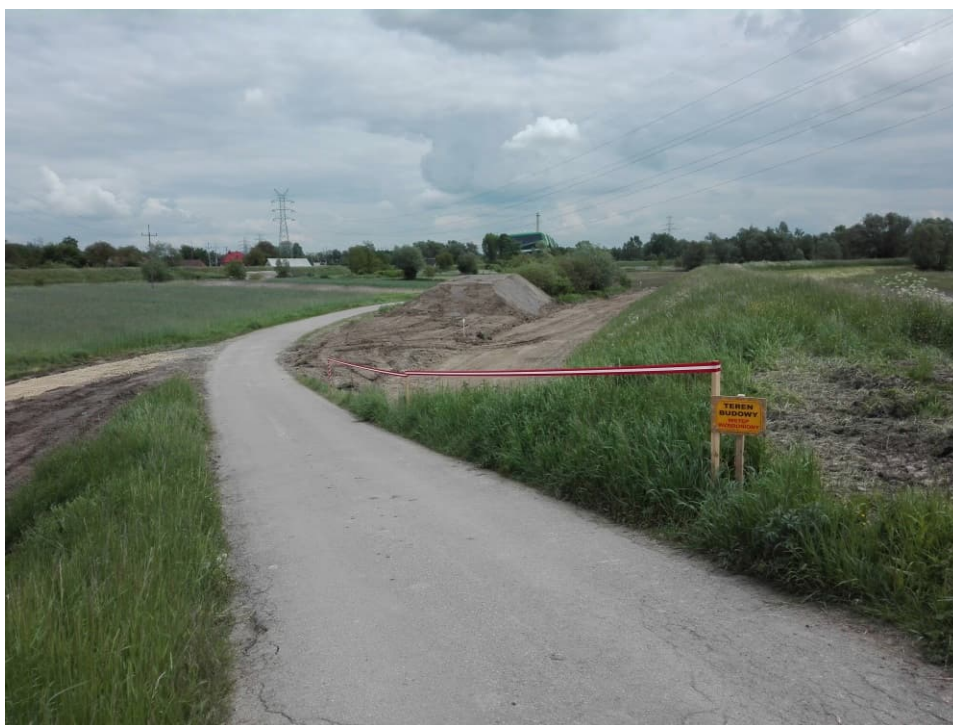
Fig. 29. Protection of top-soil piles
– the right Dłubnia embankment within *Section 1.4*,
status in the third decade of May 2022 (downstream view).

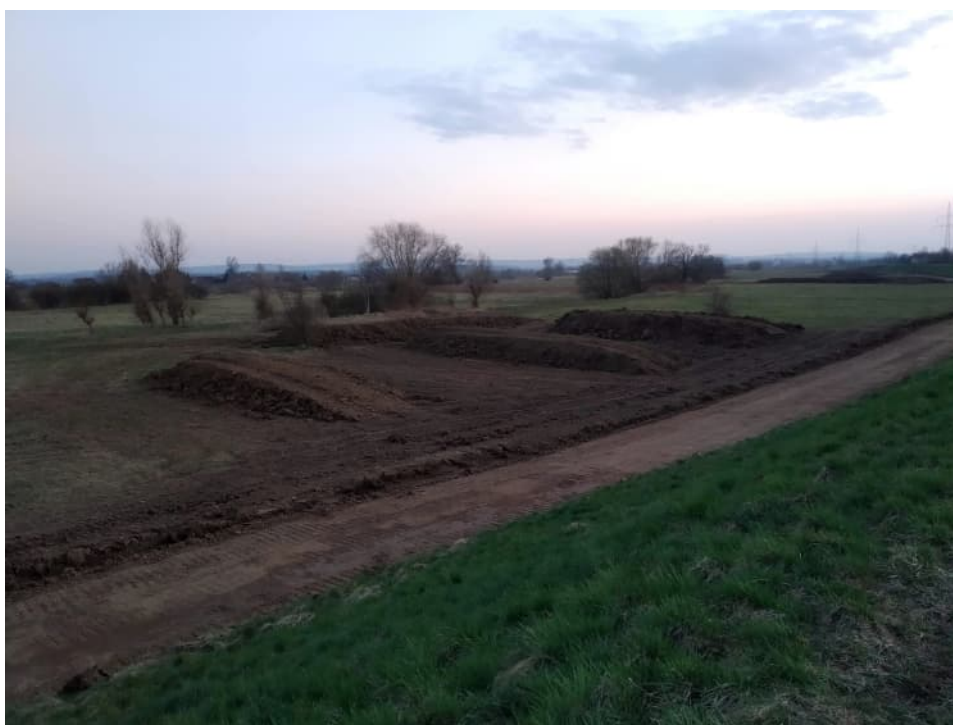
Fig. 30. Protection of top-soil piles
– the left Vistula embankment within *Section 2*,
status in the third decade of July 2021 (upstream view).

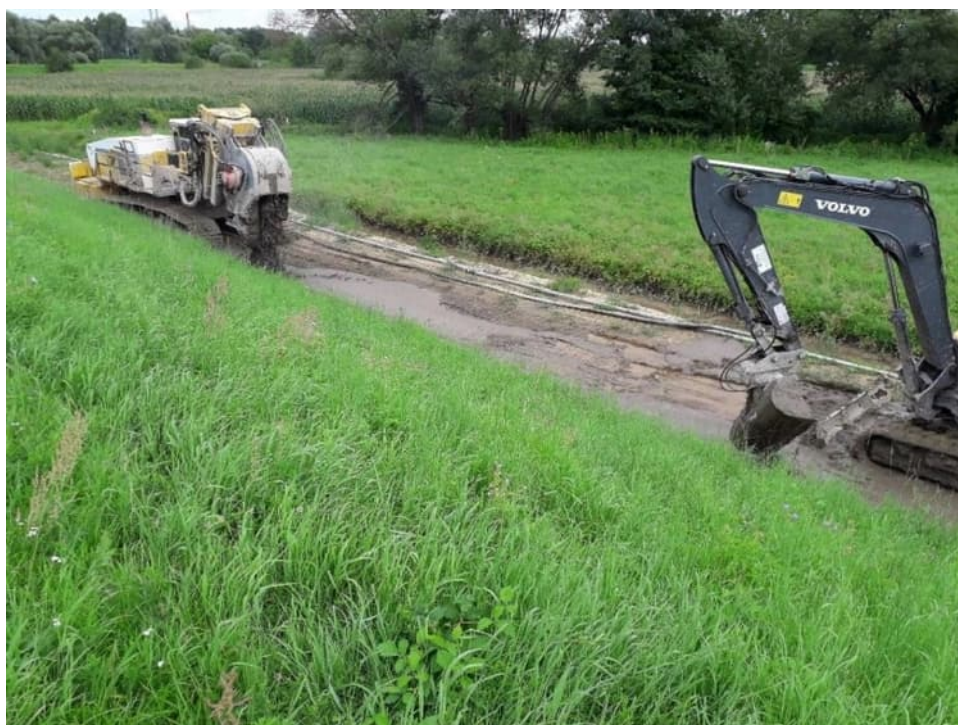
Fig. 31. Construction of a cement-bentonite barrier along the base of embankment – the right Dłubnia embankment within *Section 1.4*, status in the second decade of August 2021 (upstream view).
