PHOTO DOCUMENTATION

Appendix no. 2

to the Final Report on implementation of measures determined in EMP
for the Contract 3A.1 – Works Contract 3A.1/1

Odra-Vistula Flood Management Project

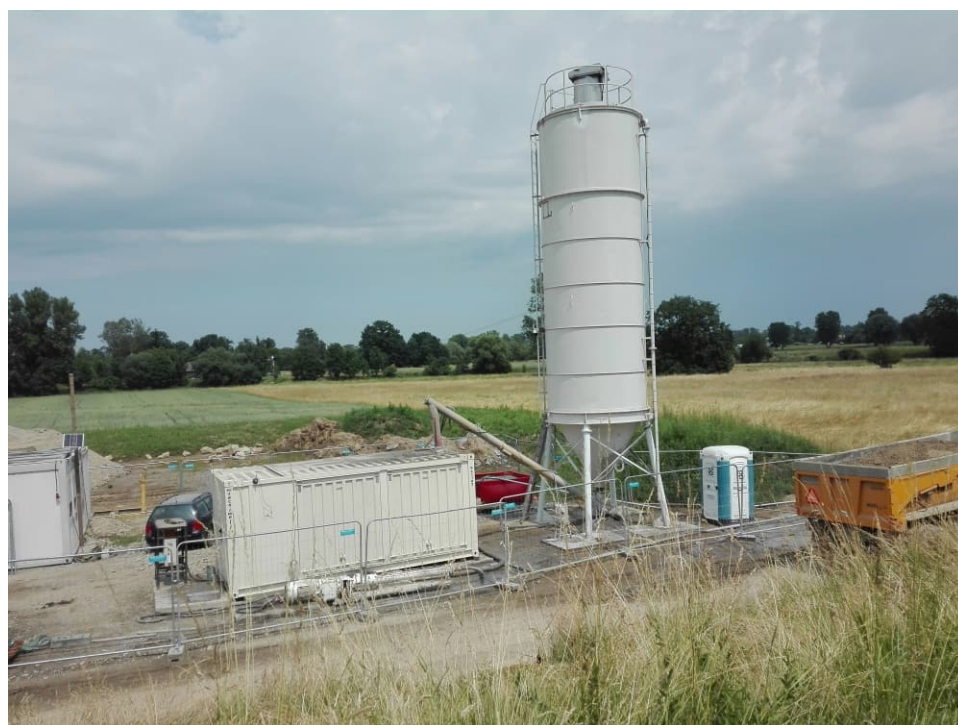
Fig. 32. Installation for producing a cement-bentonite mixture – the left Vistula embankment within *Section 2*, status in the third decade of June 2021 (downstream view).

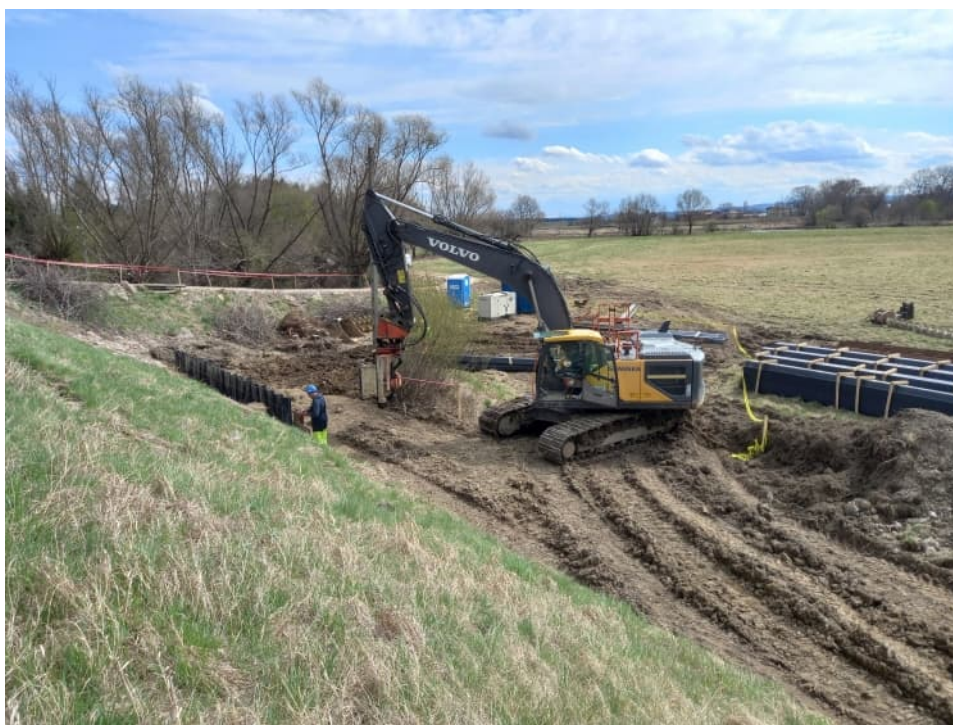
Fig. 33. Construction of a sheet piling barrier along the base of embankment – the left Vistula embankment within *Section 1.1*, status in the first decade of April 2022 (downstream view).

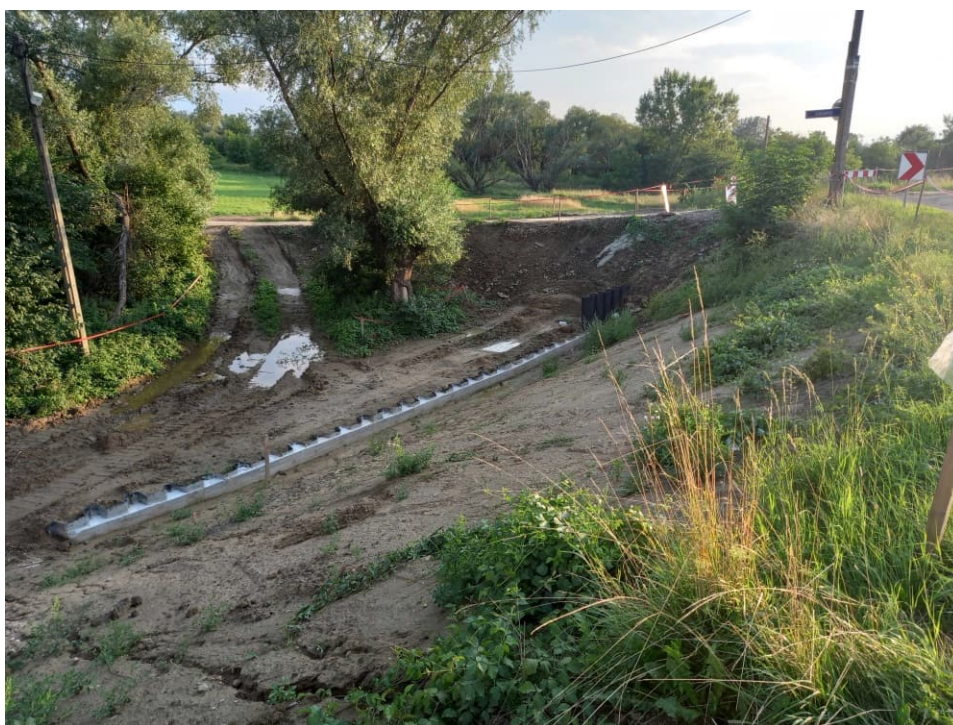
Fig. 34. Making a cap on the sheet pilings along the base of embankment – the left Vistula embankment within *Section 1.1*, status in the third decade of July 2022 (upstream view).

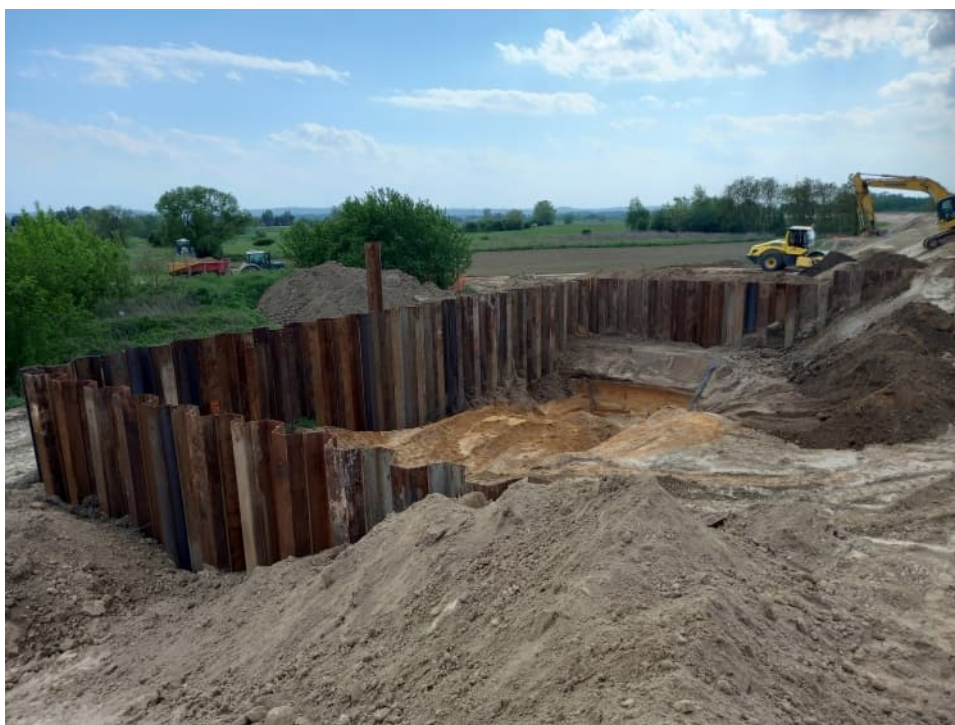
Fig. 35. Reconstruction of the embankment culvert
– the left Vistula embankment within *Section 2*,
status in the second decade of May 2022 (view towards the embanked area).

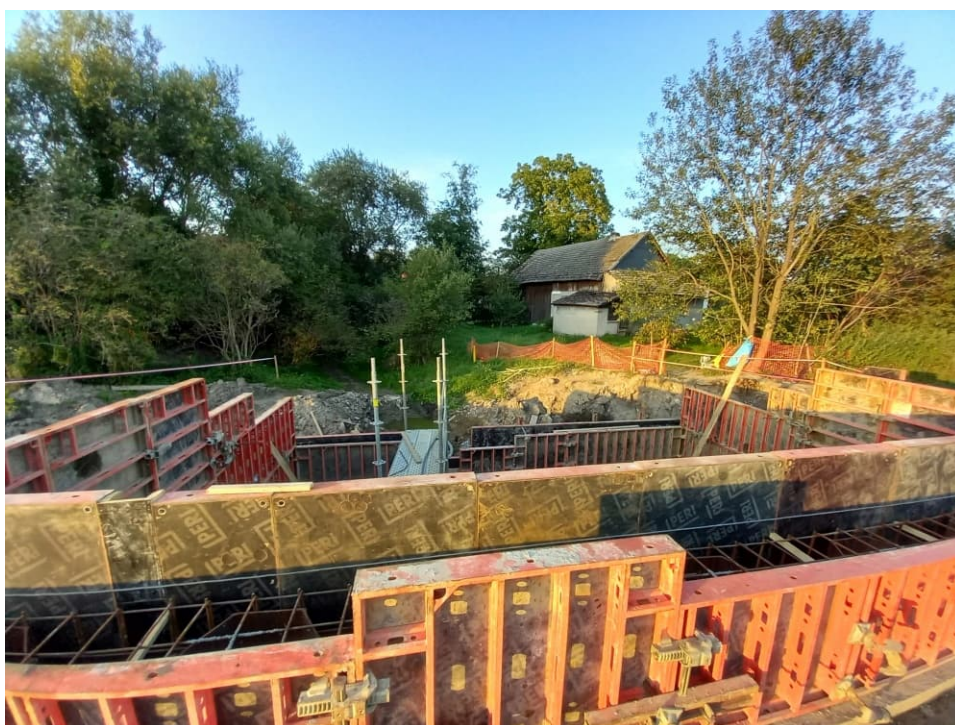
Fig. 36. Construction of the embankment culvert
– the left Dłubnia embankment within *Section 1.6*,
status in the third decade of August 2022
(view towards the area beyond the embankment).

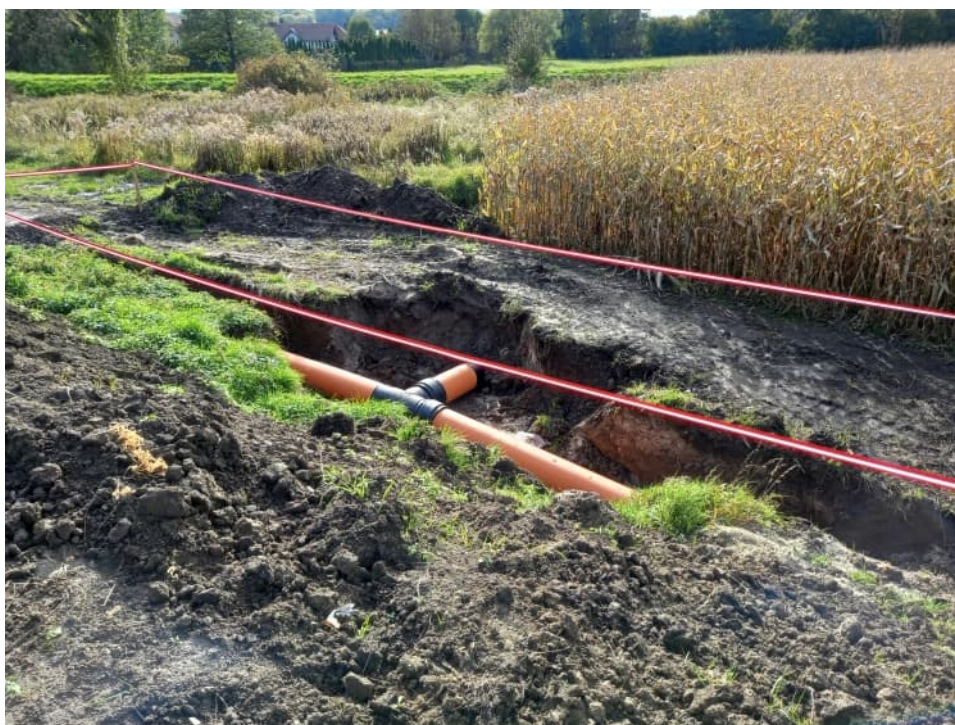
Fig. 37. Works related to the reconstruction of a gas pipeline network
– the right Dłubnia embankment within *Section 1.4*,
status in the second decade of October 2021 (downstream view).

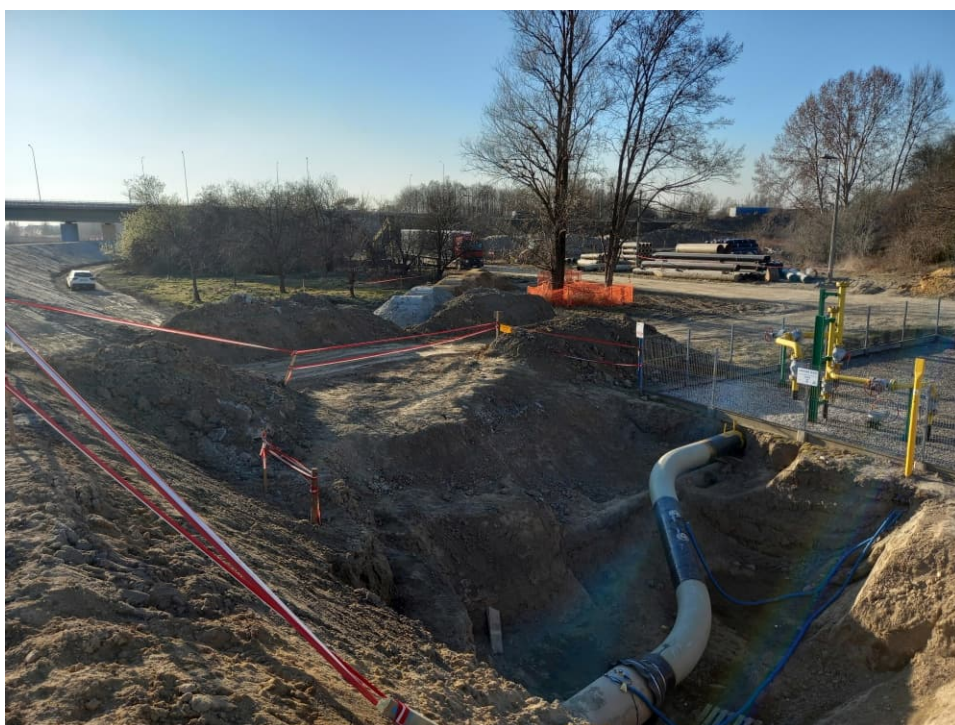
Fig. 38. Works related to the reconstruction of a gas pipeline network
– the left Vistula embankment within *Section 1.2*,
status in the third decade of March 2022 (upstream view).

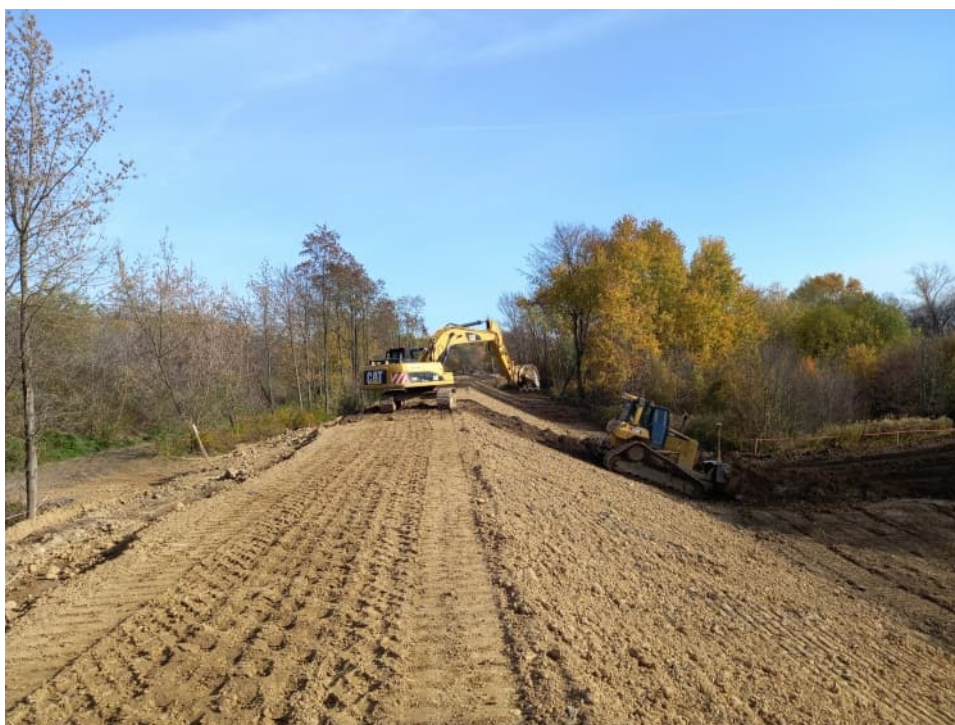
Fig. 39. Shaping the slopes of the flood embankment
– the left Vistula embankment within *Section 1.2*,
status in the third decade of October 2021 (downstream view).

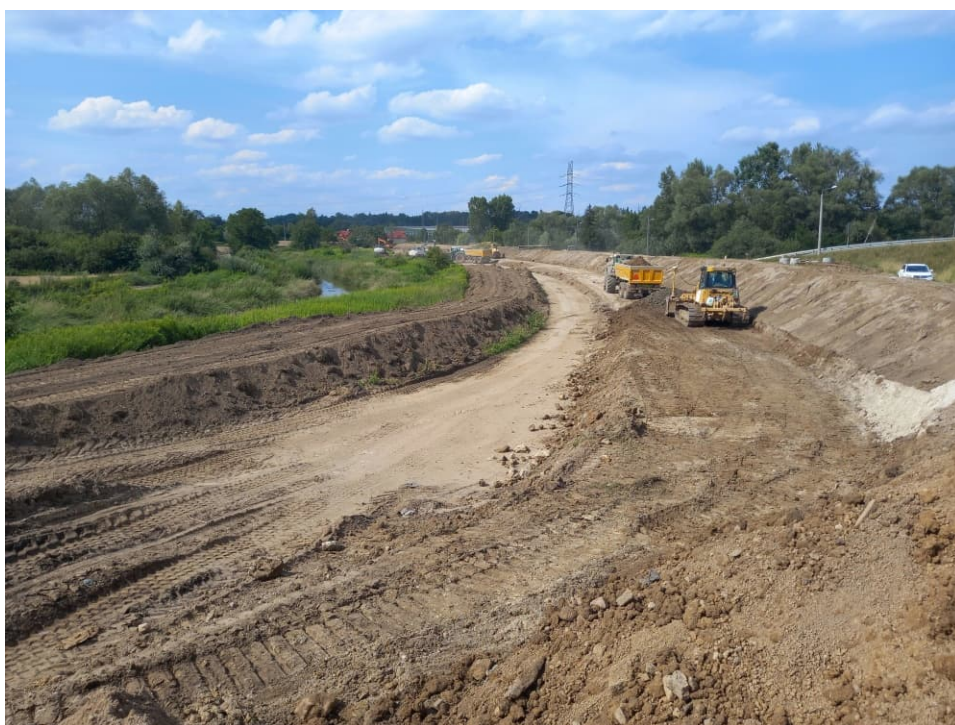
Fig. 40. Shaping the slopes of the flood embankment
– the left Dłubnia embankment within *Section 1.5*,
status in the third decade of July 2022 (upstream view).

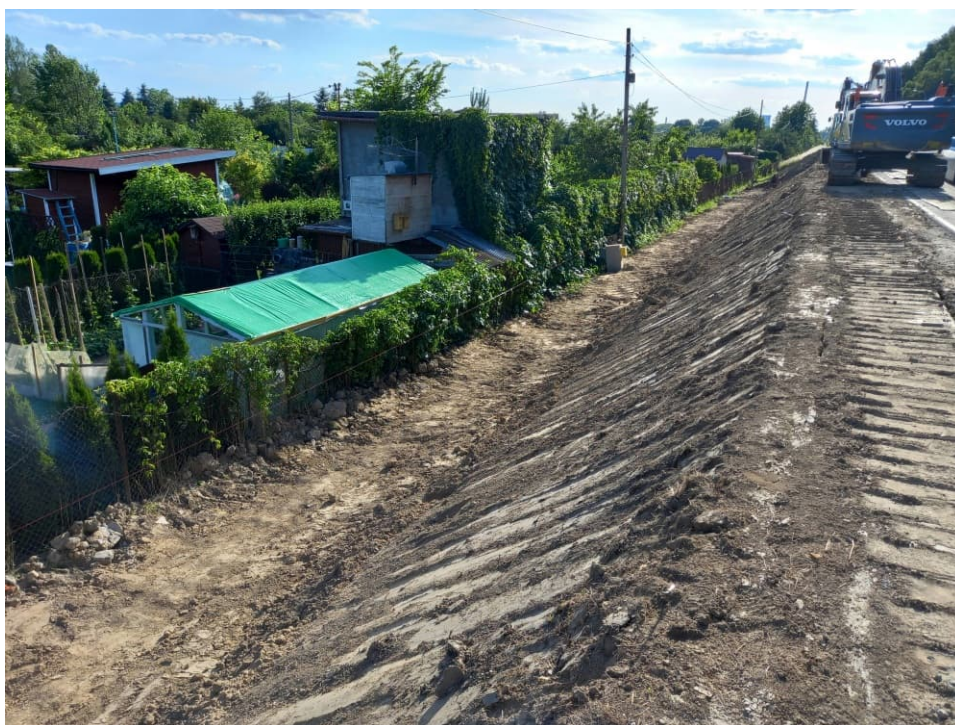
Fig. 41. Leveling the slopes of the flood embankment
– the left Vistula embankment within *Section 1.1*,
status in the second decade of June 2022 (upstream view).

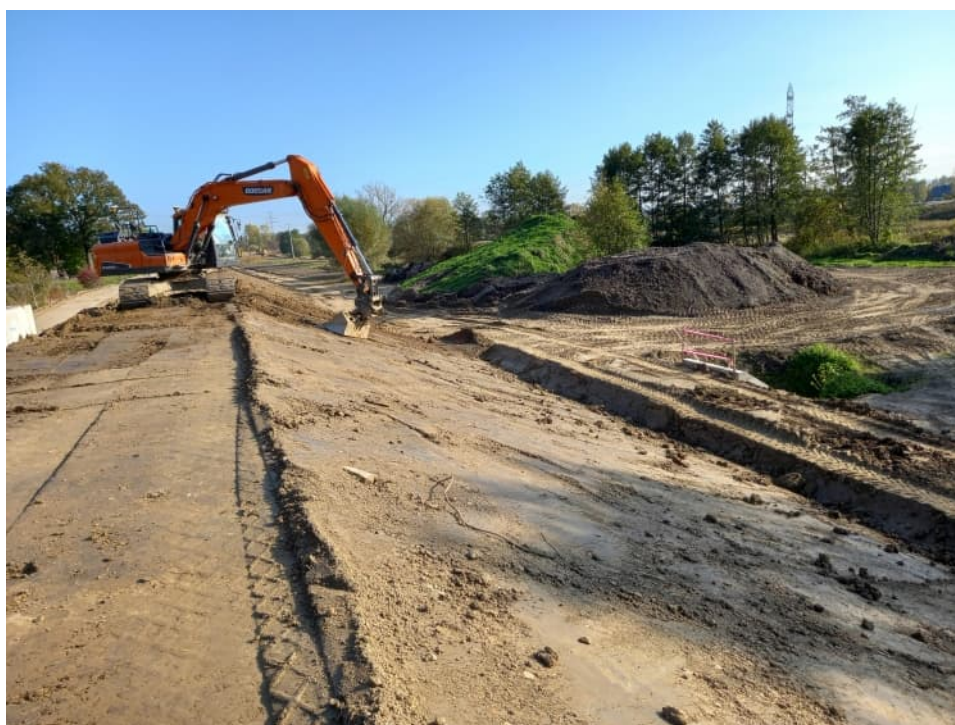
Fig. 42. Leveling the slopes of the flood embankment
– the left Dłubnia embankment within *Section 1.6*,
status in the second decade of October 2022 (downstream view).

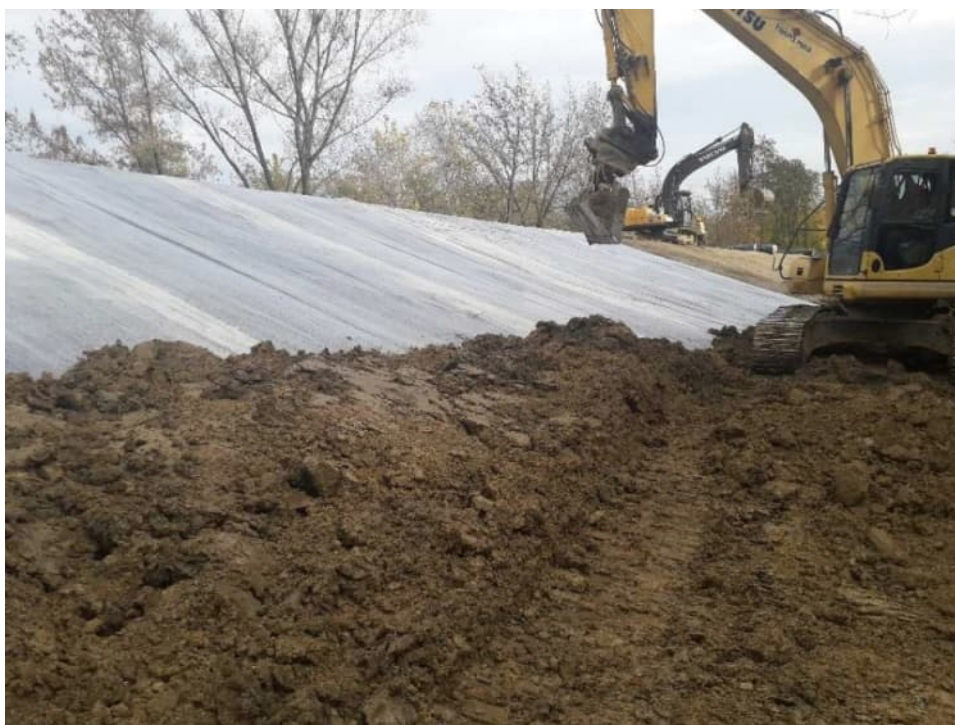
Fig. 43. Placement of bentomat on the slope of the flood embankment – the left Vistula embankment within *Section 1.2*, status in the third decade of October 2021 (downstream view).

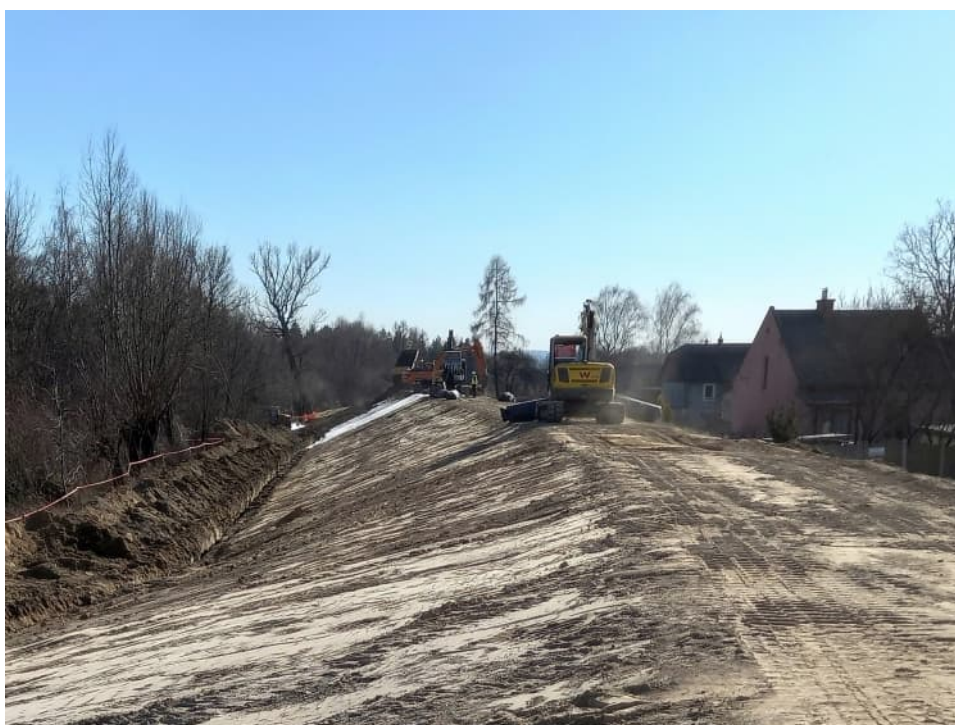
Fig. 44. Placement of bentomat on the slope of the flood embankment – the right Dłubnia embankment within *Section 1.4*, status in the third decade of March 2021 (downstream view).

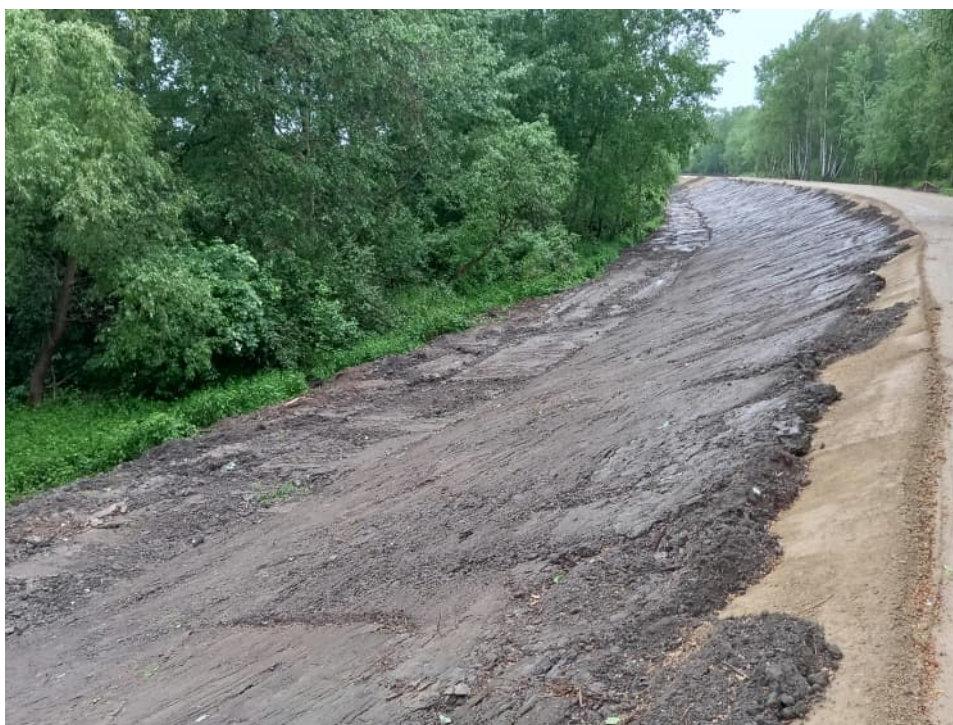
Fig. 45. Covering slopes of the flood embankment with a top-soil layer
– the left Vistula embankment within *Section 1.3*,
status in the third decade of May 2022 (upstream view).

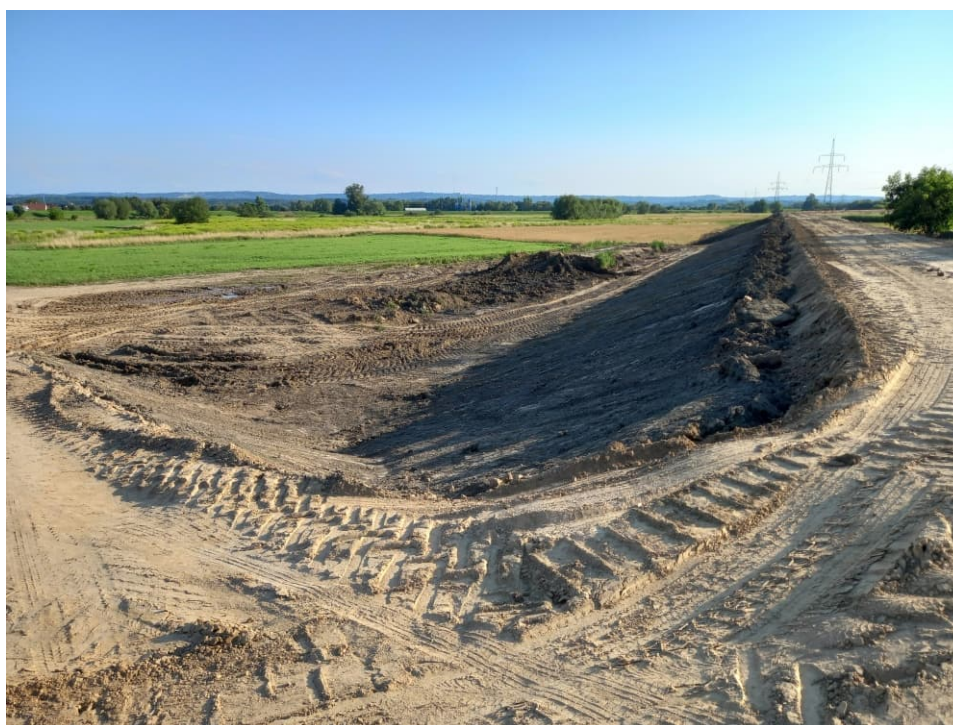
Fig. 46. Covering slopes of the flood embankment with a top-soil layer
– the left Vistula embankment within *Section 2*,
status in the third decade of July 2022 (upstream view).

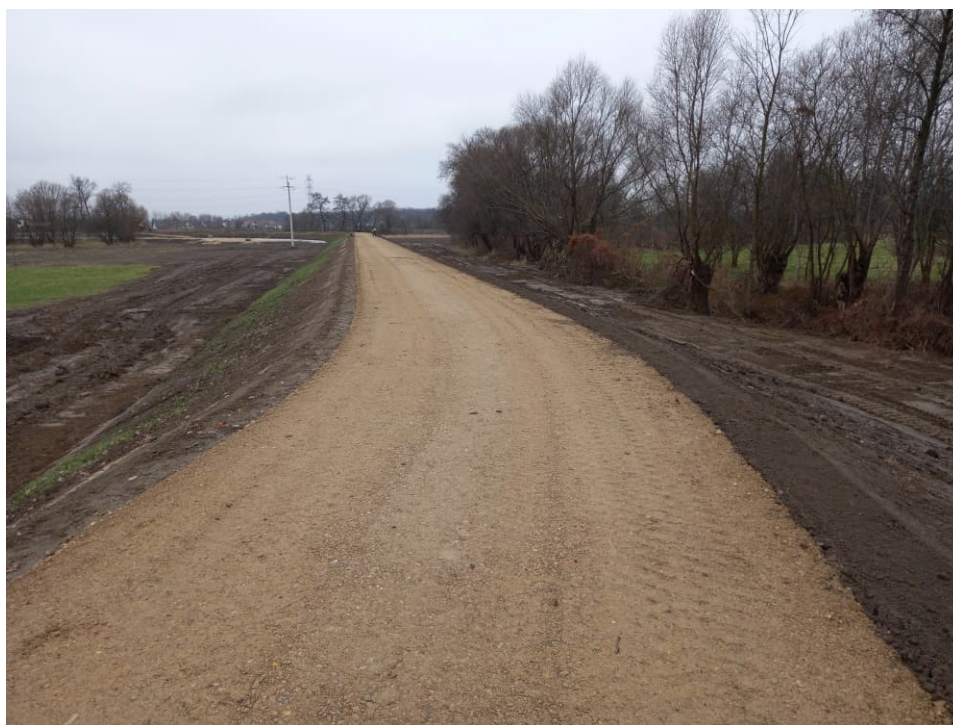
Fig. 47. Construction of a road on the crown of the flood embankment – the left Dłubnia embankment within *Section 1.6*, status in the third decade of November 2022 (downstream view).

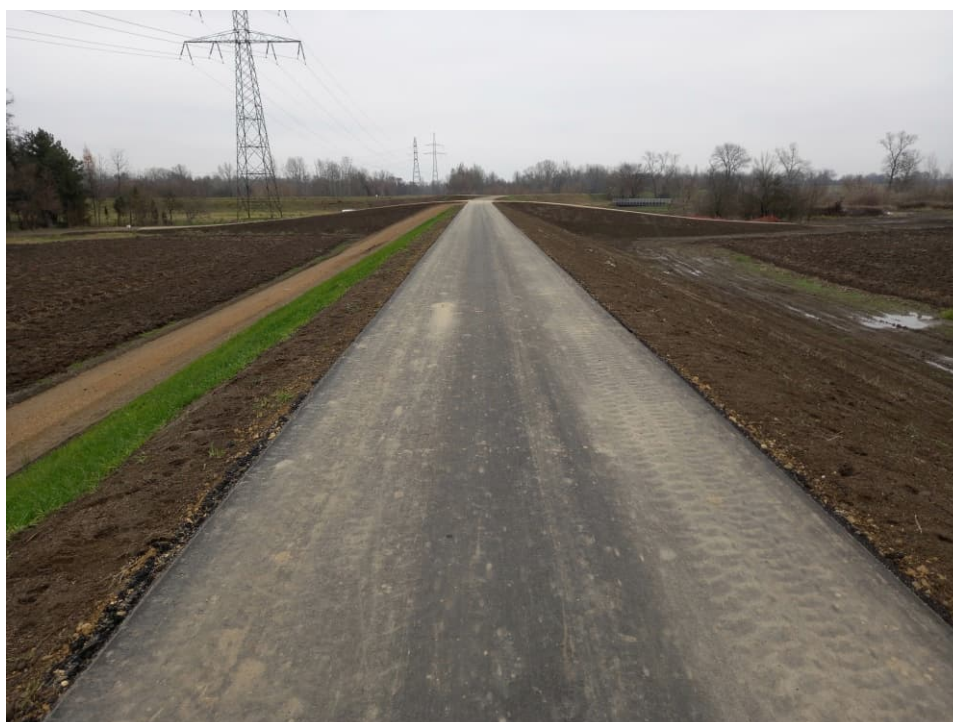
Fig. 48. Construction of a road on the crown of the flood embankment – the left Vistula embankment within *Section 2*, status in the third decade of November 2022 (downstream view).

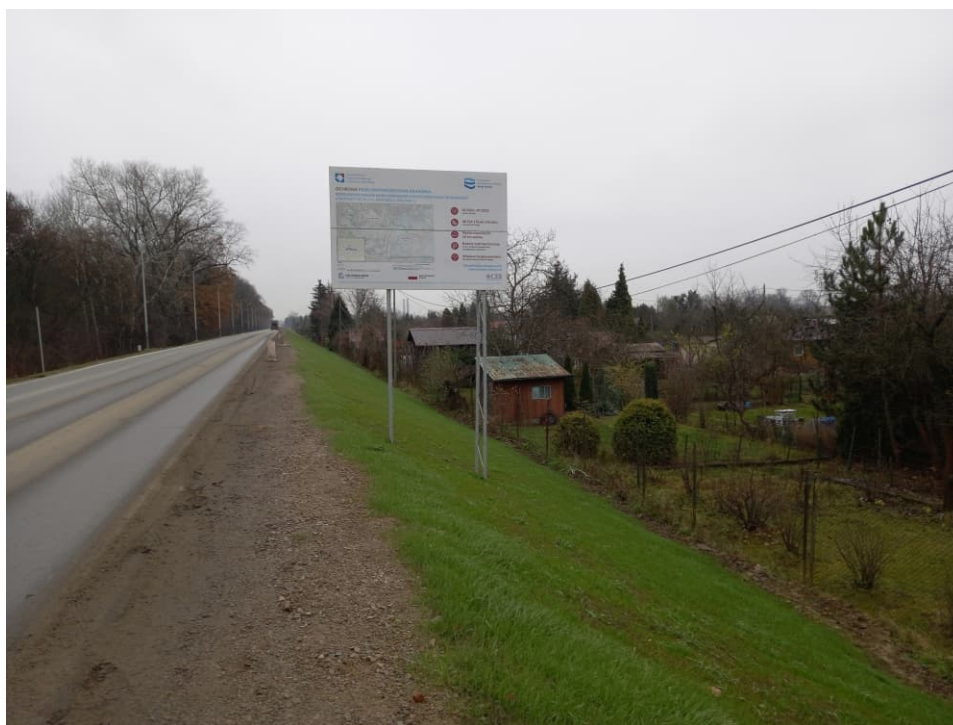
Fig. 49. Growth of grasses sown on the slope of the flood embankment – the left Vistula embankment within *Section 1.1*, status in the third decade of November 2022 (downstream view).

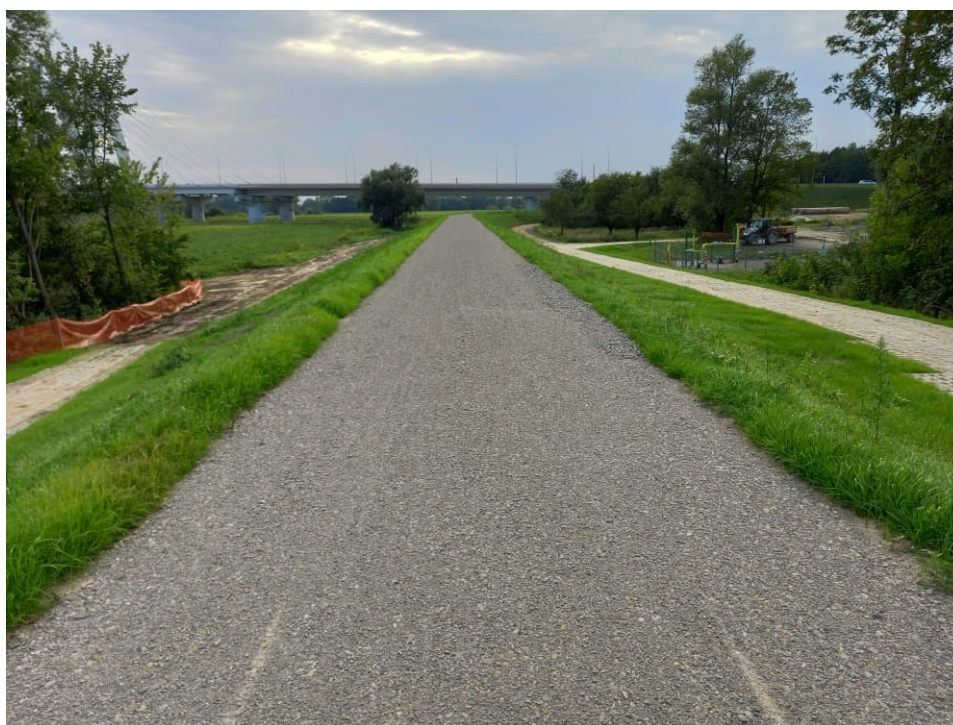
Fig. 50. Growth of grasses sown on the slope of the flood embankment – the left Vistula embankment within *Section 1.2*, status in the third decade of August 2022 (upstream view).

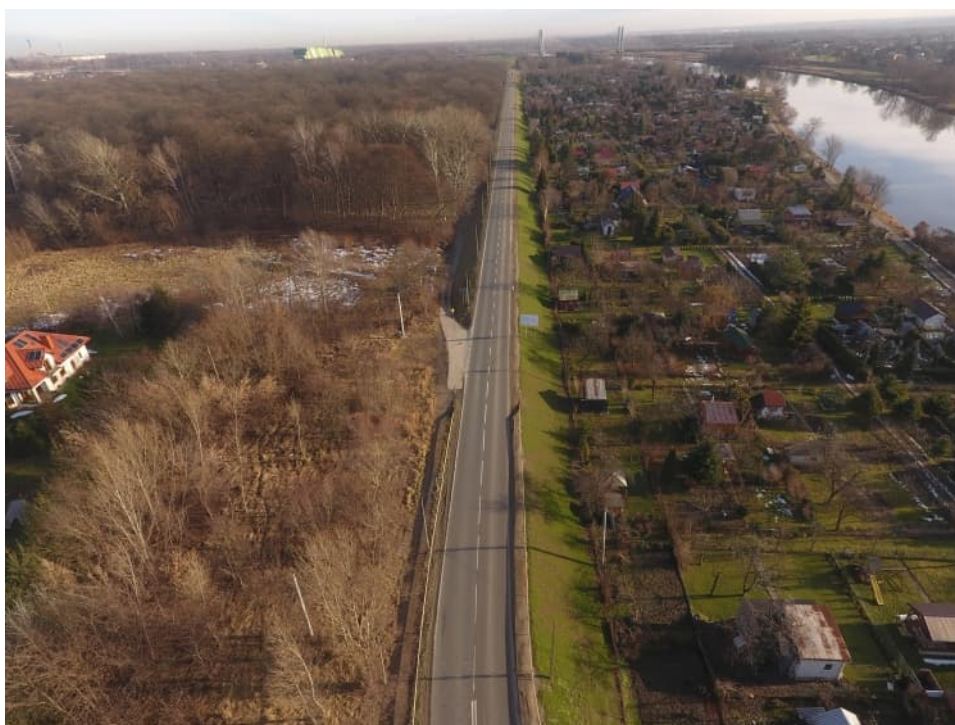
Fig. 51. Site condition in the last quarter of the works implementation period – the left Vistula embankment within *Section 1.1*, status in the third decade of December 2022 (downstream view).

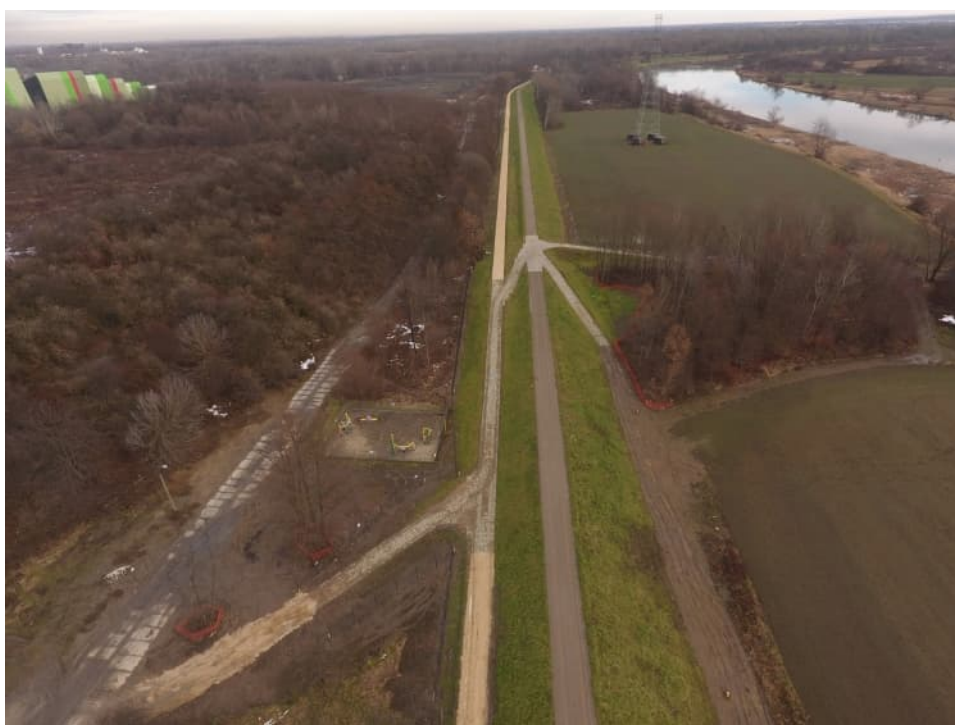
Fig. 52. Site condition in the last quarter of the works implementation period – the left Vistula embankment within *Section 1.2*, status in the third decade of December 2022 (downstream view).

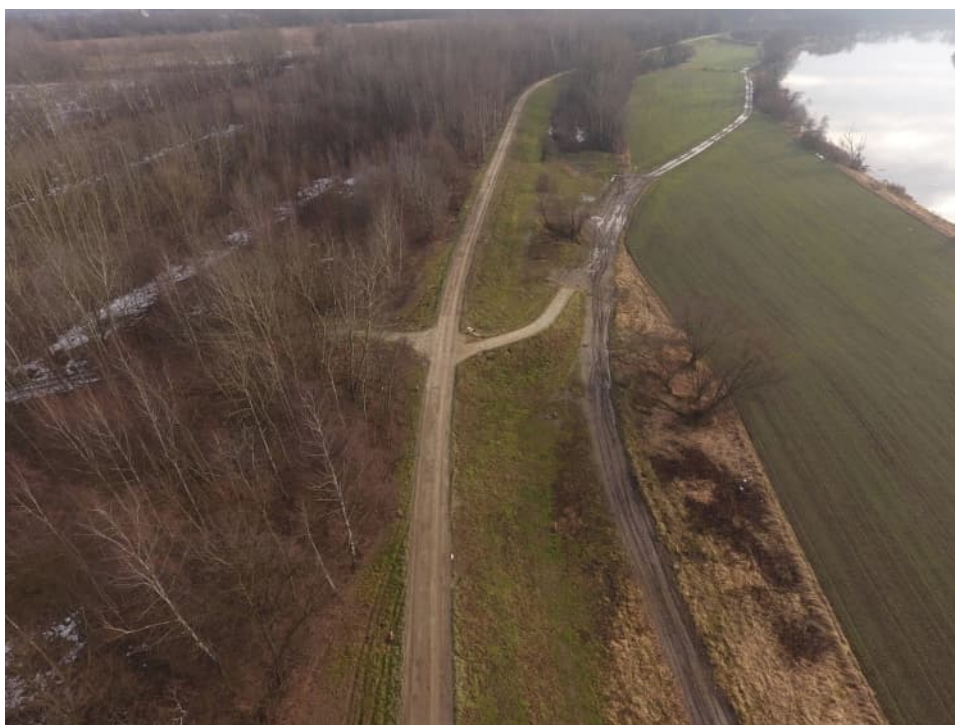
Fig. 53. Site condition in the last quarter of the works implementation period – the left Vistula embankment within *Section 1.3*, status in the third decade of December 2022 (downstream view).

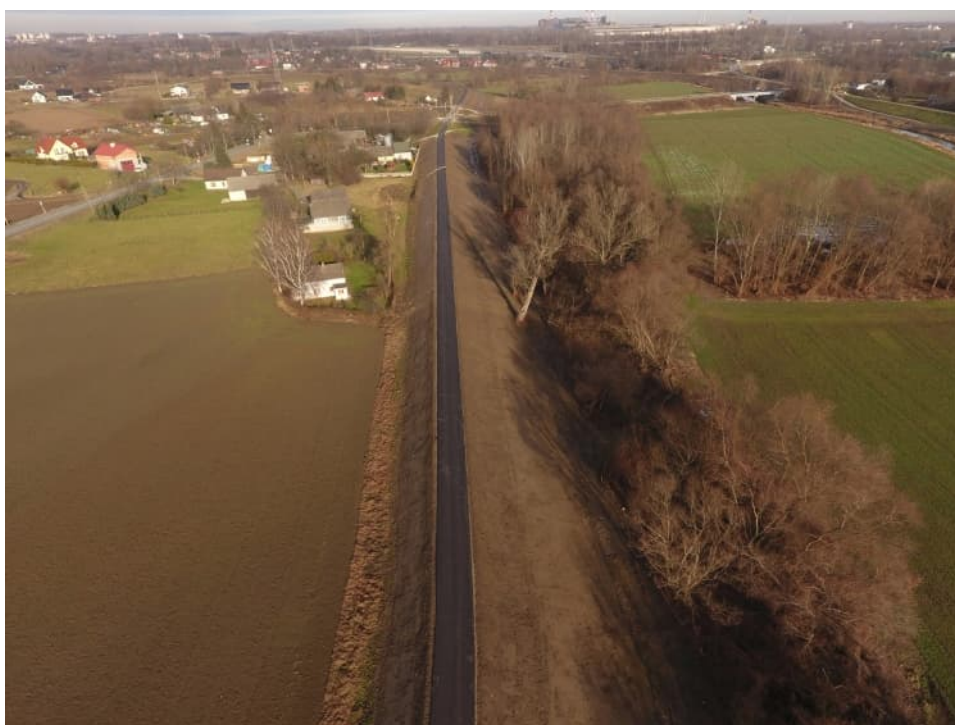
Fig. 54. Site condition in the last quarter of the works implementation period – the right Dłubnia embankment within *Section 1.4*, status in the third decade of December 2022 (upstream view).

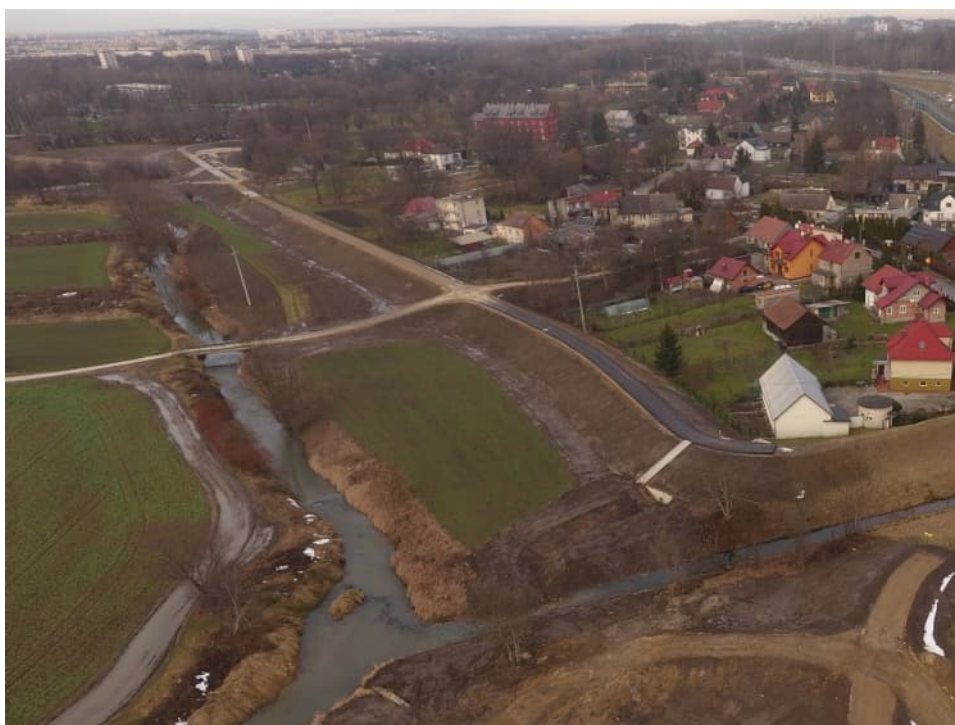
Fig. 55. Site condition in the last quarter of the works implementation period – the left Dłubnia embankment within *Section 1.5*, status in the third decade of December 2022 (upstream view).

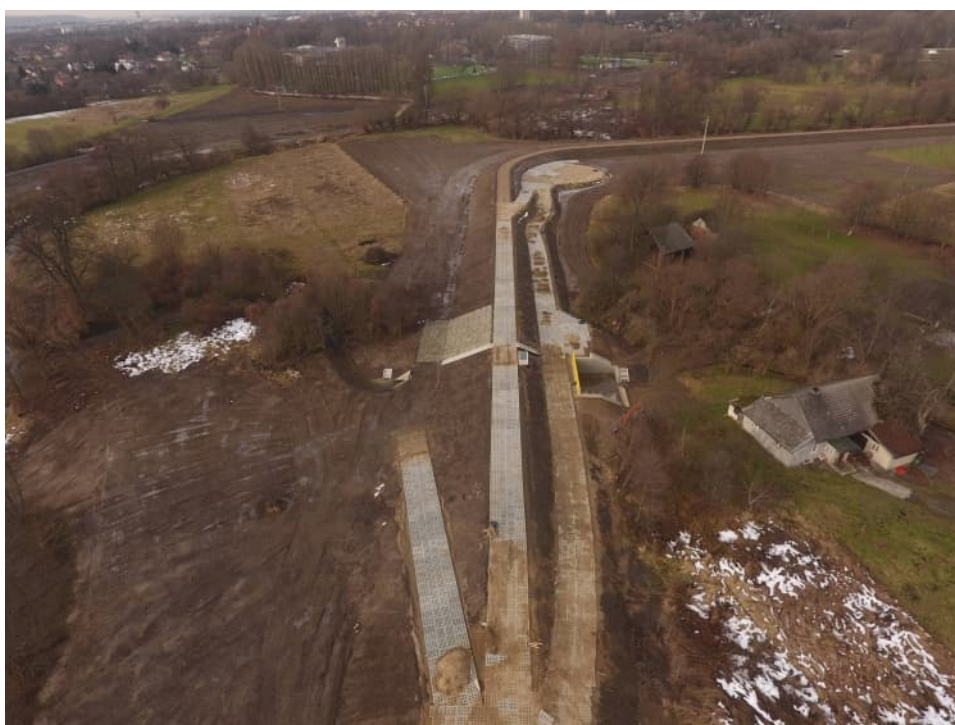
Fig. 56. Site condition in the last quarter of the works implementation period – the left Dłubnia embankment within *Section 1.6*, status in the third decade of December 2022 (upstream view).

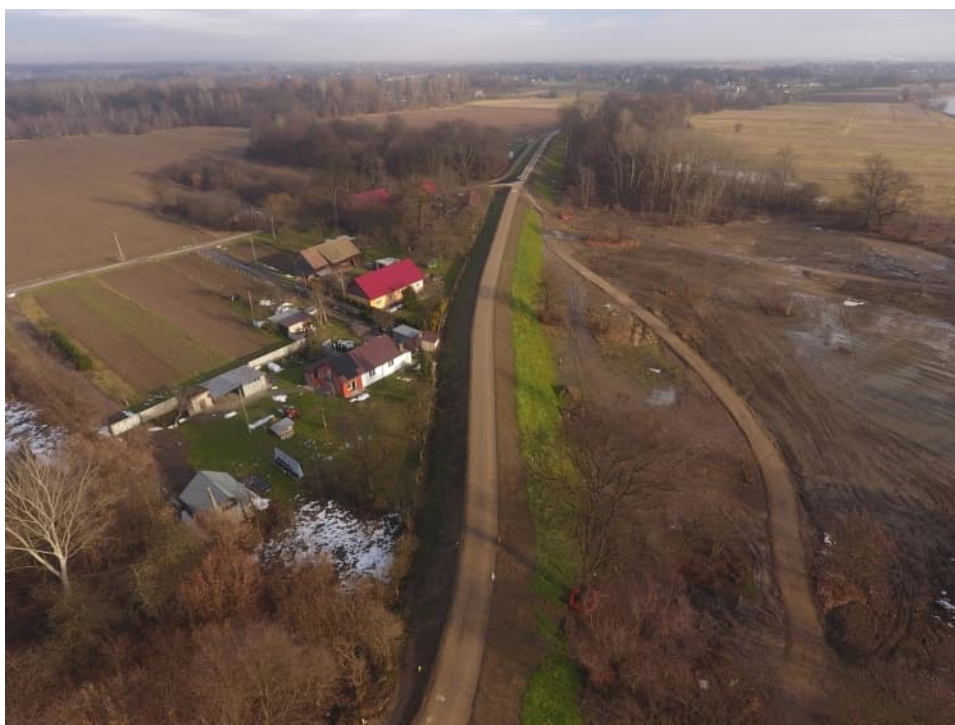
Fig. 57. Site condition in the last quarter of the works implementation period – the left Vistula embankment within *Section 2* – upper part, status in the third decade of December 2022 (downstream view).

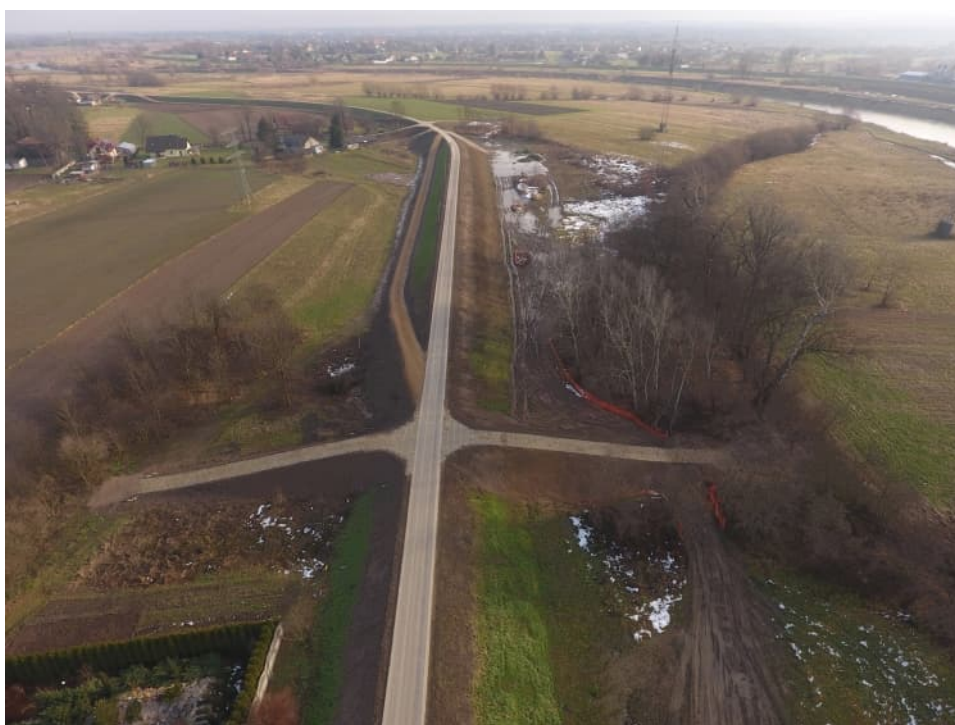
Fig. 58. Site condition in the last quarter of the works implementation period – the left Vistula embankment within *Section 2* – lower part, status in the third decade of December 2022 (downstream view).
