## PHOTOGRAPHIC DOCUMENTATION

Appendix no. 2

to the Final report on the implementation of the measures listed under the EMP  
for Contract 3D.2/2

### Odra-Vistula Flood Management Project

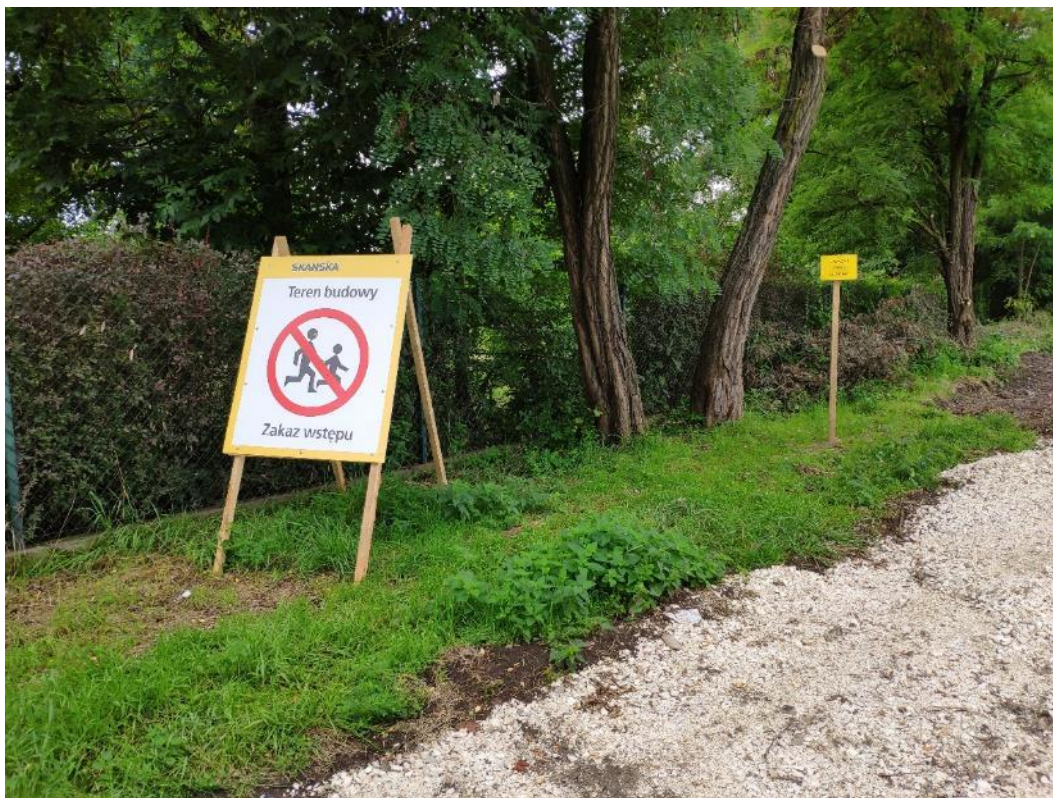
Phot. 1. Left embankment at km approx. 5+200 – example of correct marking of construction zone (3rd decade of August 2021).

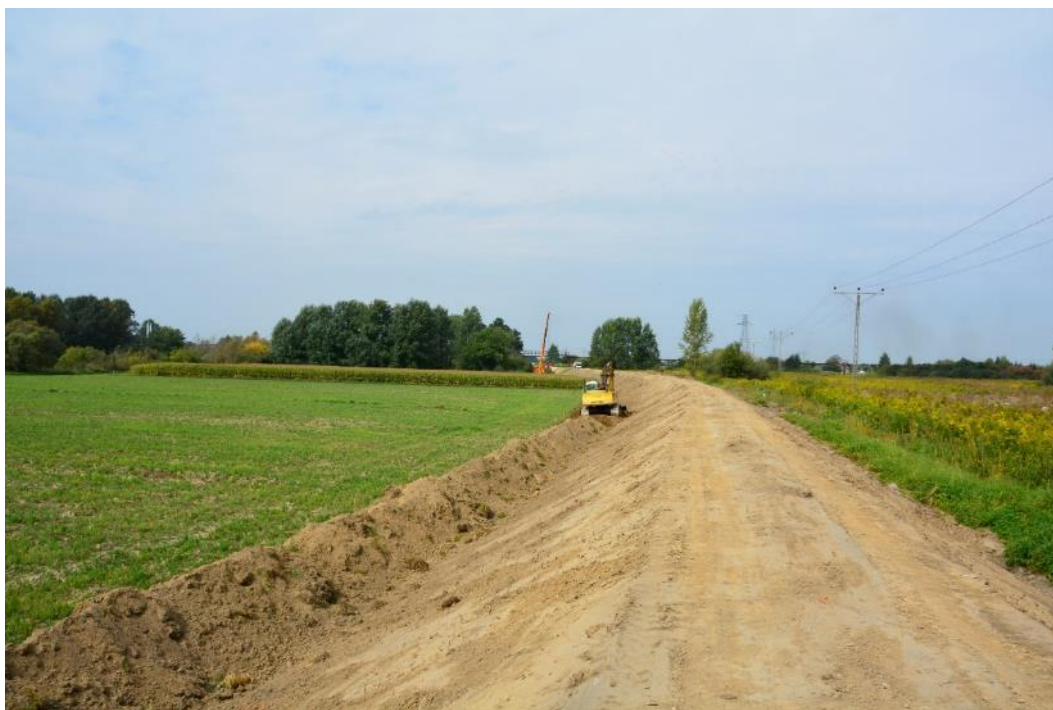
Phot. 2. Right embankment at km approx. 1+200 – topsoil removal of the embankment, maintaining the correct height of topsoil heaps (2nd decade of September, 2021).

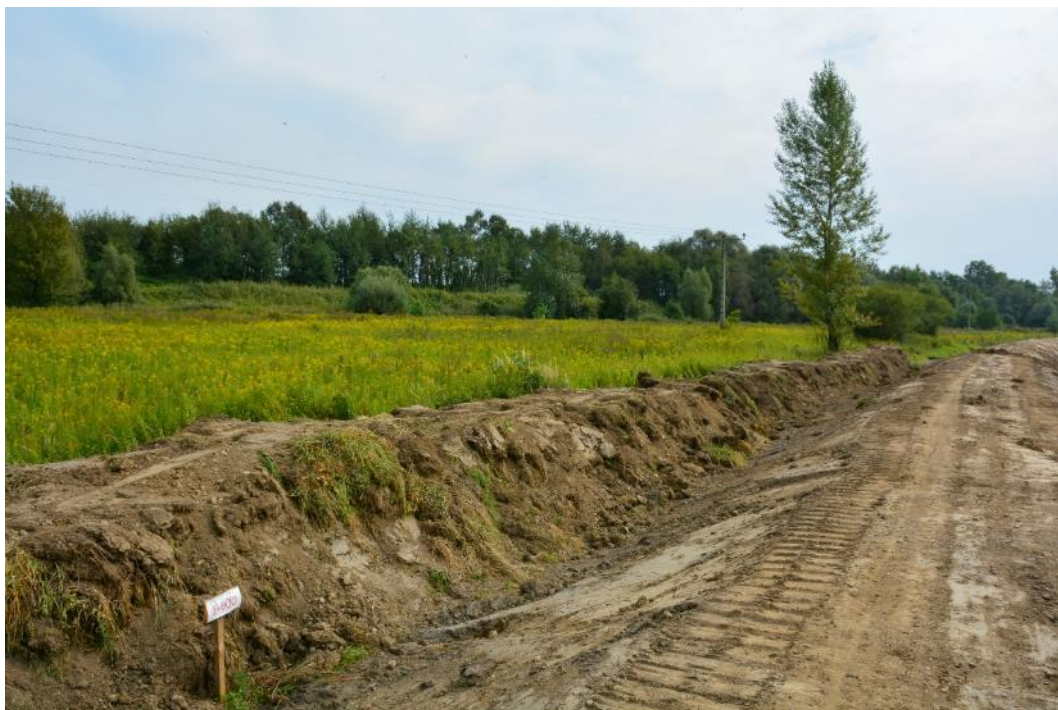
Phot. 3. Right embankment at km approx. 1+000 – marking of topsoil heaps (2nd decade of September, 2021).

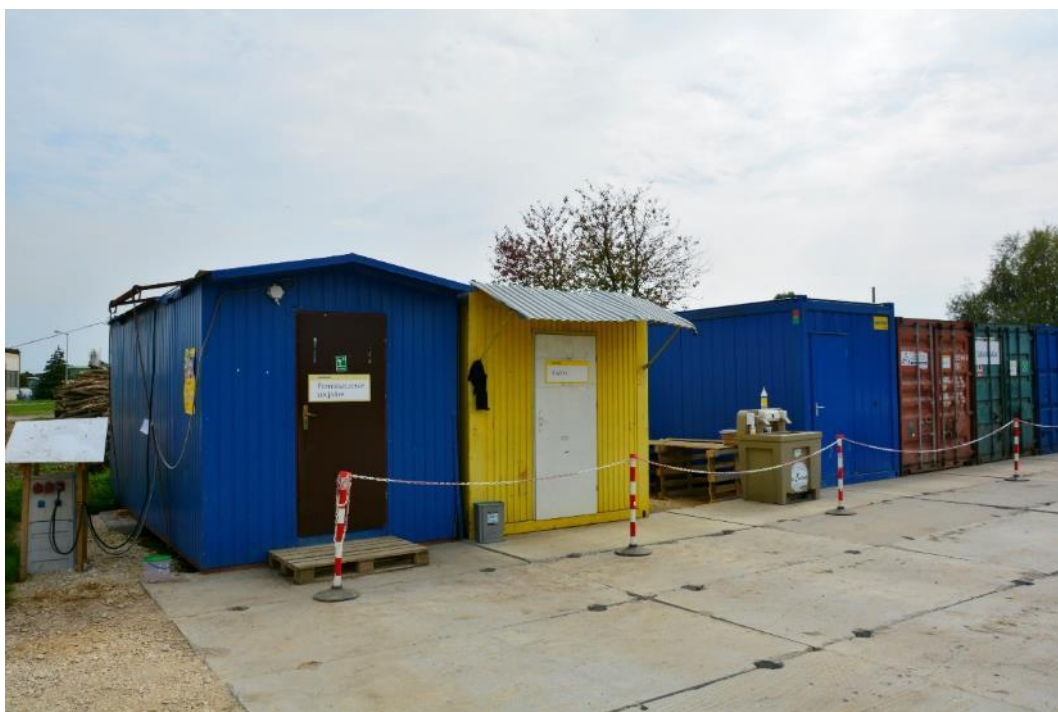
Phot. 4. Control of the Contractor's site facilities zone (2nd decade of September, 2021).

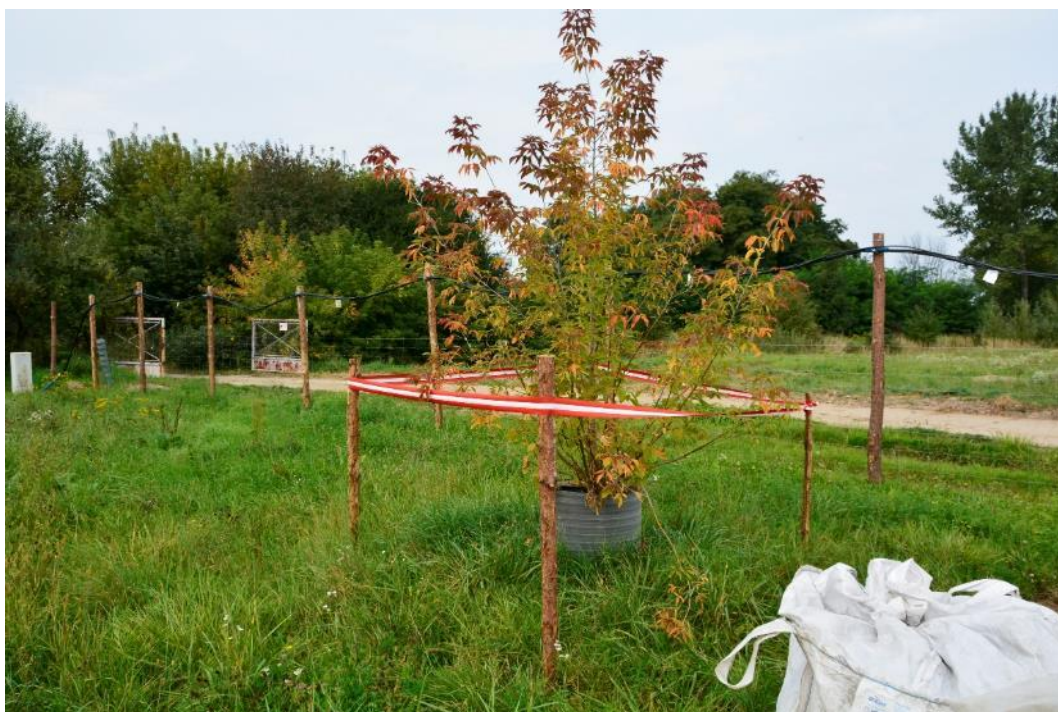
Phot. 5. Control of the Contractor's site facilities zone, view of the constructed greenery fencing (2nd decade of September, 2021).

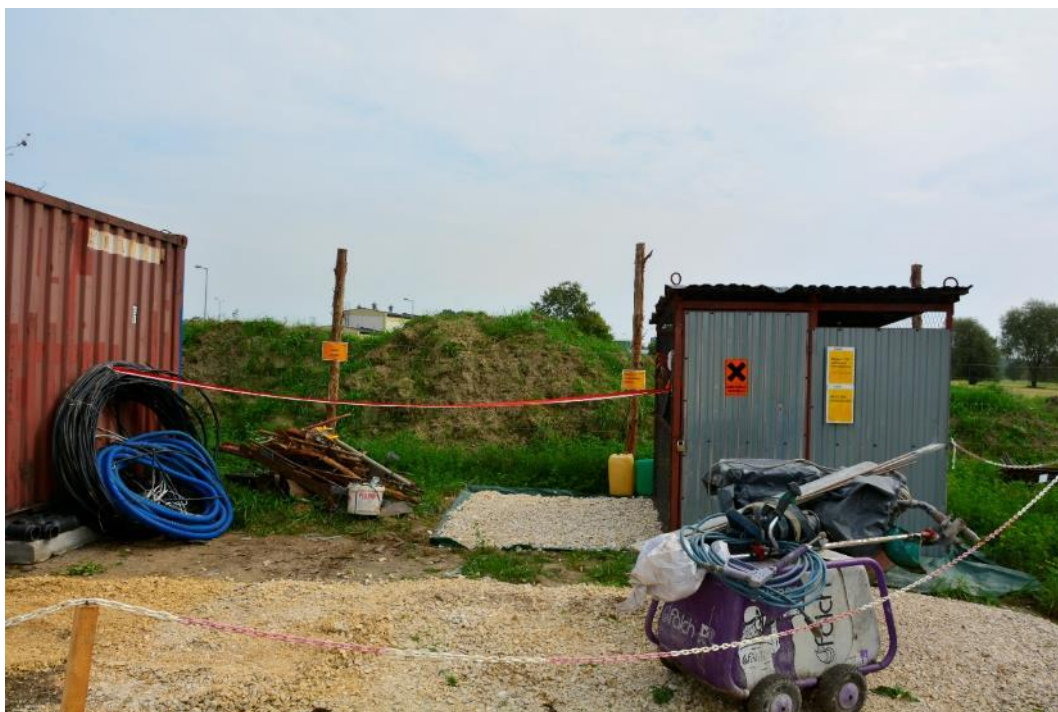
Phot. 6. Control of the Contractor's site facilities zone, view of the prepared area for the storage of hazardous substances and the sorbent access area ("ecological first aid kit") (2nd decade of September, 2021).

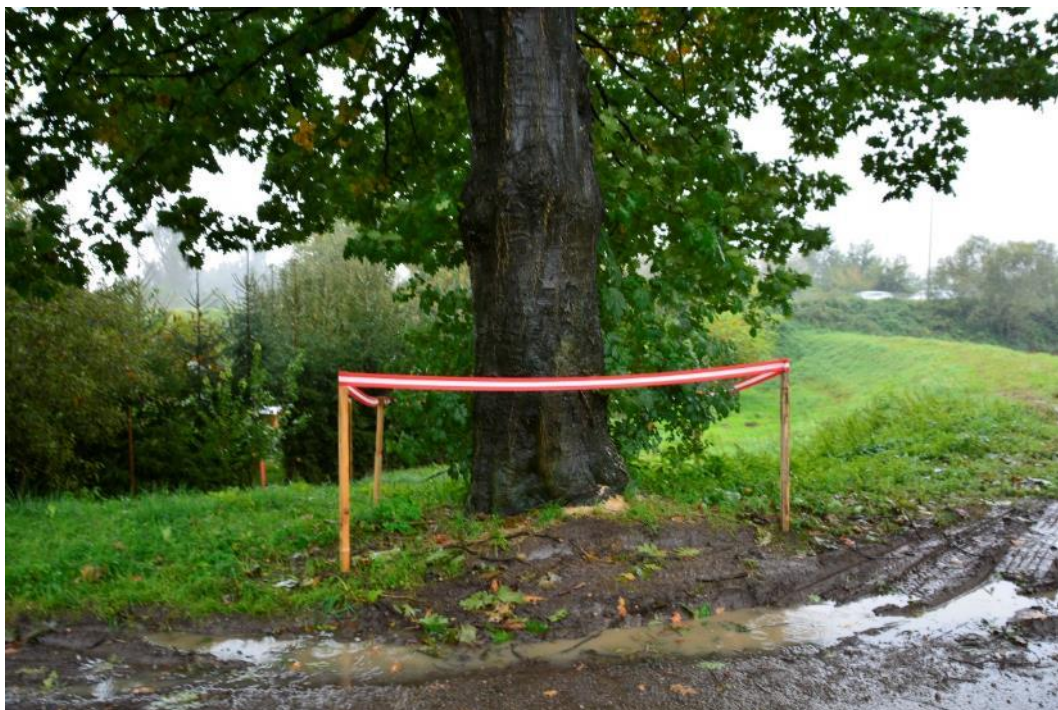
Phot. 7. Right embankment at km approx. 3+200 – example of the constructed greenery fencing (3rd decade of September, 2021).

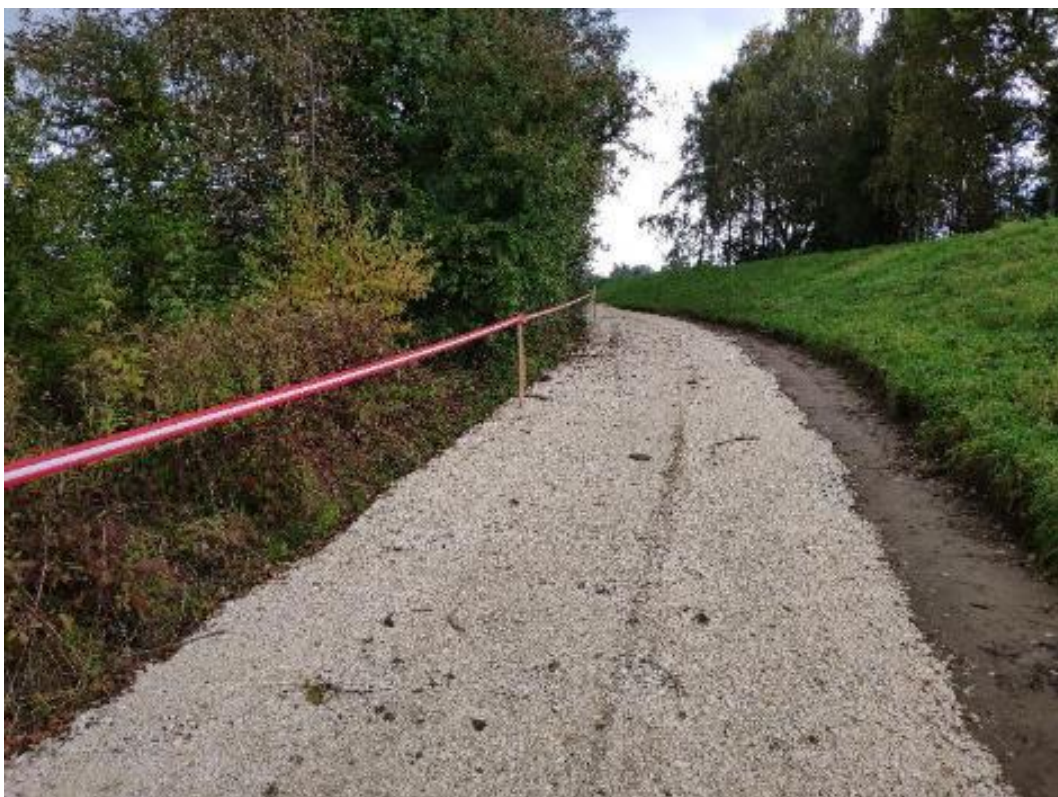
Phot. 8. Left embankment at km approx. 5+300 – example of fencing off a green zone left outside felling along an access road (1st decade of October 2021).

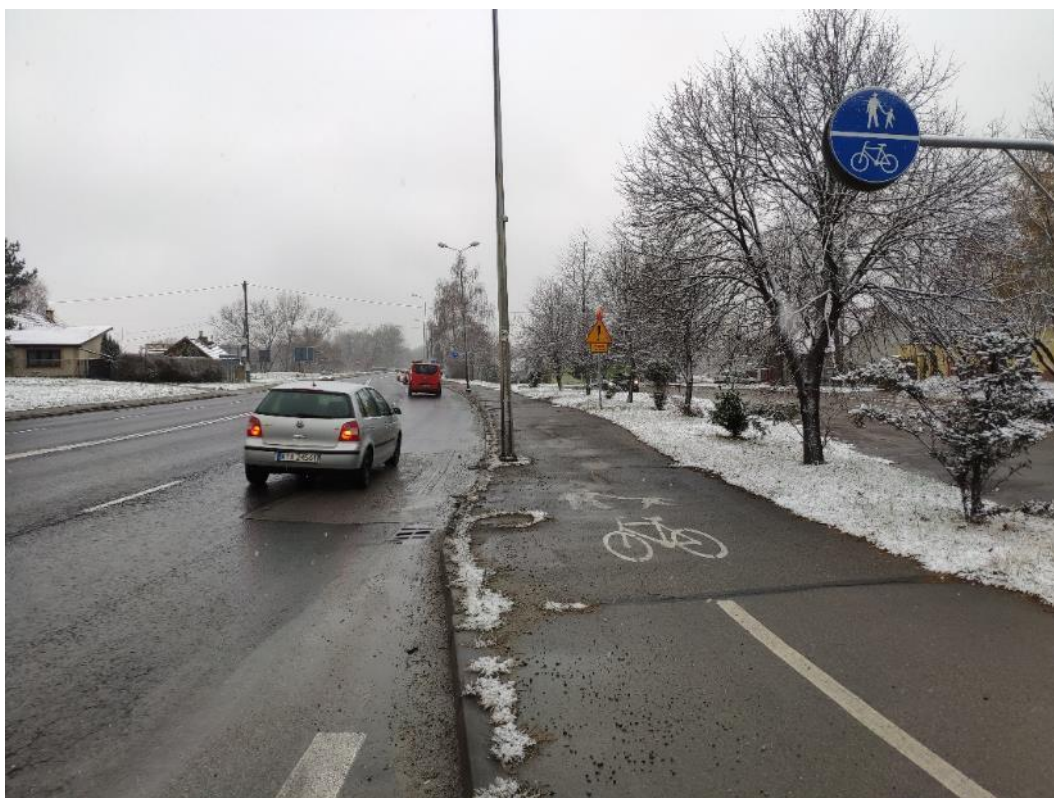
Phot. 9. Right embankment at km approx. 3+200 – Kwiatkowskiego Street in Tarnów - example of markings of the exit from the construction site (1st decade of December, 2021).

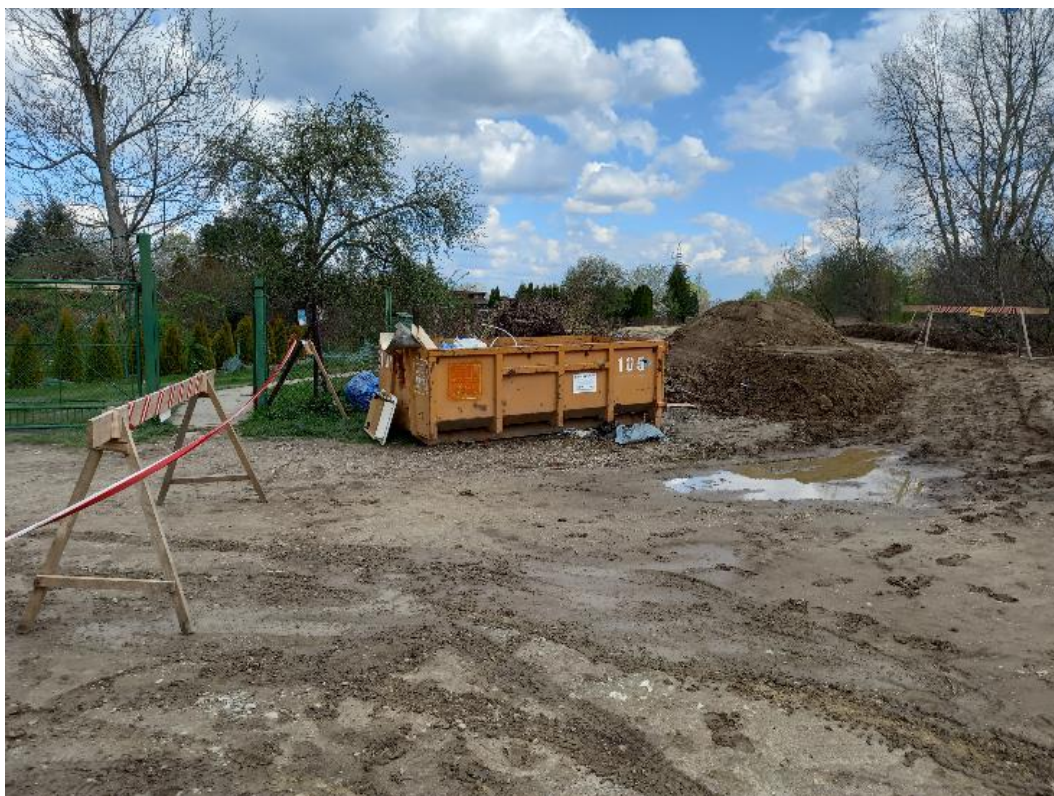
Phot. 10. Left embankment at km approx. 3+800 – the prepared rubbish container – the place where waste is dumped by users of the "Jaskolka" Allotment Gardens (3rd decade of April, 2022). The site was marked with signs indicating that dumping is prohibited and video monitoring.

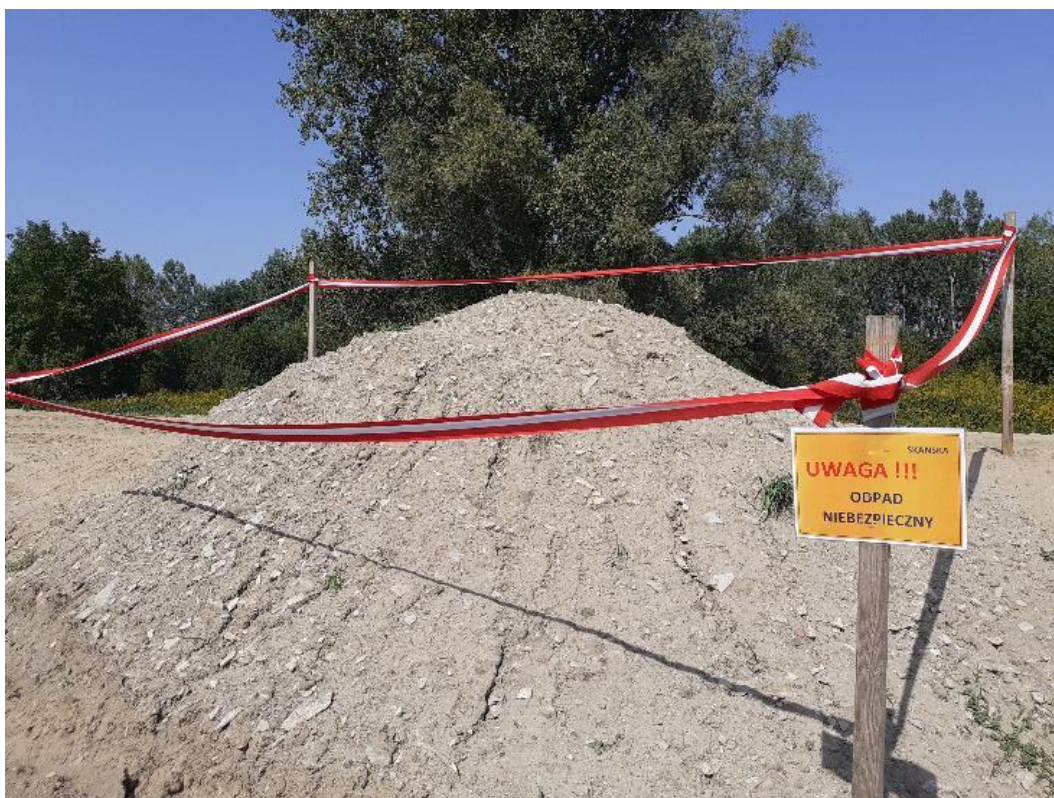
Phot. 11. Left embankment at km approx. 1+100 – example of marking of storage zones for waste discovered during earthworks (soil mixed with asbestos fragments) (3rd decade of August 2022).

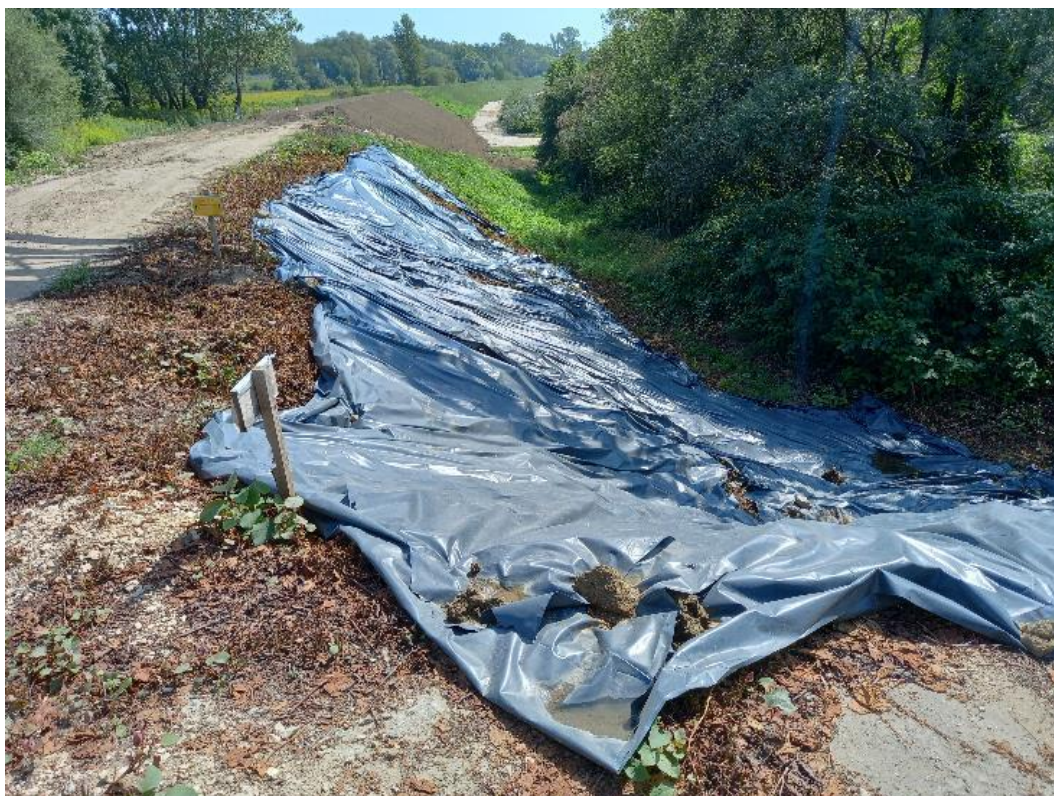
Phot. 12. Right embankment at km approx. 0+900 – example of measures to reduce the growth of invasive plants by covering with plastic sheeting (3rd decade of August 2022).

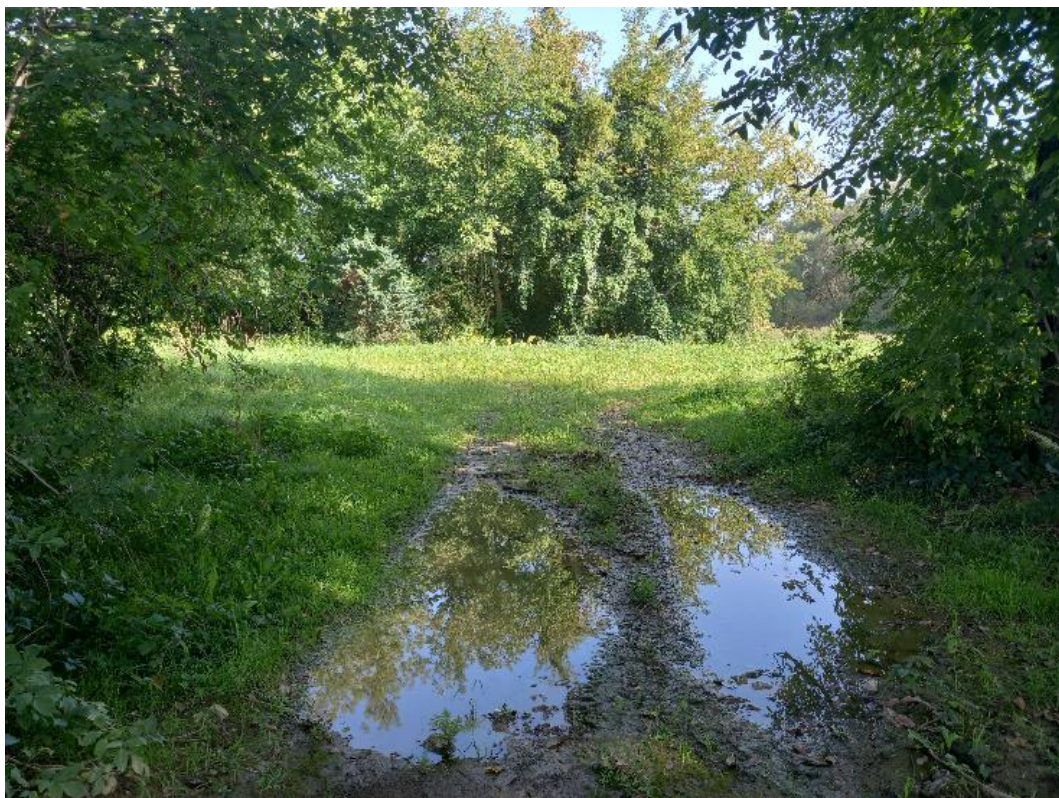
Phot. 13. Right embankment at km approx. 5+600 – inspection of places of stagnant water for the presence of amphibians (3rd decade of August 2022).

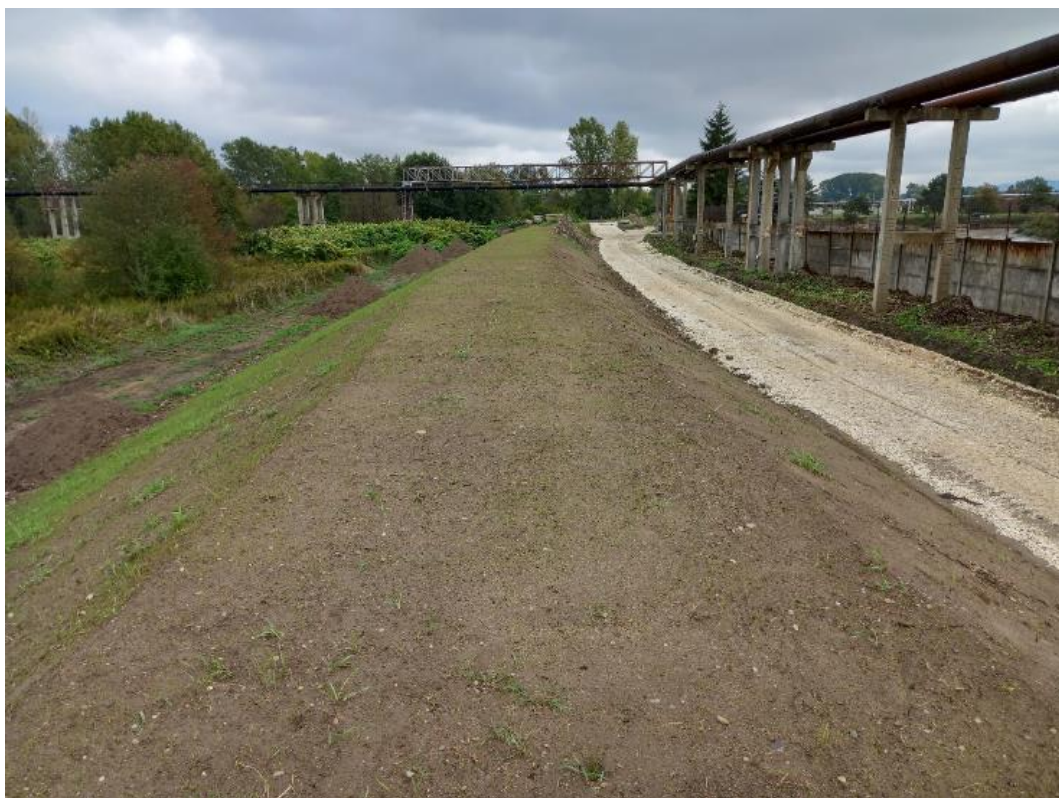
Phot. 14. Left embankment at km approx. 1+200 – example of executing topsoiling and sowing works for the section of the embankment (3rd decade of September, 2022).

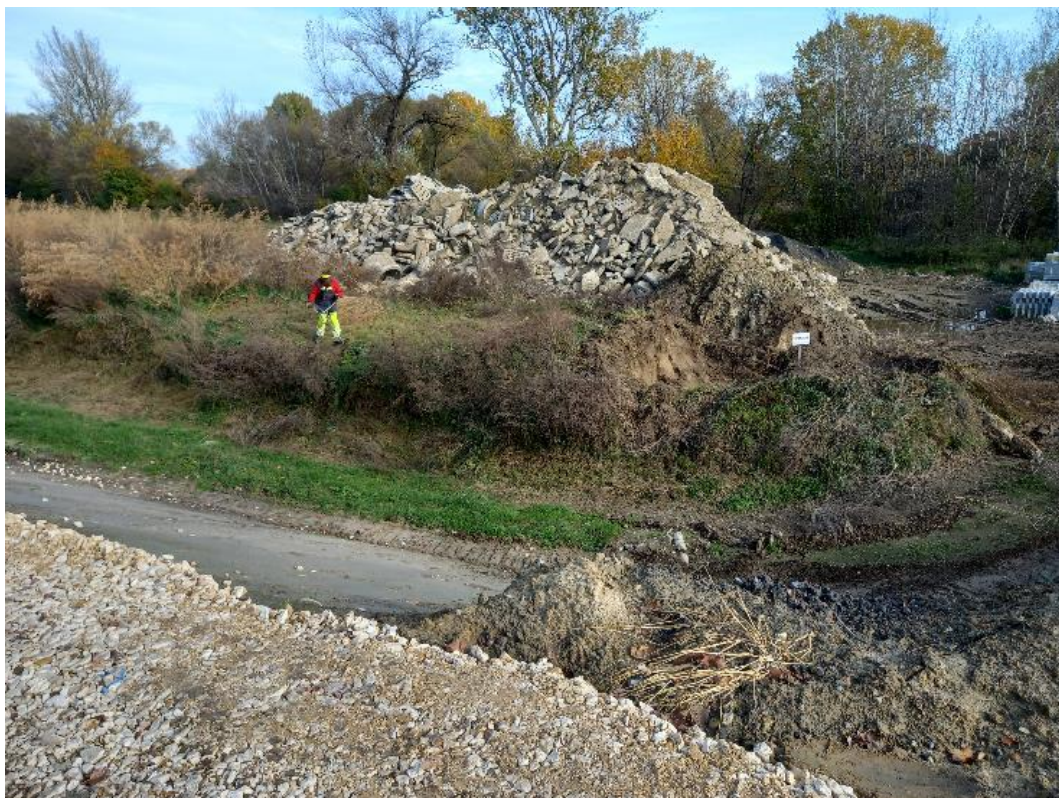
Phot. 15. Left embankment at km approx. 3+150 – mowing of invasive plants in the topsoil slope area (3rd decade of October 2022).

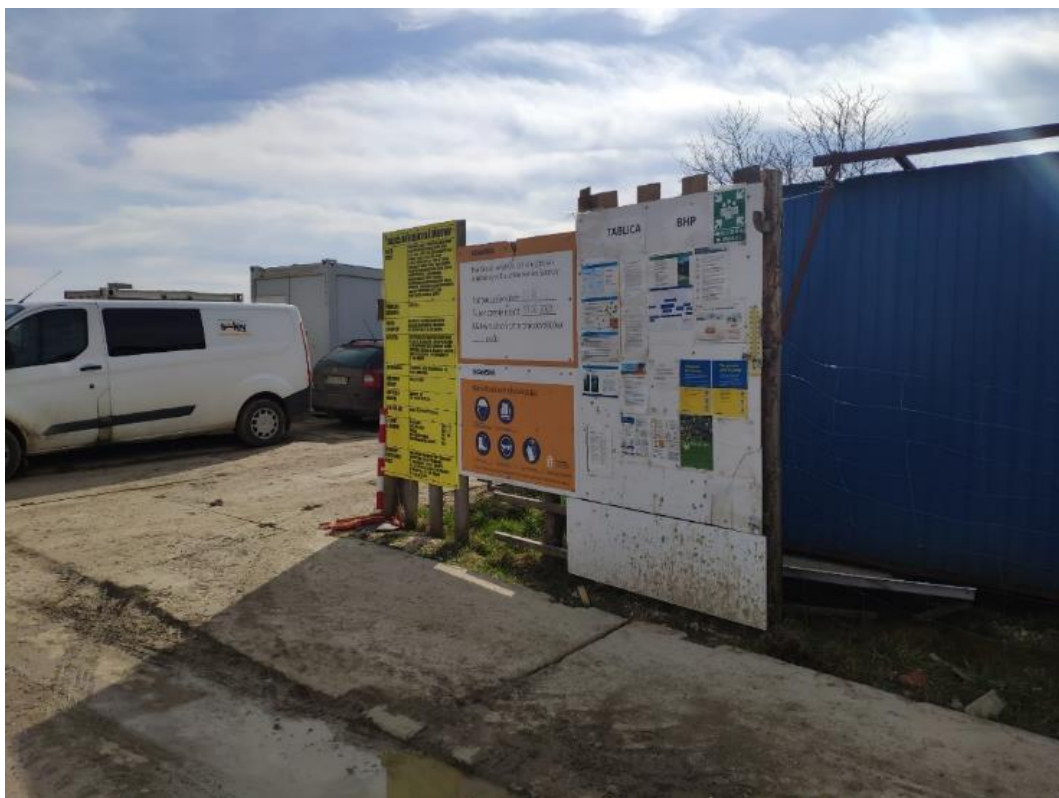
Phot. 16. Right embankment at km approx. 2+000 (construction site facilities) – health and safety board with information on safe working practices (2nd decade of March, 2023).

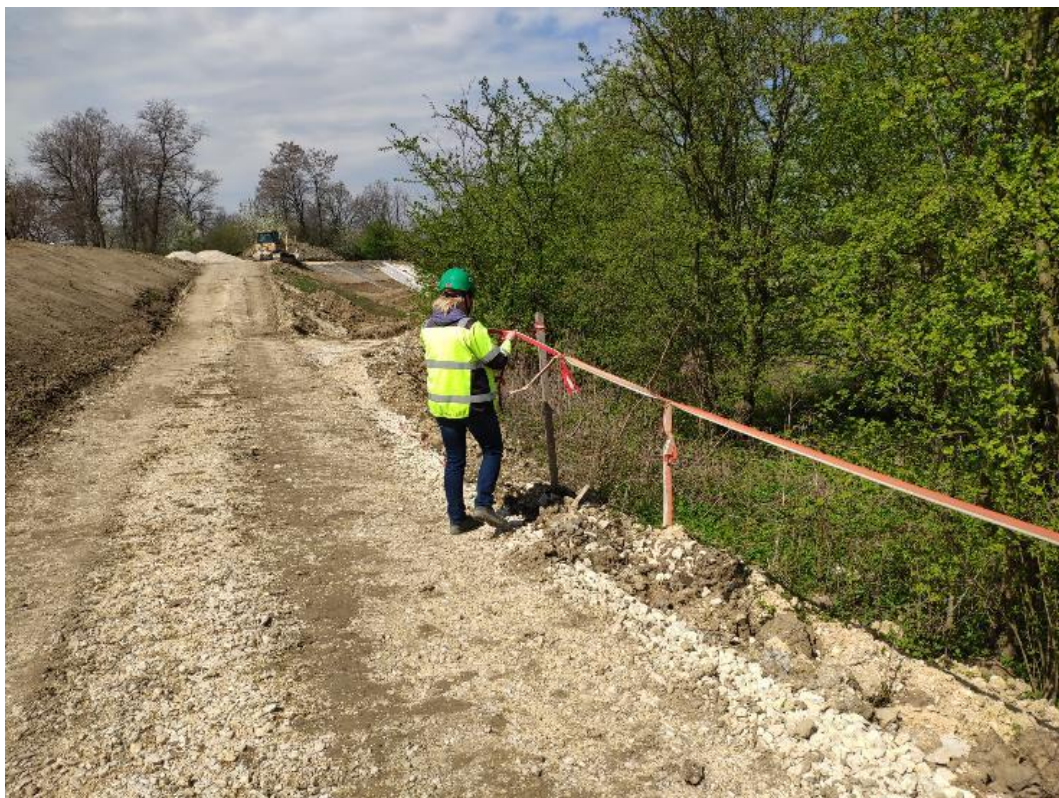
Phot. 17. Left embankment at km approx. 5+200 – reconstruction of damaged greenery fences (2nd decade of April, 2023).

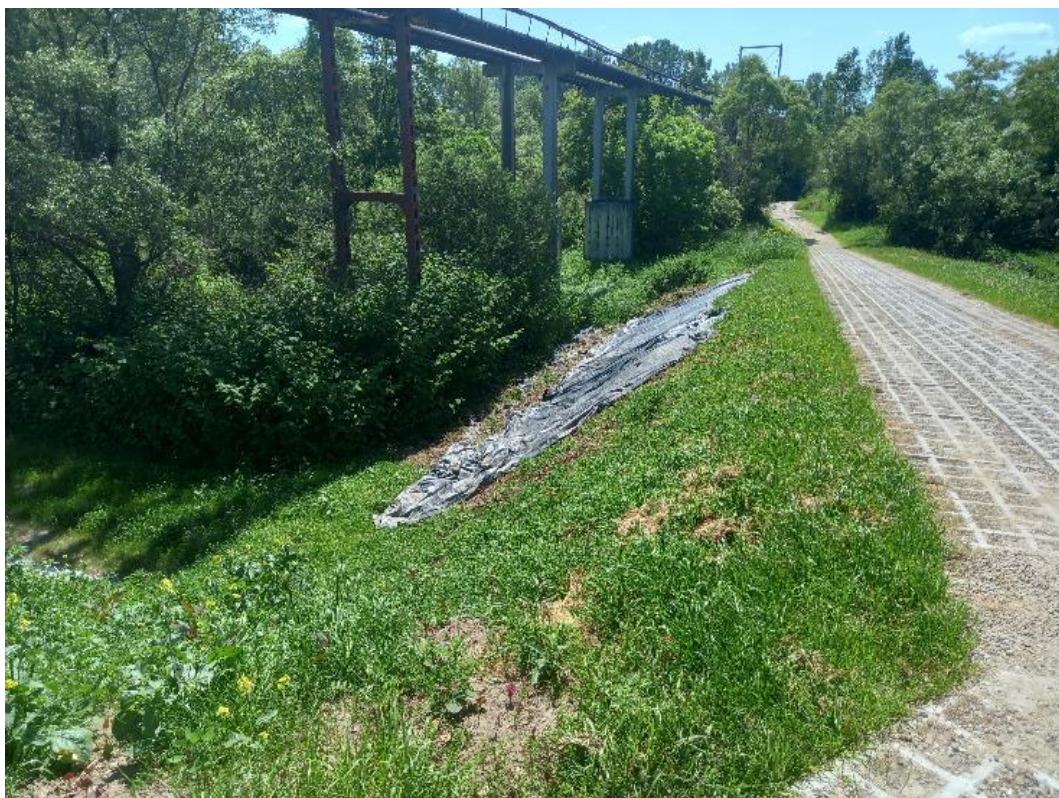
Phot. 18. Right embankment at km approx. 0+500 – measures to reduce the growth of invasive plants (knot weeds) by covering with plastic sheeting (3rd decade of May 2023).

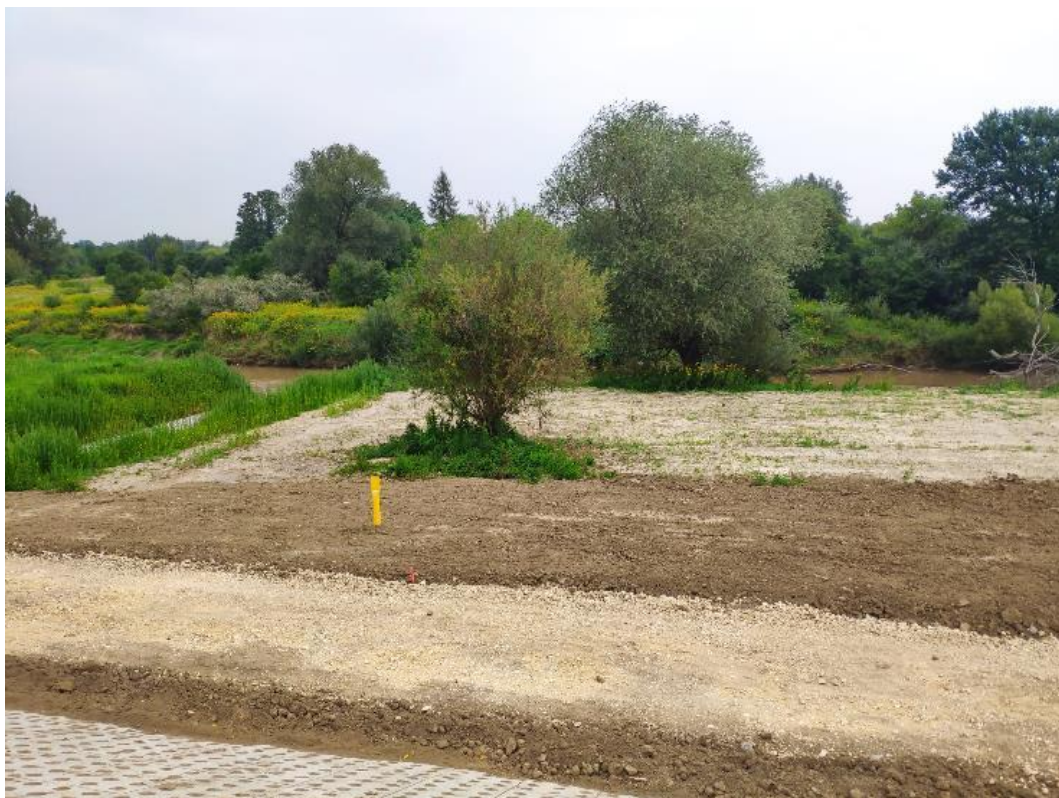
Phot. 19. Left embankment at km approx. 5+200 – view of the tidied-up area after the finished works (2nd decade of August 2023).

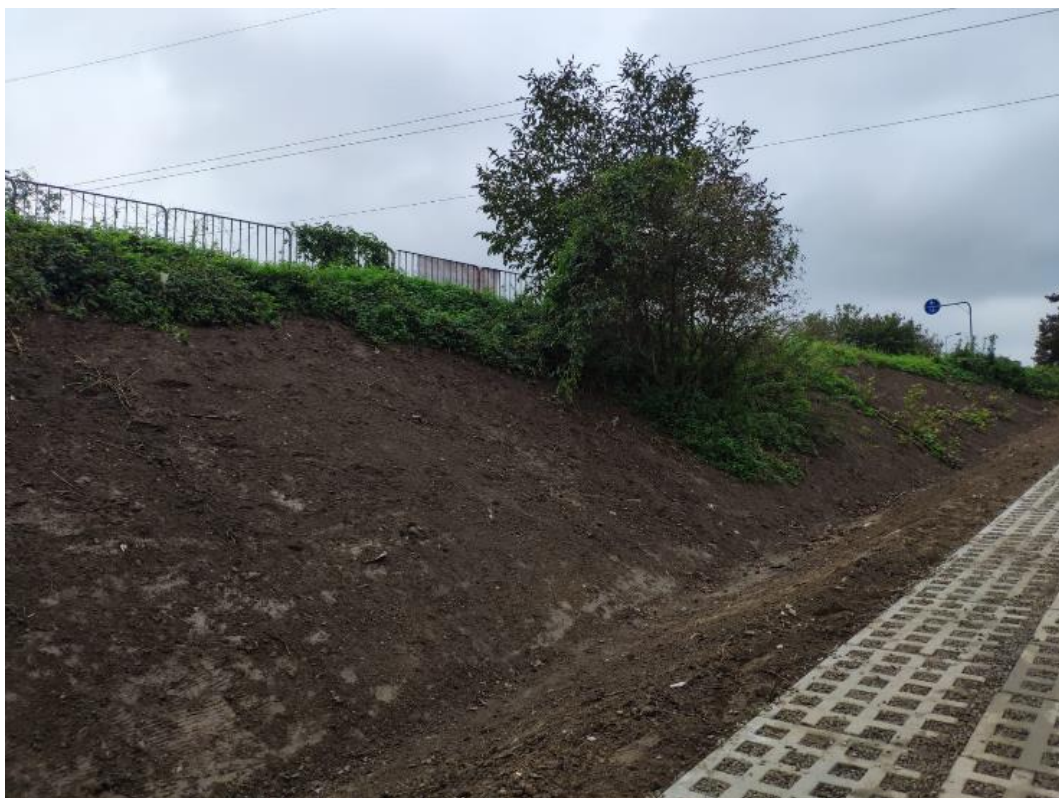
Phot. 20. Left embankment at km approx. 3+150 – example of results of measures to remove invasive plants (2nd decade of September, 2023).
