PHOTOGRAPHIC DOCUMENTATION

Appendix no. 2

to the Final Report on the implementation of the measures listed under the EMP
for Contract 2B.2/1

Odra-Vistula Flood Management Project

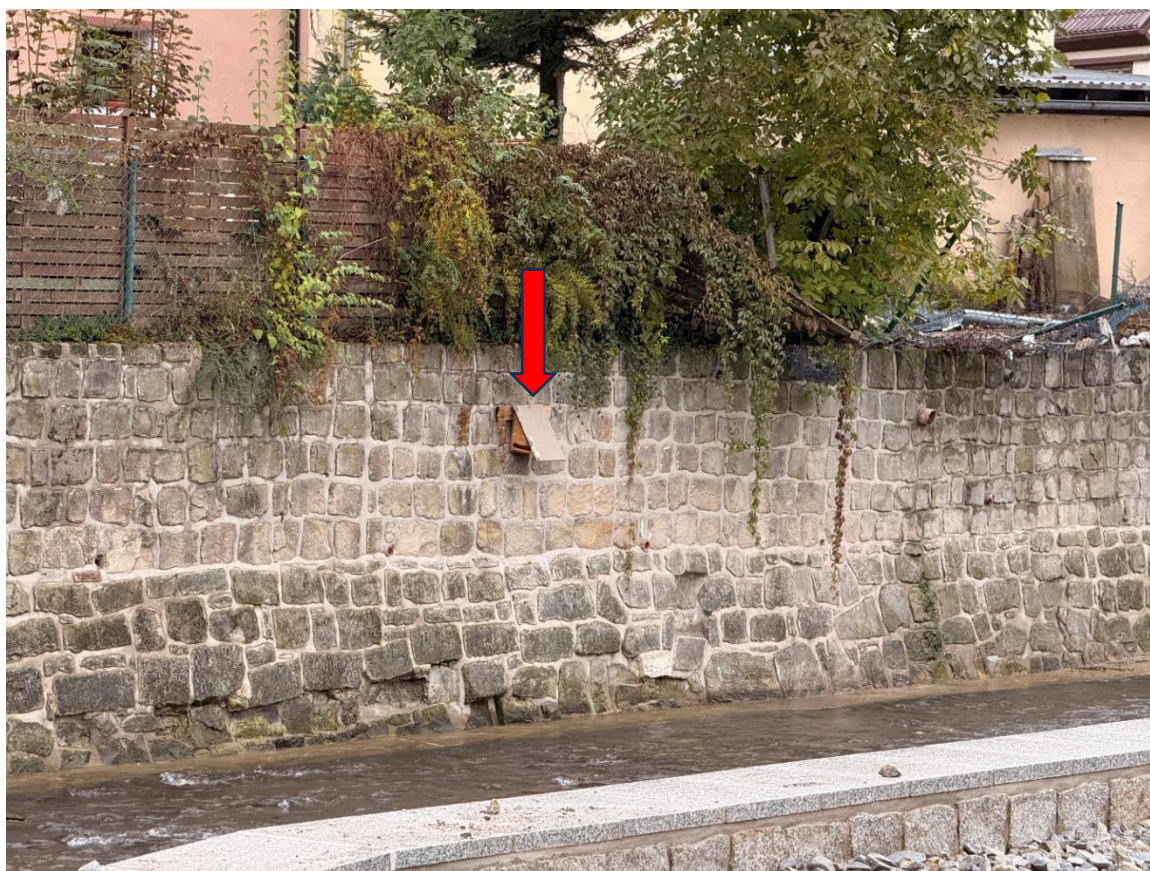
Phot. 1. Box for birds mounted on the retaining wall (red arrow) (item no. 115 App. 1 of the EMP).

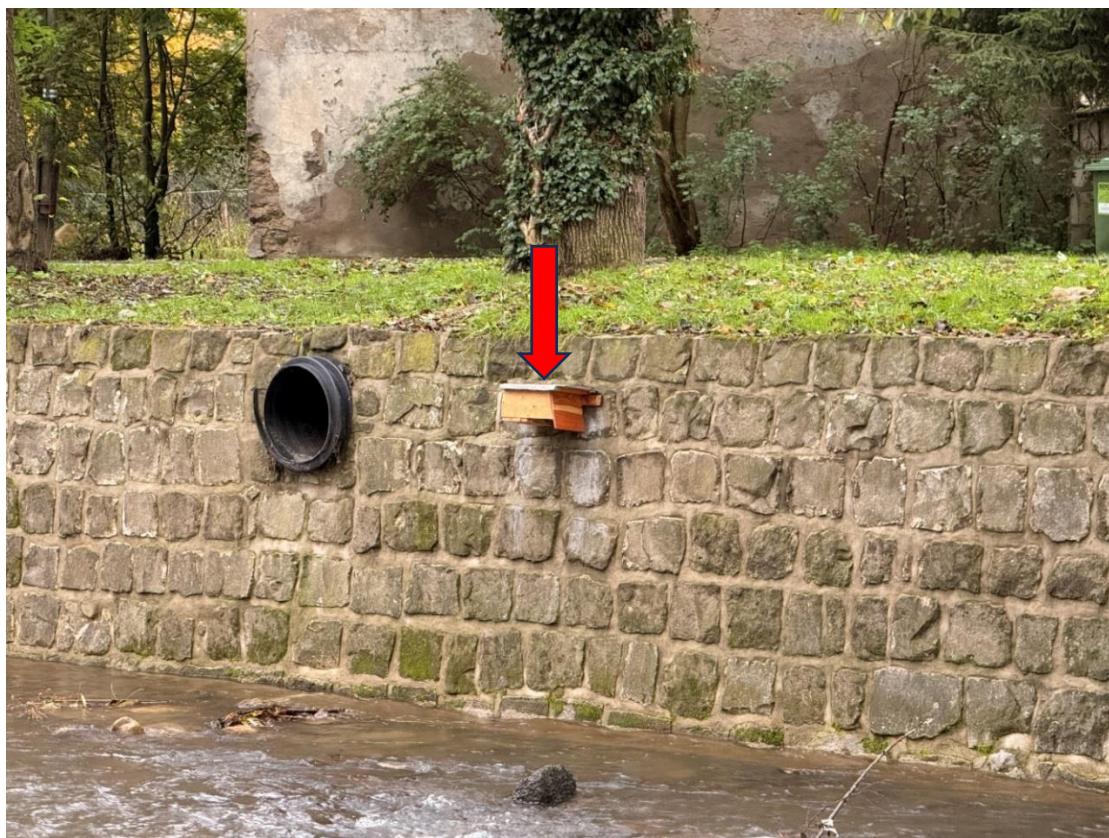
Phot. 2. Box for birds mounted on the retaining wall (red arrow) (item no. 115 App. 1 of the EMP).

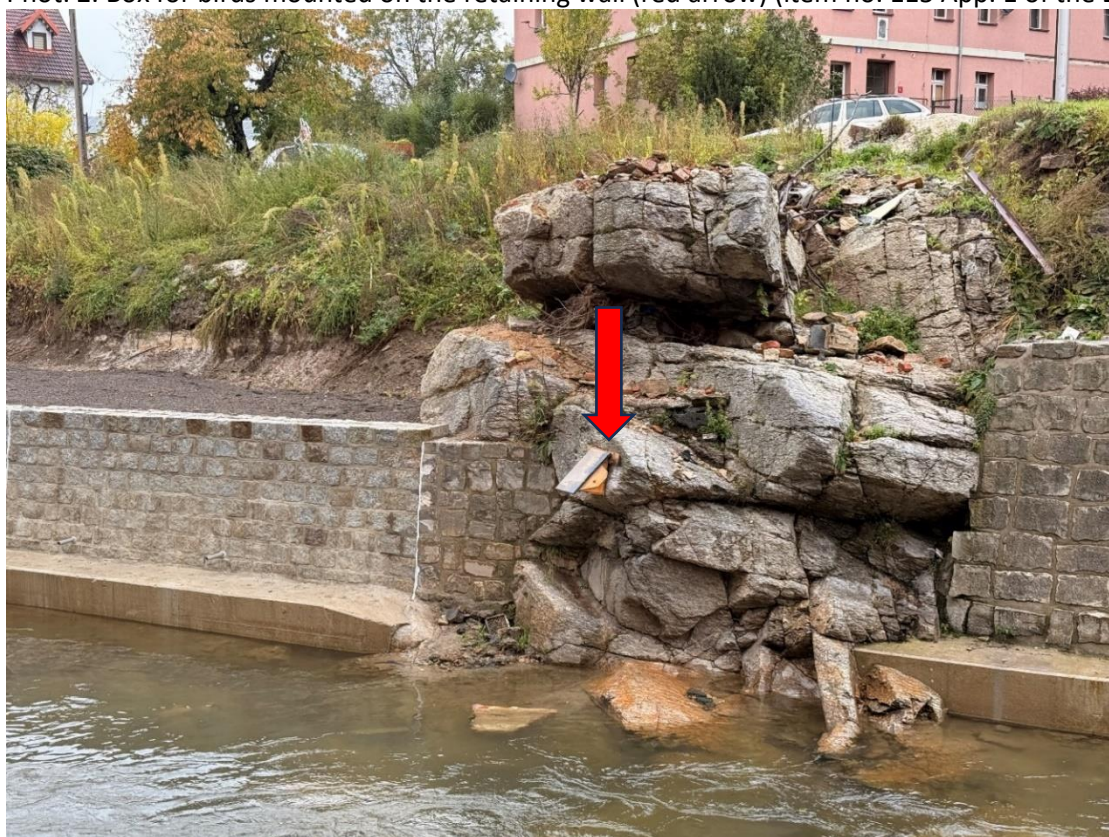
Phot. 3. Box for birds mounted on rock outcrop (red arrow) (item no. 115 App. 1 of the EMP).

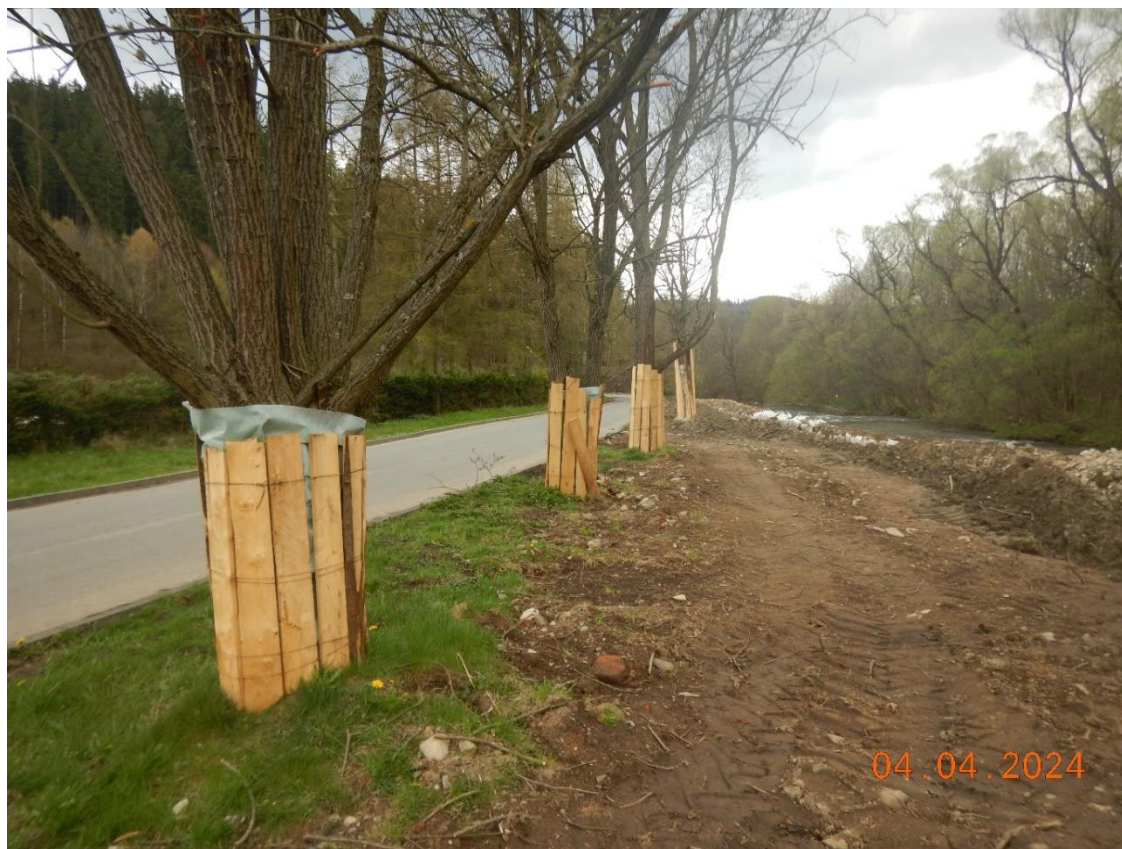
Phot. 4. Protection of trees not intended for felling at the Construction Site (item no. 22).

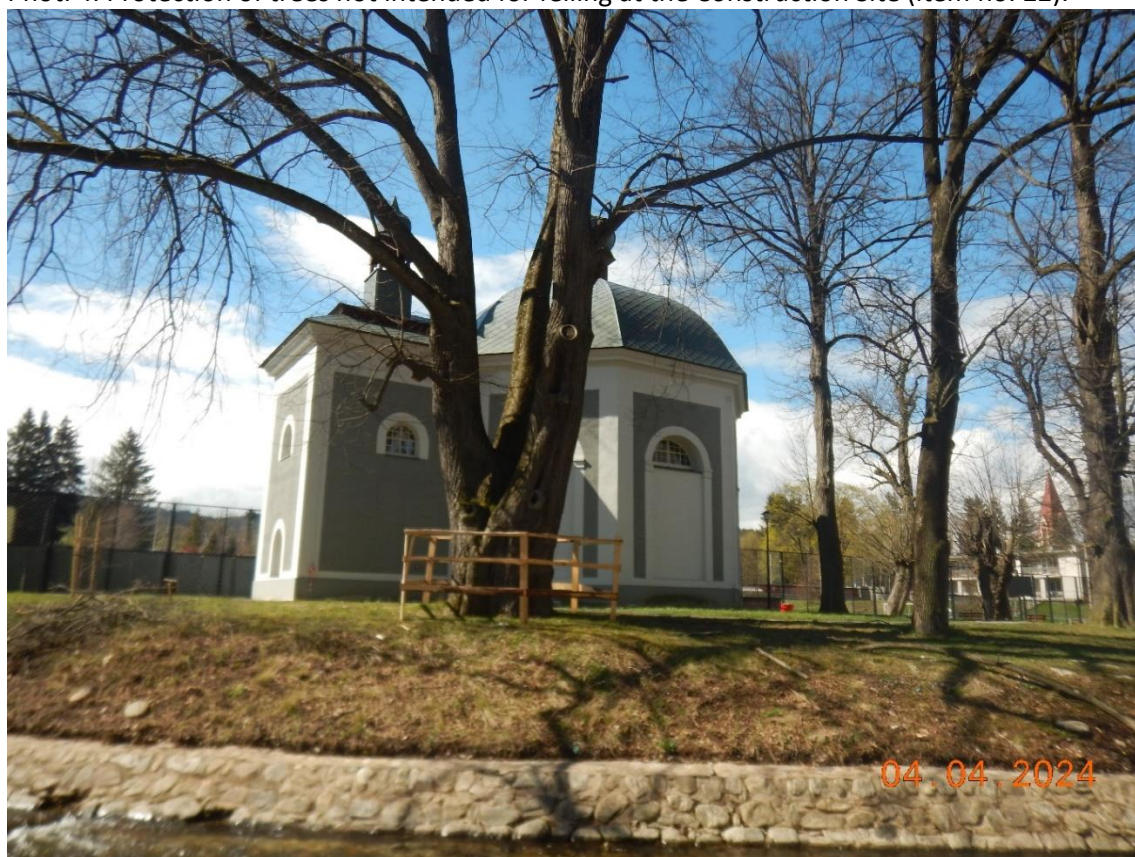
Phot. 5. Protection of natural monument against damage – a small-leaved lime tree in Stronie Śląskie (item no. 118).

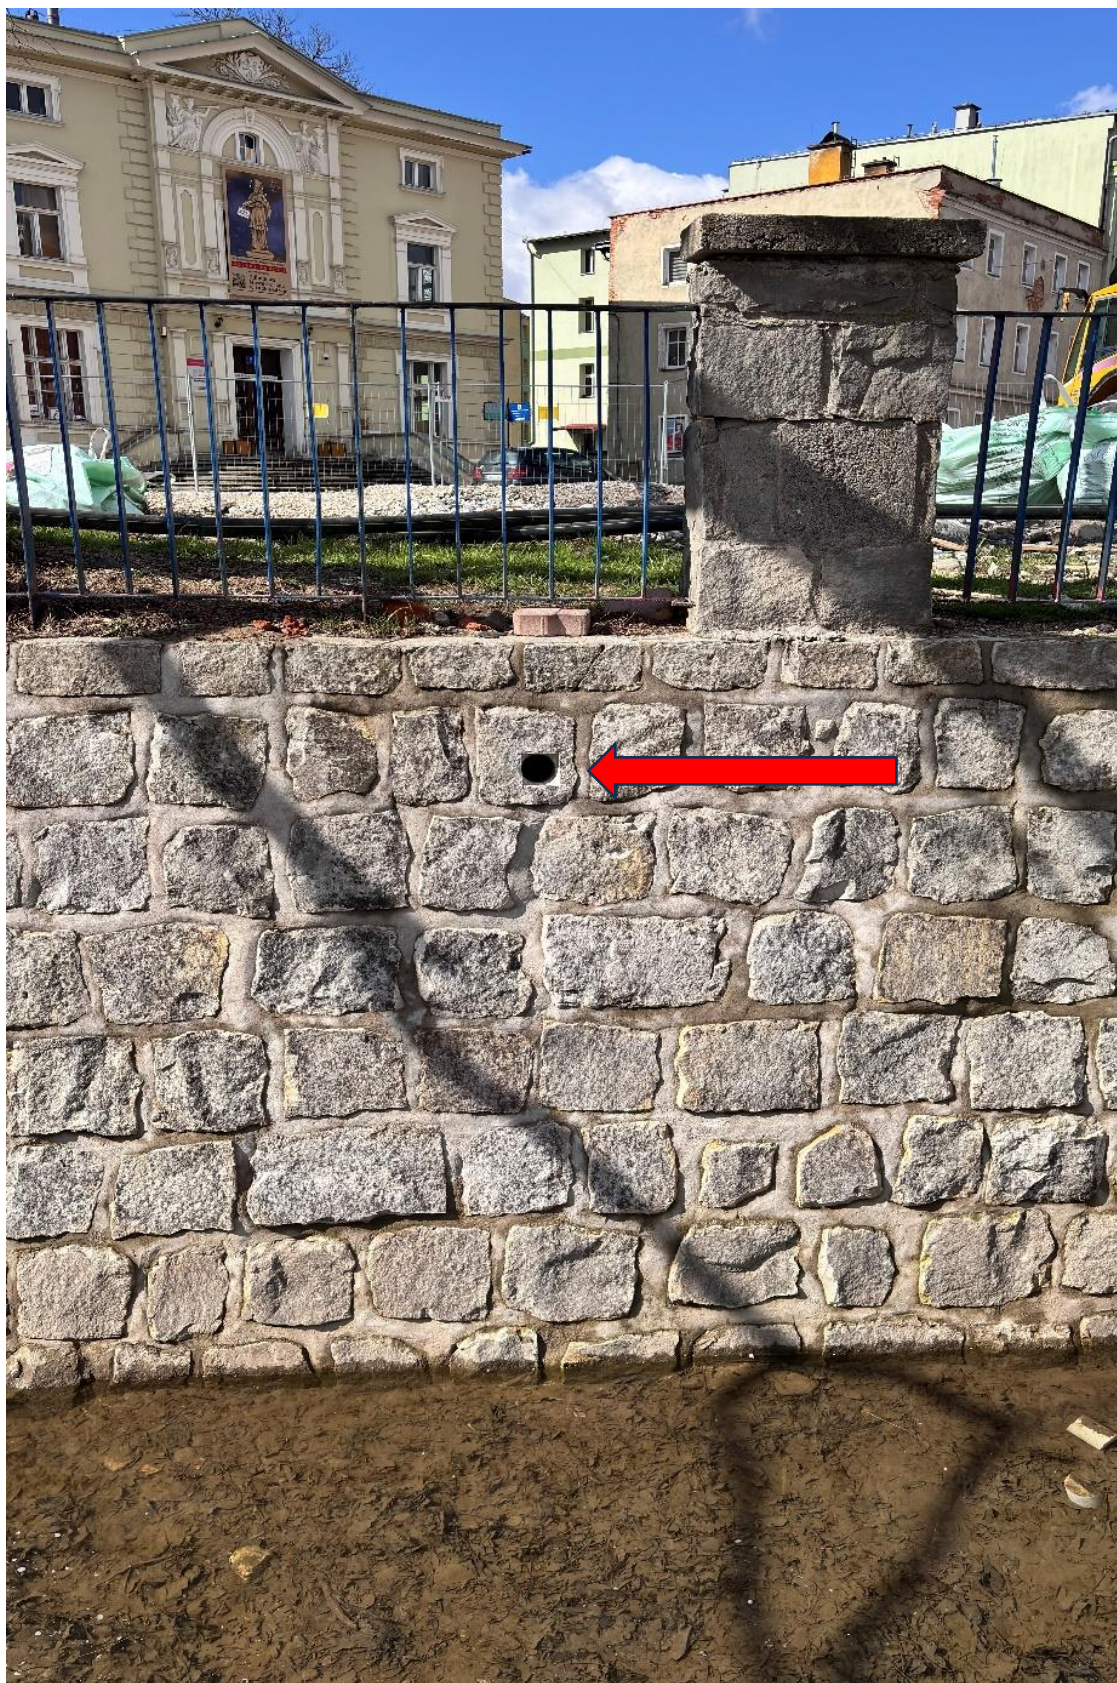
Phot.6. The red arrow indicates a nesting niche for birds made in the retaining wall (item no. 70).

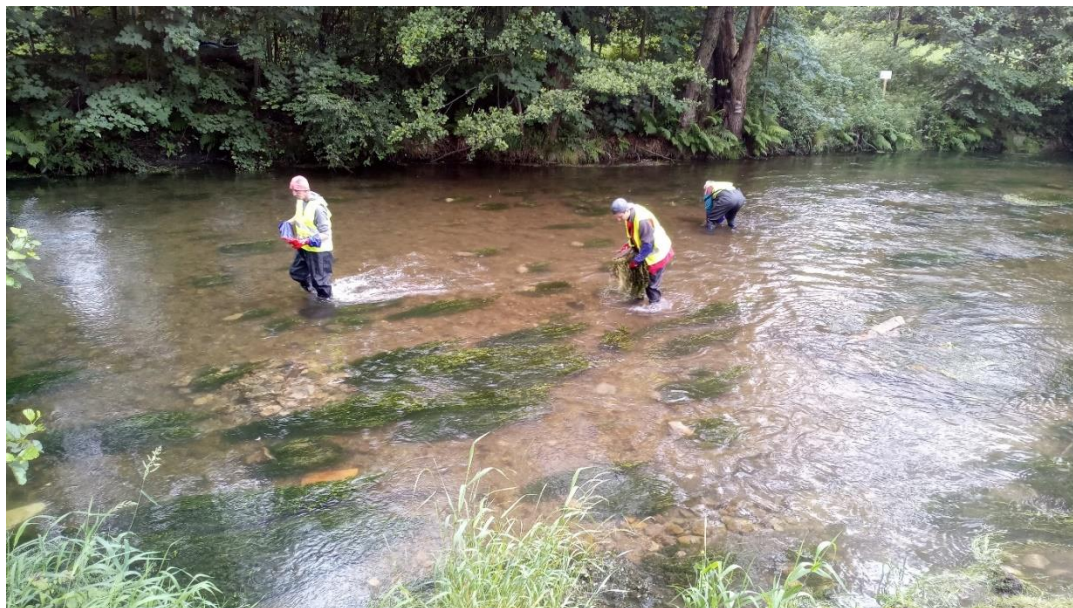
Phot. 7. Replanting of specimens of Water-crowfoot in places suitable for the habitat along sections not covered by the works (item no. 60).

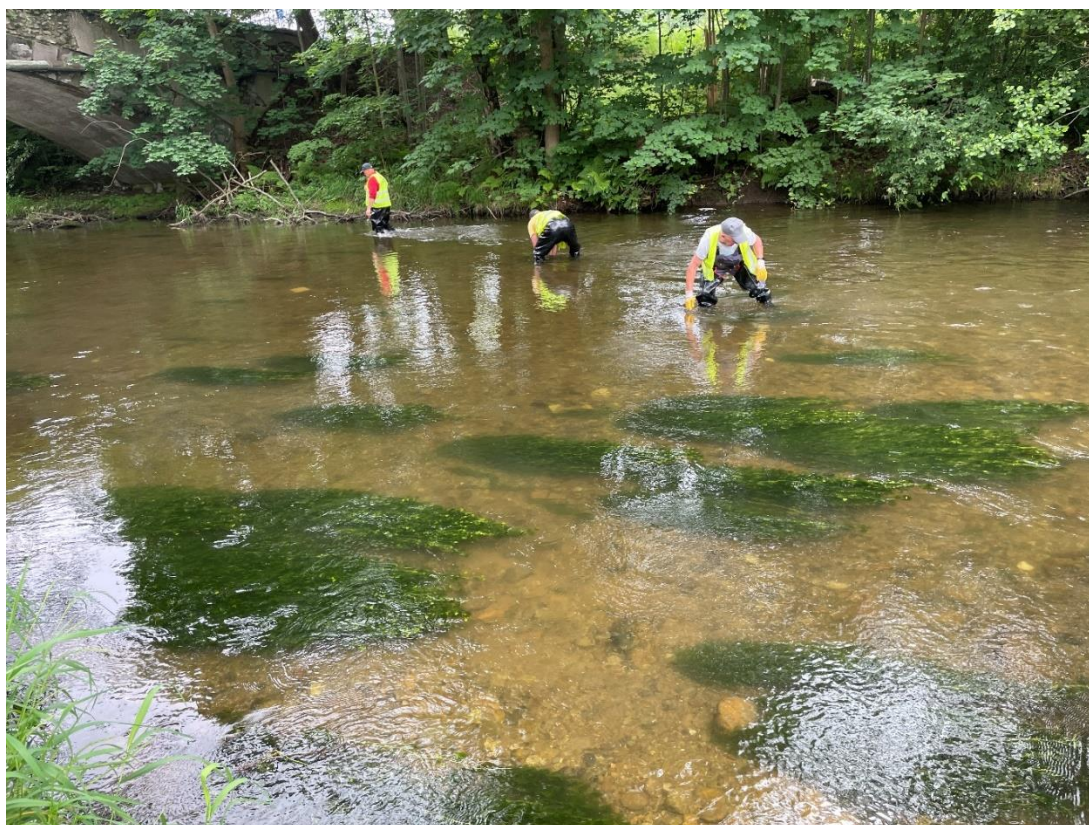
Phot. 8. Replanting of specimens of Water-crowfoot in places suitable for the habitat along sections not covered by the works (item no. 60).

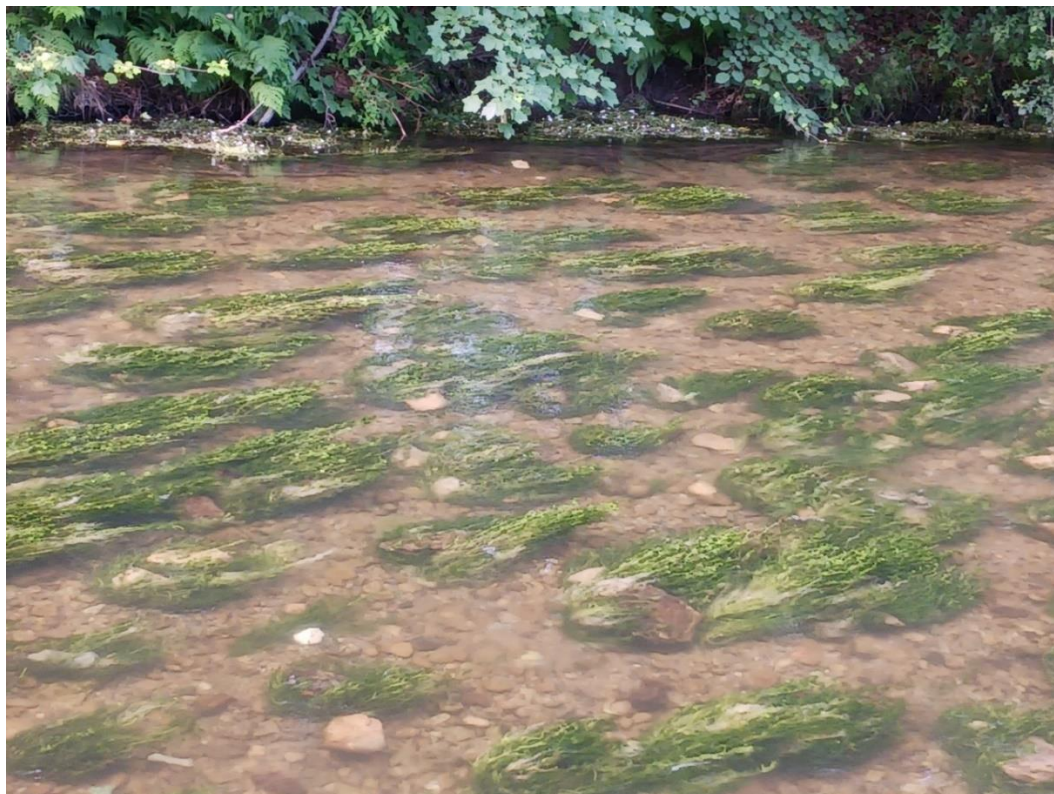
Phot. 9. New site of Water-crowfoot – specimens pressed down by river stones visible in the photograph (item no. 60).

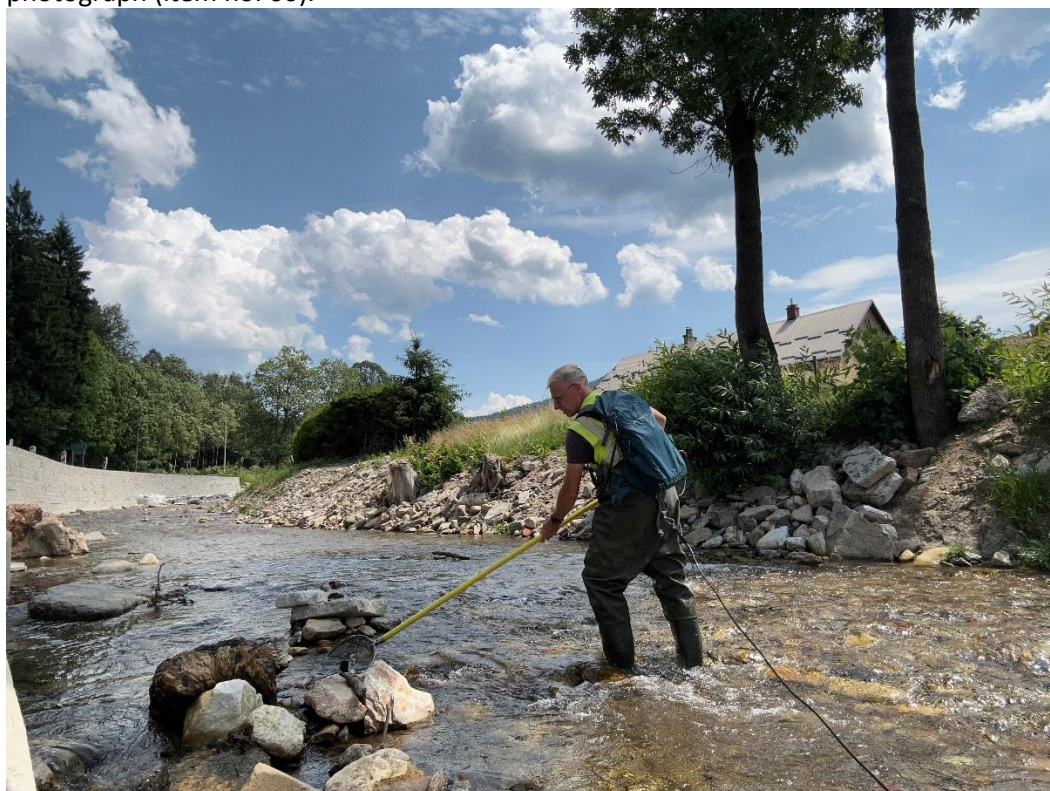
Phot. 10. Advance catching of fish in the Biała Łądecka riverbed from the zone of conducting construction works (item no. 64).

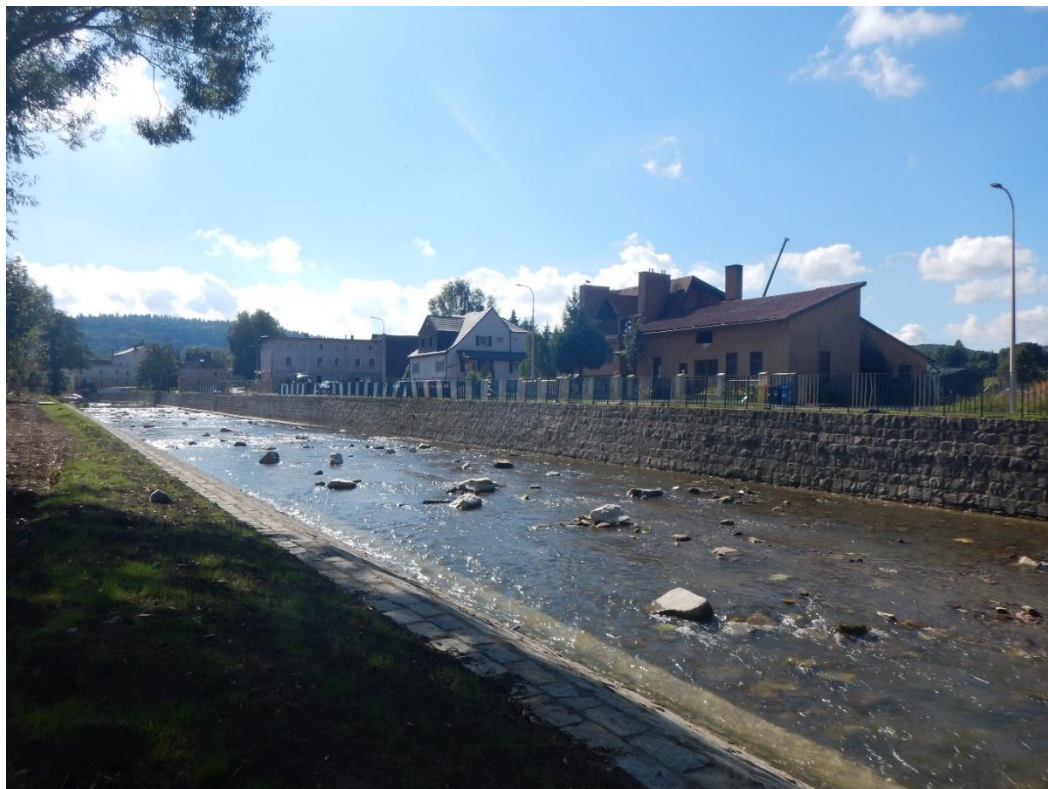
Phot. 11. Microhabitats for fish in the riverbed made after completed construction works (item no. 72).

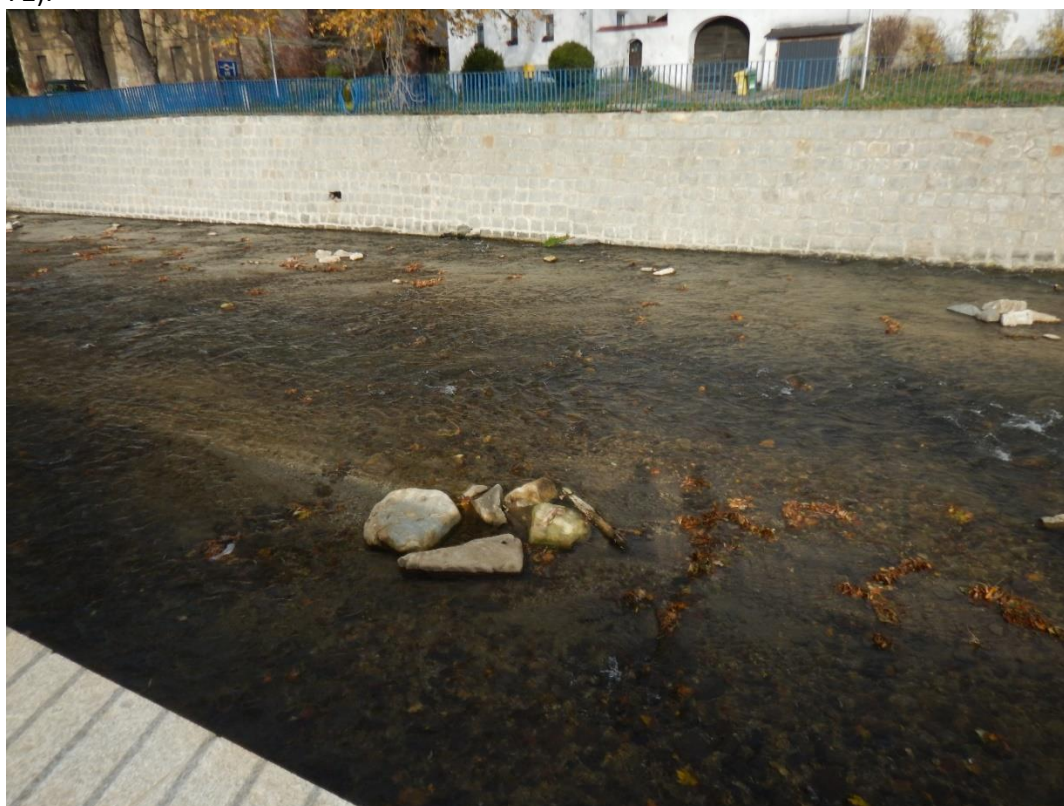
Phot. 12. Microhabitats for fish in the riverbed made after completed construction works (item no. 72).

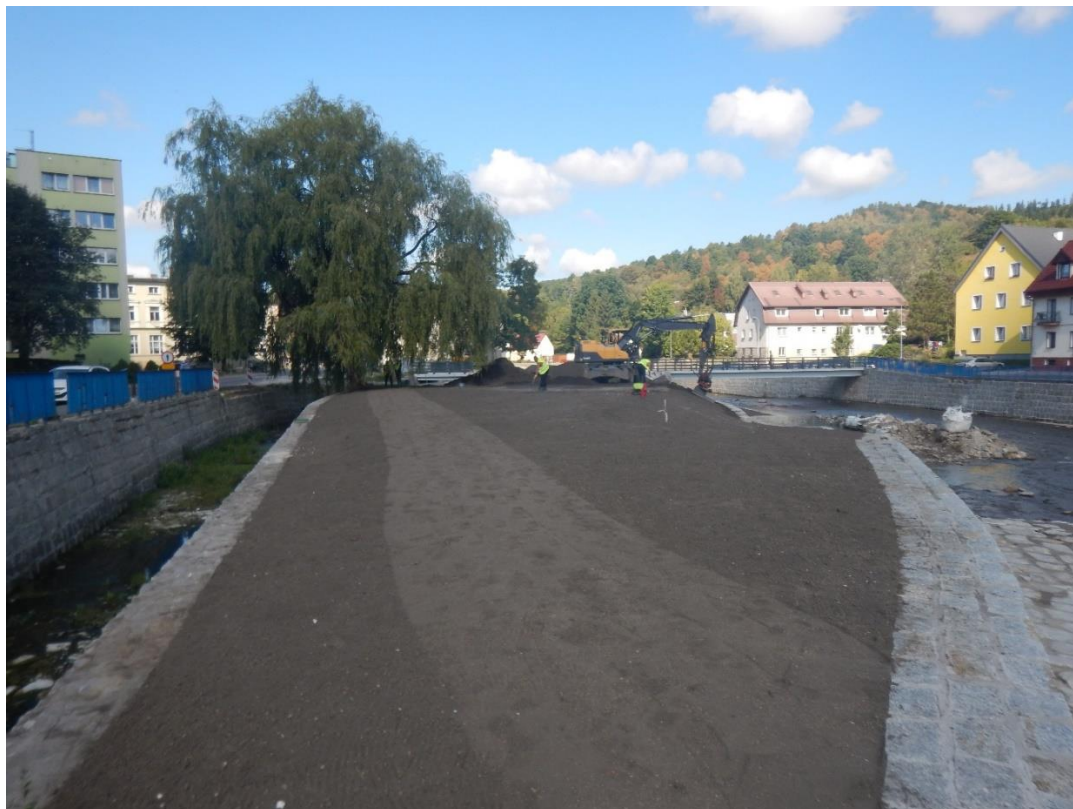
Phot. 13. Reclamation of land after completion of construction works – Młyńska Island, Łądek Zdrój (item no. 16).

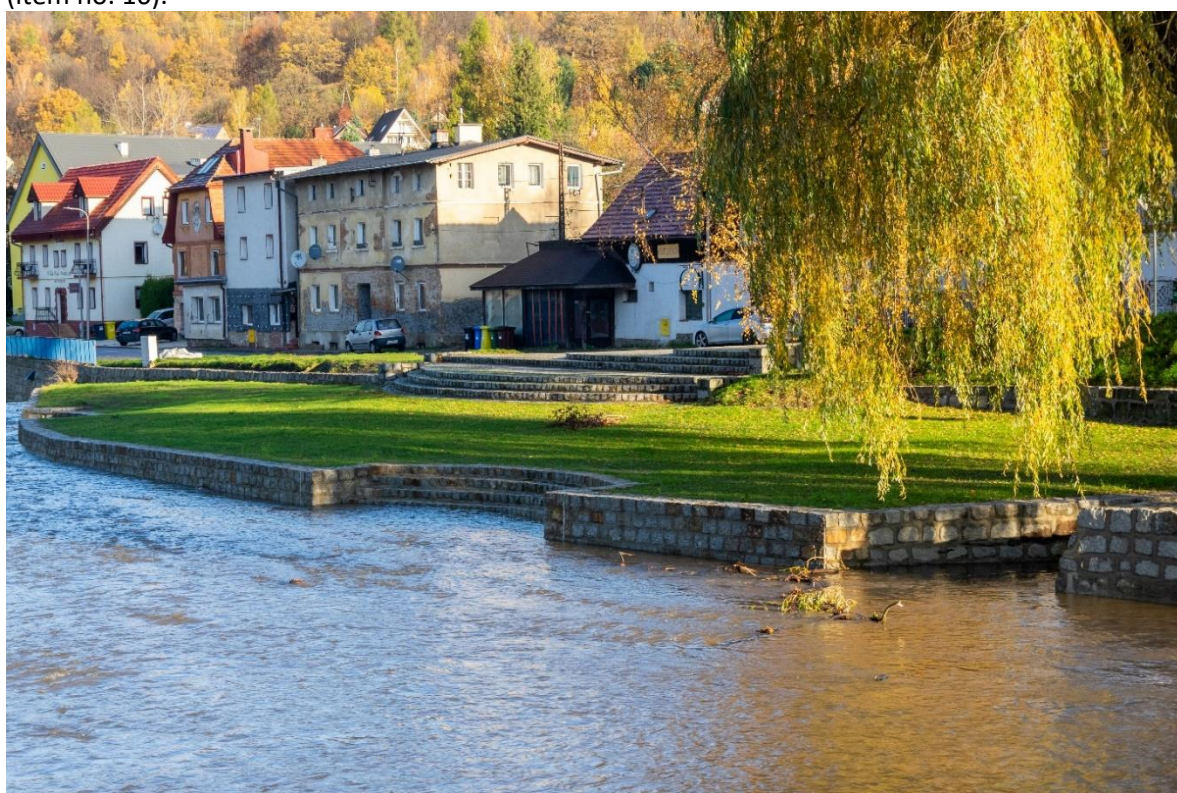
Phot. 14. Młyńska Island, Łądek Zdrój – restored surface of after completion of construction works (item no. 16).

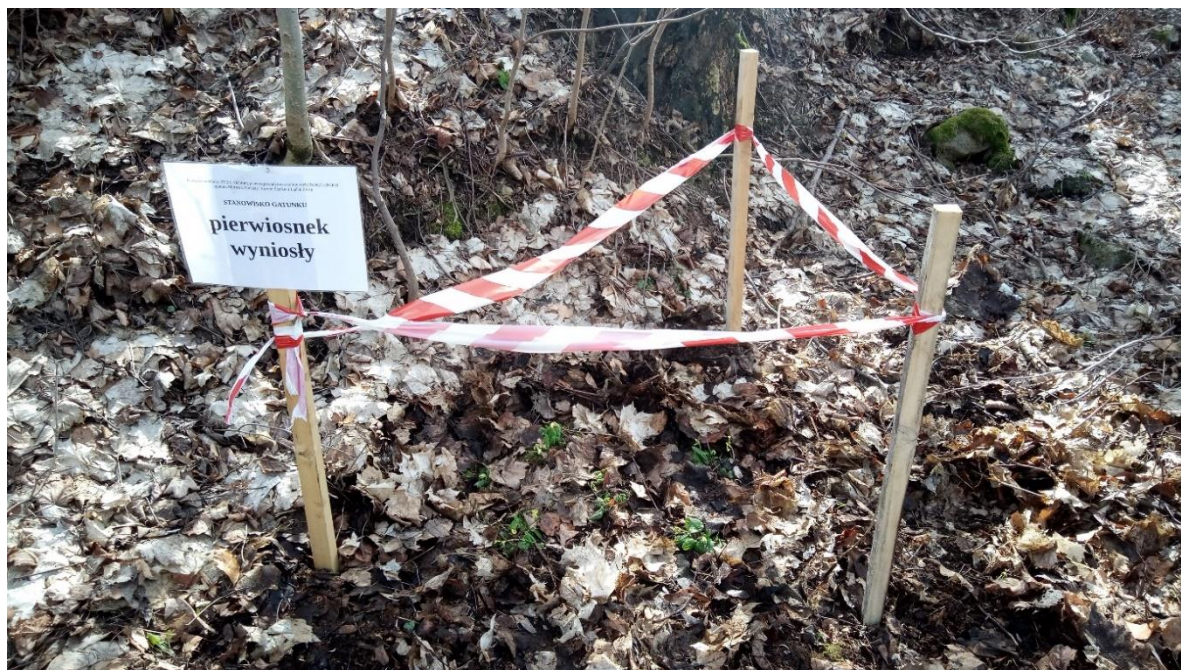
Phot. 15. Marked site of the translocated Oxlip (item no. 60).

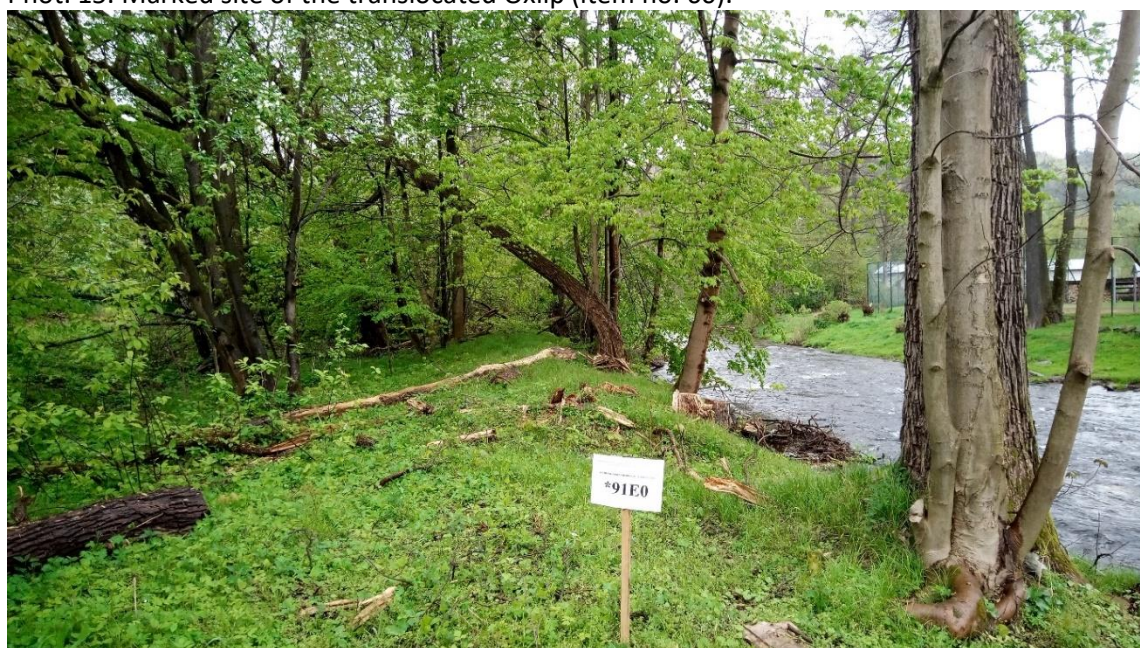
Phot. 16. Marked patch of the nature habitat situated in the neighborhood of the construction site (item no. 66).

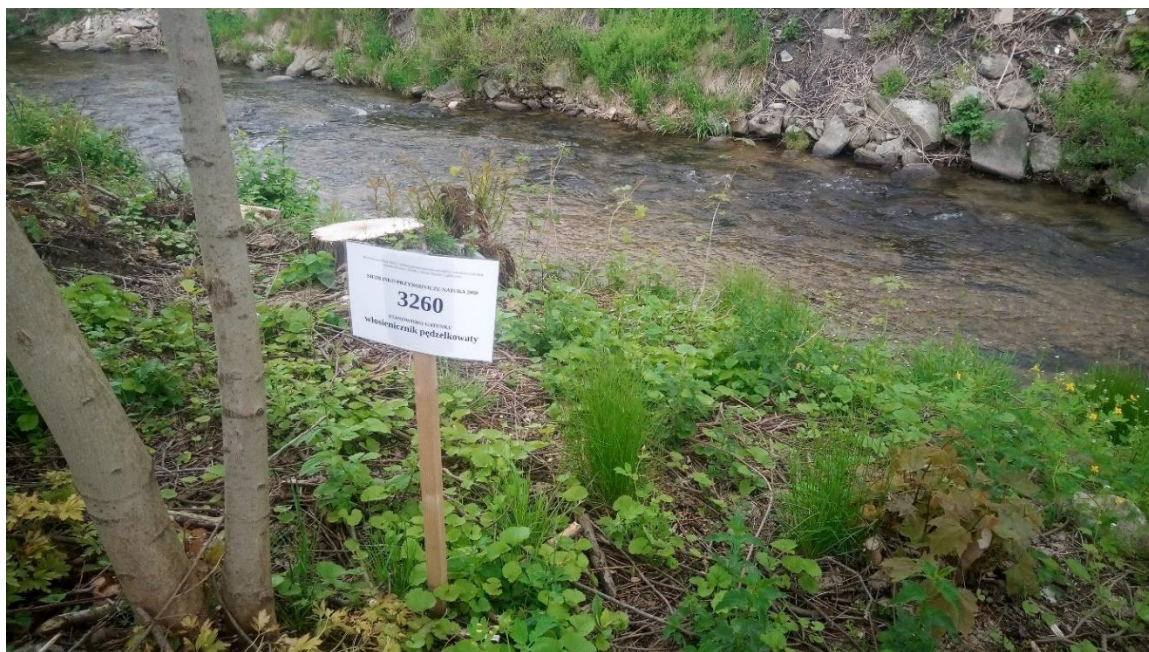
Phot. 17. Marked patch of the nature habitat 3260 situated on the construction site (item no. 67).

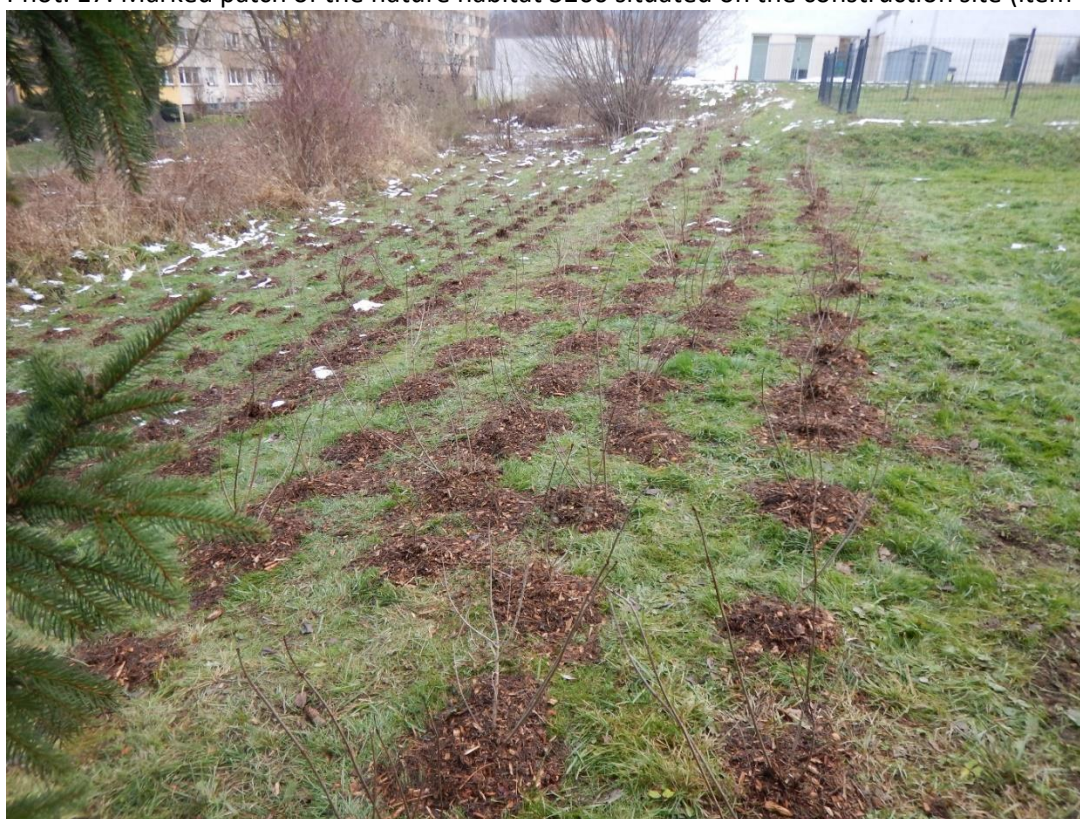
Phot. 18. Compensation plantings – Łądek Zdrój (item no. 114).

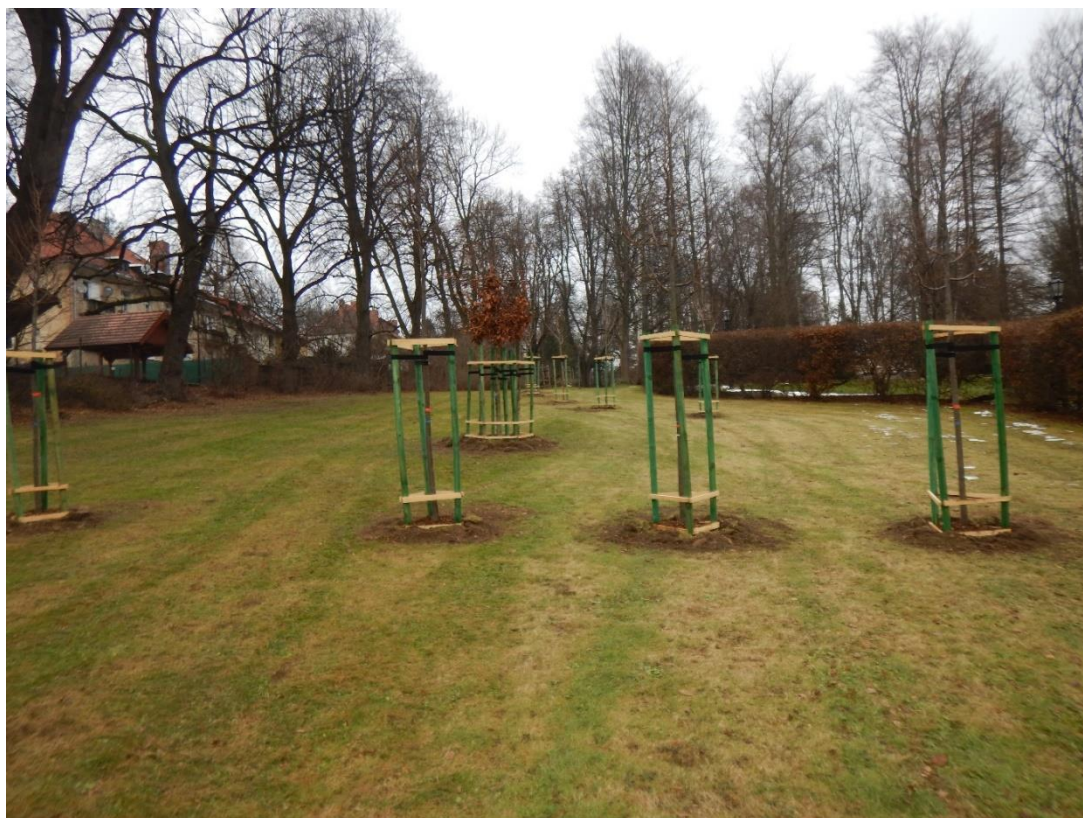
Phot. 19. Compensation plantings – Łądek Zdrój (item no. 114).

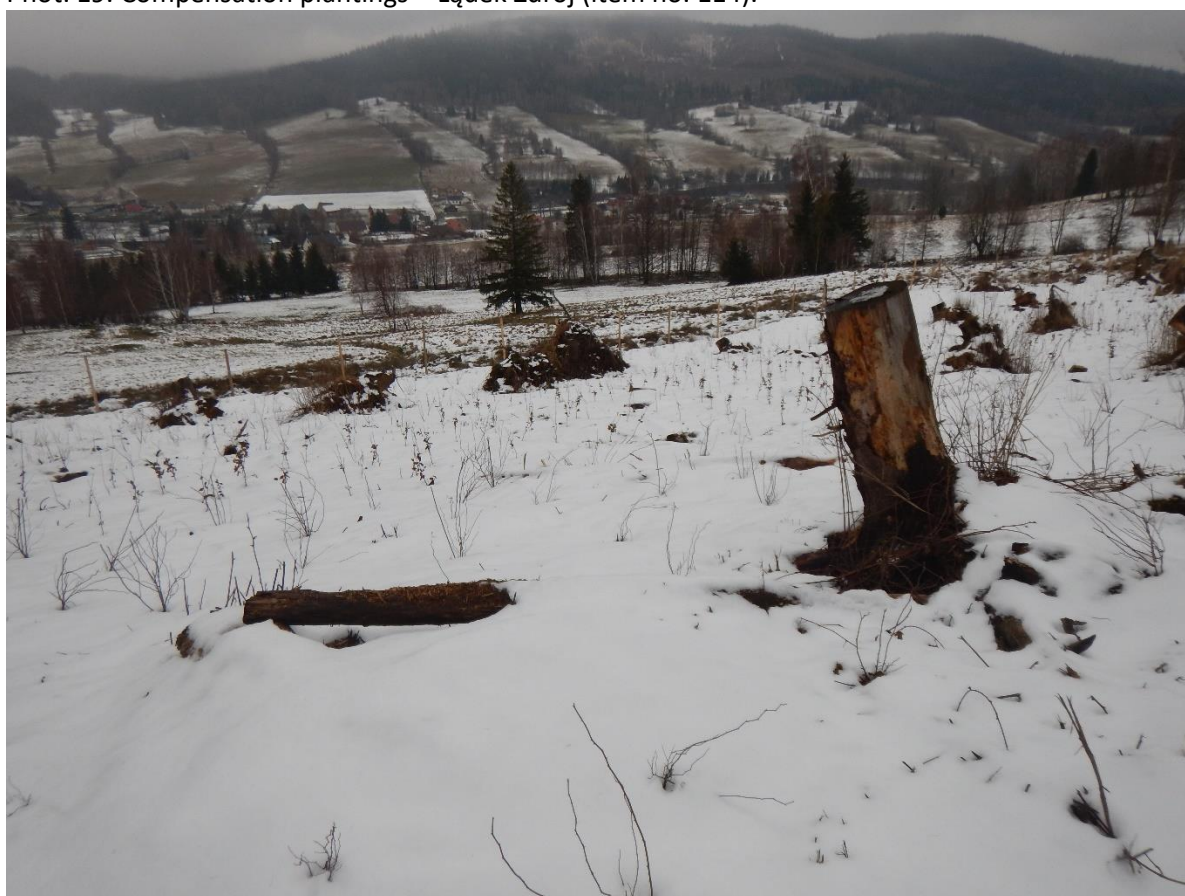
Phot. 20. Compensation area – Stronie Śląskie (item no. 123).

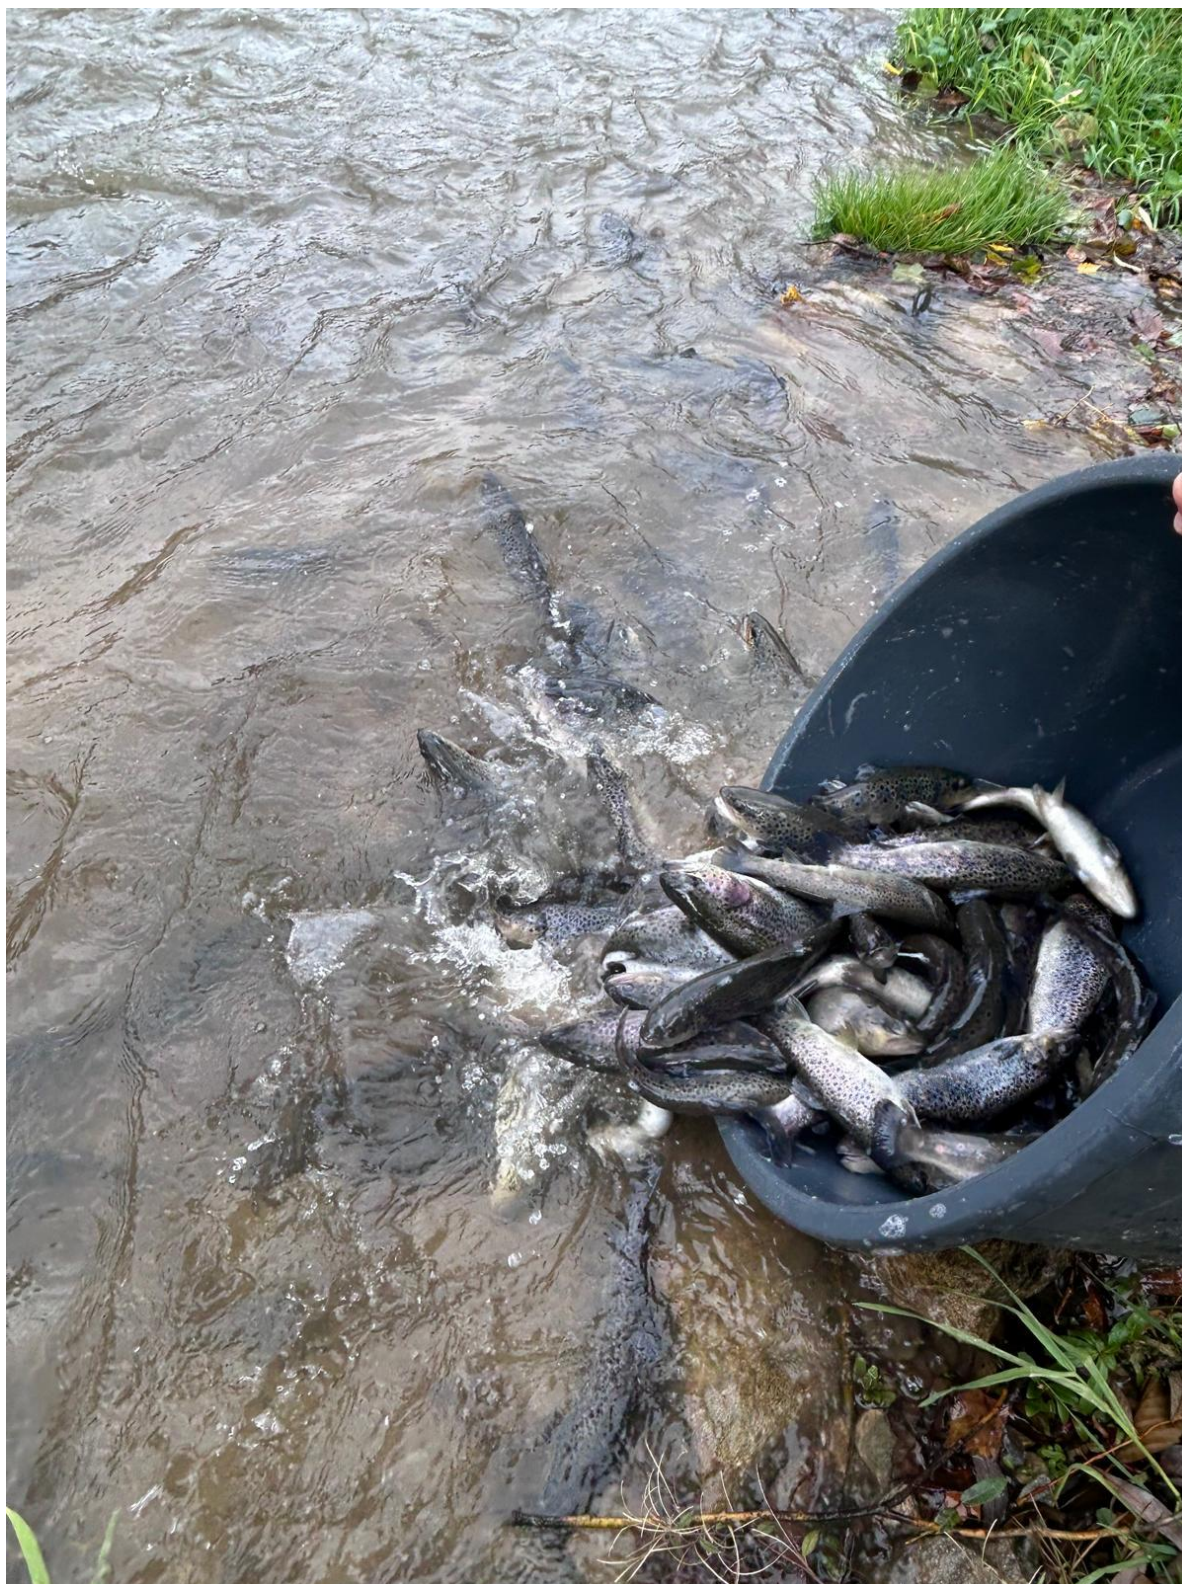
Phot. 21. Stocking the Biała Łądecka River with stream trout (items nos. 113, 122).

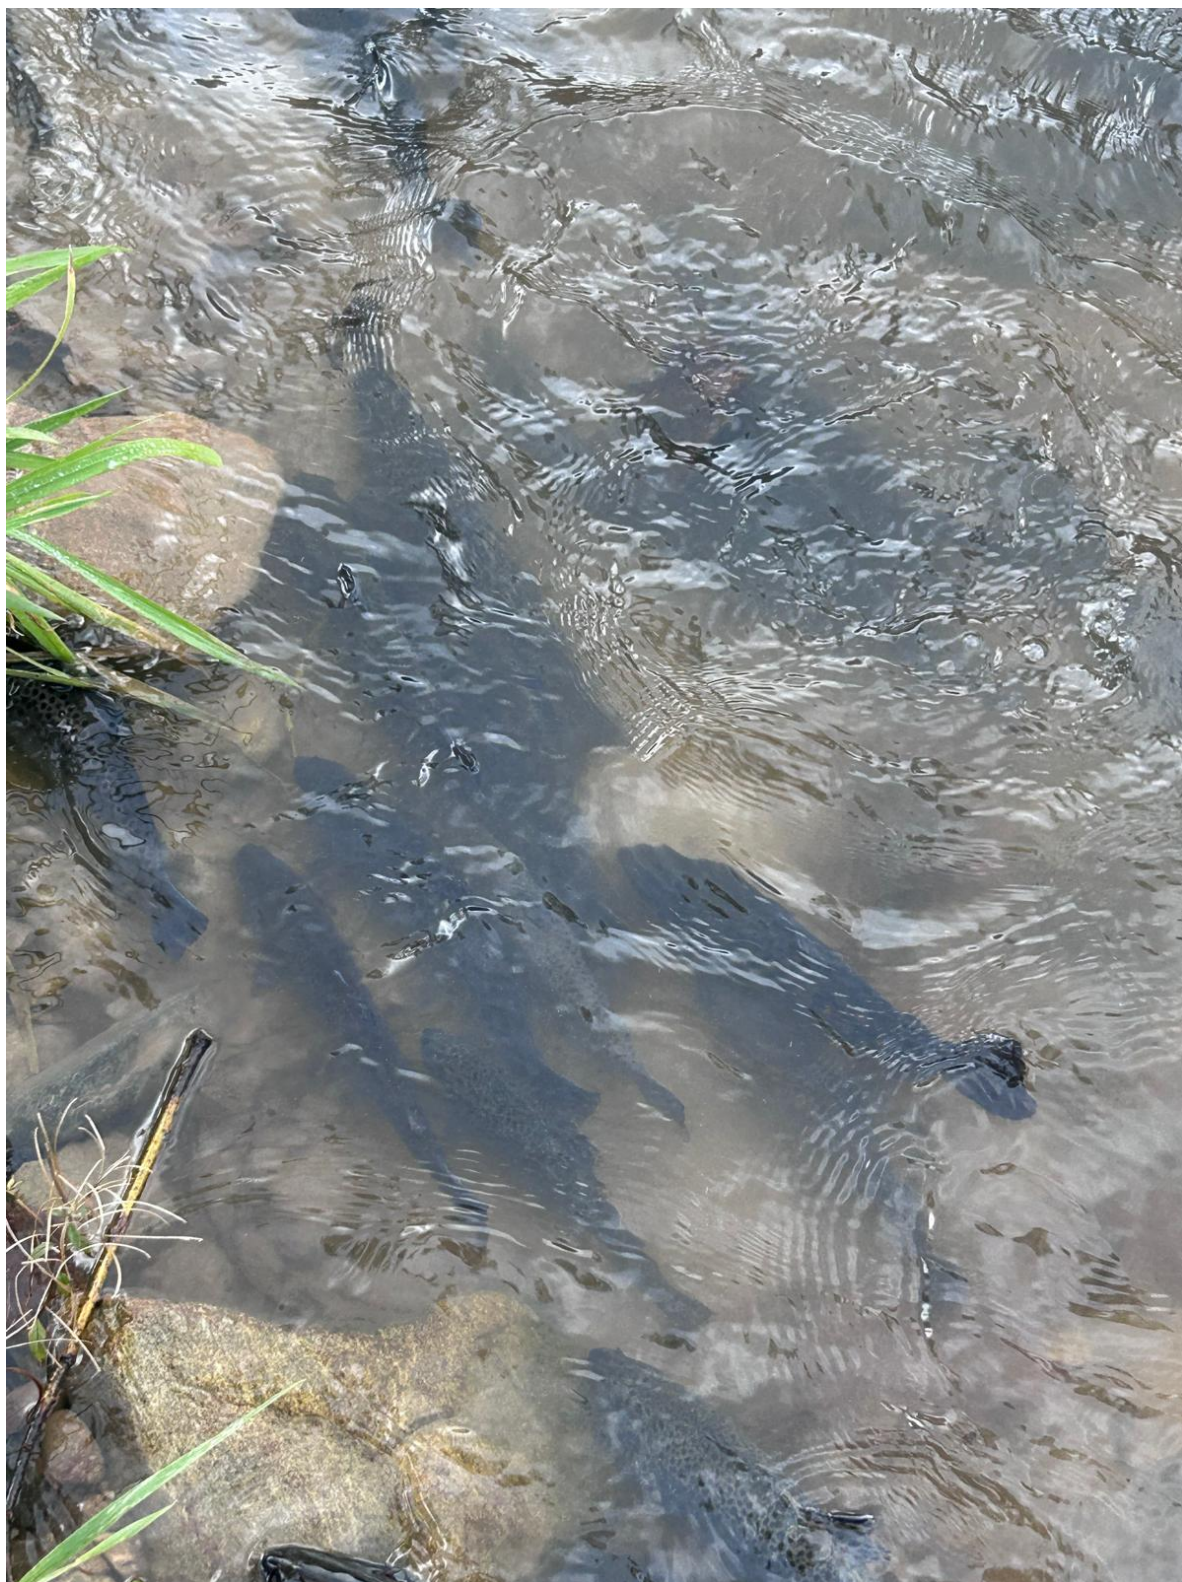
Phot. 22. Stocking the Biała Łądecka River with stream trout (items nos. 113, 122).
