PHOTOGRAPHIC DOCUMENTATION

Appendix no. 2

to the Final Report on the implementation of the measures listed under the EMP
for Contract 2B.2/1

Odra-Vistula Flood Management Project

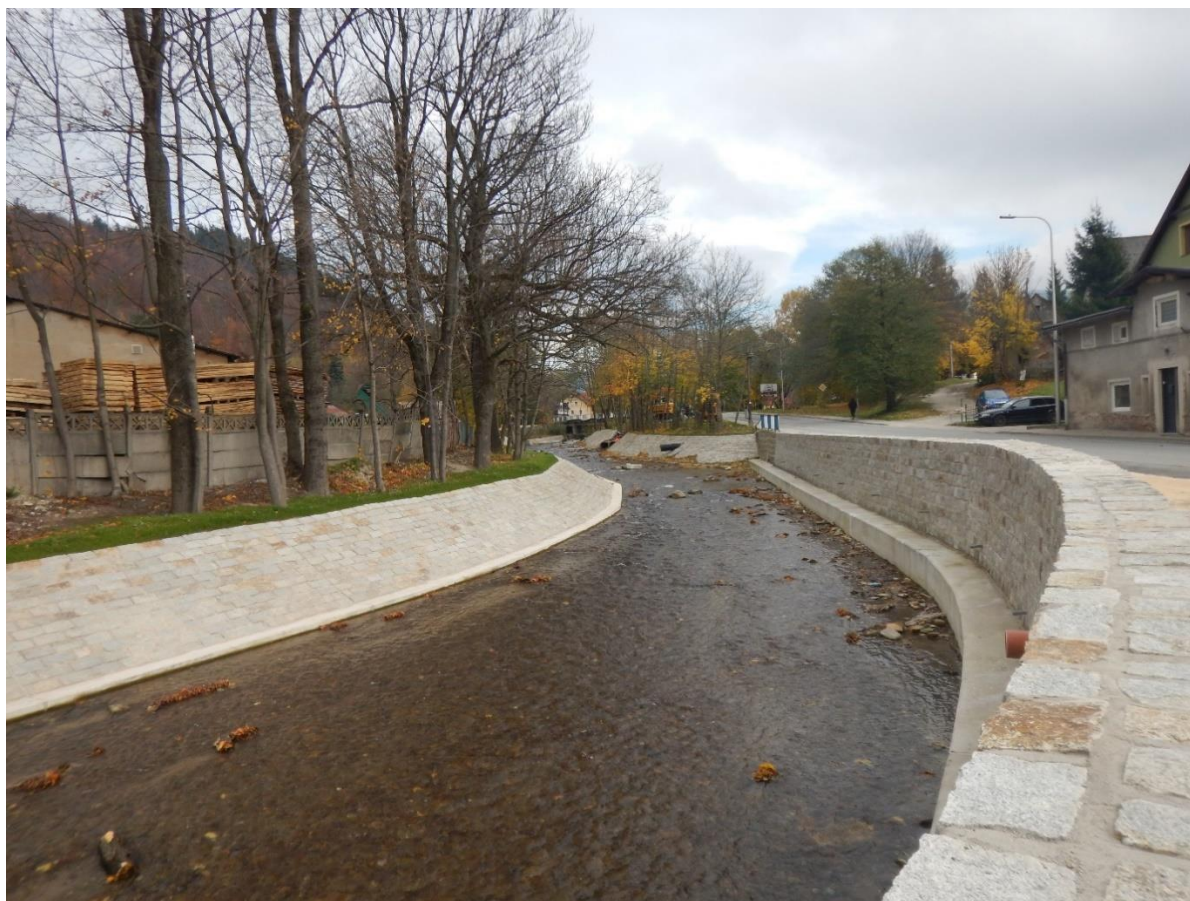
Phot. 23. Stronie Śląskie – view of the reconstructed retaining wall and slope revetment.

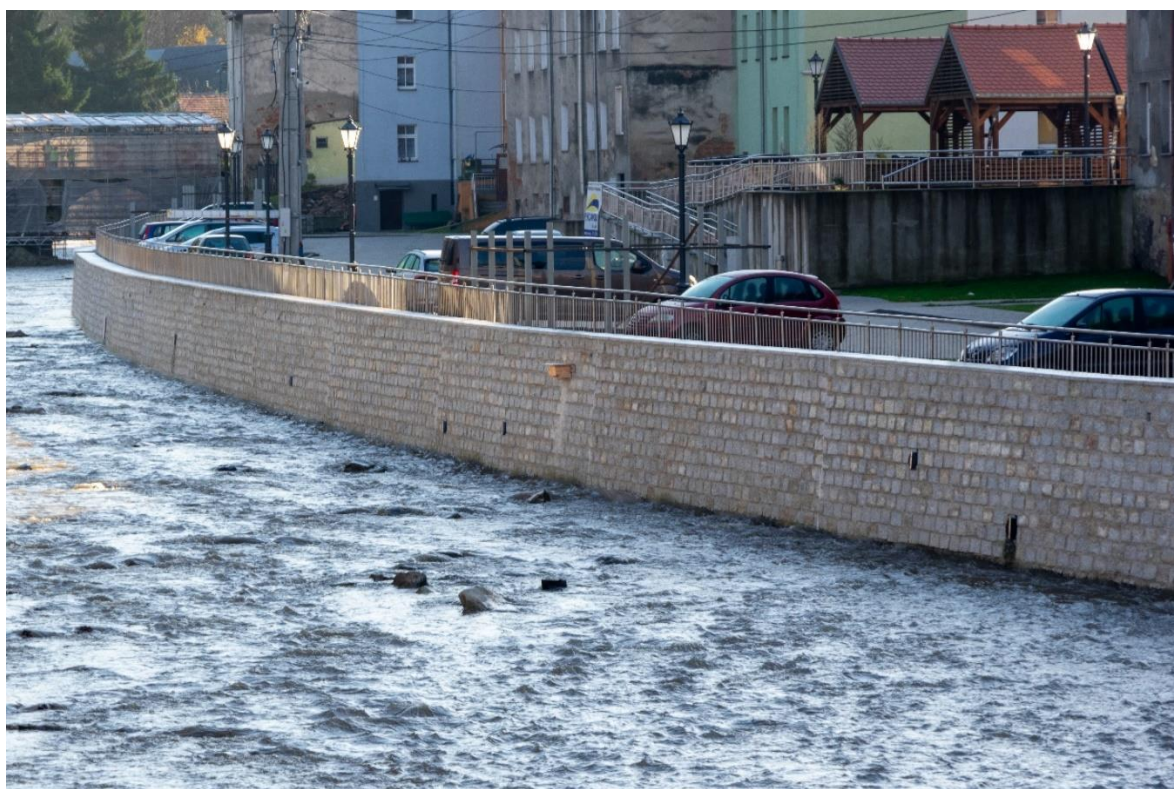
Phot. 24. Łądek Zdrój – view of the reconstructed retaining wall.

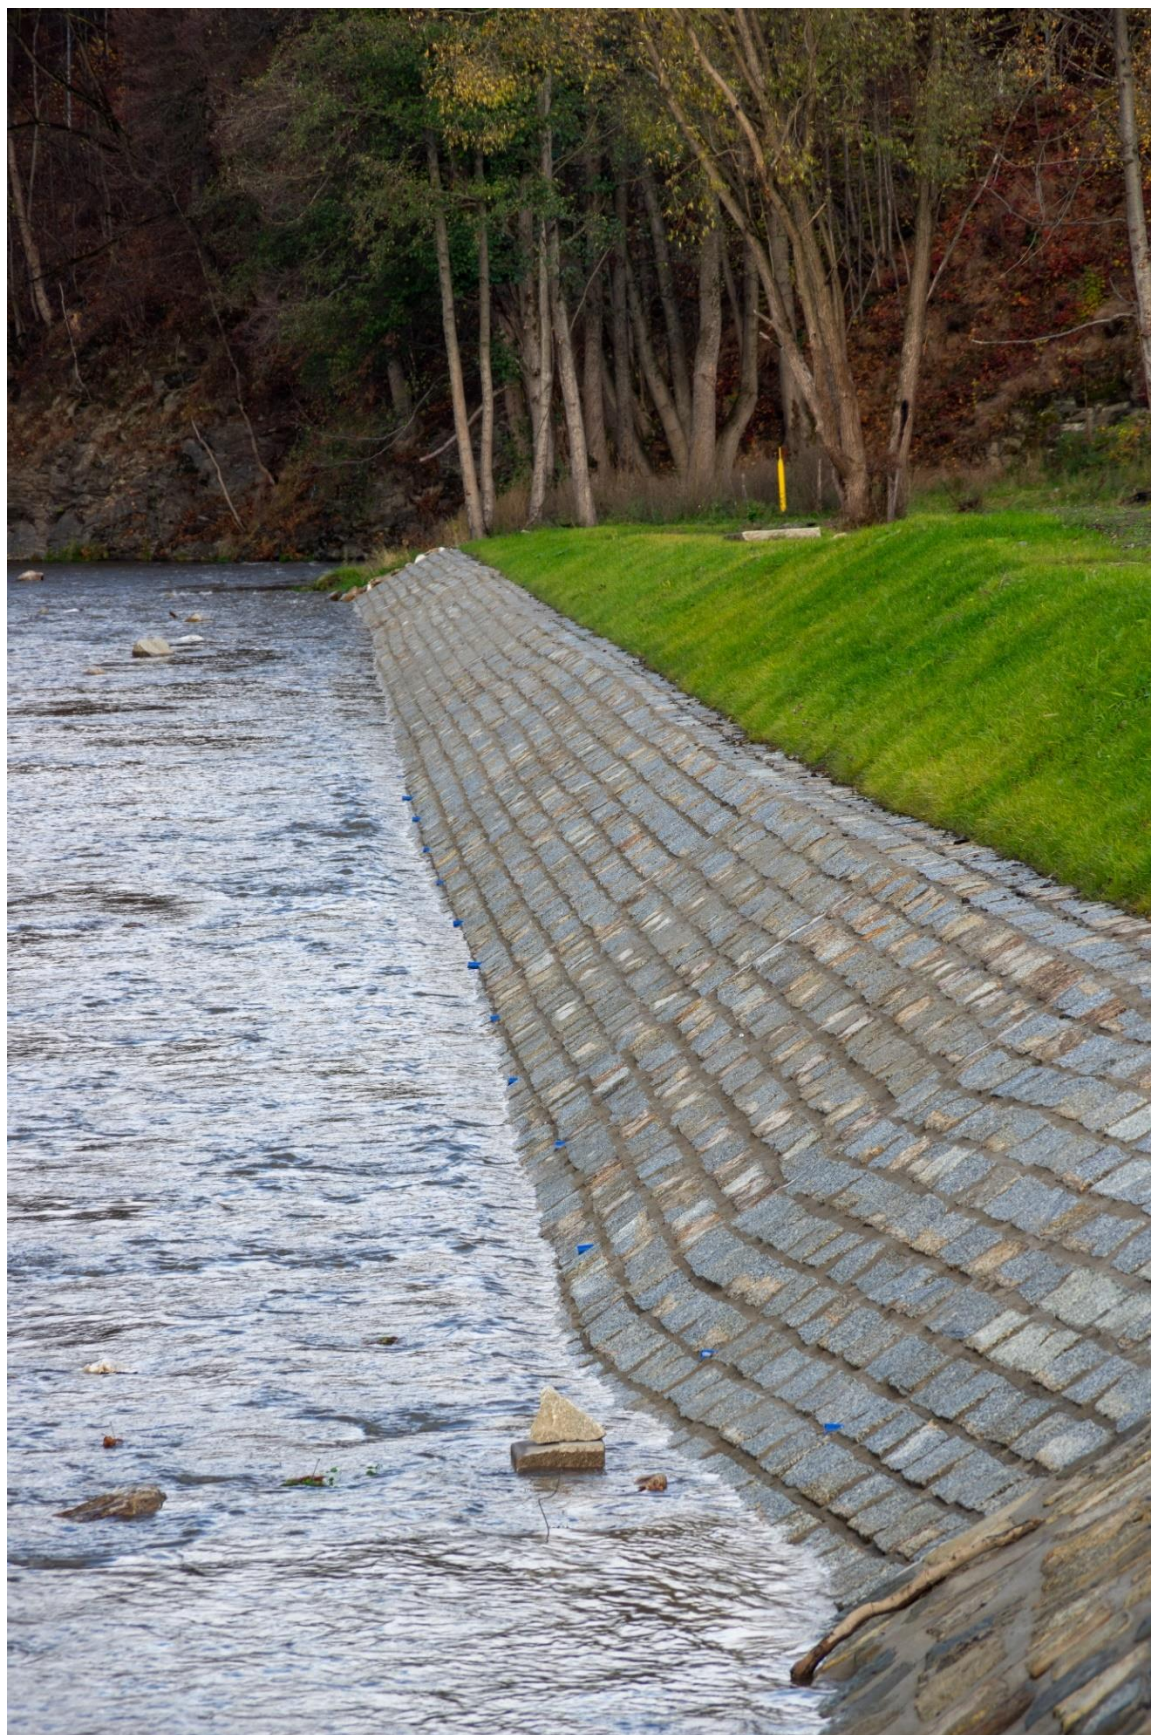
Phot. 25. Łądek Zdrój – reconstructed slope revetments.
