**STATE COMMISSION ON RAILWAY ACCIDENT INVESTIGATION**

**ANNUAL REPORT 2024**

**ON THE ACTIVITIES**  
**OF THE STATE COMMISSION**  
**ON RAILWAY ACCIDENT INVESTIGATION**

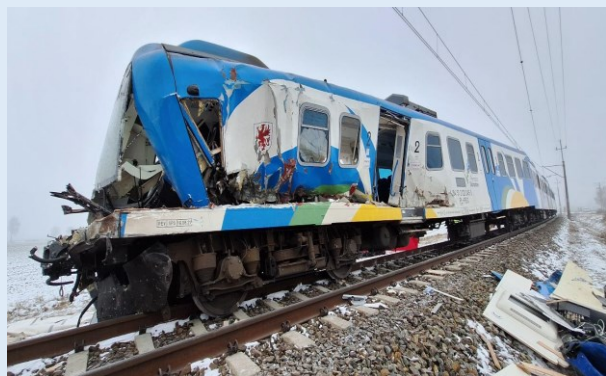
Photograph 1 - Consequences of the occurrence - the damaged EMU EN57AL-1527 (source: own material of PKBWK)

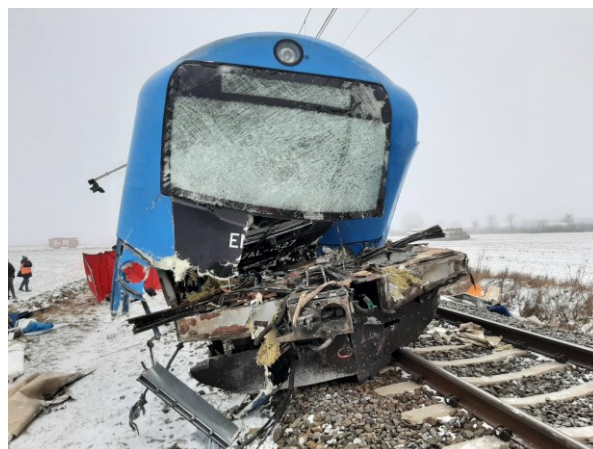
Photograph 2 - Consequences of the occurrence - the damaged EMU EN57AL-1527 (source: own material of PKBWK)

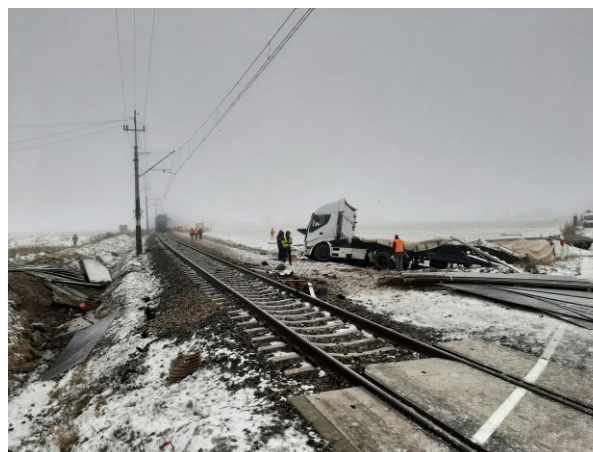
Photograph 3 - Consequences of the occurrence - the damaged lorry with semi-trailer, scattered cargo - 10 mm thick metal sheets (source: own material of PKBWK)

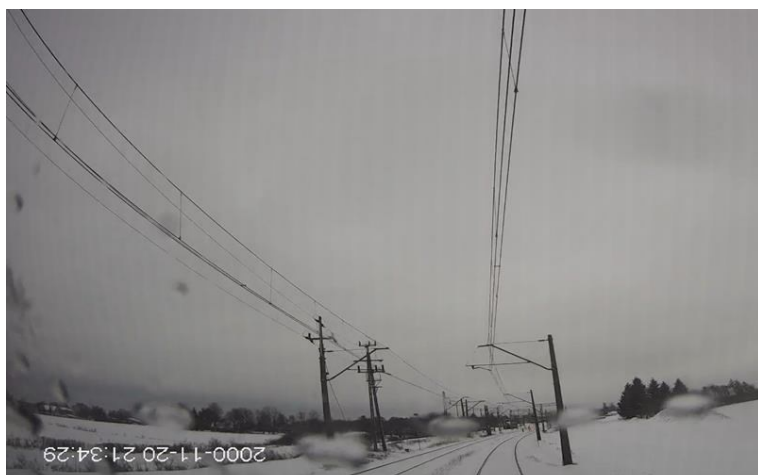
Photograph 4 - The SA134-019 front camera view of the working group (source: materials provided by POLREGIO S.A.).

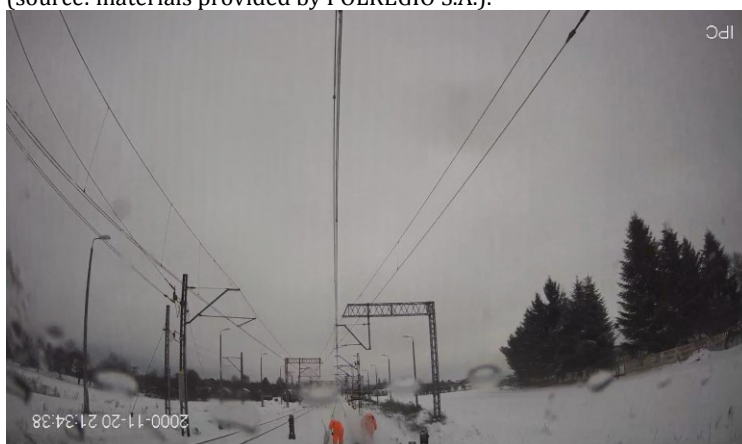
Photograph 5 - The SA134-019 front camera view of the working group immediately prior to the accident (source: materials provided by POLREGIO S.A.)

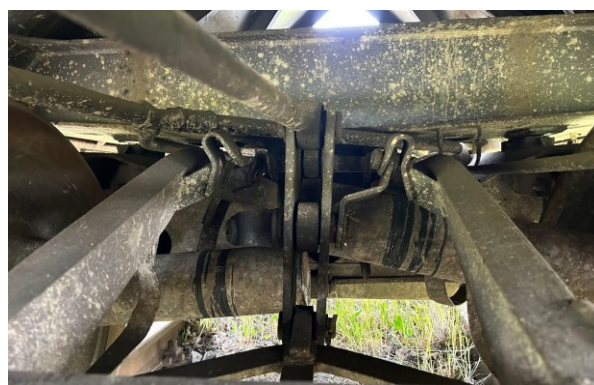
- the fractured wheelset axle led to derailment of the following wagons: 9, 10, 14, 15, 16 and 17 behind the locomotive
- furthermore, the train was torn apart between the fourteenth and fifteenth wagon behind the locomotive
- turnouts no. 3 and 7, including turnout elements and track sections in the path of the train, were damaged

Photograph 7 - **Consequences** of the occurrence - a view of the fractured axle (source: own material of PKBWK)

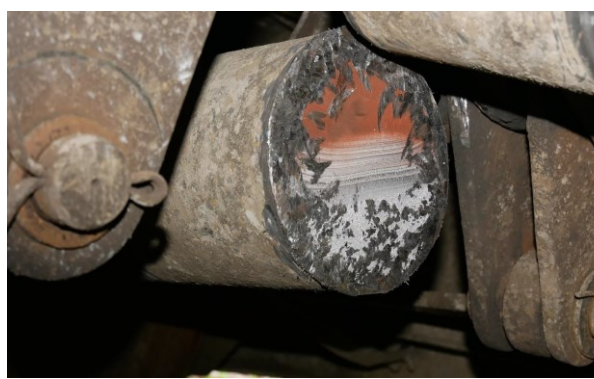
<p>Photograph 6 - A view of the wagon with the fractured axle following the accident (source: materials provided by the railway commission)</p>

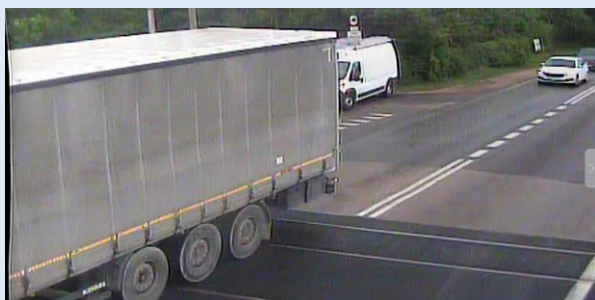
Photograph 9 - A view of the lorry's semi-trailer at the crossing approx. 0.5 s before the occurrence (source: material provided by PKP PLK S.A.).

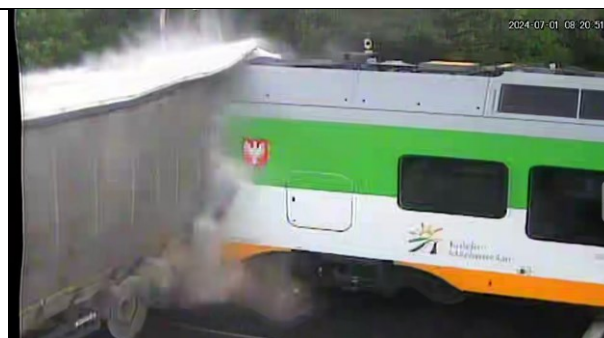
Photograph 10 - A view of the collision of the KM passenger train with the semi-trailer (source: material provided by PKP PLK S.A.)

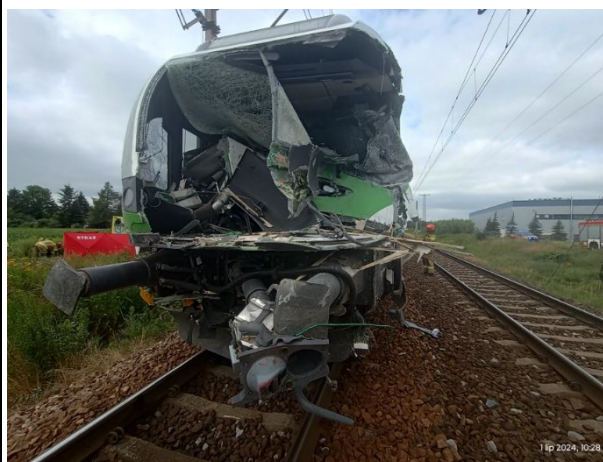
Photograph 11 - Consequences of the occurrence - a view of the destroyed driver's cab of rail vehicle ER75-001 (source: material provided by KM)

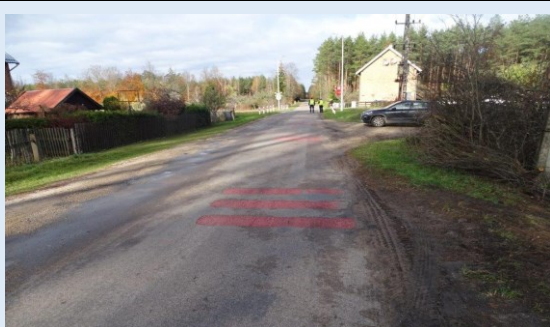
Photograph 12 - A view of the level crossing from the direction of the passenger car's travel (source: railway commission)

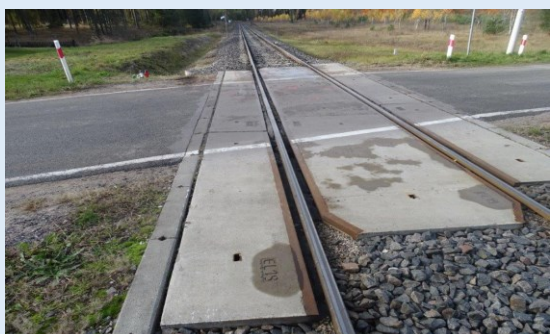
Photograph 13 - A view of the technical condition of the level crossing from the direction of passenger car's travel (source: materials provided by the railway commission)

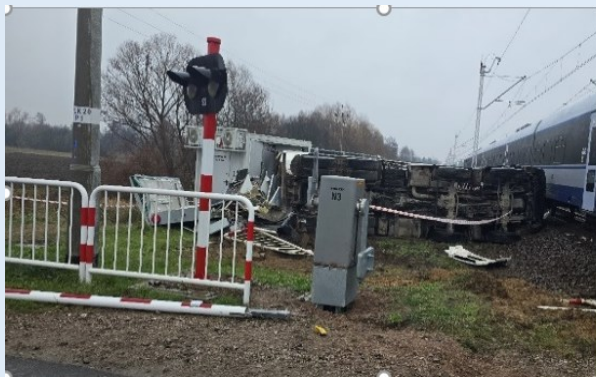
Photograph 15 - Consequences of the occurrence at the level crossing (source: materials provided by the railway commission)

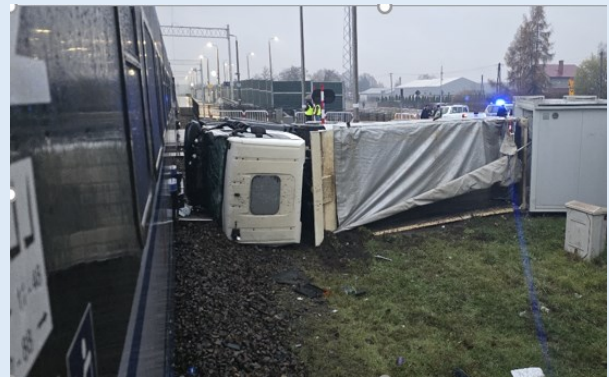
Photograph 16 - Consequences of the occurrence at the level crossing (source: materials provided by the railway commission)

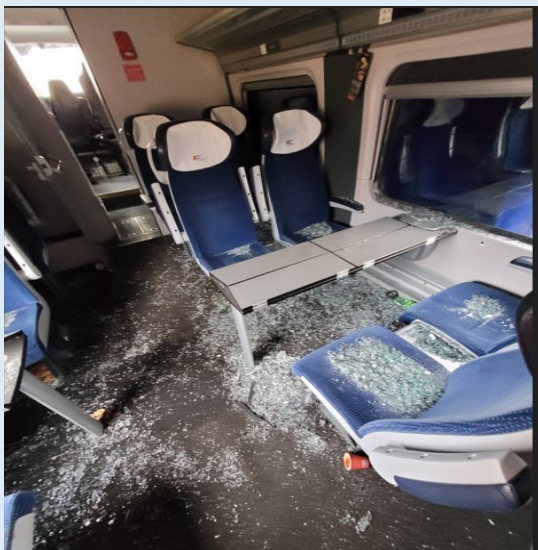
Photograph 17 - Consequences of the occurrence - the interior of ED161-004a (source: own material of PKBWK)

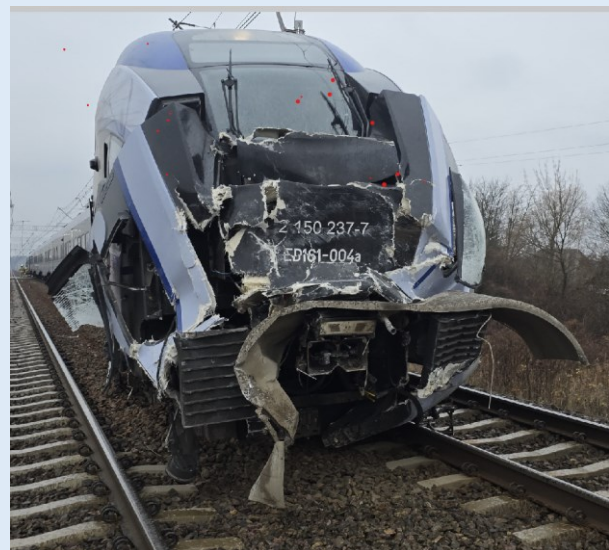
Photograph 18 - Consequences of the occurrence - the damaged ED161-004a cab (source: materials of the railway commission)
