PHOTO DOCUMENTATION

Appendix no. 2

to the Final Report on implementation of measures determined in EMP
for the Contract 3A.1 – Works Contract 3A.1/2

Odra-Vistula Flood Management Project

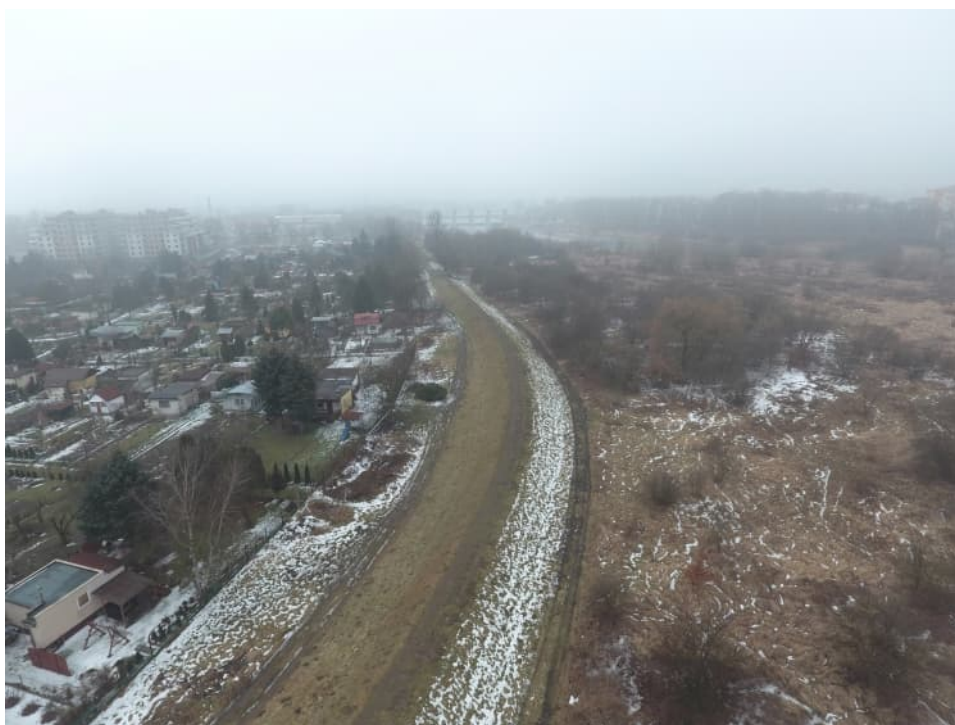
Fig. 1. Site condition in the first quarter of the works implementation period – the right Vistula embankment within *Section 3.1*, status in the first decade of February 2021 (upstream view).

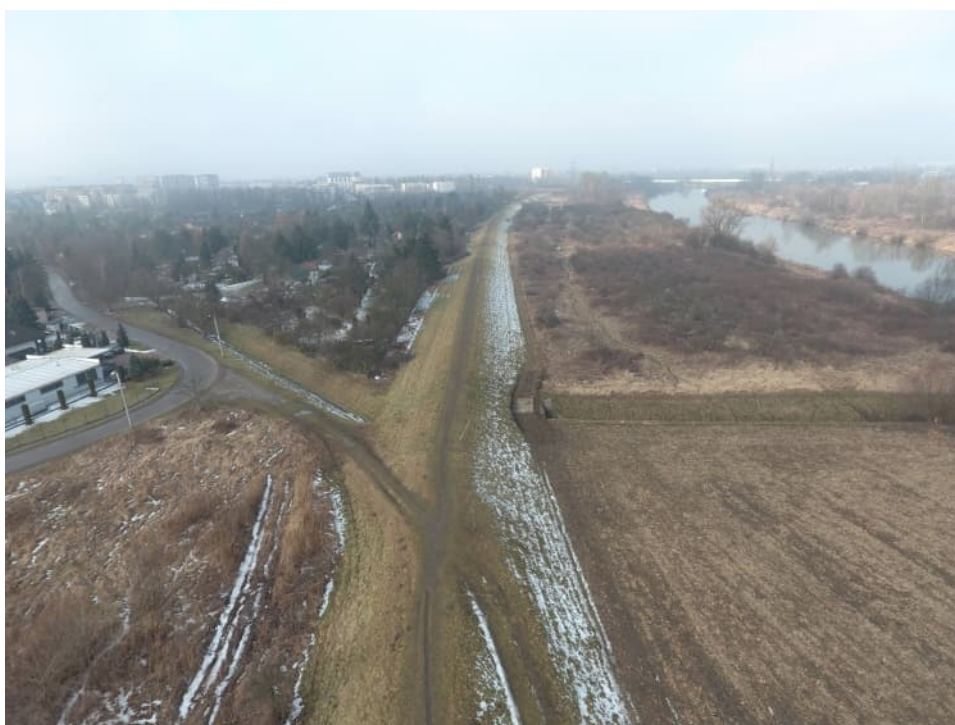
Fig. 2. Site condition in the first quarter of the works implementation period – the right Vistula embankment within *Section 3.2a*, status in the first decade of February 2021 (upstream view).

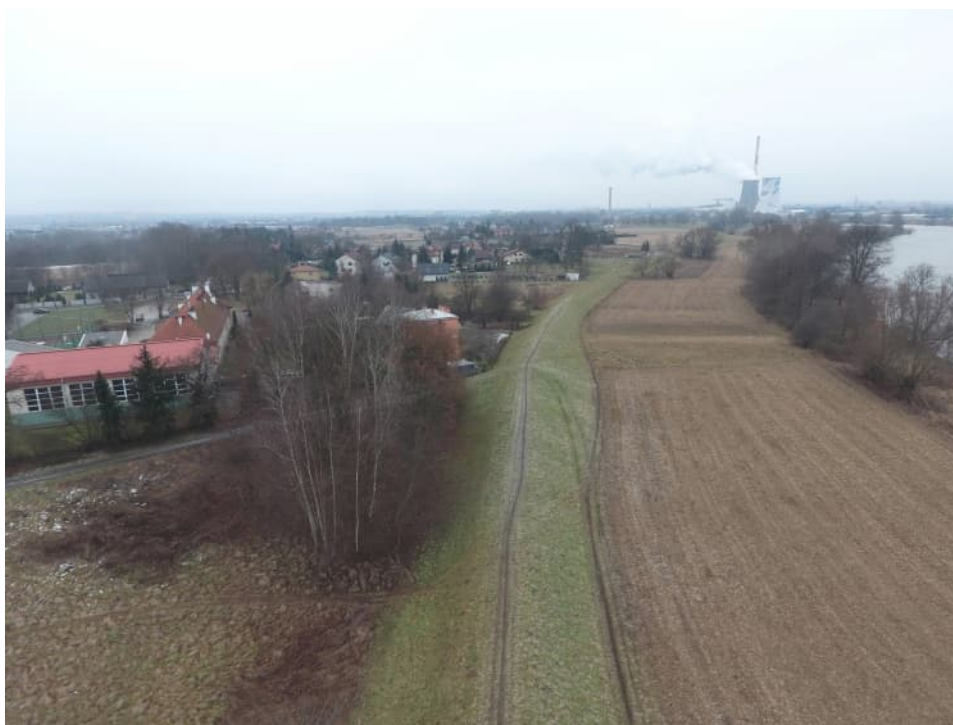
Fig. 3. Site condition in the first quarter of the works implementation period – the right Vistula embankment within *Section 3.2b*, status in the first decade of February 2021 (upstream view).

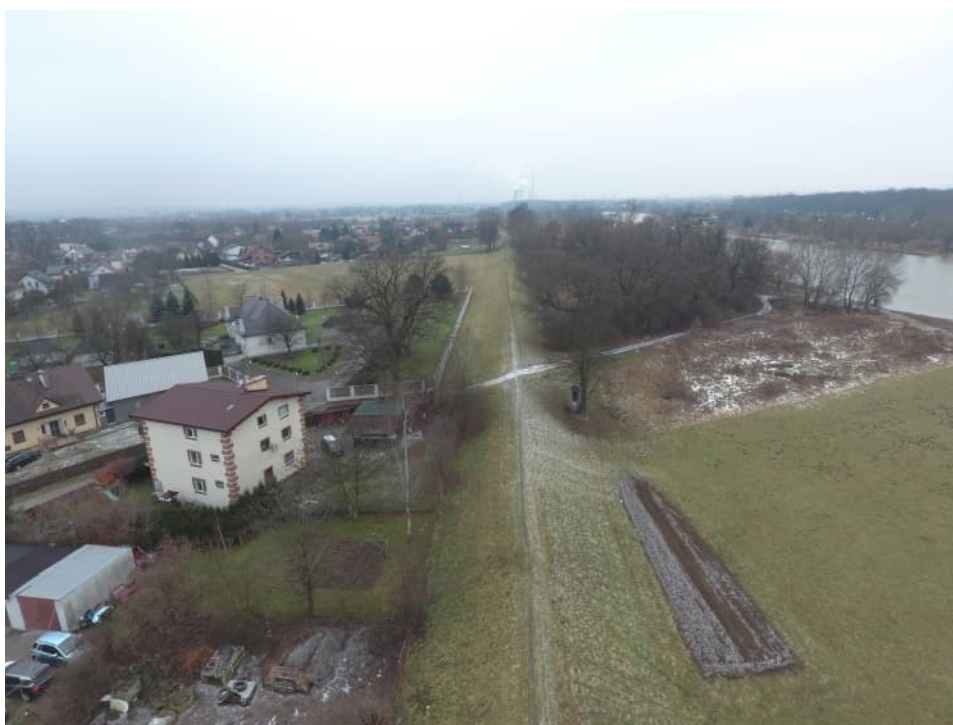
Fig. 4. Site condition in the first quarter of the works implementation period – the right Vistula embankment within *Section 3.3* – upper part, status in the first decade of February 2021 (upstream view).

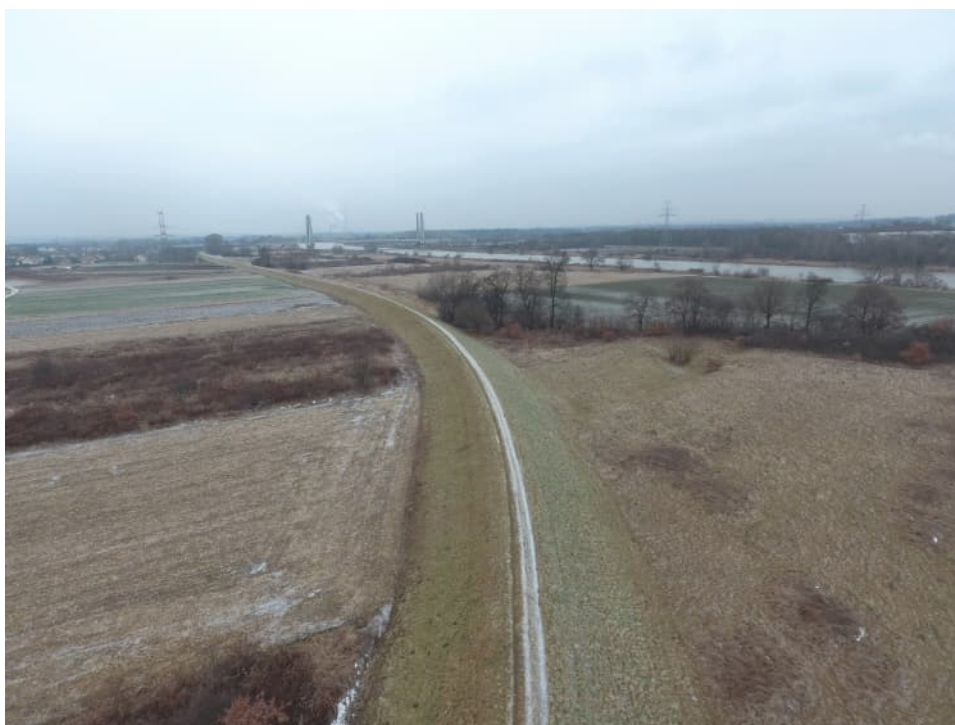
Fig. 5. Site condition in the first quarter of the works implementation period – the right Vistula embankment within *Section 3.3* – lower part, status in the first decade of February 2021 (upstream view).

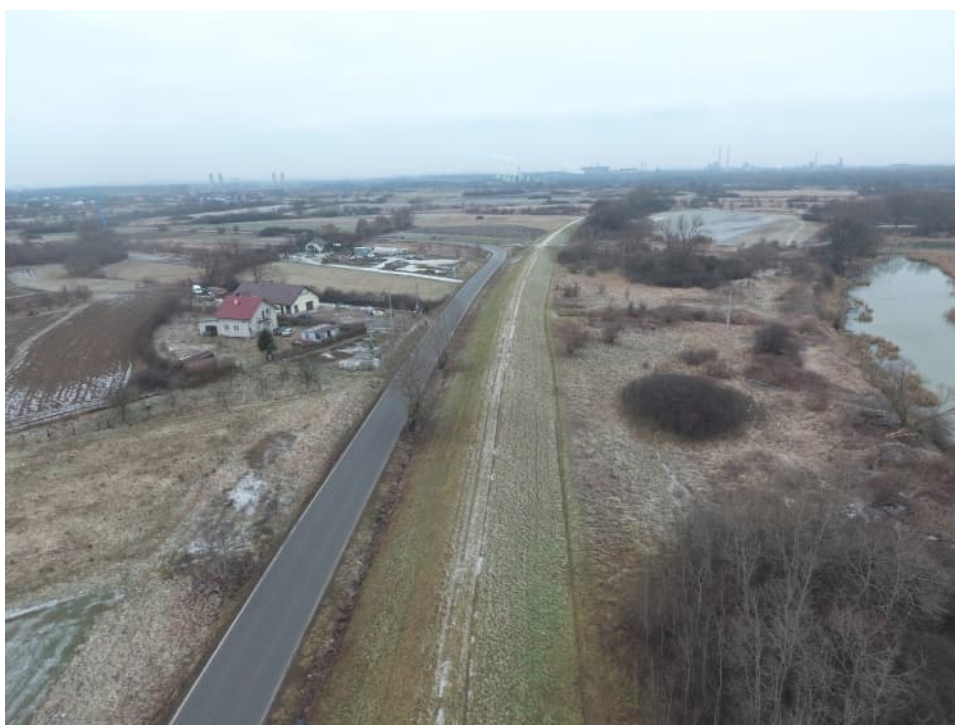
Fig. 6. Site condition in the first quarter of the works implementation period – the right Vistula embankment within *Section 3.4*, status in the first decade of February 2021 (upstream view).

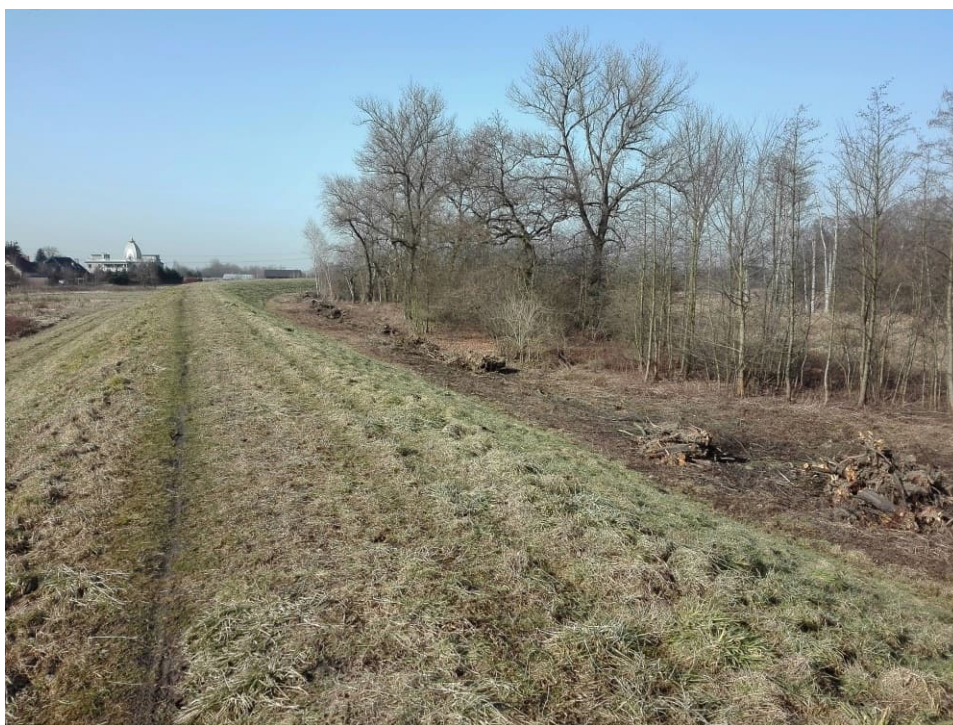
Fig. 7. Construction site after tree felling
– the right Vistula embankment within *Section 3.4*,
status in the third decade of February 2021 (upstream view).

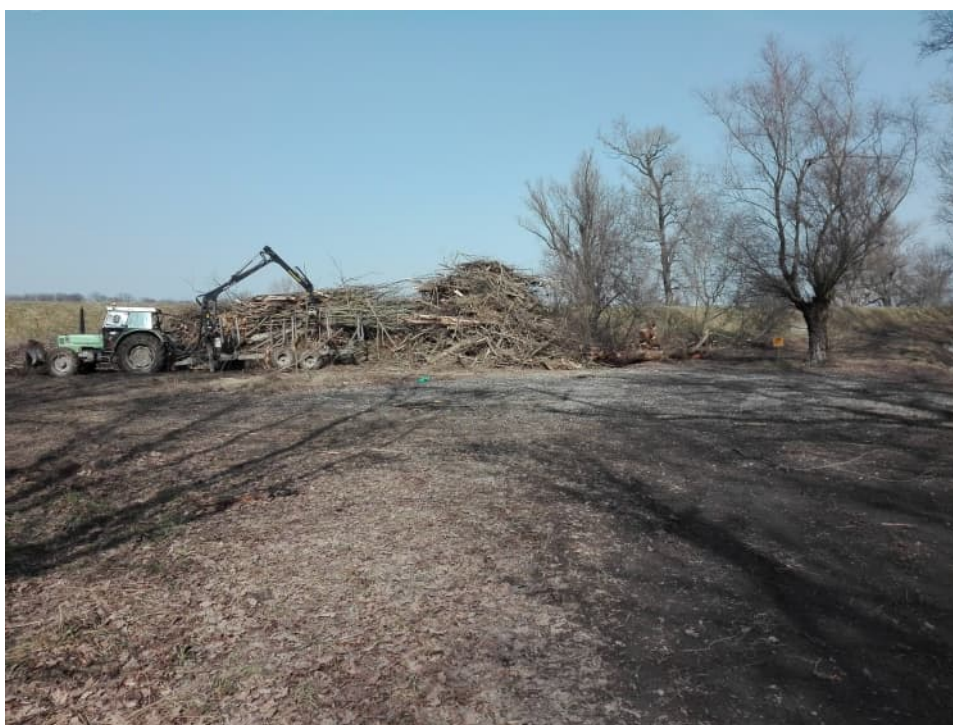
Fig. 8. Cleaning up after felling trees
– the right Vistula embankment within *Section 3.2b*,
status in the third decade of February 2021 (downstream view).

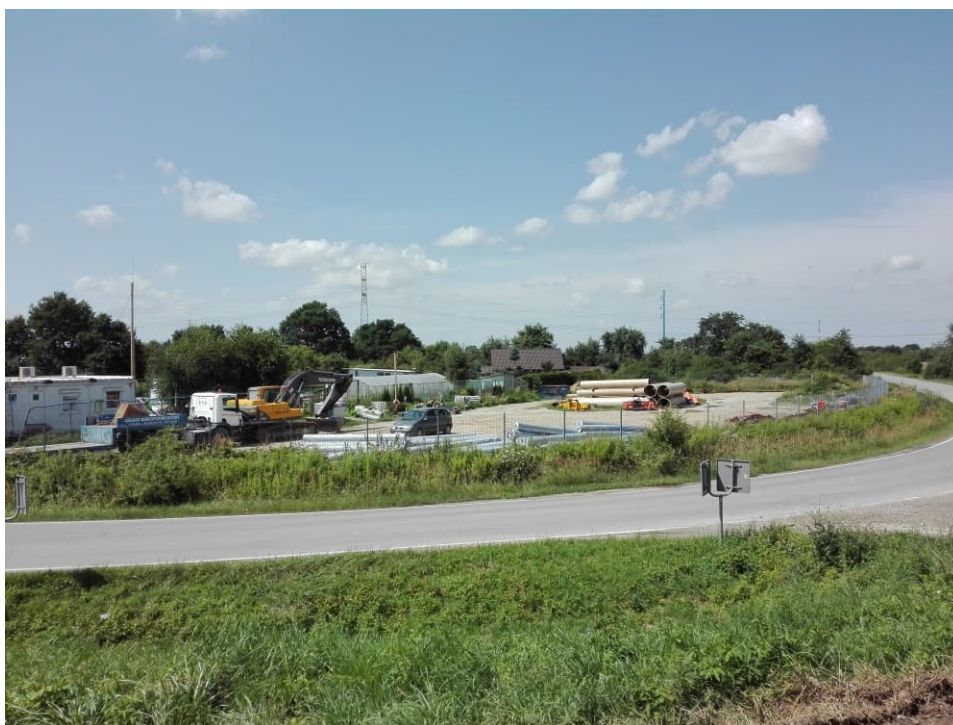
Fig. 9. Site facilities in the area beyond the right Vistula embankment – the right bank of the Vistula within *Section 3.4*, status in the third decade of July 2021 (view towards the west).

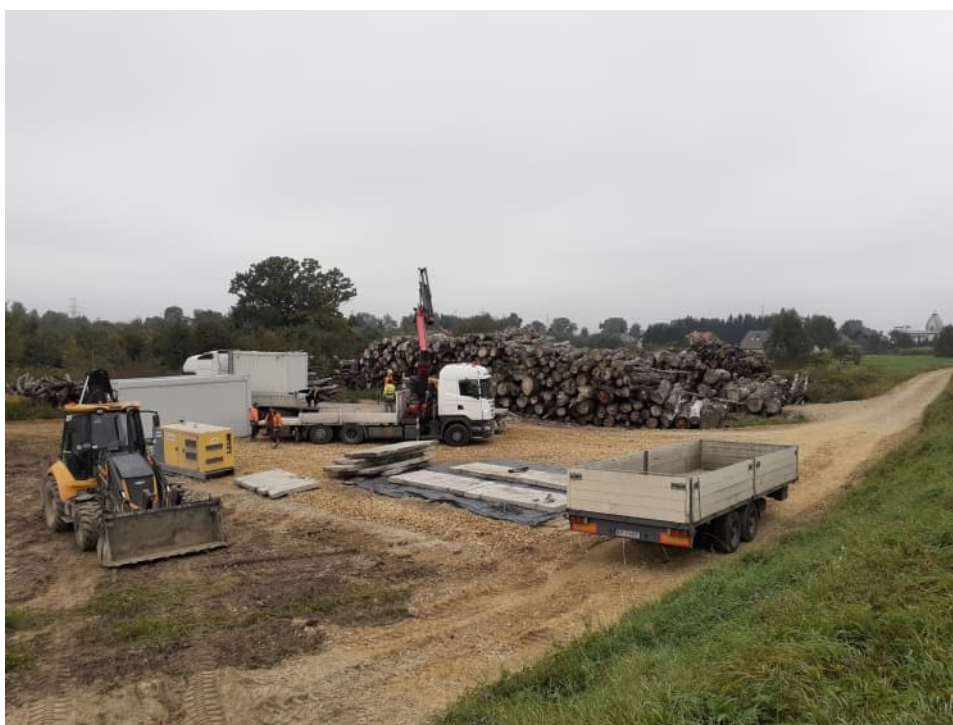
Fig. 10. Storage yard in the area beyond the right Vistula embankment – the right bank of the Vistula within *Section 3.4*, status in the third decade of September 2021 (upstream view).

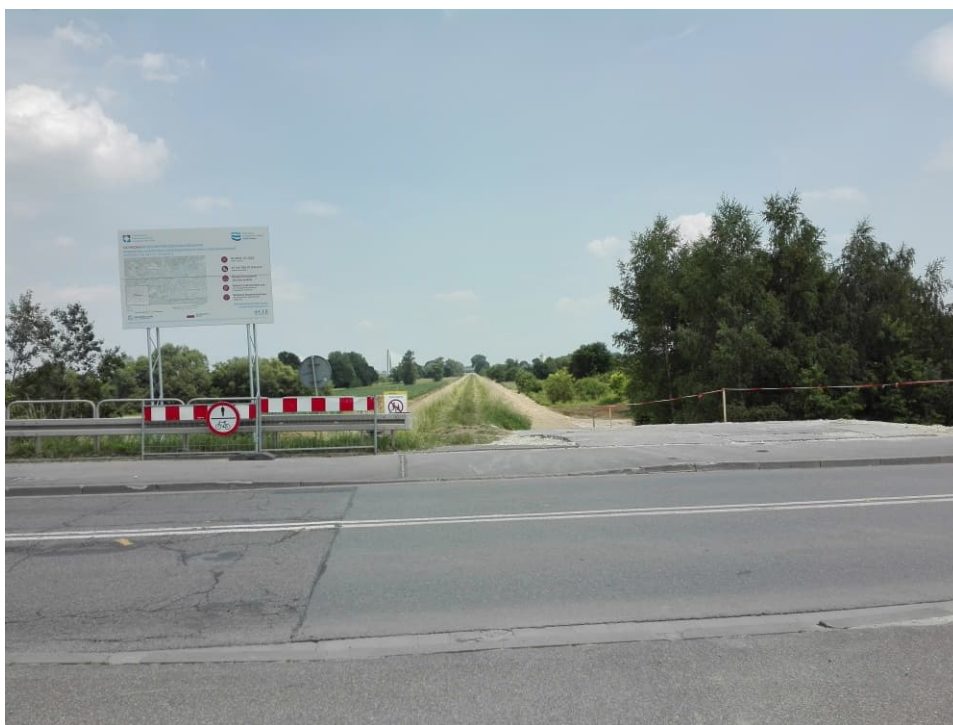
Fig. 11. Marking of the construction site
– the right Vistula embankment within *Section 3.3*,
status in the third decade of June 2021 (downstream view).

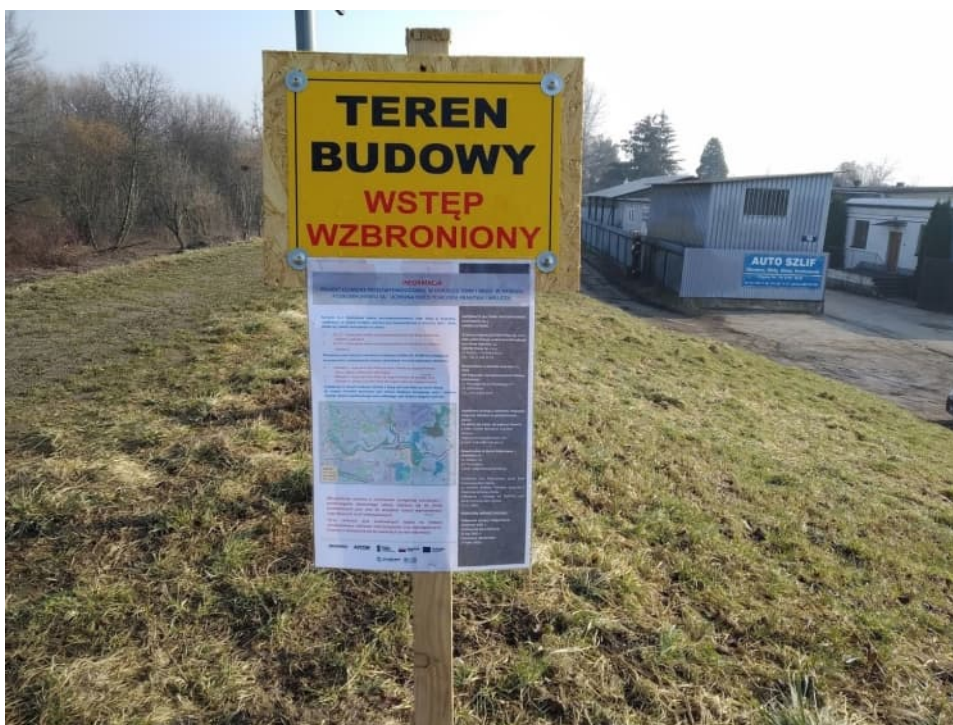
Fig. 12. Marking of the construction site
– the right Vistula embankment within *Section 3.1*,
status in the second decade of March 2021 (downstream view).

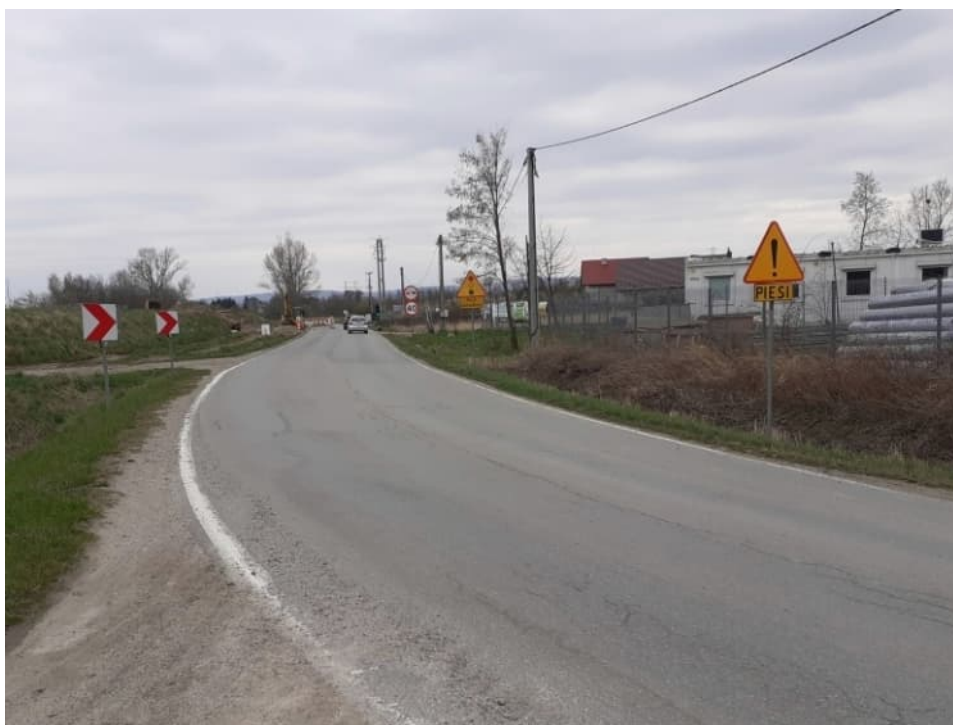
Fig. 13. Marking of public road in the vicinity of the construction site
– the right Vistula embankment within *Section 3.4*,
status in the second decade of April 2021 (downstream view).

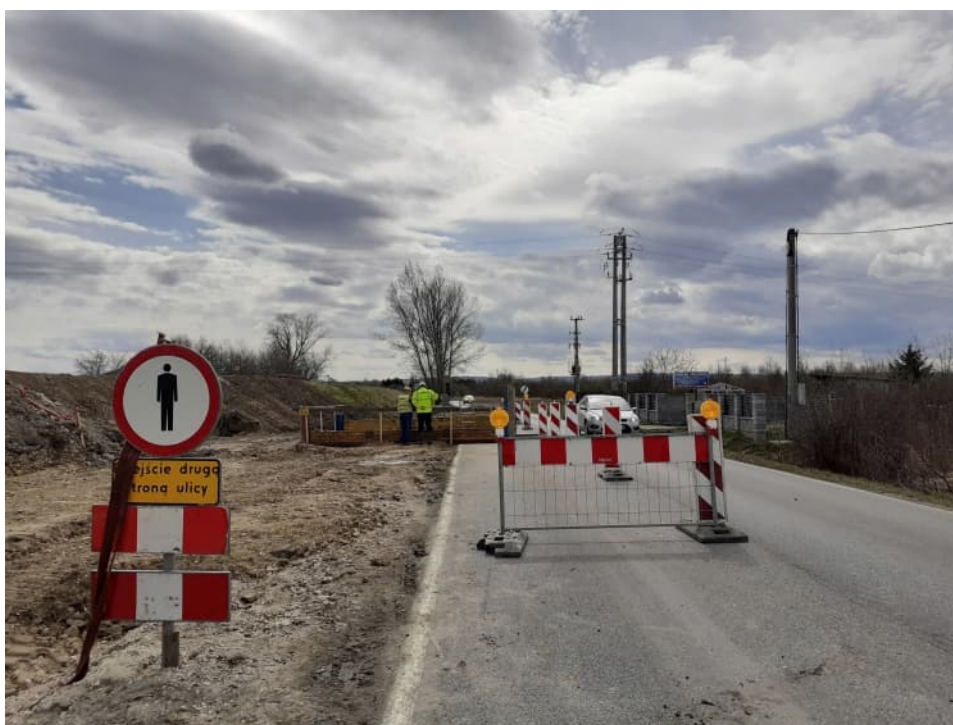
Fig. 14. Marking of public road in the vicinity of the construction site
– the right Vistula embankment within *Section 3.4*,
status in the first decade of April 2022 (downstream view).

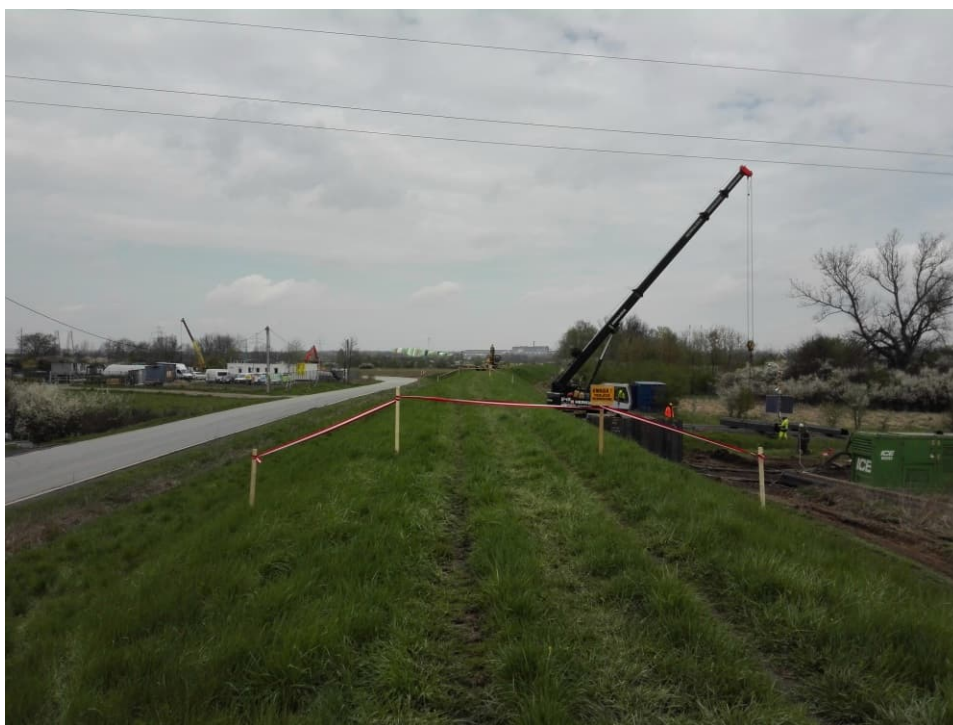
Fig. 15. Protection of hazardous sites
– the right bank of the Vistula within *Section 3.4*,
status in the third decade of April 2021 (upstream view).

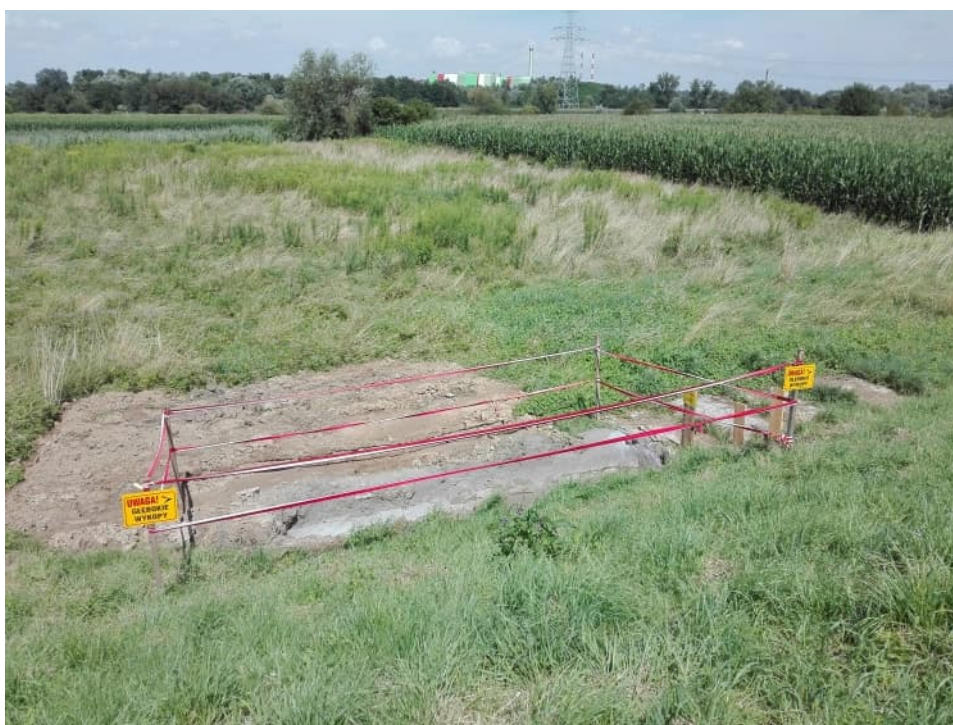
Fig. 16. Protection of hazardous sites
– the right Vistula embankment within *Section 3.3*,
status in the third decade of July 2021 (downstream view).

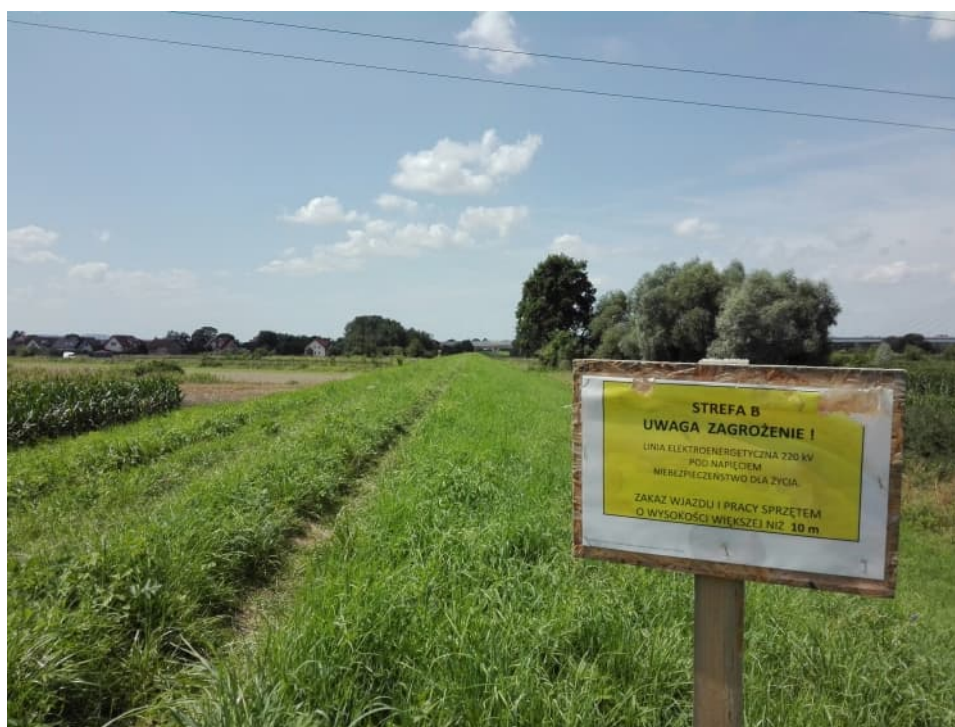
Fig. 17. Protection of hazardous sites under the power line
– the right Vistula embankment within *Section 3.3*,
status in the third decade of July 2021 (upstream view).

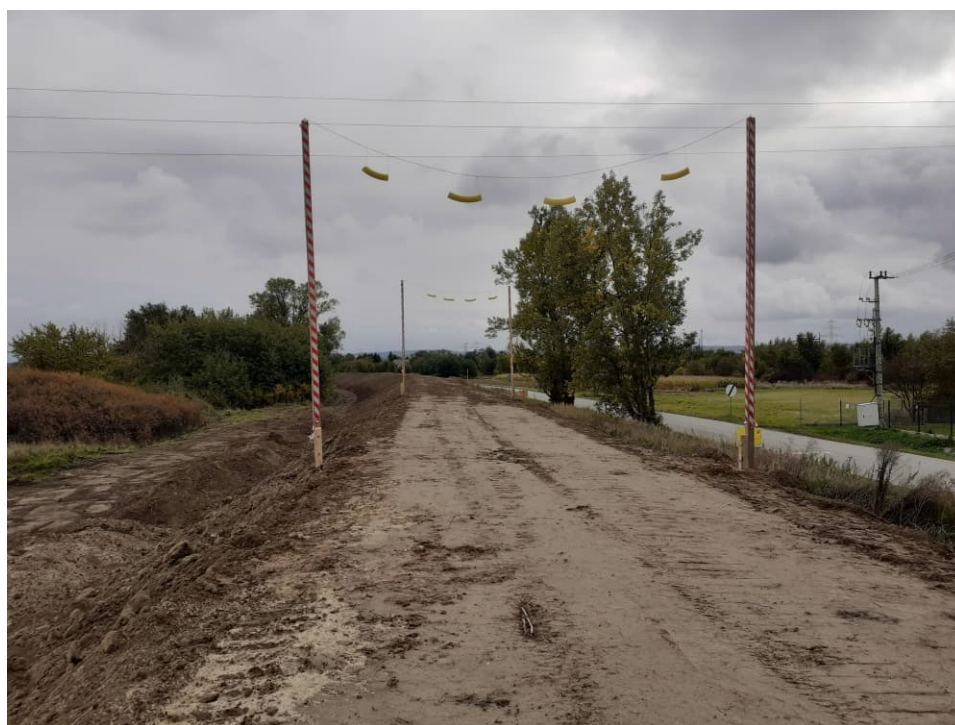
Fig. 18. Protection of hazardous sites under the power line
– the right Vistula embankment within *Section 3.4*,
status in the third decade of September 2022 (downstream view).

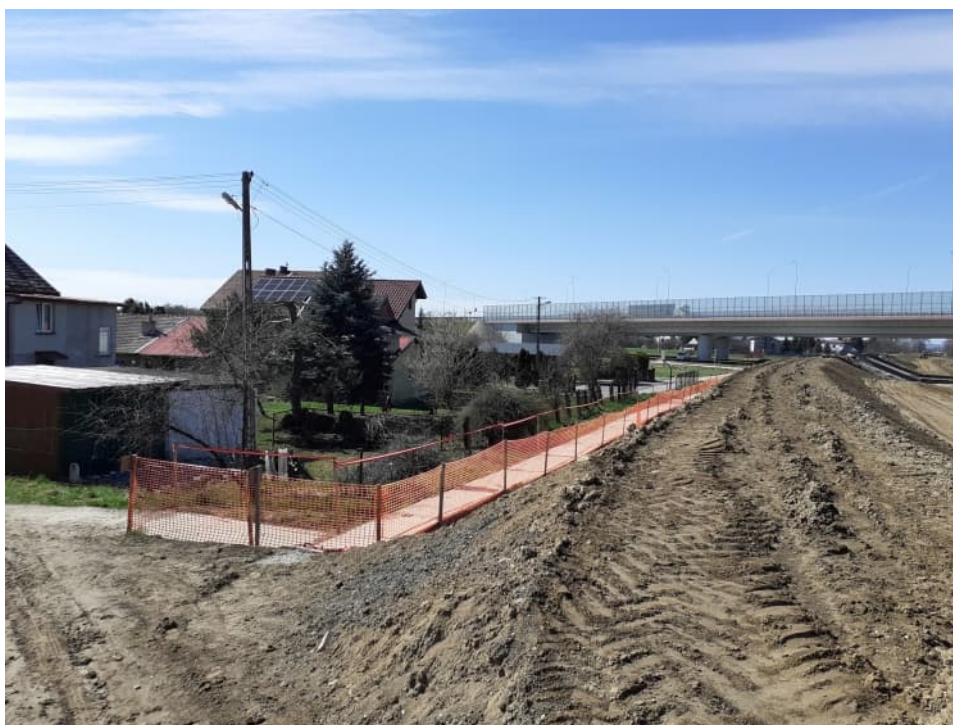
Fig. 19. Protection of hazardous sites in the vicinity of residential buildings – the right Vistula embankment within *Section 3.3*, status in the third decade of March 2023 (upstream view).

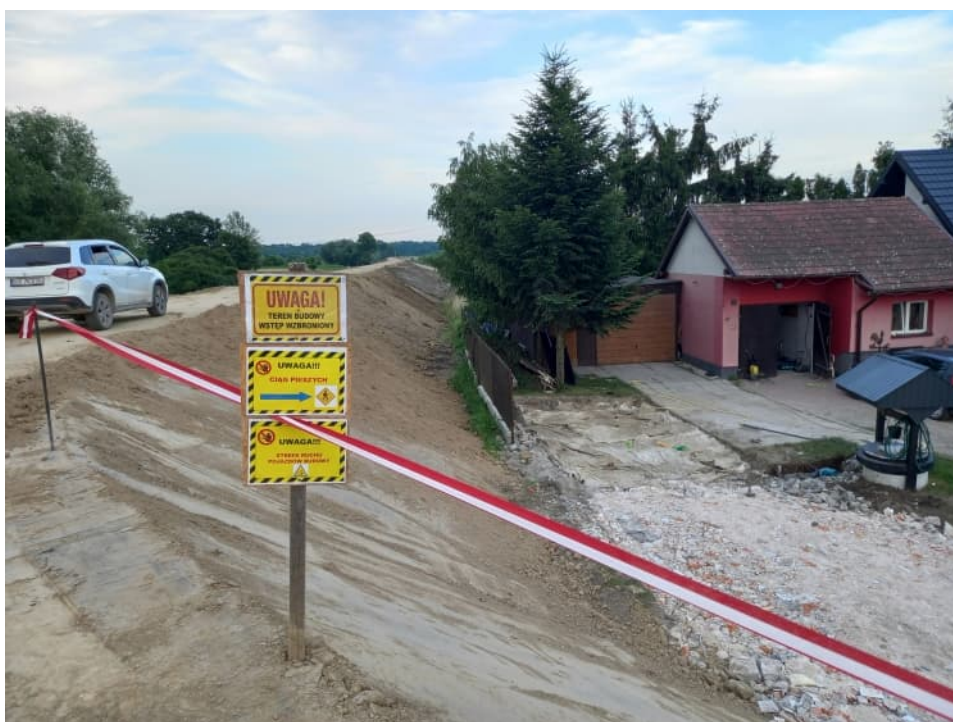
Fig. 20. Protection of hazardous sites in the vicinity of residential buildings – the right Vistula embankment within *Section 3.3*, status in the third decade of June 2023 (downstream view).

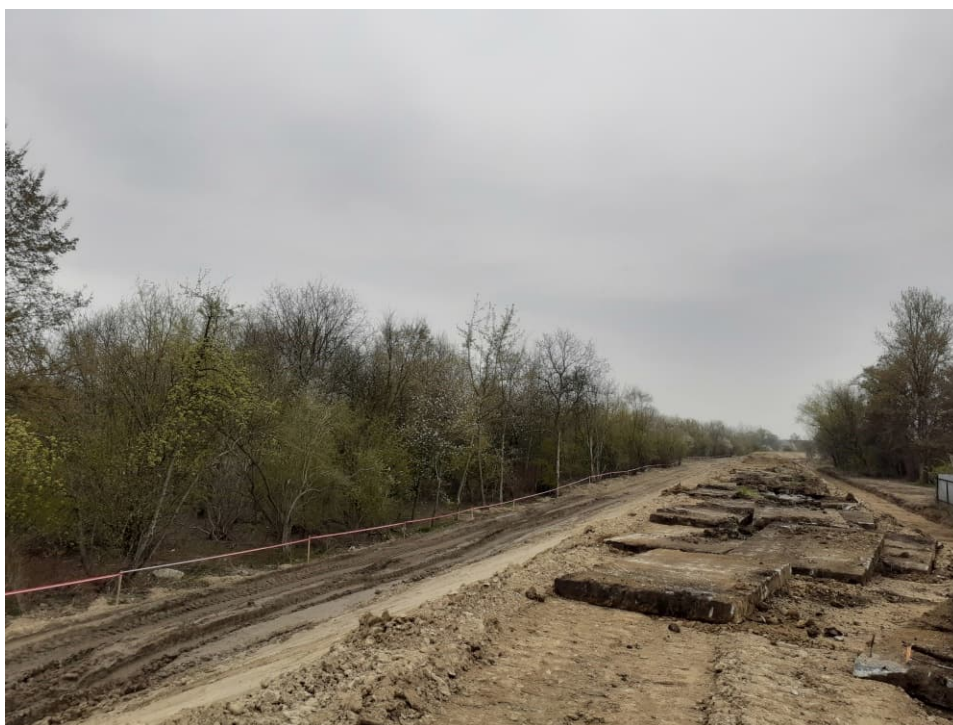
Fig. 21. Protection of trees and shrubs not intended to felling
– the right Vistula embankment within *Section 3.1*,
status in the second decade of April 2022 (downstream view).

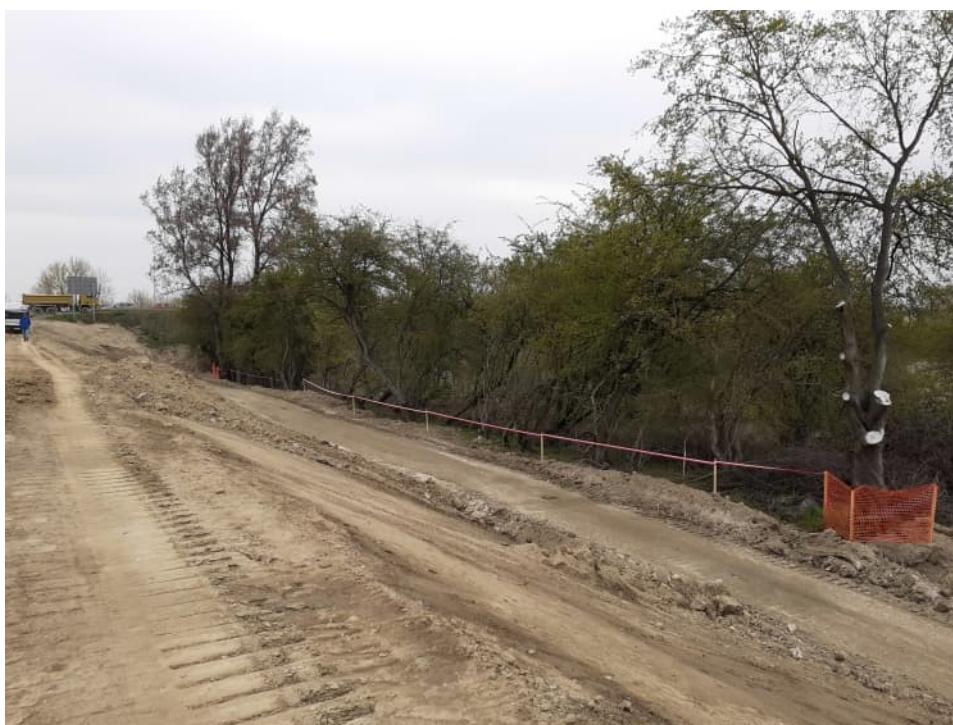
Fig. 22. Protection of trees and shrubs not intended to felling
and preventive trimming of tree branches
– the right Vistula embankment within *Section 3.2a*,
status in the second decade of April 2022 (upstream view).

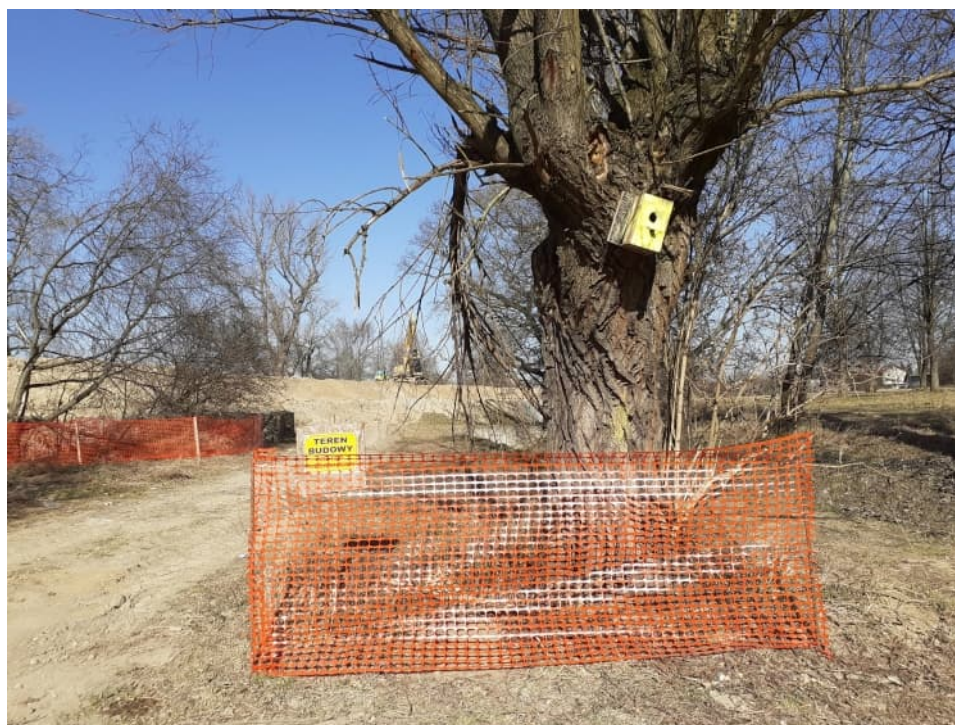
Fig. 23. Protection of trees and shrubs not intended to felling
– the right Vistula embankment within *Section 3.2b*,
status in the third decade of March 2022 (downstream view).

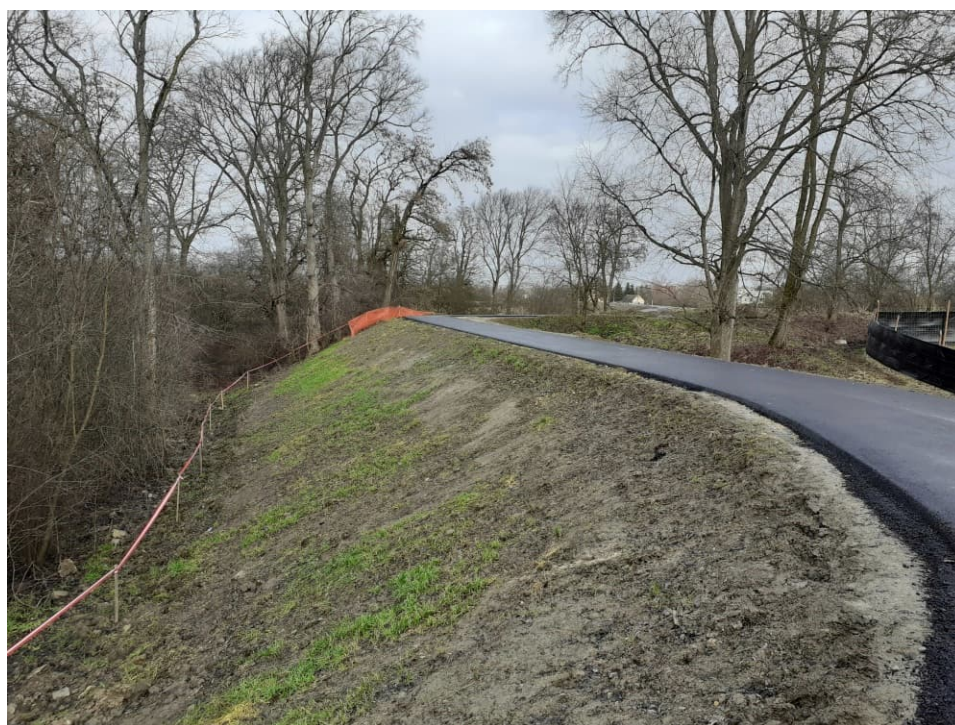
Fig. 24. Protection of the tree stand within the boundaries of Fort 50a Lasówka
(facility entered into the register of monuments)
– the right Vistula embankment within *Section 3.2a*,
status in the third decade of January 2023 (downstream view).

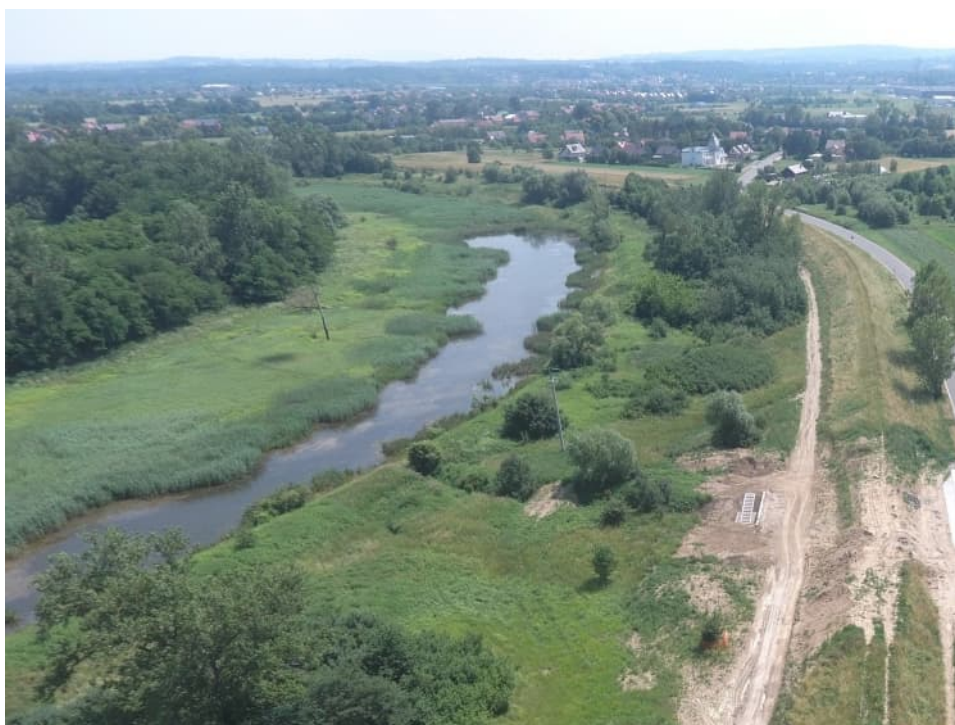
Fig. 25. No impact of works on the condition of natural habitats in the Vistula oxbow lake near the town of Brzegi – the right Vistula embankment within *Section 3.4*, status in the third decade of June 2022 (downstream view).

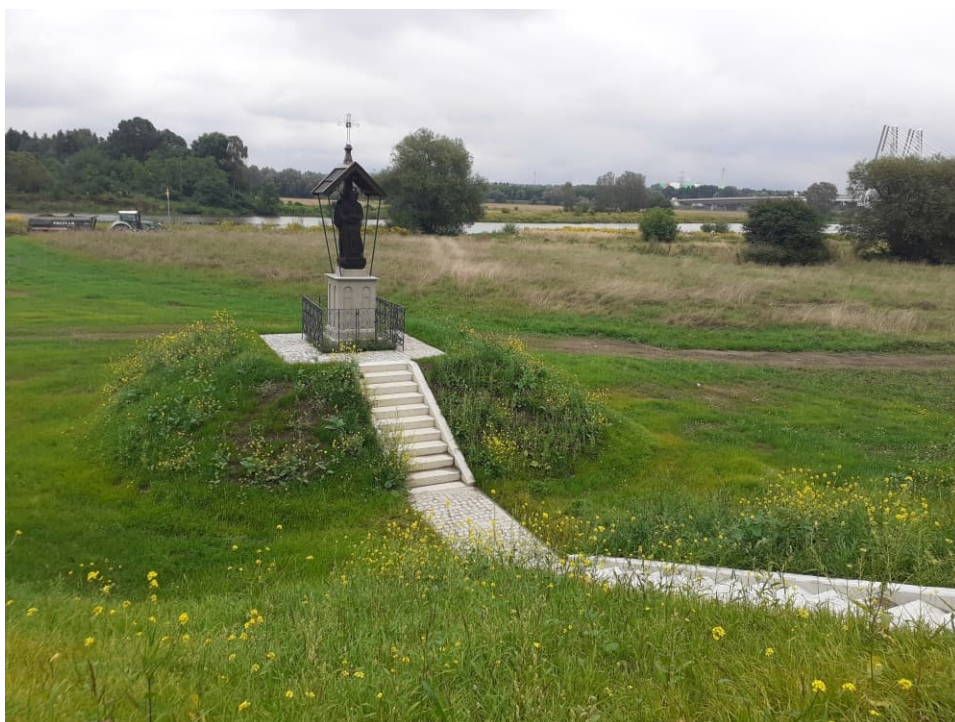
Fig. 26. Renovated historic chapel in the embanked area of Vistula – the right bank of the Vistula within *Section 3.3*, status in the third decade of August 2023 (downstream view).

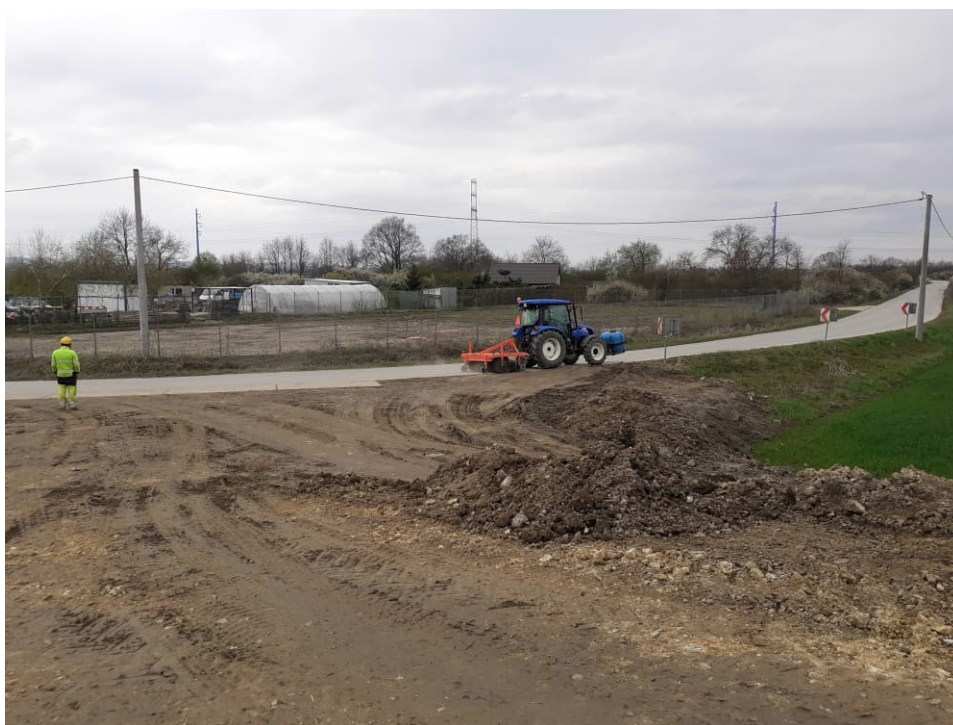
Fig. 27. Keeping public roads clean in the vicinity of the construction site – the right bank of the Vistula within *Section 3.4*, status in the second decade of April 2023 (view towards the west).

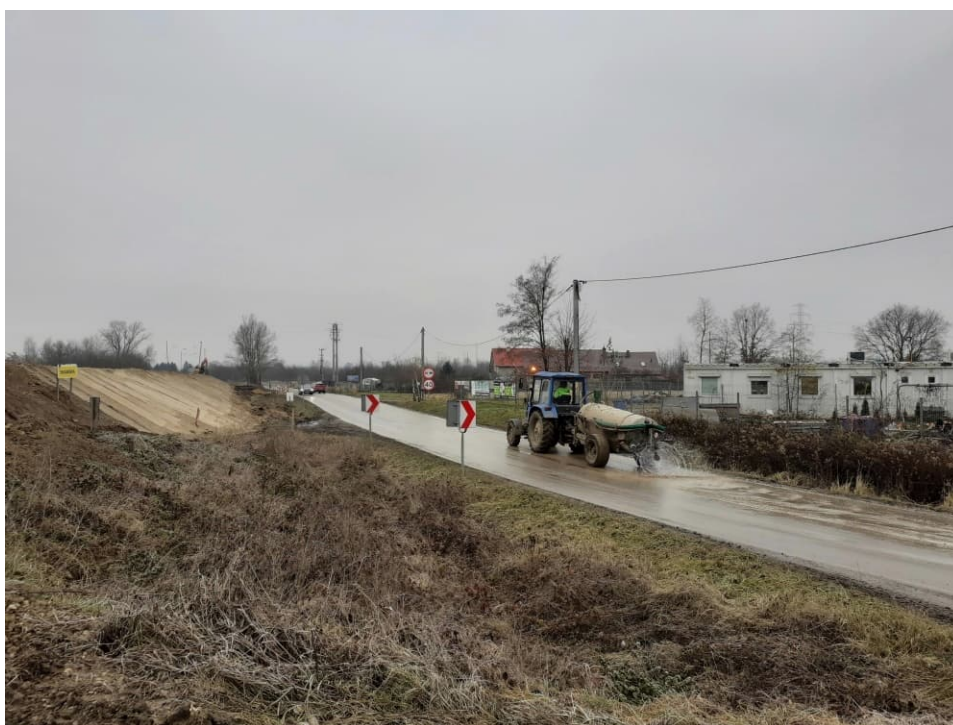
Fig. 28. Keeping public roads clean in the vicinity of the construction site – the right bank of the Vistula within *Section 3.4*, status in the third decade of November 2022 (downstream view).

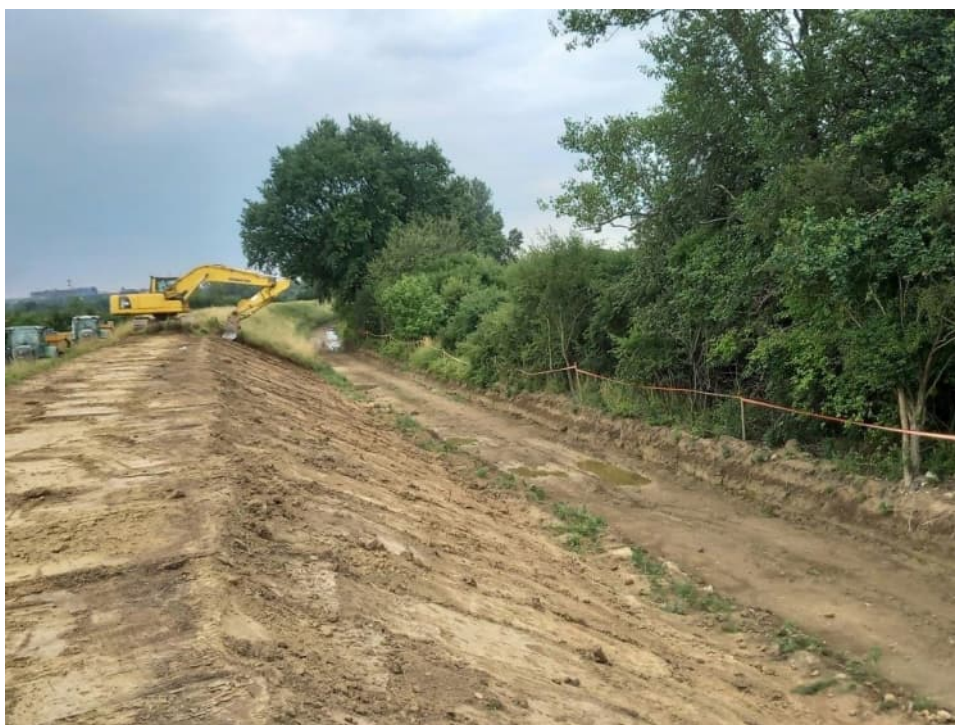
Fig. 29. Removal of a top soil layer
– the right Vistula embankment within *Section 3.4*,
status in the first decade of July 2022 (upstream view).

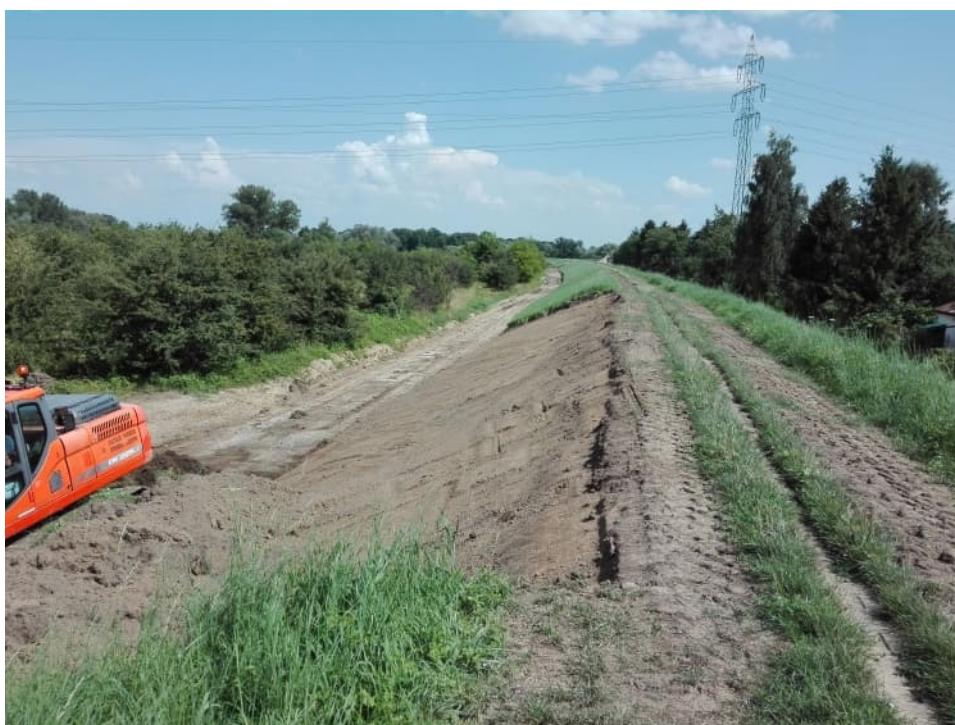
Fig. 30. Removal of a top soil layer
– the right Vistula embankment within *Section 3.2a*,
status in the third decade of July 2021 (downstream view).

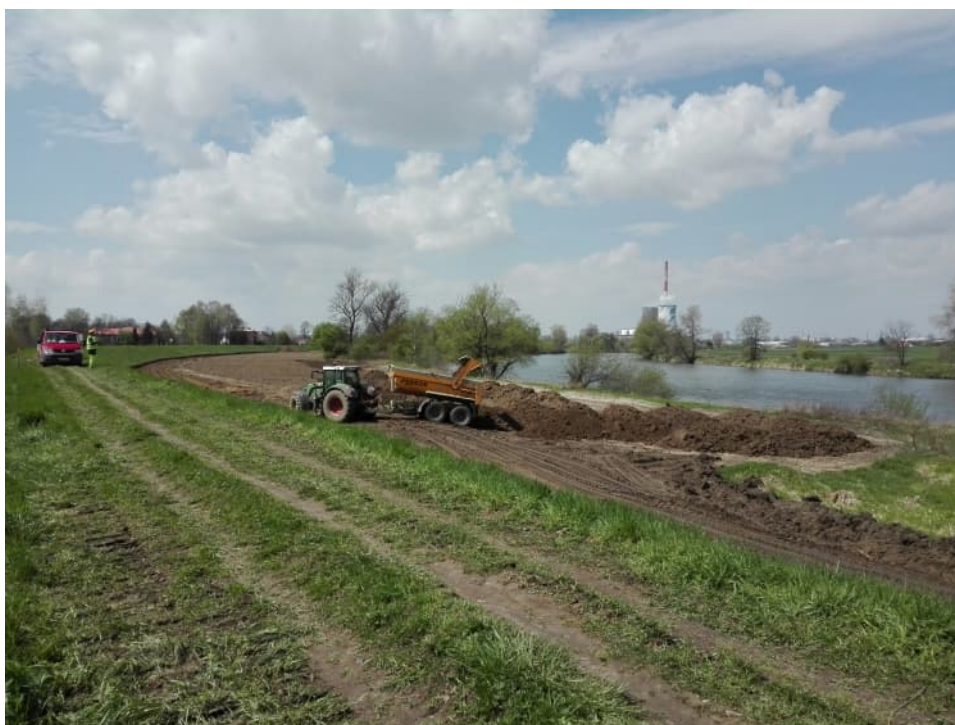
Fig. 31. Protection of top-soil piles
– the right Vistula embankment within *Section 3.2a*,
status in the third decade of April 2021 (upstream view).
