PHOTO DOCUMENTATION

Appendix no. 2

to the Final Report on implementation of measures determined in EMP
for the Contract 3A.1 – Works Contract 3A.1/2

Odra-Vistula Flood Management Project

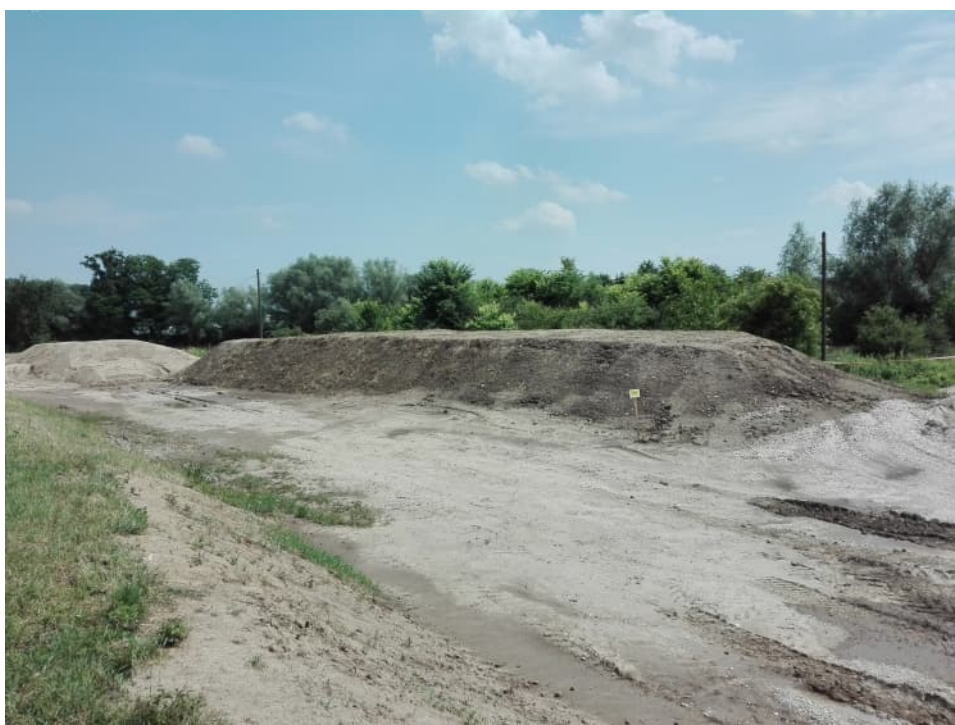
Fig. 32. Protection of top-soil piles
– the right Vistula embankment within *Section 3.2a*,
status in the third decade of June 2021 (downstream view).

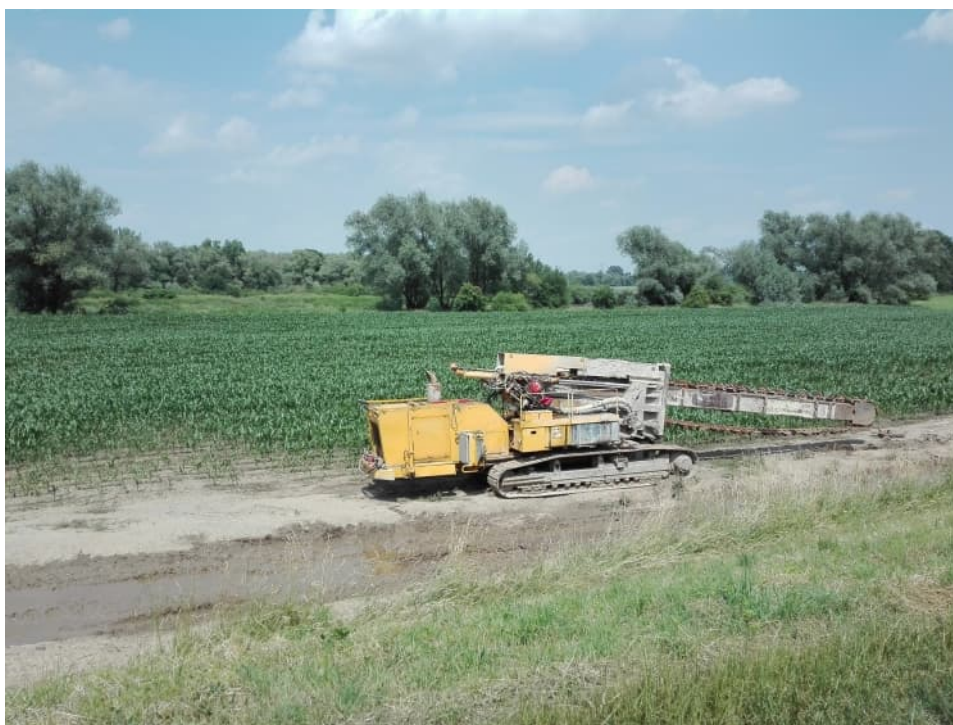
Fig. 33. Construction of a cement-bentonite barrier along the base of embankment – the right Vistula embankment within *Section 3.2a*, status in the third decade of June 2021 (downstream view).

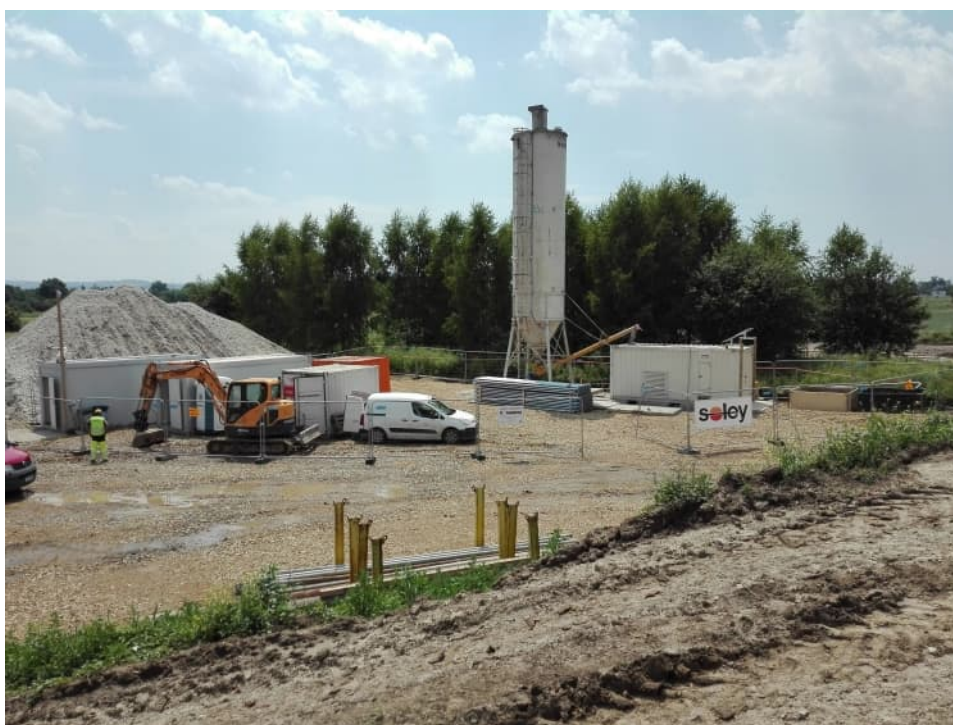
Fig. 34. Installation for producing a cement-bentonite mixture – the right bank of the Vistula within *Section 3.3*, status in the third decade of June 2021 (upstream view).

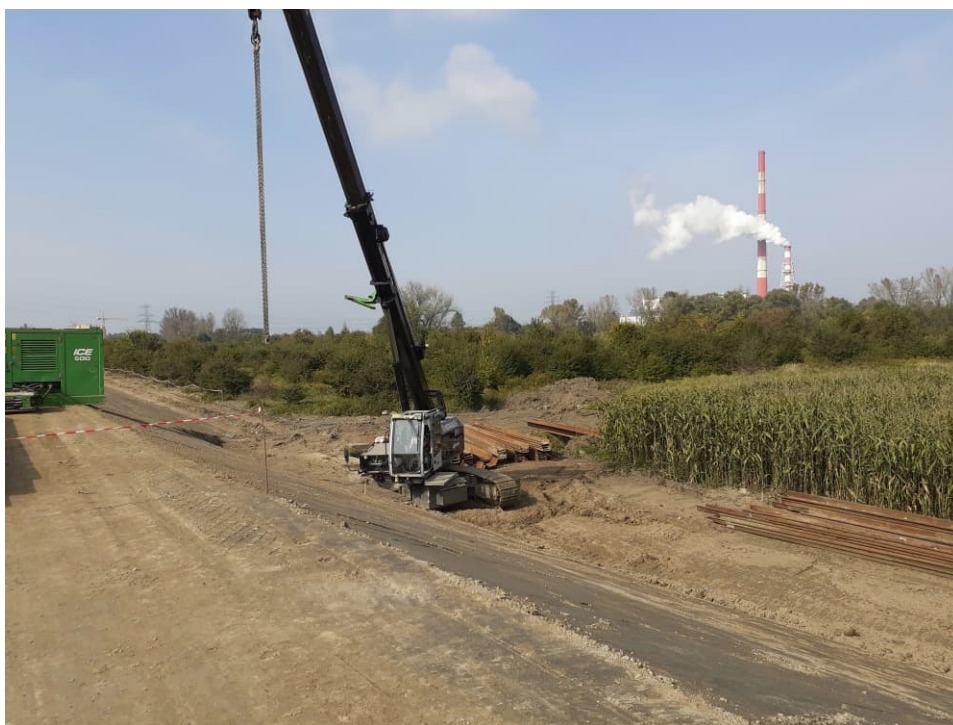
Fig. 35. Construction of a sheet piling to protect the embankment culvert during reconstruction
– the right Vistula embankment within *Section 3.2a*,
status in the third decade of September 2021 (upstream view).

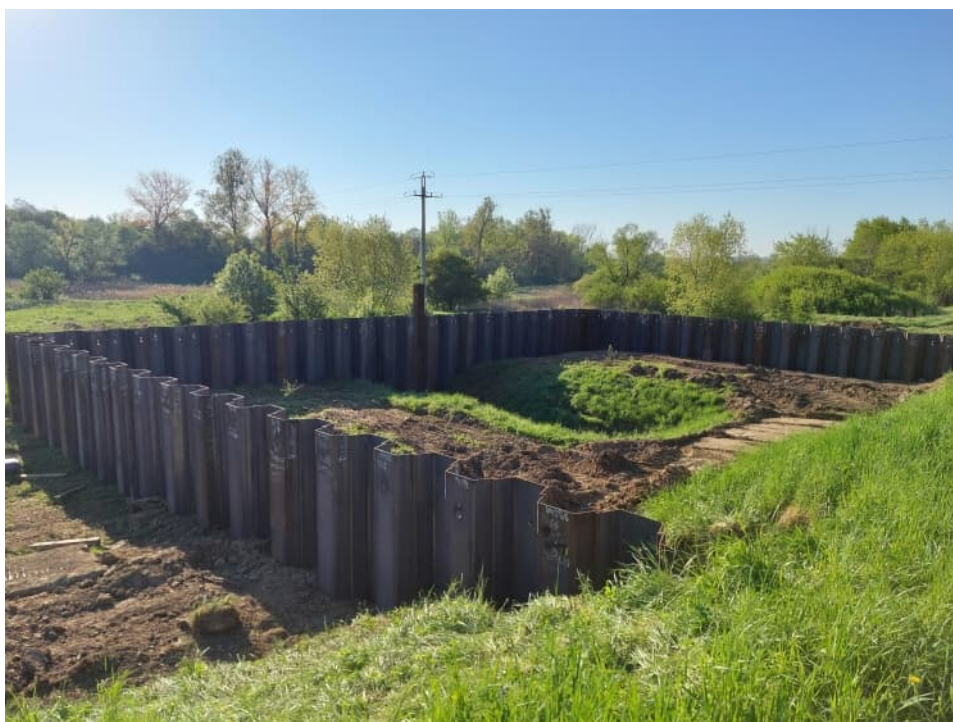
Fig. 36. A sheet piling protecting the embankment culvert during reconstruction
– the right Vistula embankment within *Section 3.4*,
status in the second decade of May 2021 (downstream view).

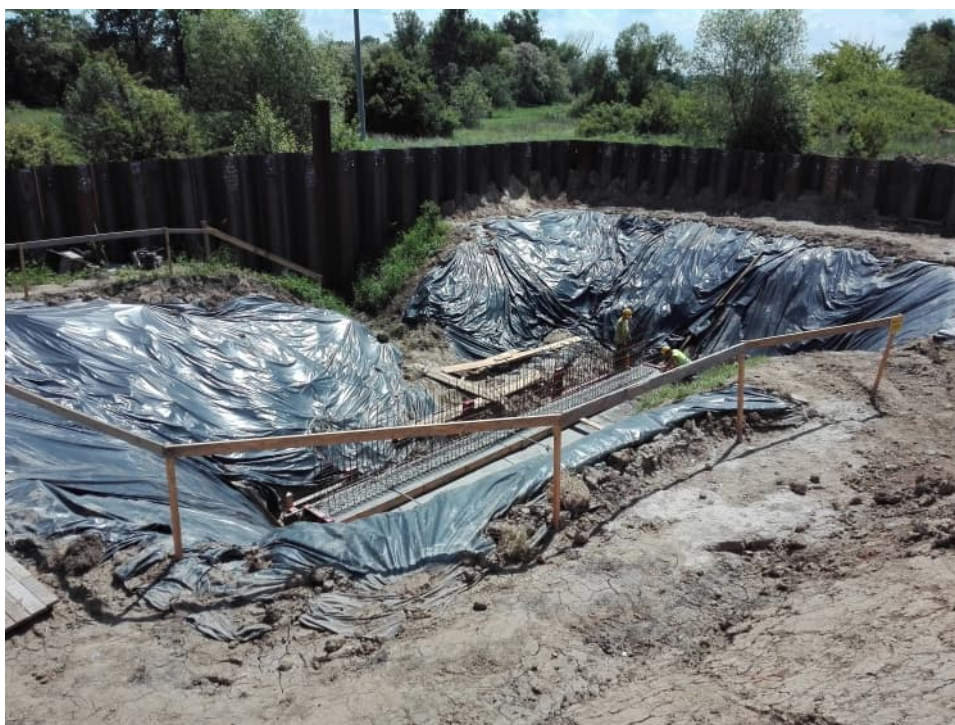
Fig. 37. Reconstruction of the embankment culvert
– the right Vistula embankment within *Section 3.4*,
status in the third decade of May 2021 (downstream view).

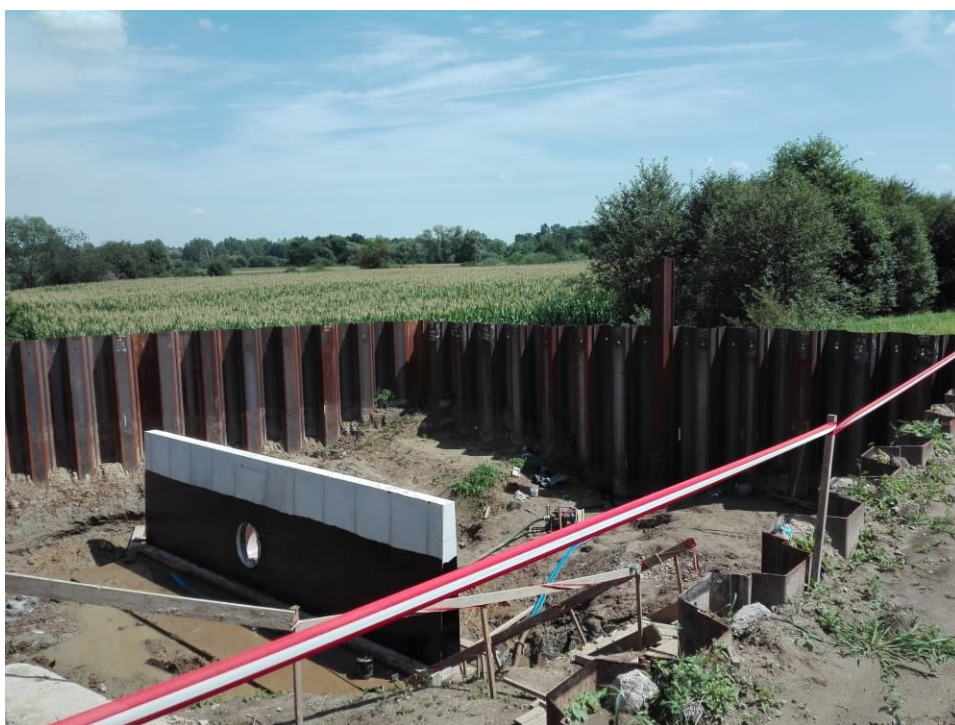
Fig. 38. Reconstruction of the embankment culvert
– the right Vistula embankment within *Section 3.4*,
status in the third decade of July 2021 (upstream view).

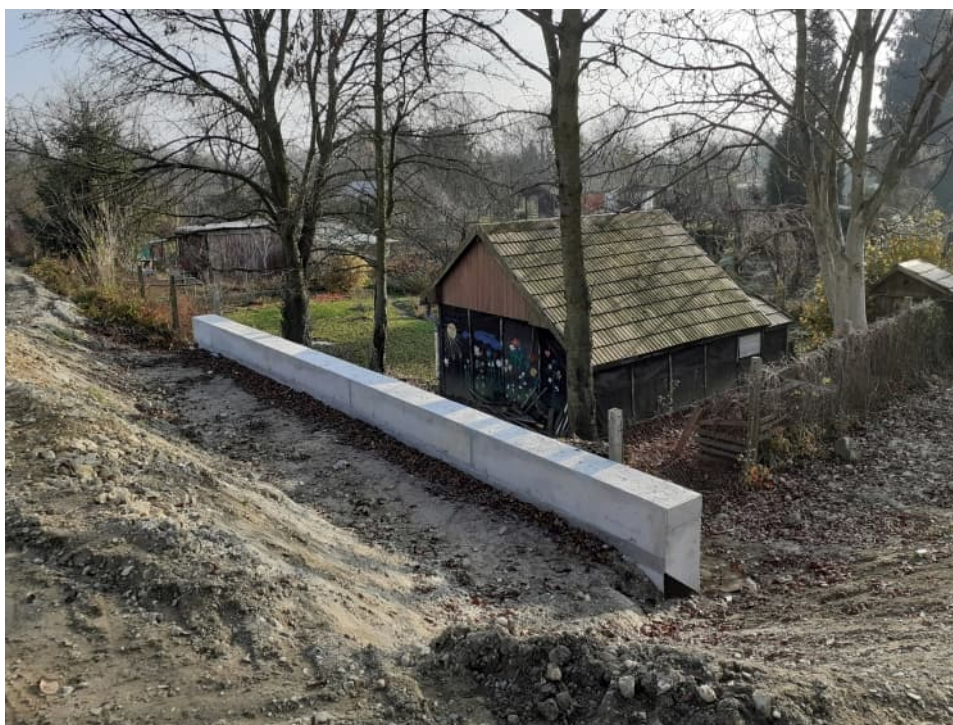
Fig. 39. Construction of a retaining wall
– the right Vistula embankment within *Section 3.2a*,
status in the second decade of November 2021 (downstream view).

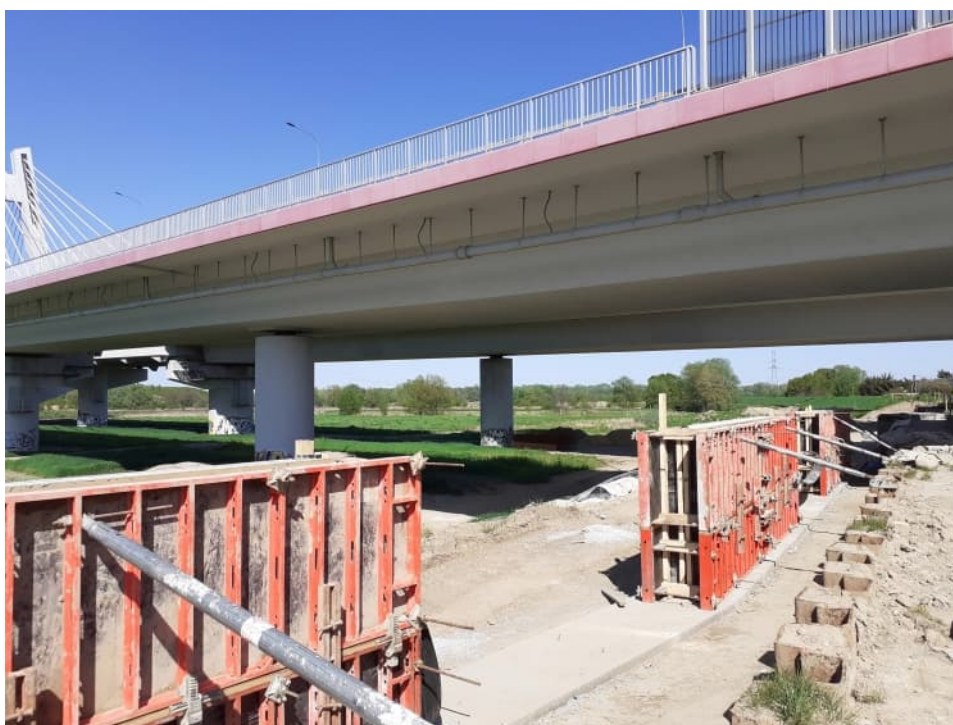
Fig. 40. Construction of a retaining wall
– the right Vistula embankment within *Section 3.3*,
status in the first decade of May 2022 (downstream view).

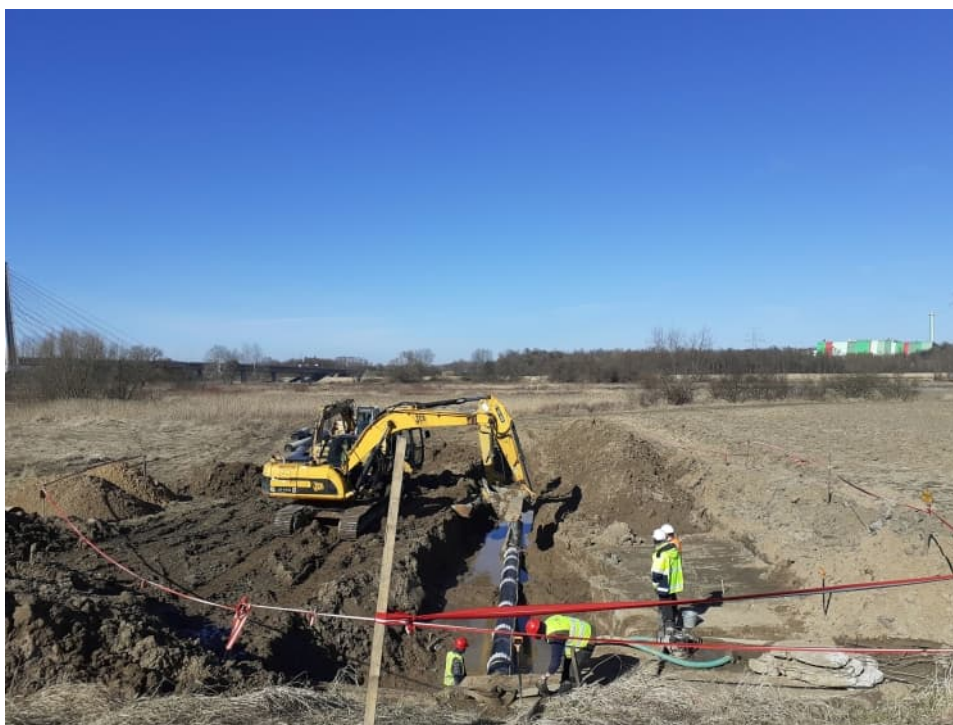
Fig. 41. Works related to the reconstruction of a gas pipeline network
– the right Vistula embankment within *Section 3.3*,
status in the third decade of February 2022 (view towards the embanked area).

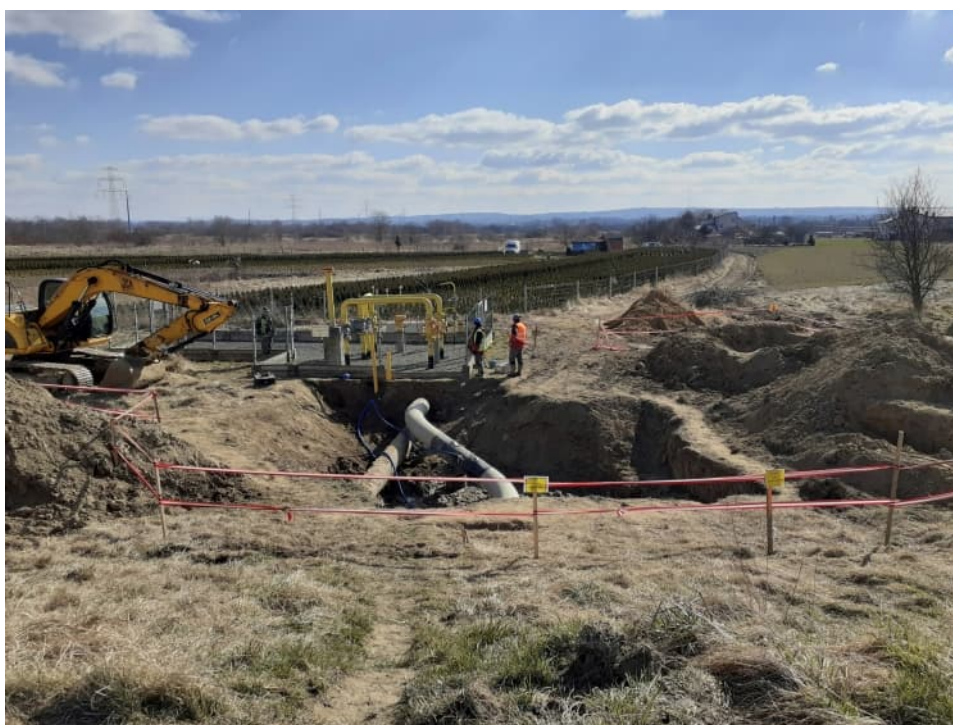
Fig. 42. Works related to the reconstruction of a gas pipeline network
– the right Vistula embankment within *Section 3.3*,
status in the first decade of March 2022
(view towards the area beyond the embankment).

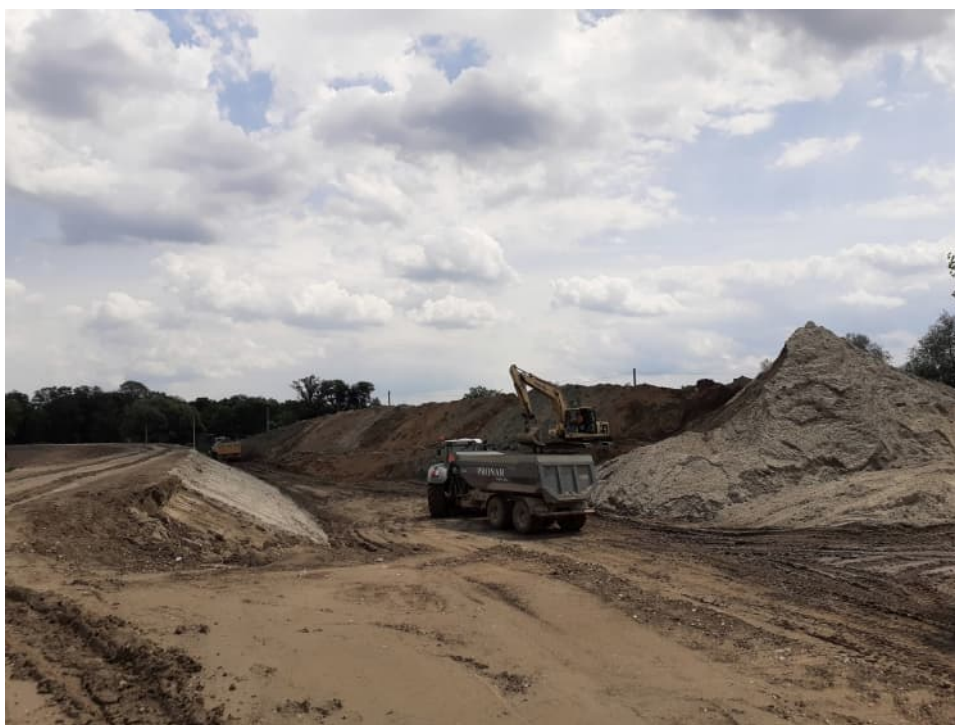
Fig. 43. Transport of earth masses for the reconstruction of a flood embankment – the right Vistula embankment within *Section 3.2a*, status in the first decade of July 2022 (downstream view).

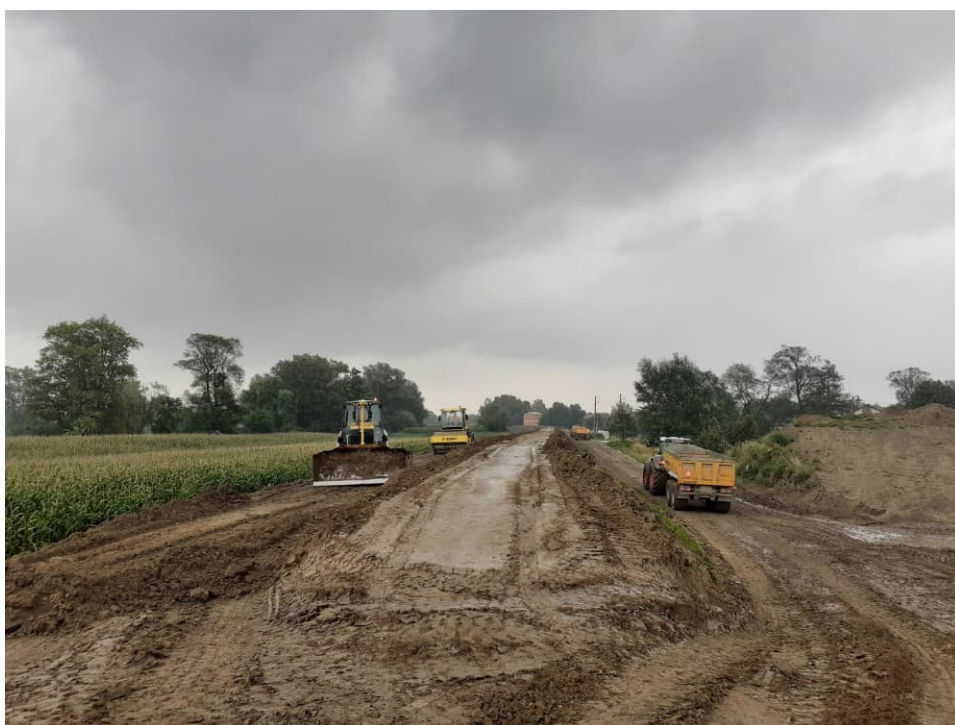
Fig. 44. Transport of earth masses for the reconstruction of a flood embankment – the right Vistula embankment within *Section 3.2b*, status in the third decade of July 2022 (downstream view).

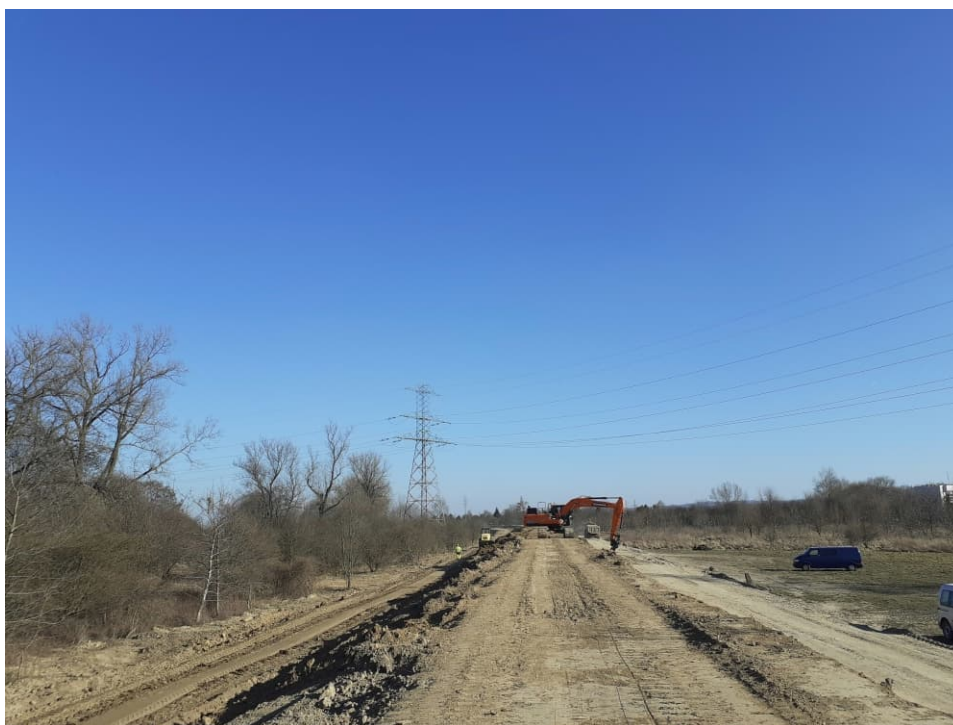
Fig. 45. Shaping the slopes of the flood embankment
– the right Vistula embankment within *Section 3.2a*,
status in the third decade of March 2022 (downstream view).

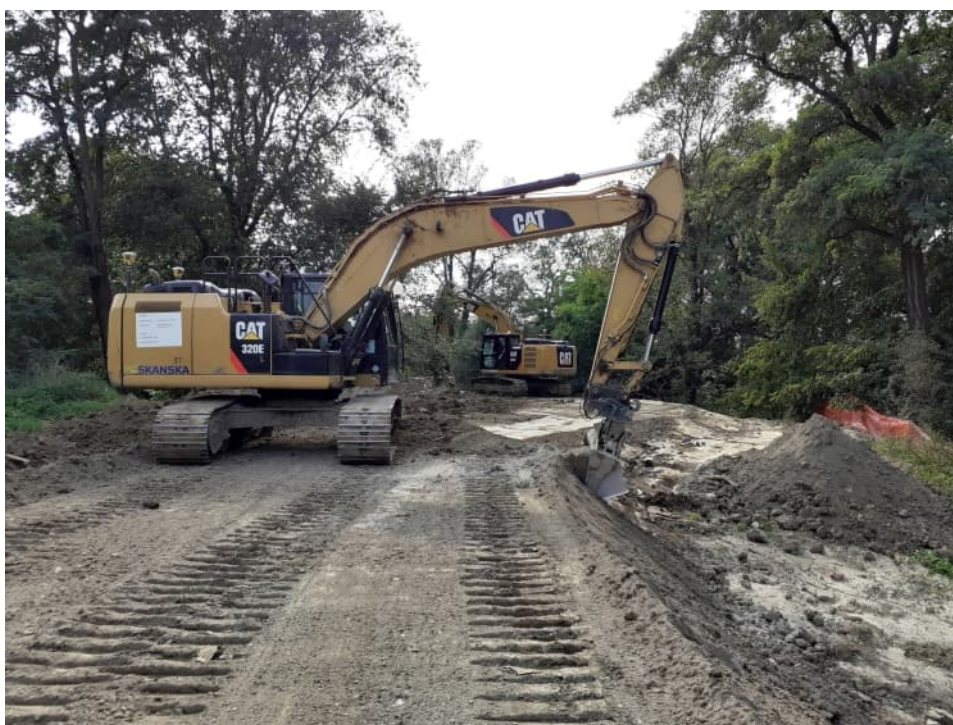
Fig. 46. Shaping the slopes of the flood embankment
– the right Vistula embankment within *Section 3.2a*,
status in the first decade of September 2022 (downstream view).

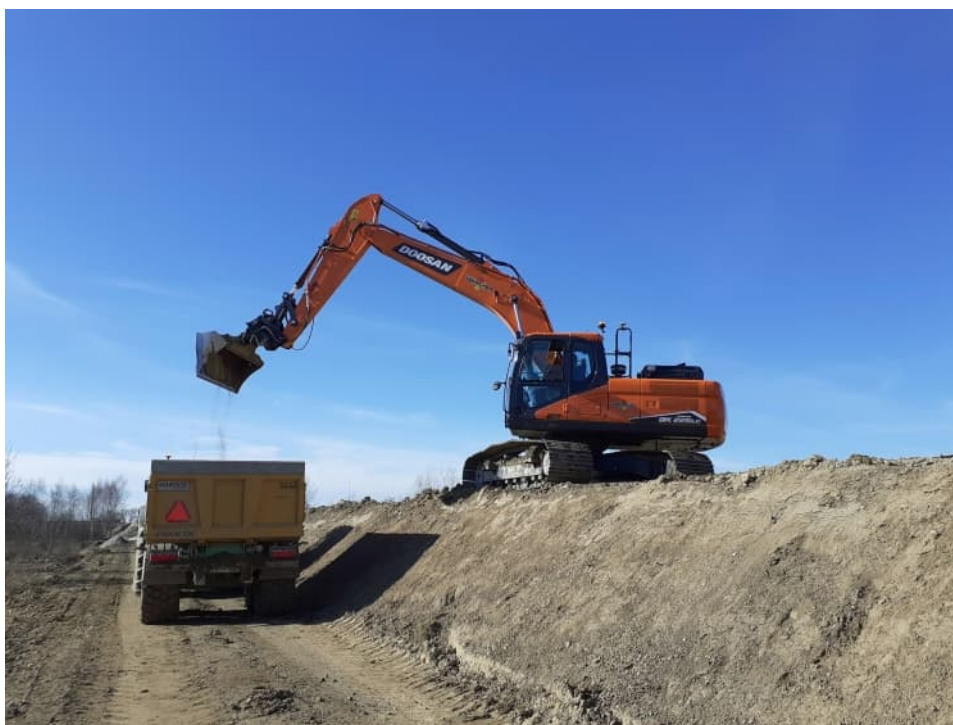
Fig. 47. Leveling the slopes of the flood embankment
– the right Vistula embankment within *Section 3.3*,
status in the third decade of February 2022 (upstream view).

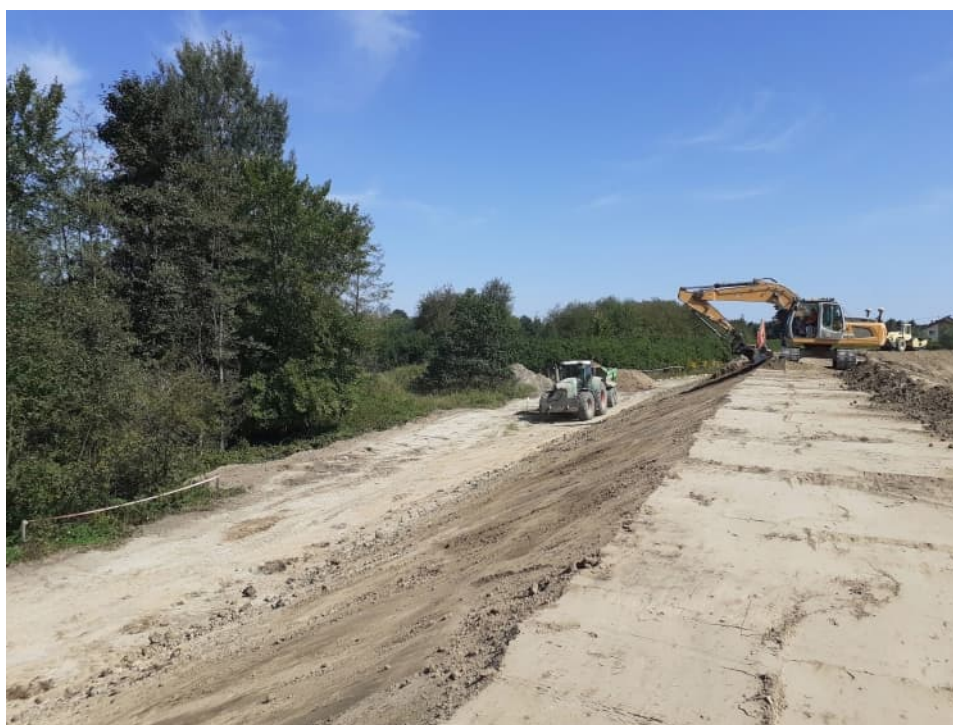
Fig. 48. Leveling the slopes of the flood embankment
– the right Vistula embankment within *Section 3.4*,
status in the first decade of September 2022 (downstream view).

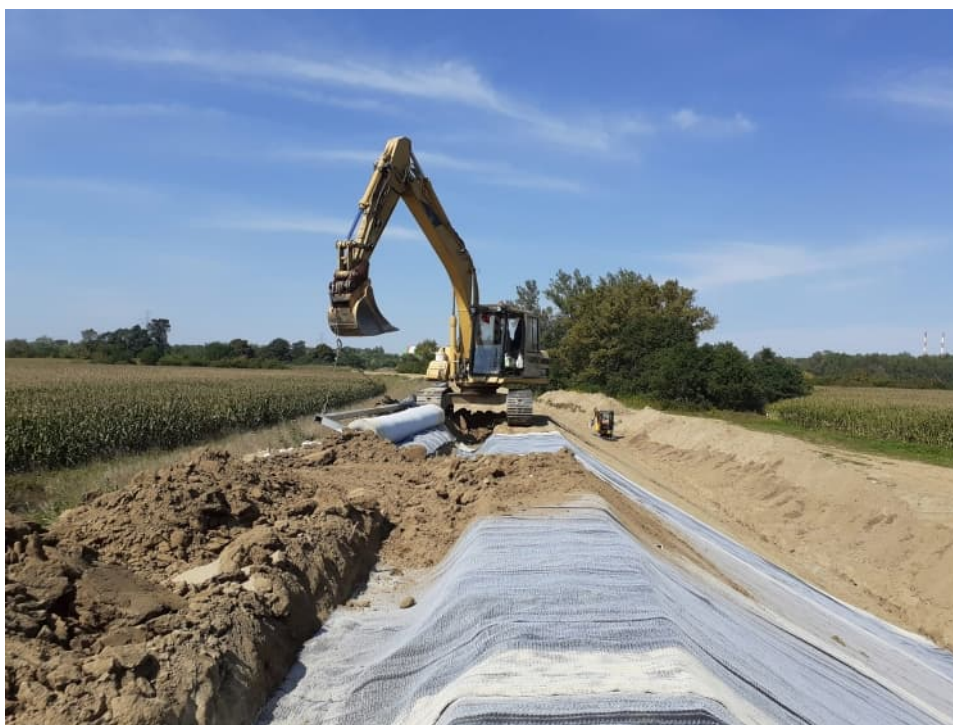
Fig. 49. Placement of bentomat on the slope of the flood embankment – the right Vistula embankment within *Section 3.3*, status in the first decade of September 2022 (upstream view).

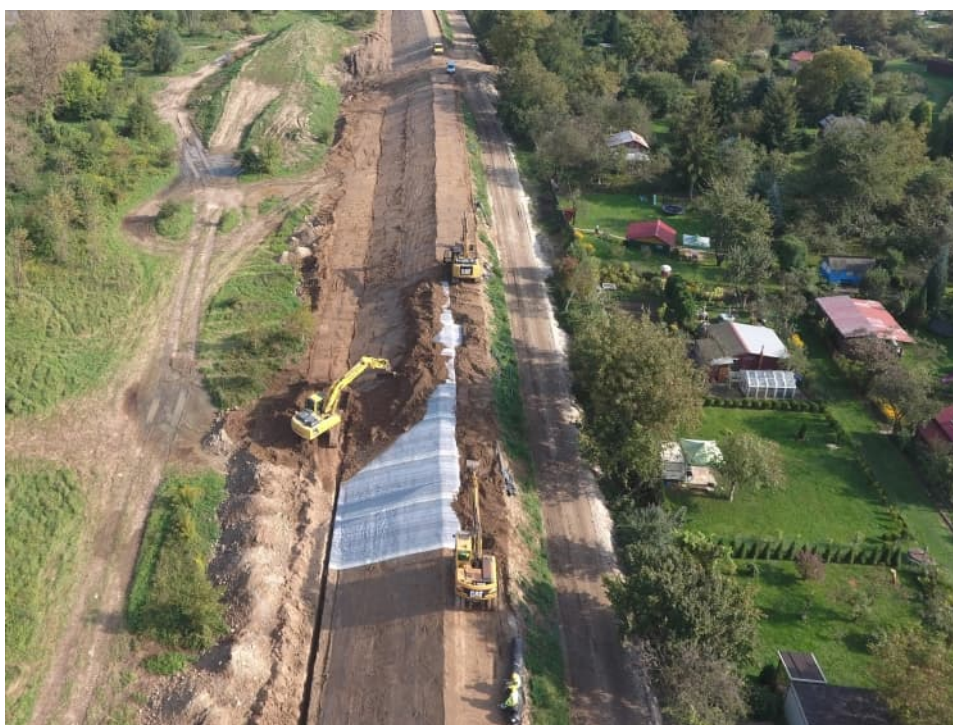
Fig. 50. Placement of bentomat on the slope of the flood embankment – the right Vistula embankment within *Section 3.2a*, status in the third decade of September 2021 (downstream view).

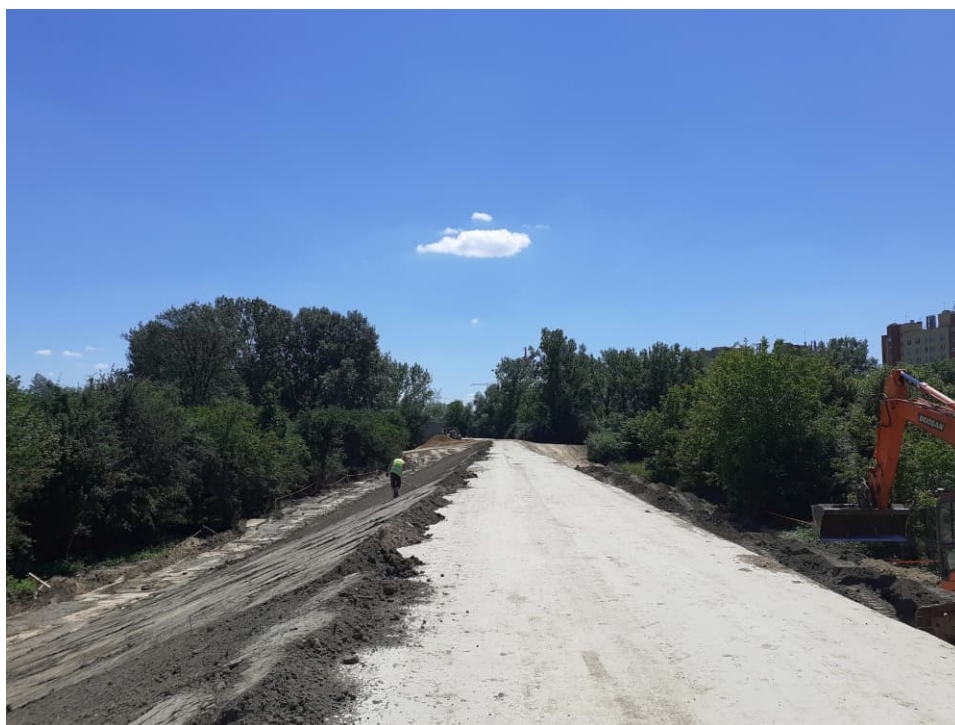
Fig. 51. Covering slopes of the flood embankment with a top-soil layer – the right Vistula embankment within *Section 3.2a*, status in the third decade of June 2022 (downstream view).

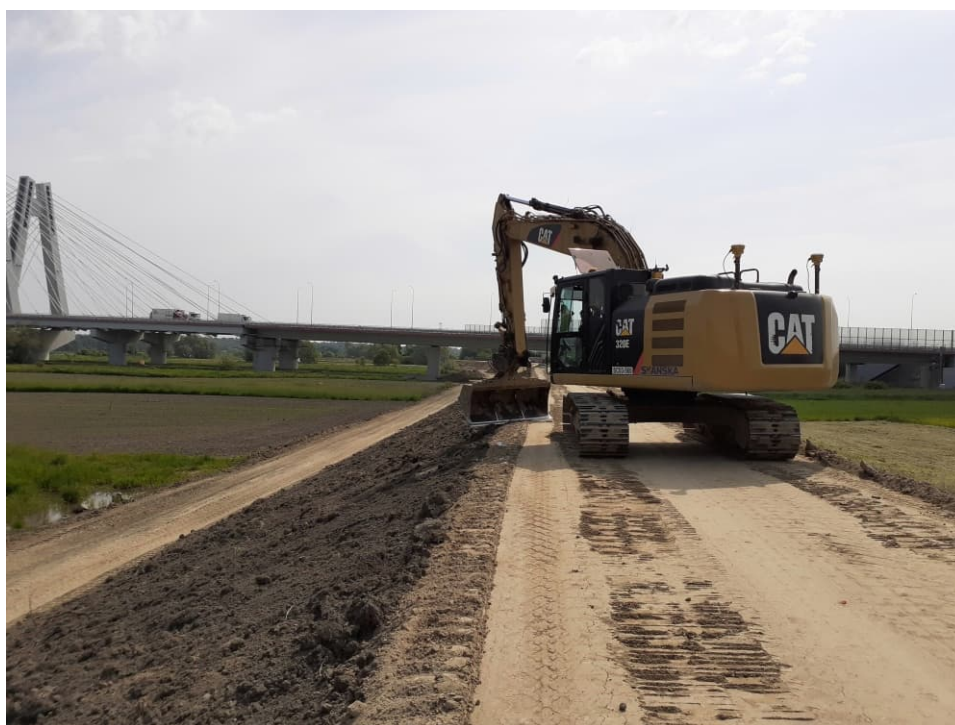
Fig. 52. Covering slopes of the flood embankment with a top-soil layer – the right Vistula embankment within *Section 3.3*, status in the third decade of May 2023 (downstream view).

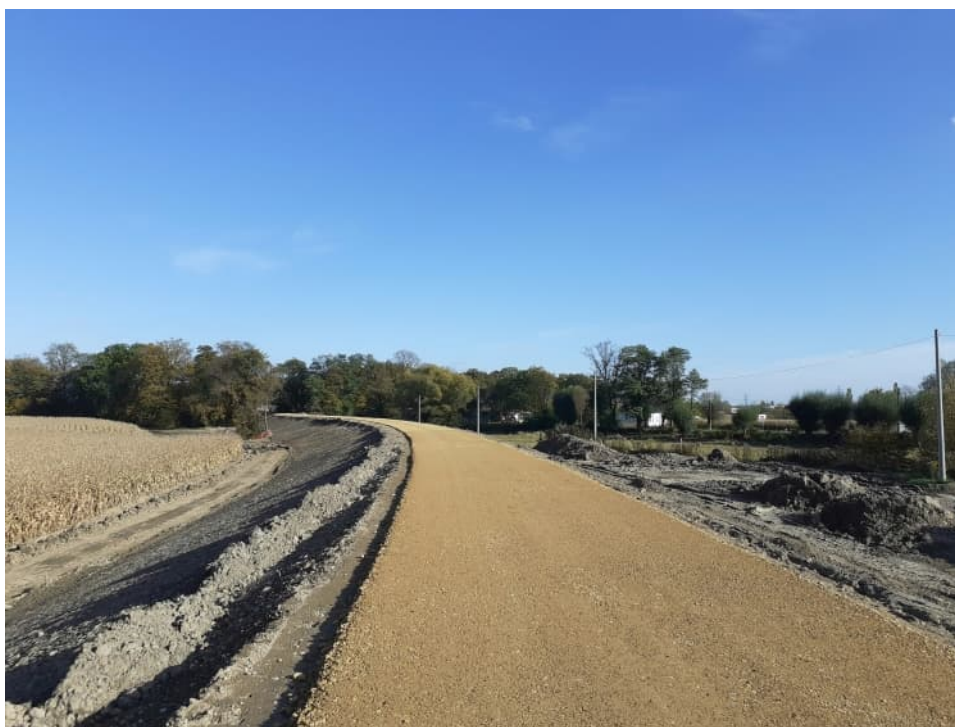
Fig. 53. Construction of a road on the crown of the flood embankment – the right Vistula embankment within *Section 3.2a*, status in the second decade of October 2022 (downstream view).

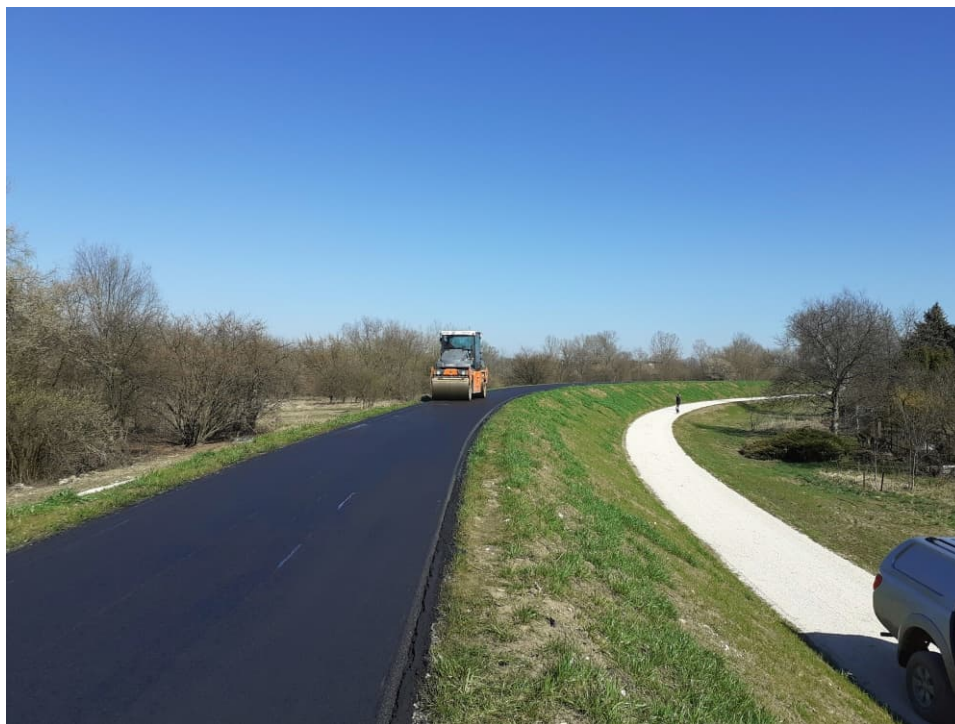
Fig. 54. Construction of a road on the crown of the flood embankment – the right Vistula embankment within *Section 3.1*, status in the third decade of March 2023 (downstream view).

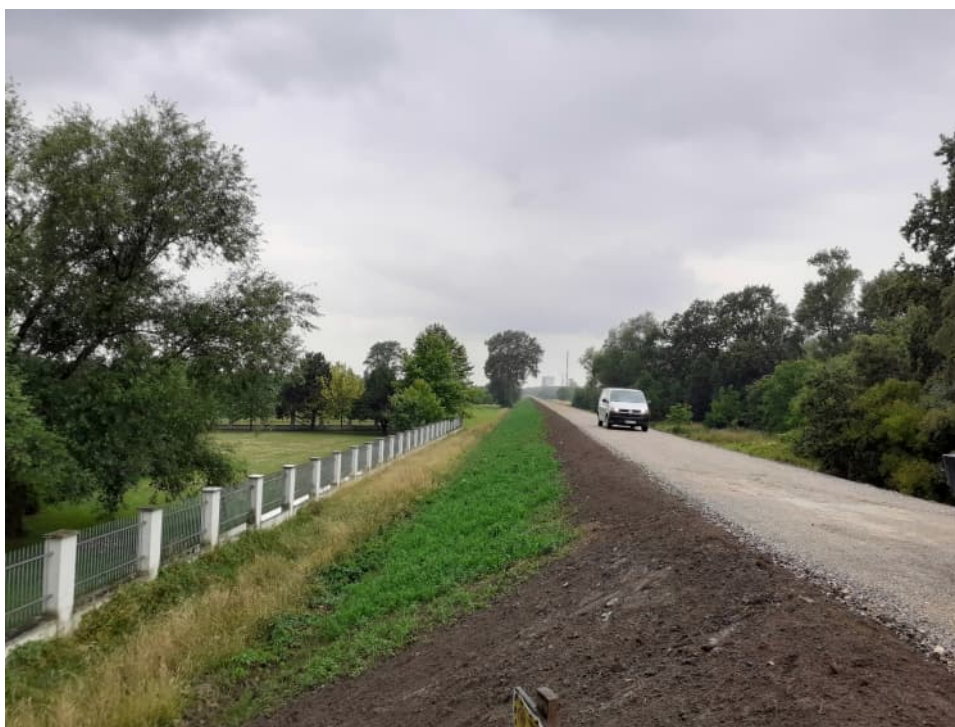
Fig. 55. Growth of grasses sown on the slope of the flood embankment – the right Vistula embankment within *Section 3.3*, status in the second decade of July 2023 (upstream view).

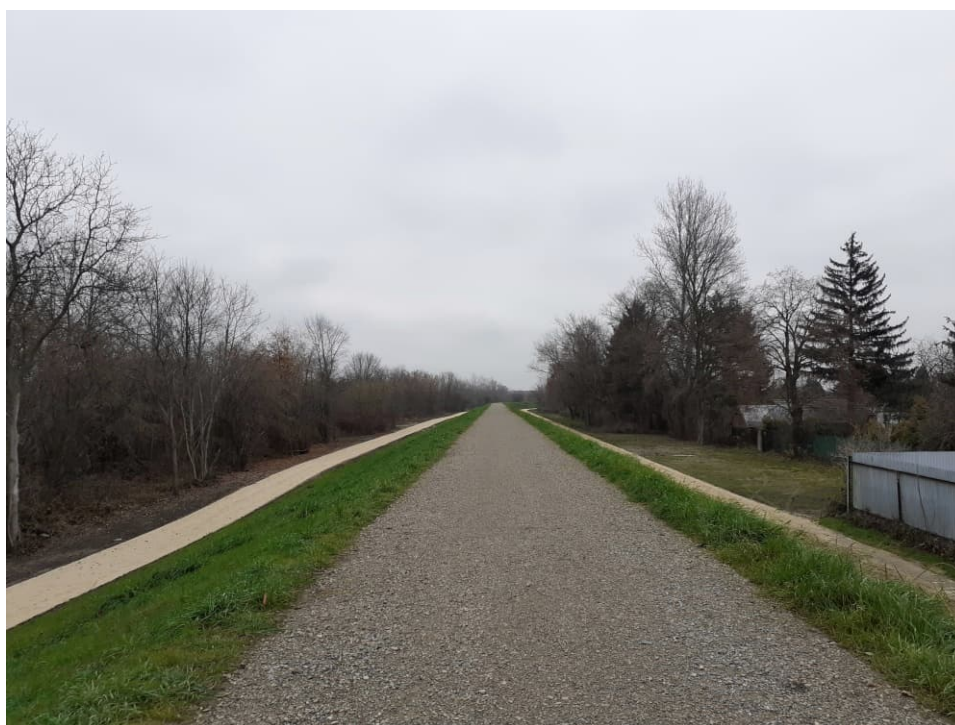
Fig. 56. Growth of grasses sown on the slope of the flood embankment – the right Vistula embankment within *Section 3.1*, status in the third decade of November 2022 (downstream view).

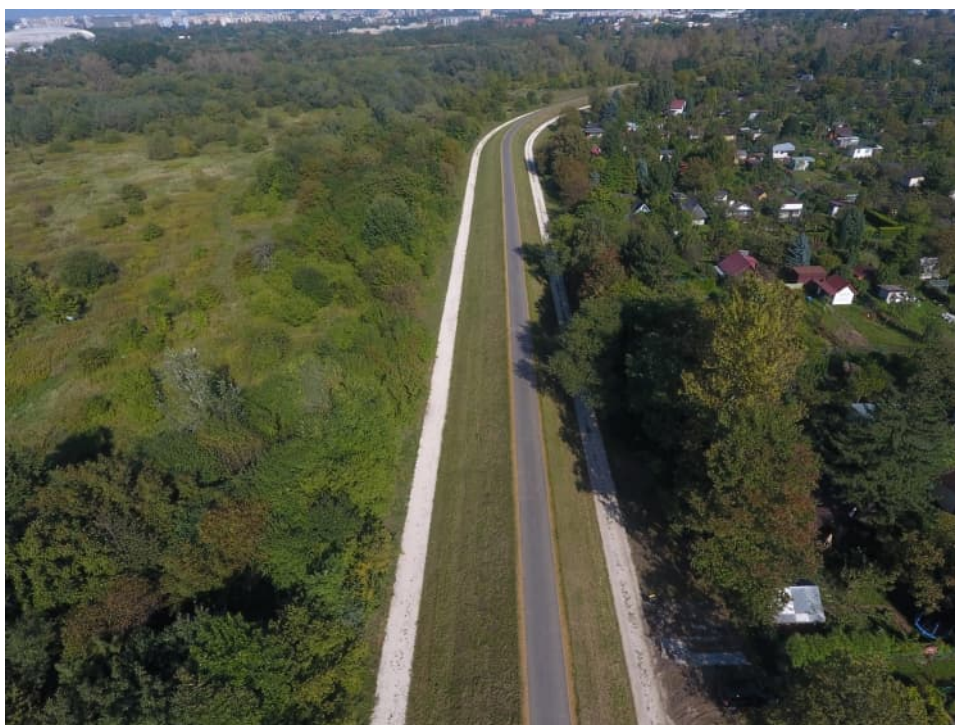
Fig. 57. Site condition in the last quarter of the works implementation period – the right Vistula embankment within *Section 3.1*, status in the third decade of September 2023 (downstream view).

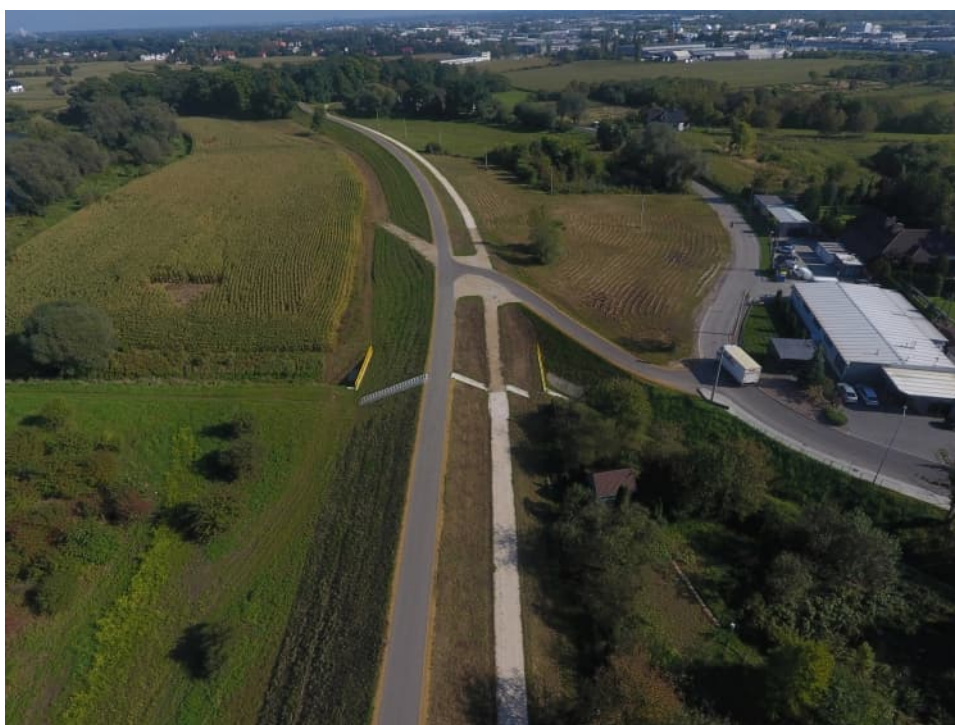
Fig. 58. Site condition in the last quarter of the works implementation period – the right Vistula embankment within *Section 3.2a*, status in the third decade of September 2023 (downstream view).

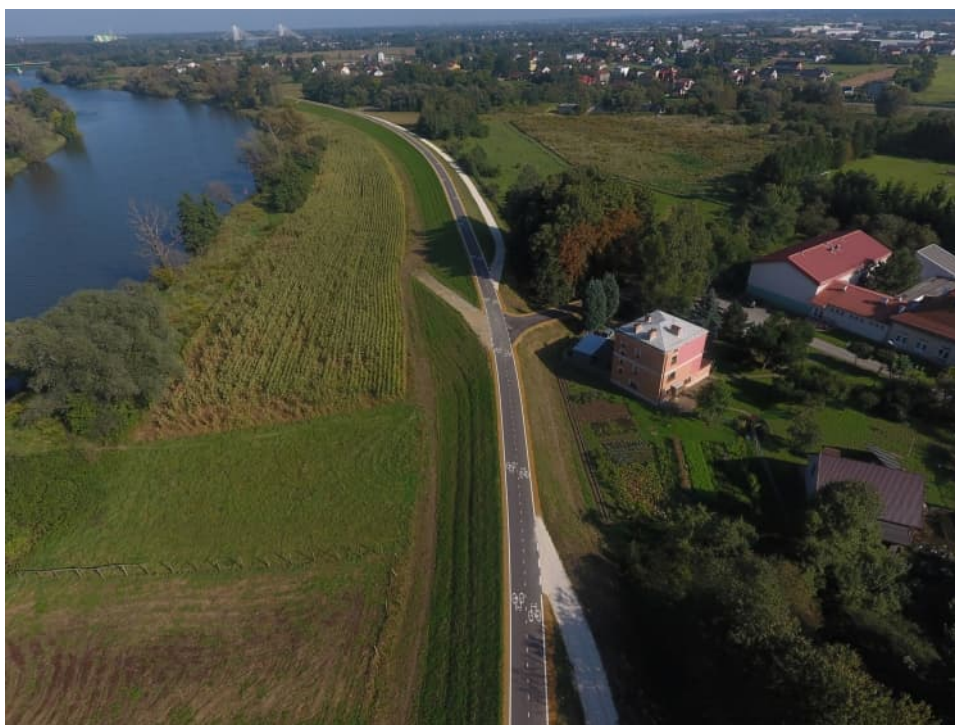
Fig. 59. Site condition in the last quarter of the works implementation period – the right Vistula embankment within *Section 3.2b*, status in the third decade of September 2023 (downstream view).

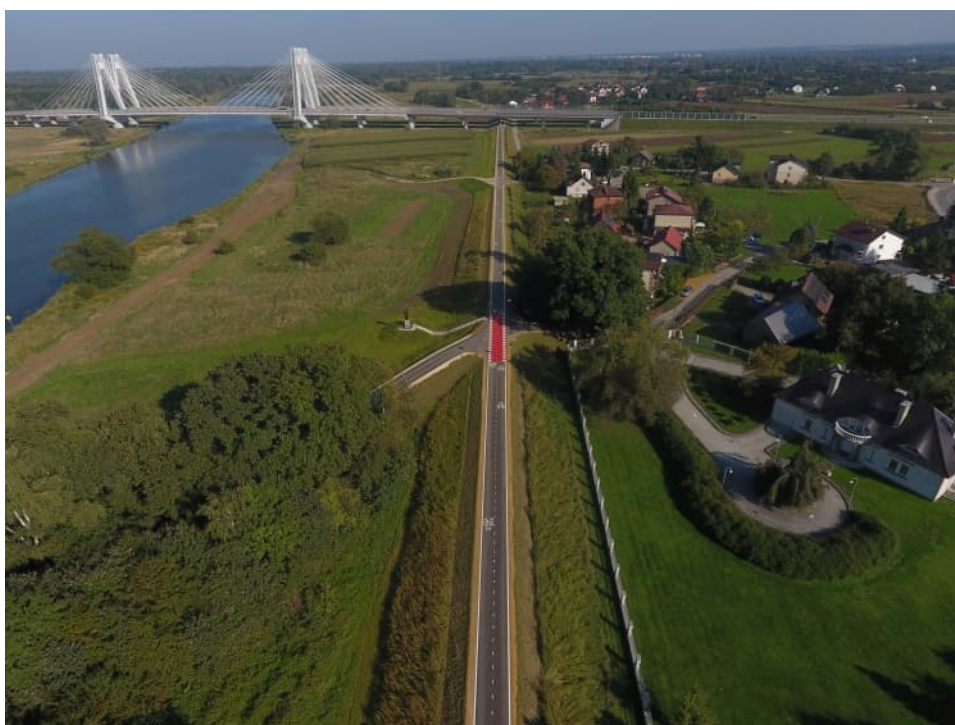
Fig. 60. Site condition in the last quarter of the works implementation period – the right Vistula embankment within *Section 3.3* – upper part, status in the third decade of September 2023 (downstream view).

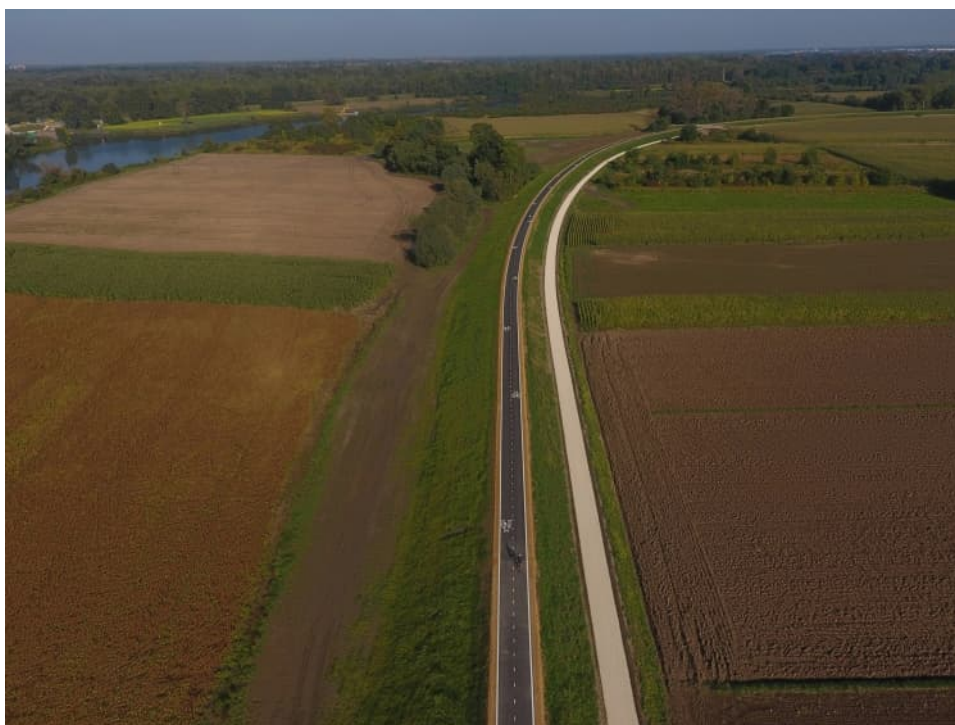
Fig. 61. Site condition in the last quarter of the works implementation period – the right Vistula embankment within *Section 3.3* – lower part, status in the third decade of September 2023 (downstream view).

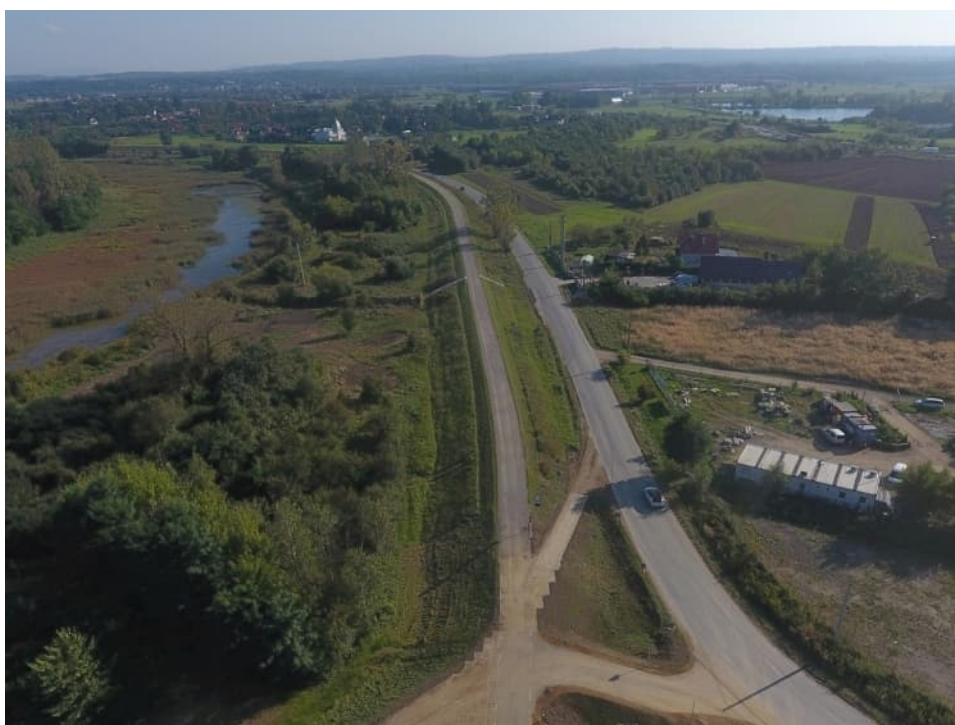
Fig. 62. Site condition in the last quarter of the works implementation period – the right Vistula embankment within *Section 3.4*, status in the third decade of September 2023 (downstream view).
