Appendix no. 6
to the Final Report on Implementation of the Land Acquisition and
Resettlement Action Plan (LARAP) for Works Contract 3D.2/2 - *Expansion of*
the left and right embankment of the Biala River in the Tarnow Municipality and
the City of Tarnow

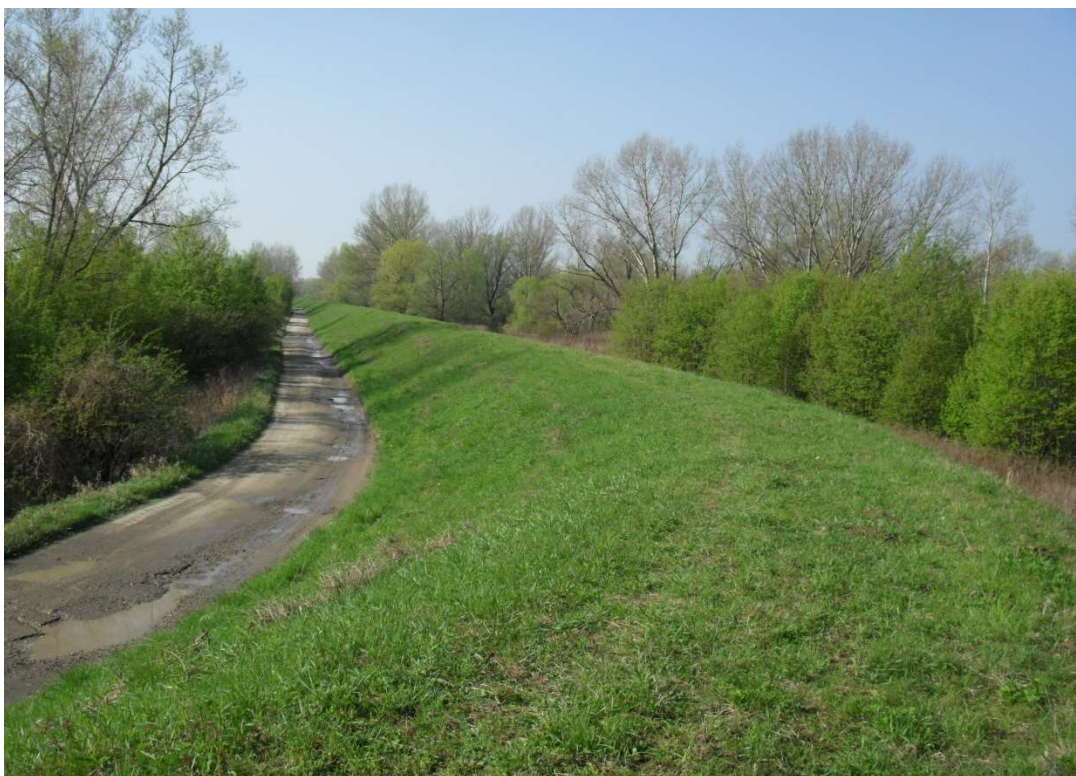
Photo. 1. Condition of the Construction Site before the start of works implementation – left embankment at chainage km 0+000 – view to the embanked area and hardened road.

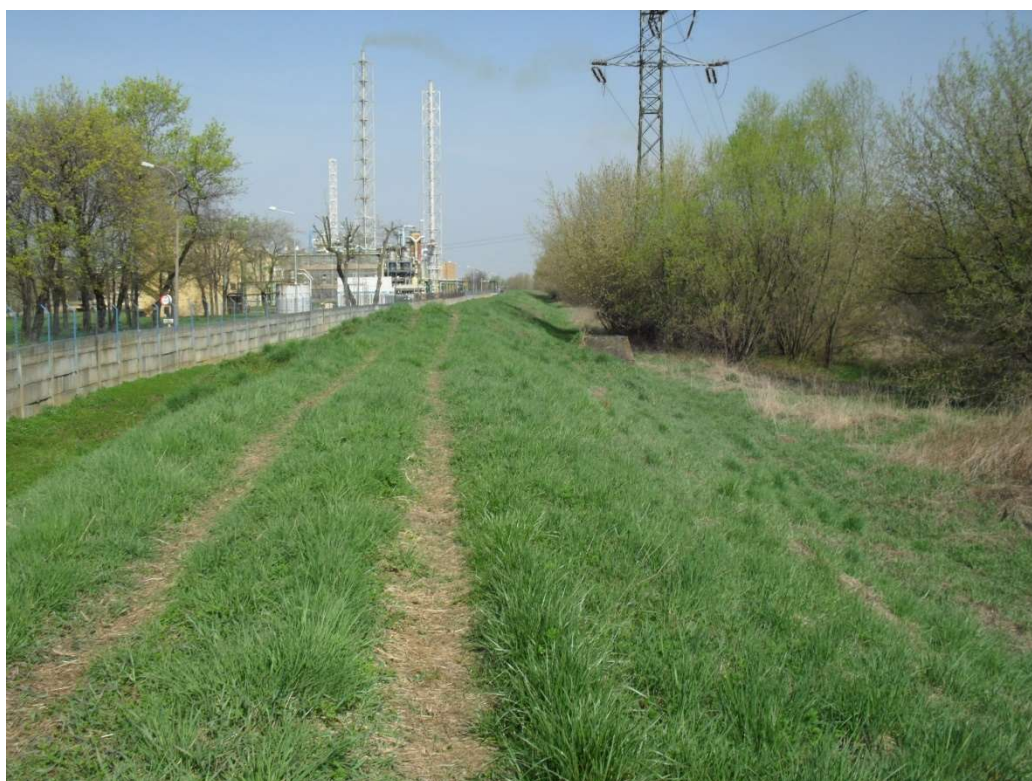
Photo. 2. Condition of the Construction Site before the start of works implementation – left embankment - area beyond the embankment, industrial plants, fence along the embankment.

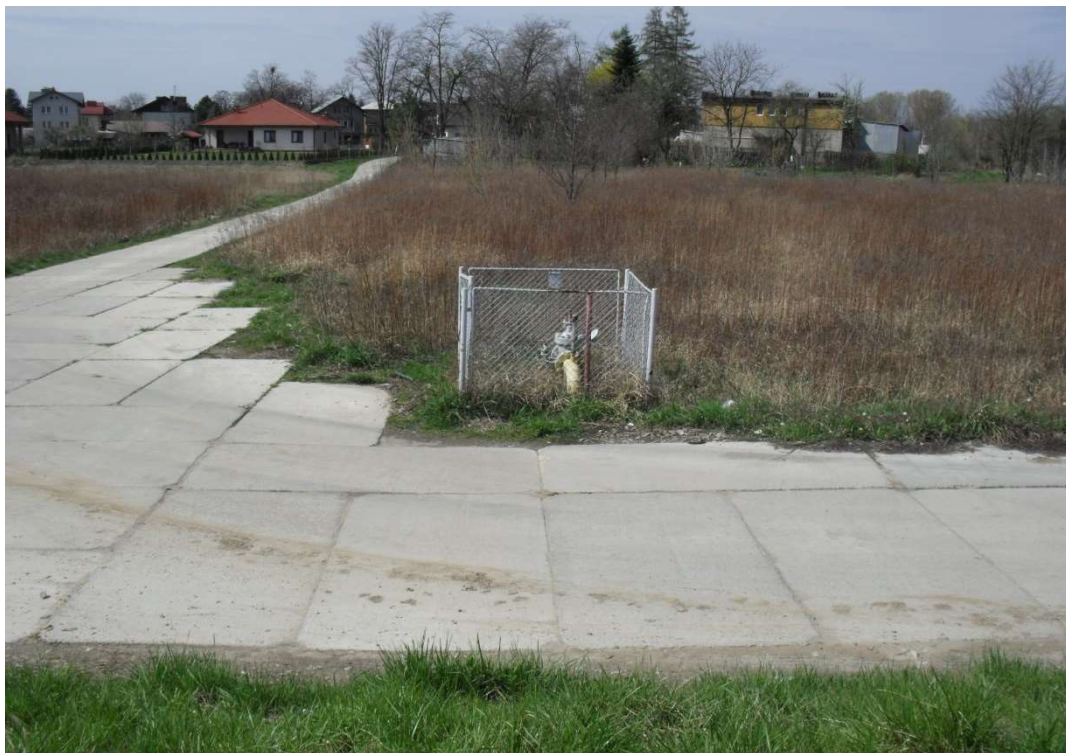
Photo. 3. Condition of the Construction Site before the start of works implementation – left embankment – residential buildings outside the area of works.

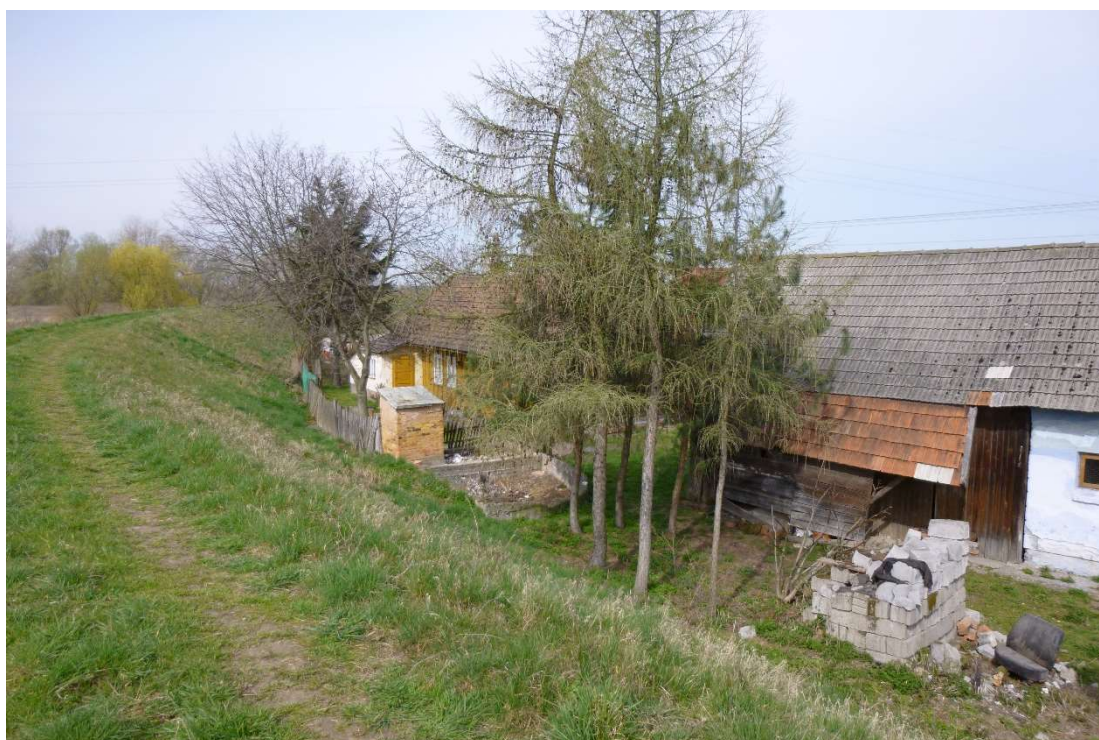
Photo. 4. Condition of the Construction Site before the start of works implementation – right embankment at chainage 2+956 – 3+120 - the outer-embankment zone, buildings about 2.0 m from the embankment.

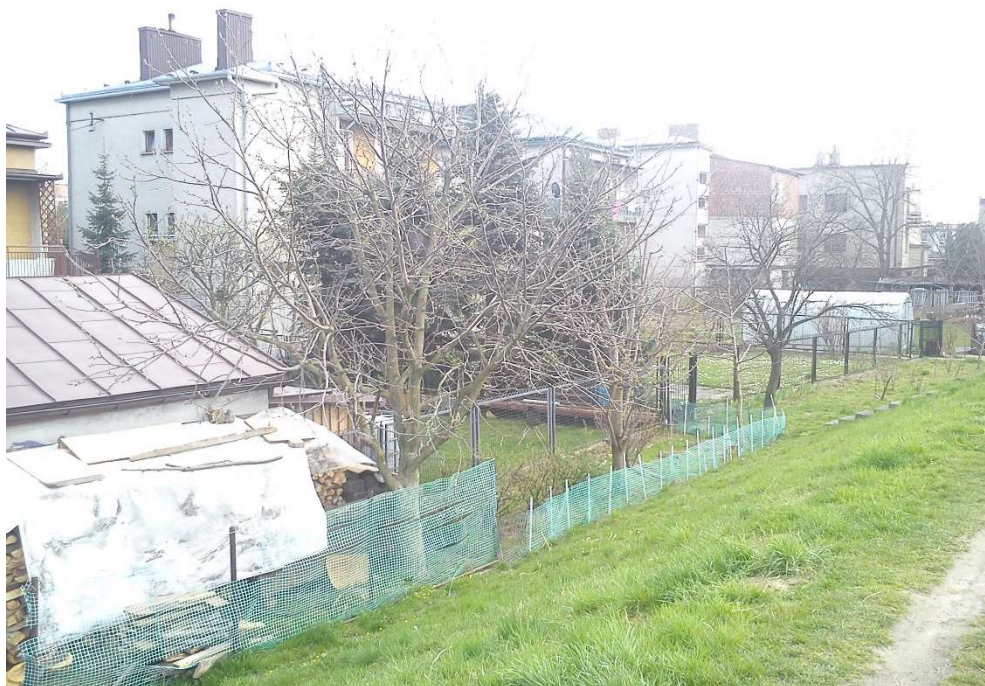
Photo. 5. Condition of the Construction Site before the start of works implementation – right embankment at chainage 5+260 – 5+860 - utility building with a fence.

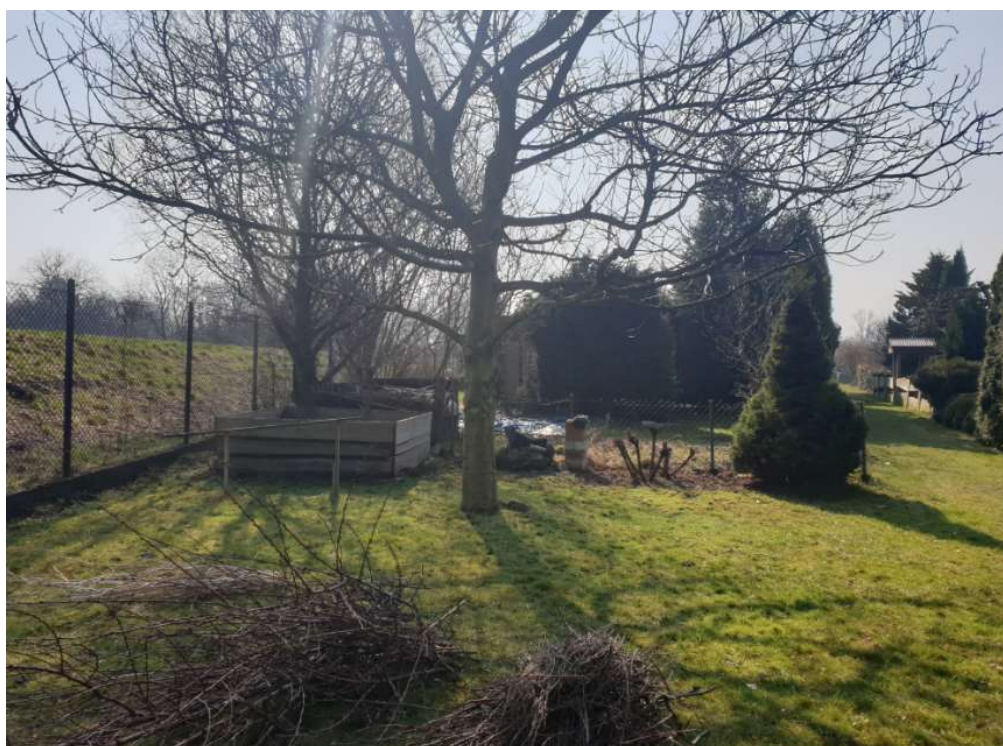
Photo. 6. Condition of the Construction Site before the start of works implementation – allotment gardens on FAG JASKÓŁKA.

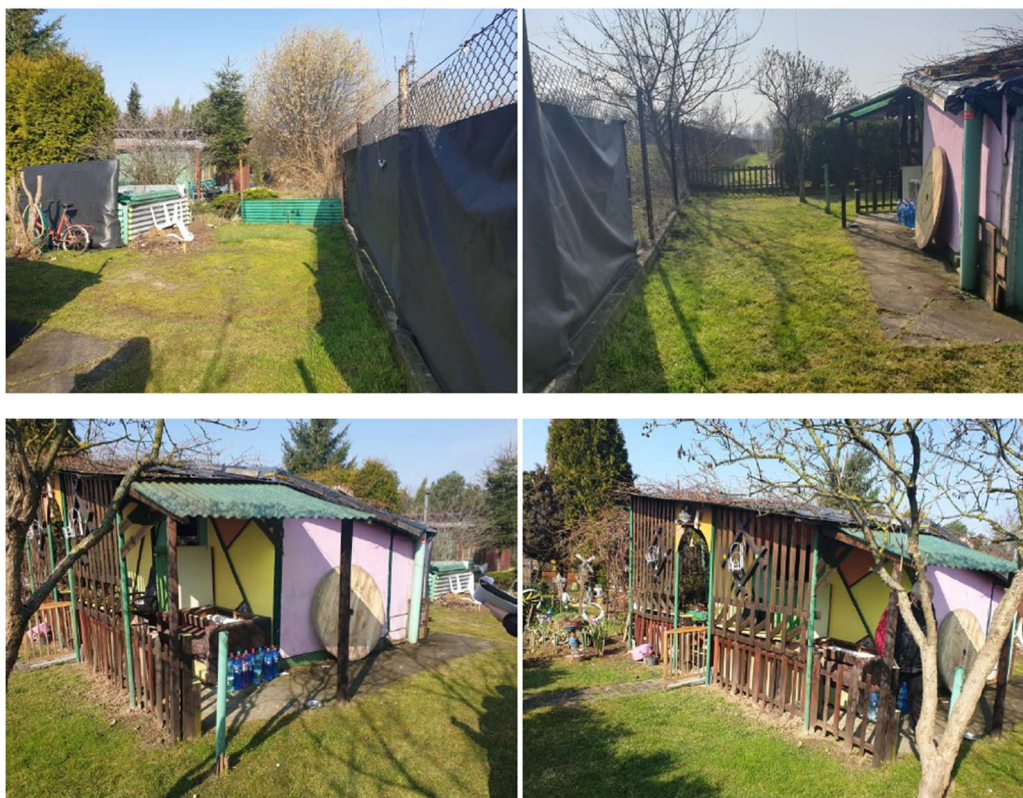
Photo. 7. Condition of the Construction Site before the start of works implementation – allotment gardens on FAG JASKÓŁKA.

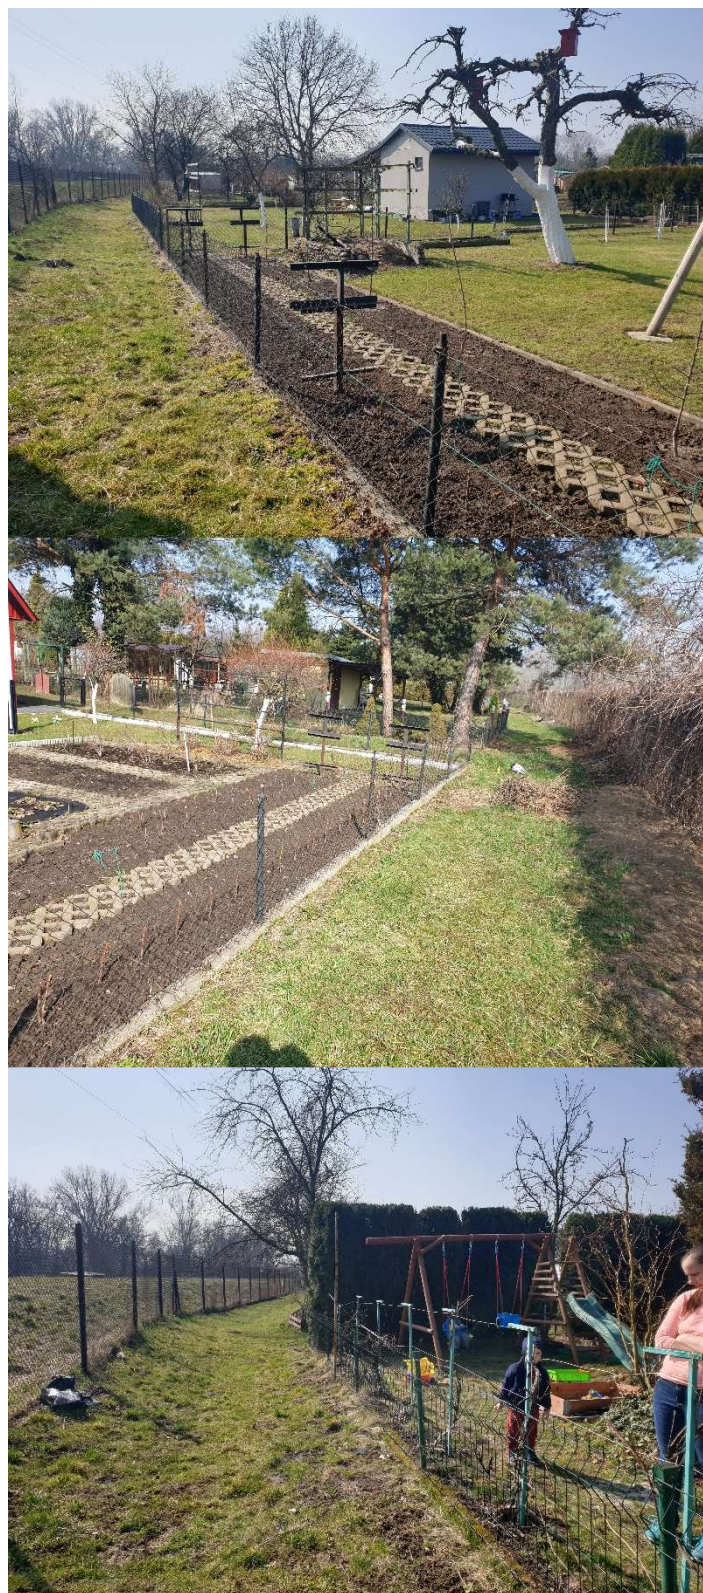
Photo. 8. Condition of the Construction Site before the start of works implementation – allotment gardens on FAG JASKÓŁKA.

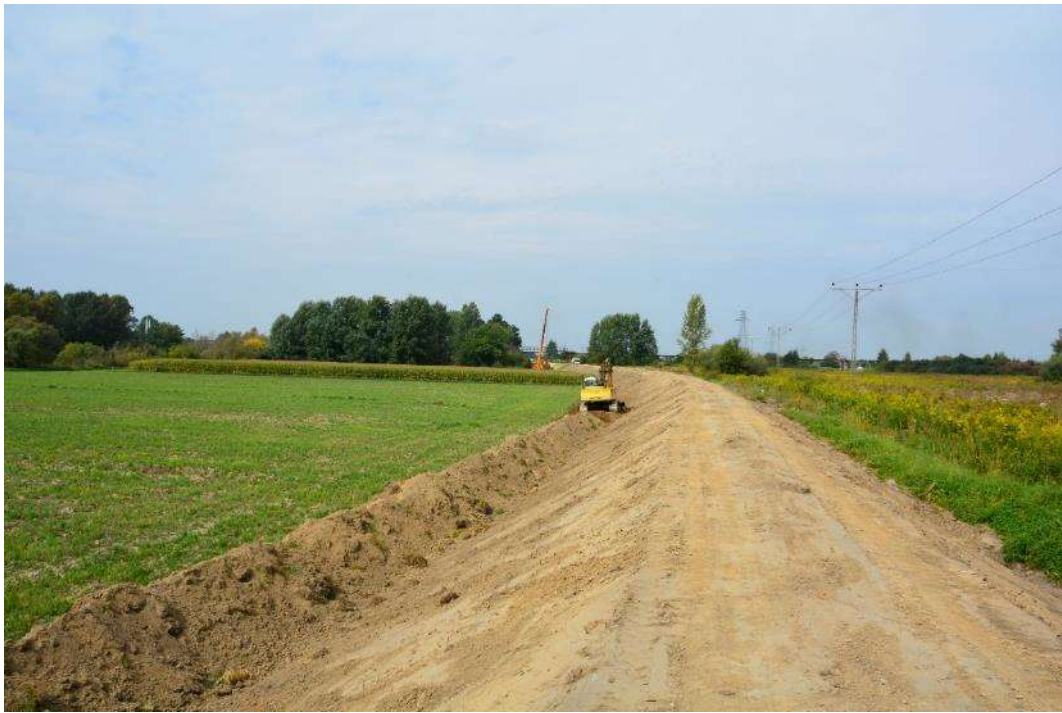
Photo. 9. Right embankment at km approx. 1+200 – topsoil removal of the embankment (September 2021).

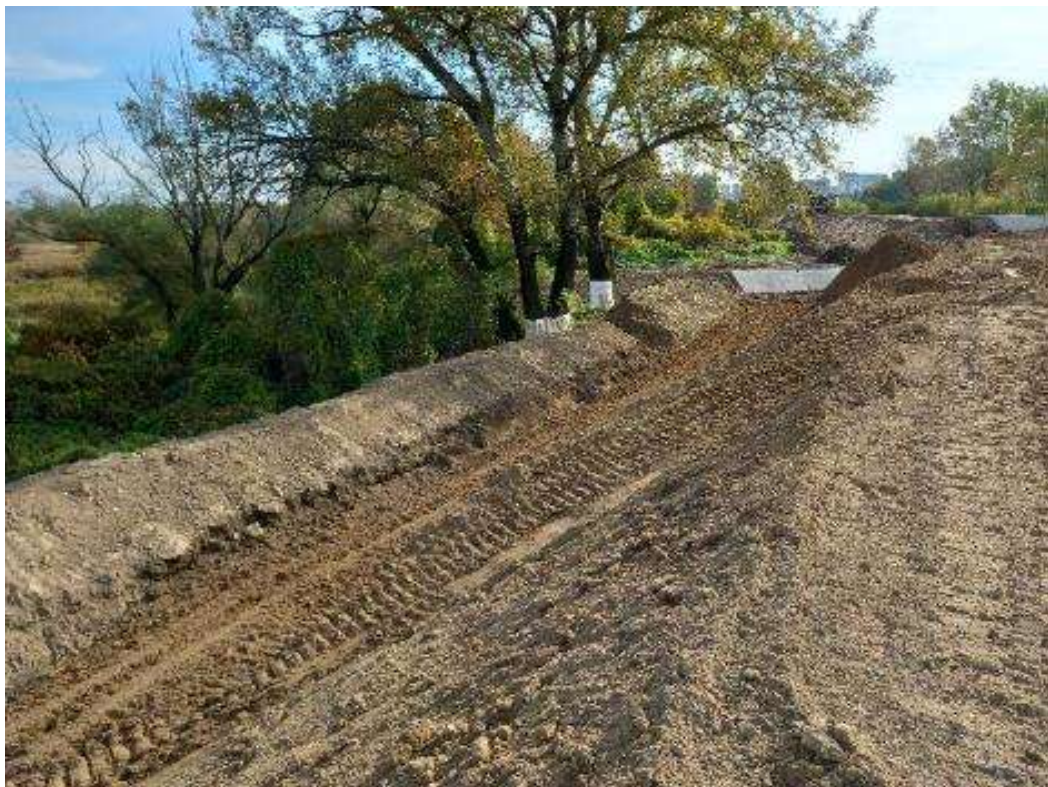
Photo. 10. Right embankment at km approx. 0+500 – covers of single, thick-barked trees by means of boards (3rd decade of October 2021).

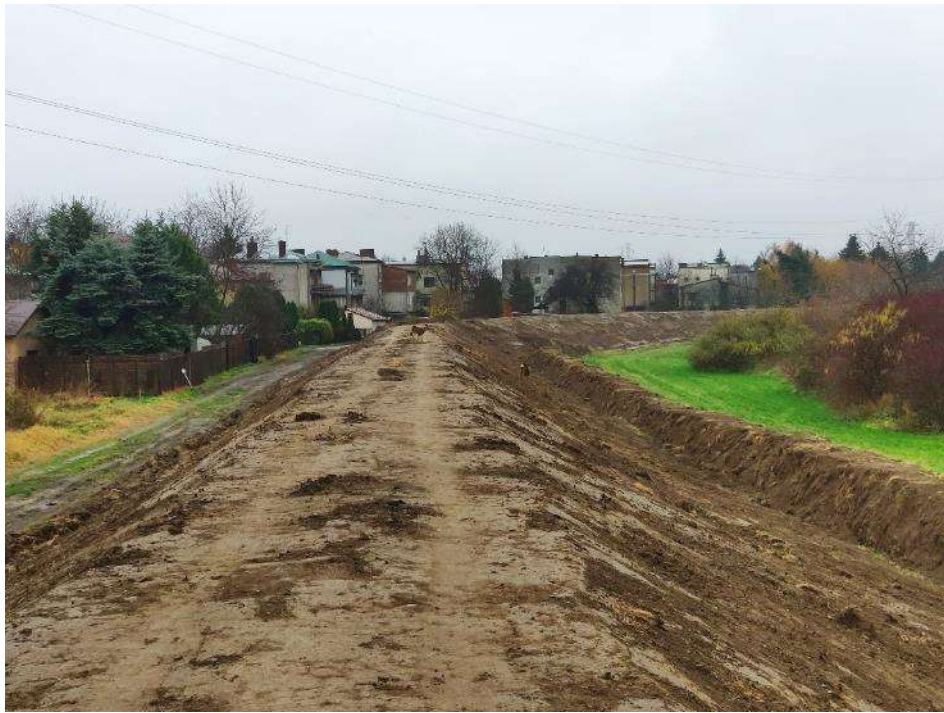
Photo. 11. Right embankment at km approx. 5+600 – the area of the works performed (1st decade of November 2021).

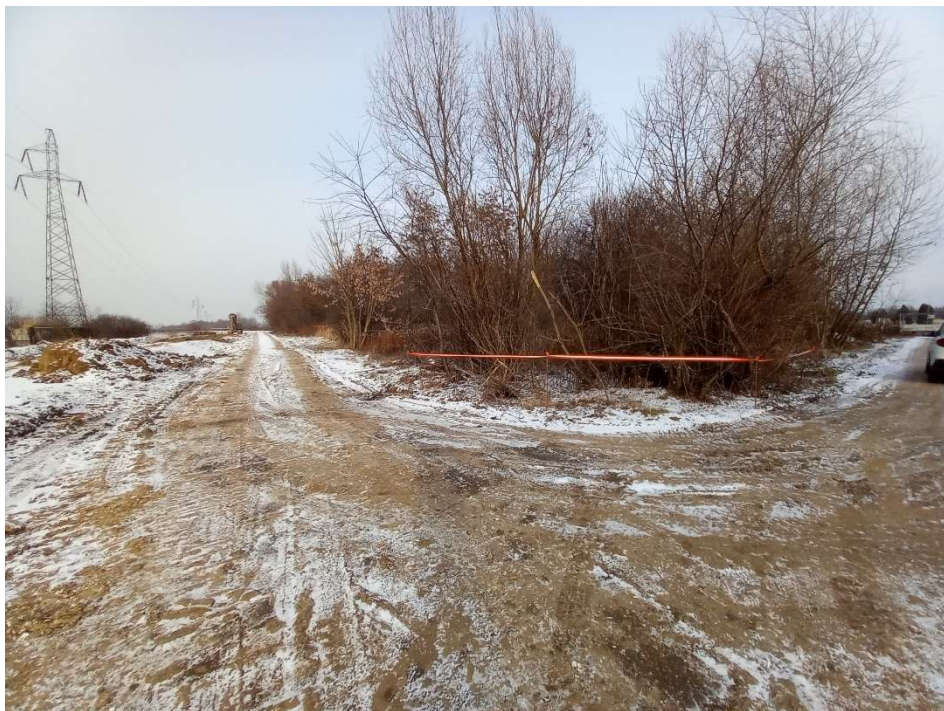
Photo. 12. Right embankment at km approx. 2+100 – the constructed additional greenery fencing at entrance to back-up facilities (3rd decade of December 2021)

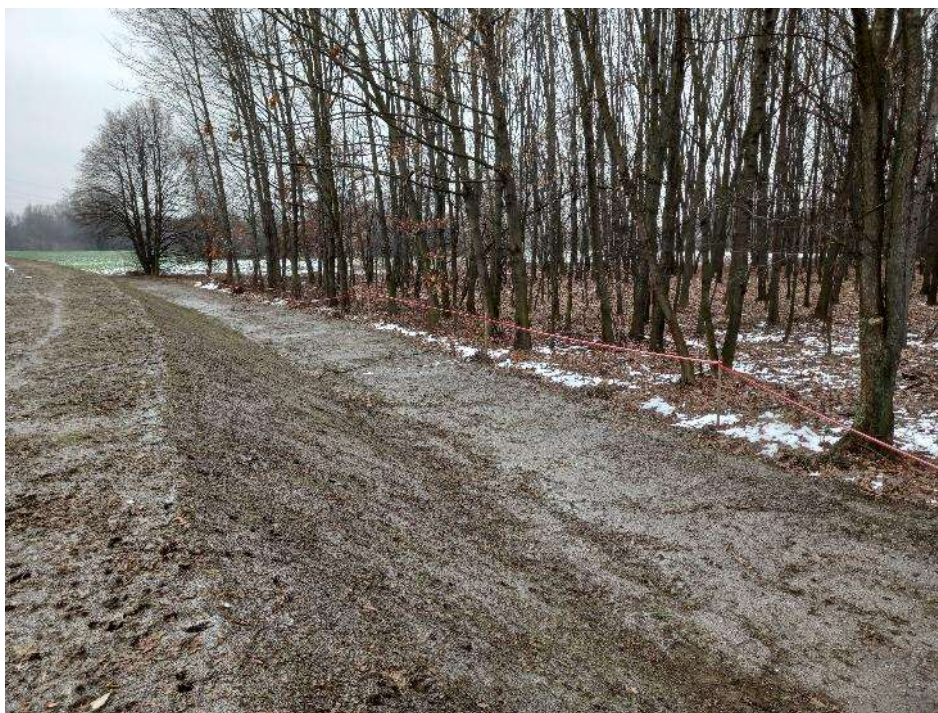
Photo. 13. Left embankment at km approx. 4+500 – condition of fences for trees left outside felling (3rd decade of January 2023).

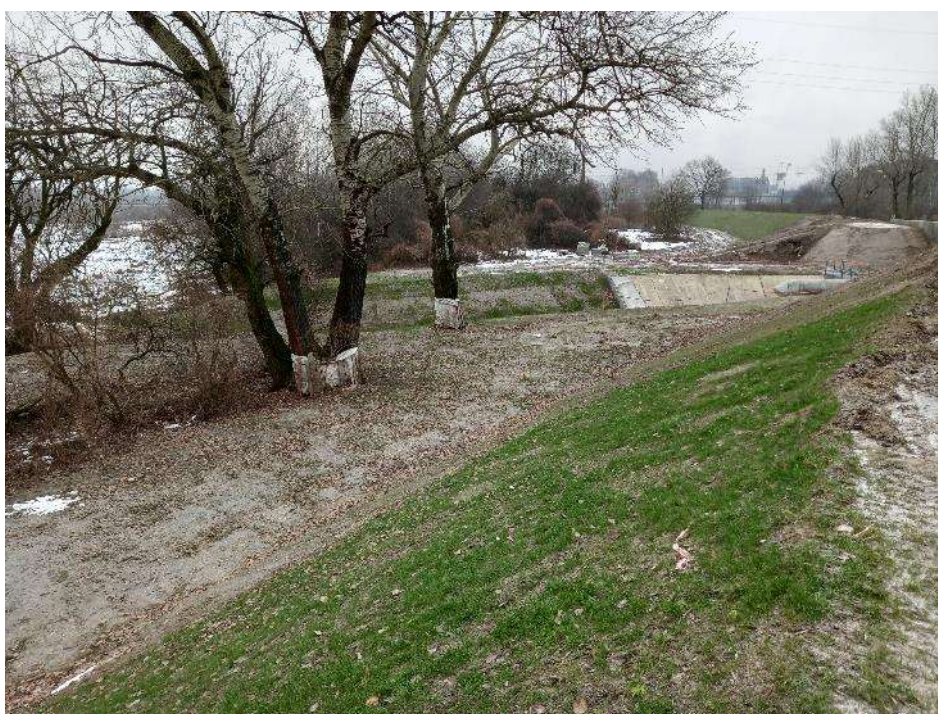
Photo. 14. Left embankment at km approx. 0+400 – securing the greenery bordering the zone of conducted works (3rd decade of January 2023)

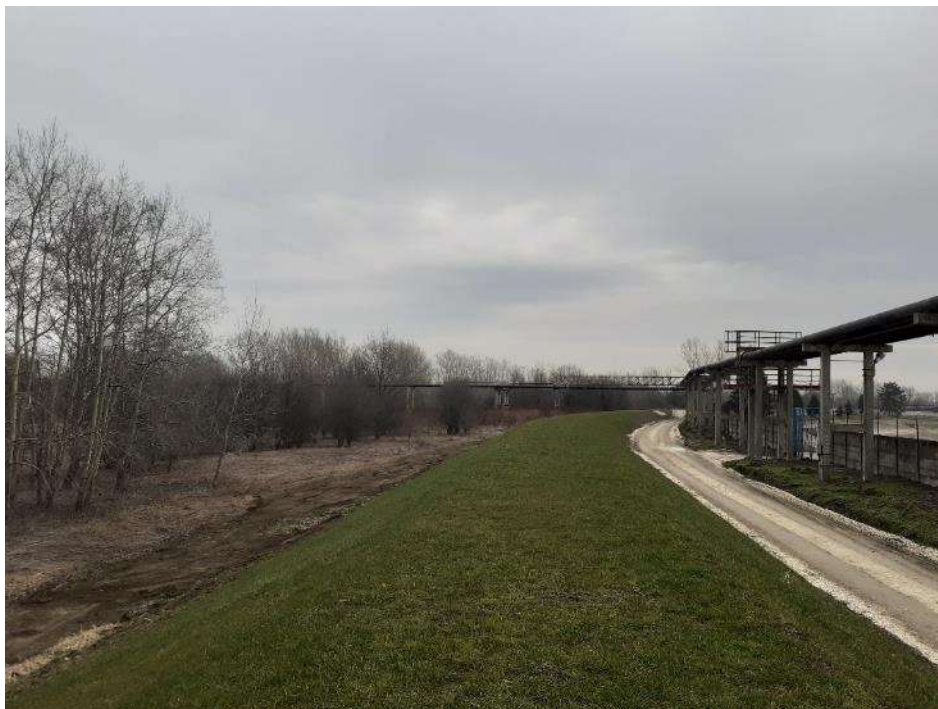
Photo. 15. Left embankment at km approx. 0+600 – grass growth after topsoiling and reclamation of the embankment (2nd decade of February 2023).

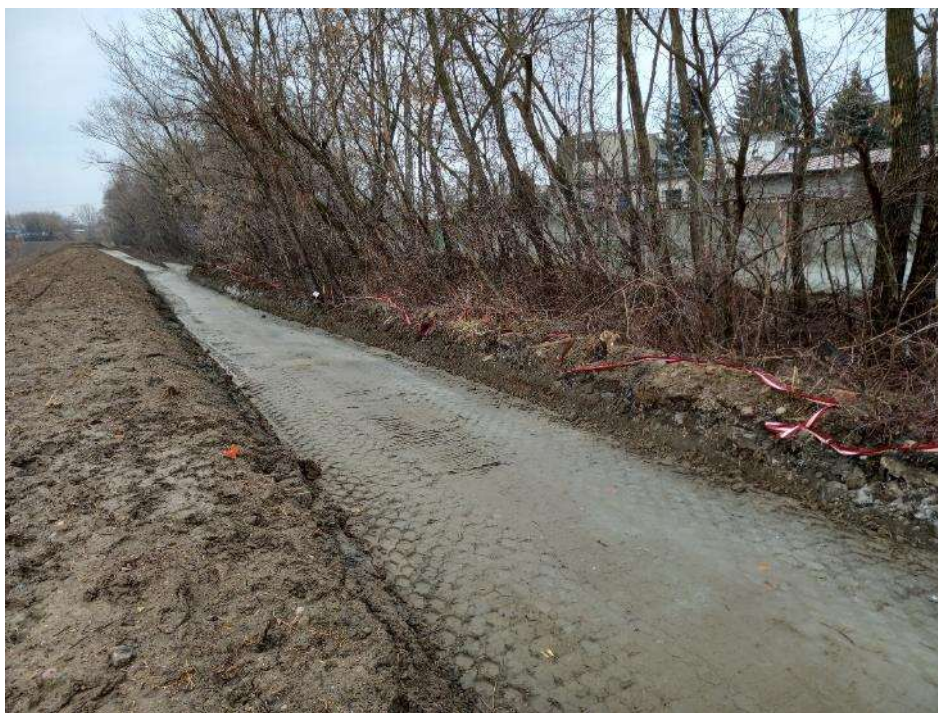
Photo. 16. Right embankment at km approx. 4+500 – works in progress (2nd decade of February 2023).

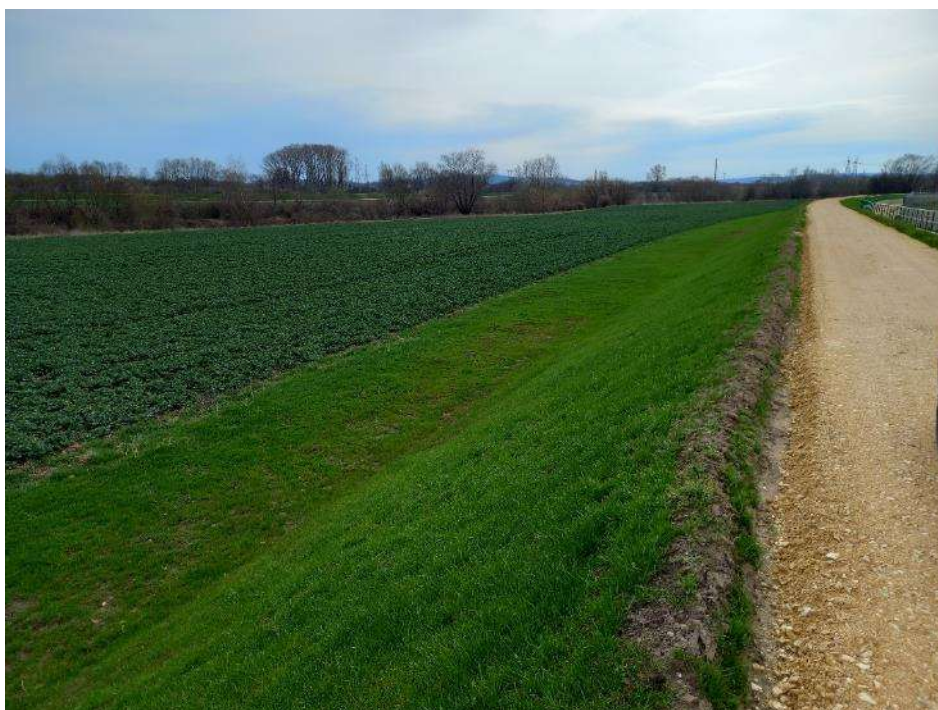
Photo. 17. Left embankment at km approx. 1+300 – grass growth after topsoiling and reclamation of the embankment (3rd decade of March 2023).

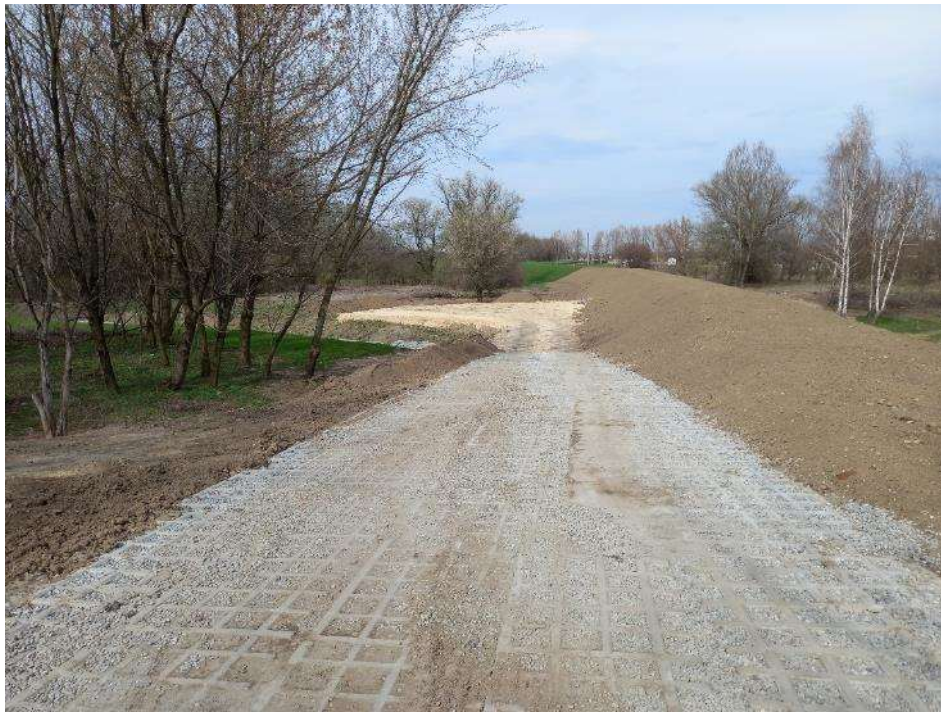
Photo. 18. Right embankment at km approx. 3+150 – reclamation of the site after the completion of works (3rd decade of March 2023).

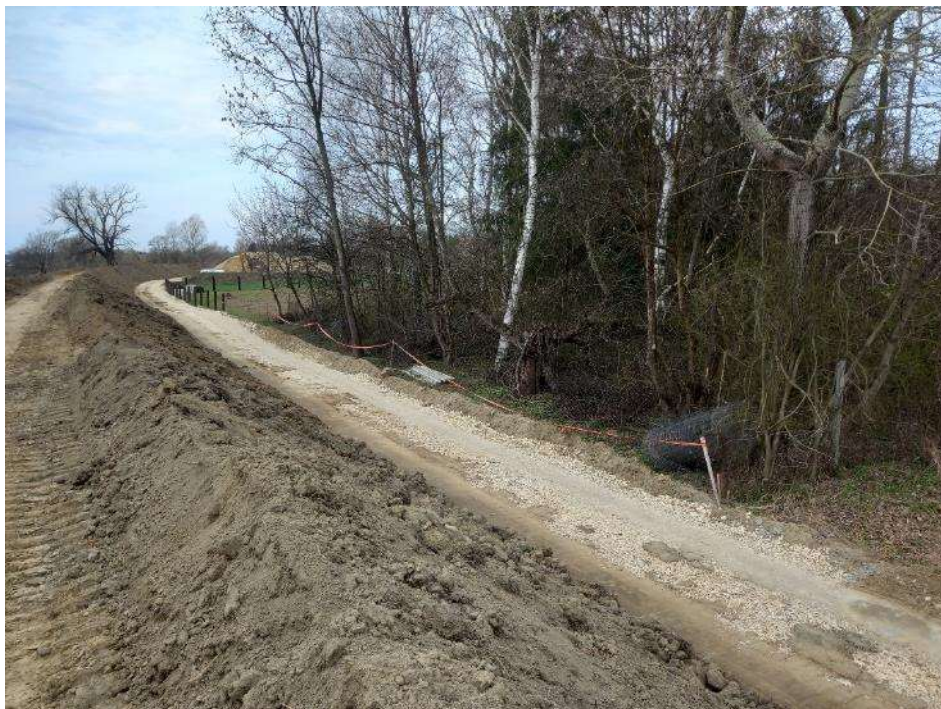
Photo. 19. Right embankment, final section of the embankment – works in progress (3rd decade of March 2023).

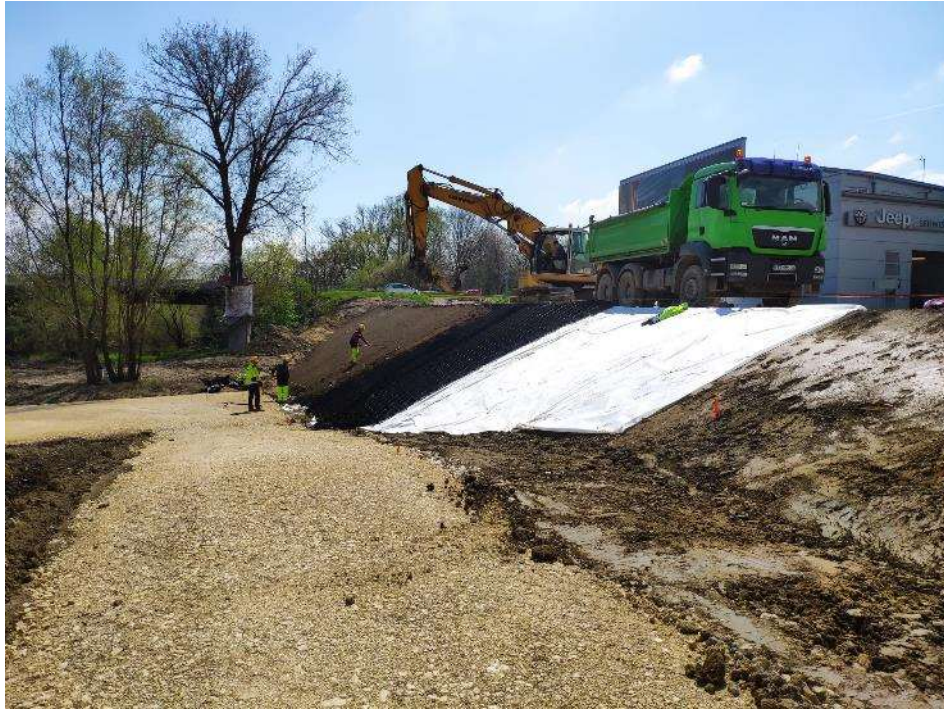
Photo. 20. Left embankment at km approx. 6+000 – topsoiling and reclamation of the embankment (2nd decade of April 2023).

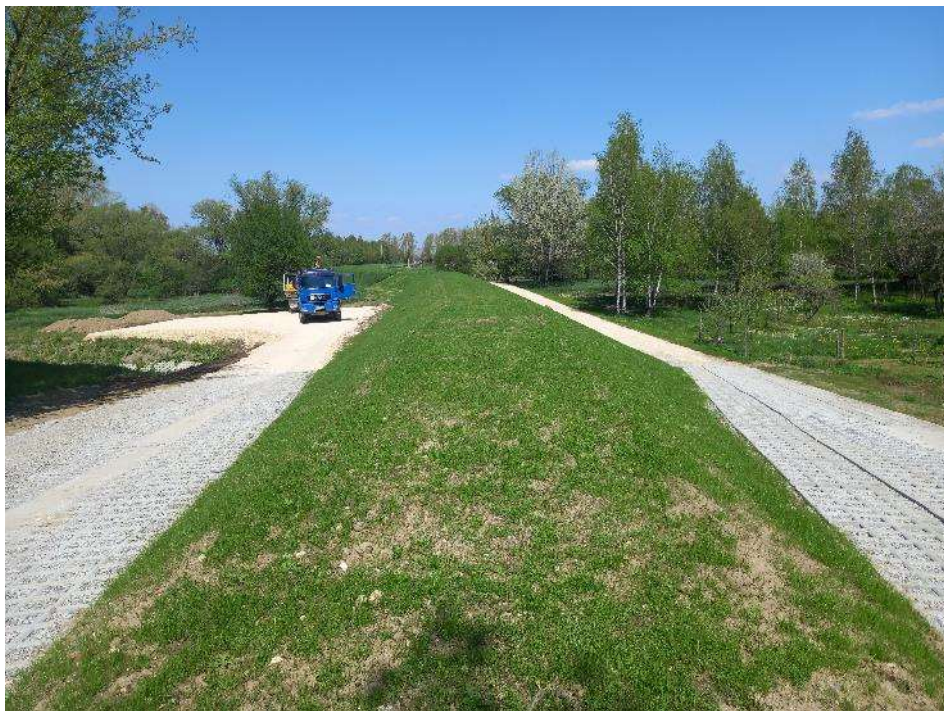
Photo. 21. Right embankment at km approx. 3+150 – site reclamation (3rd decade of April 2023).

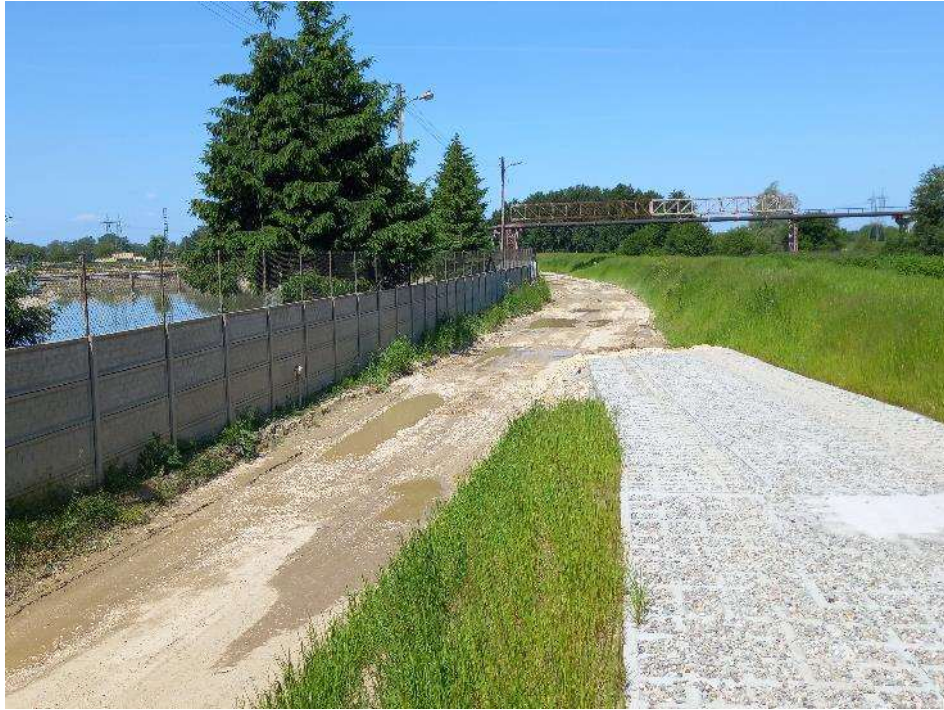
Photo. 22. Left embankment at km approx. 1+000 – site after the completion of works (May 2023).

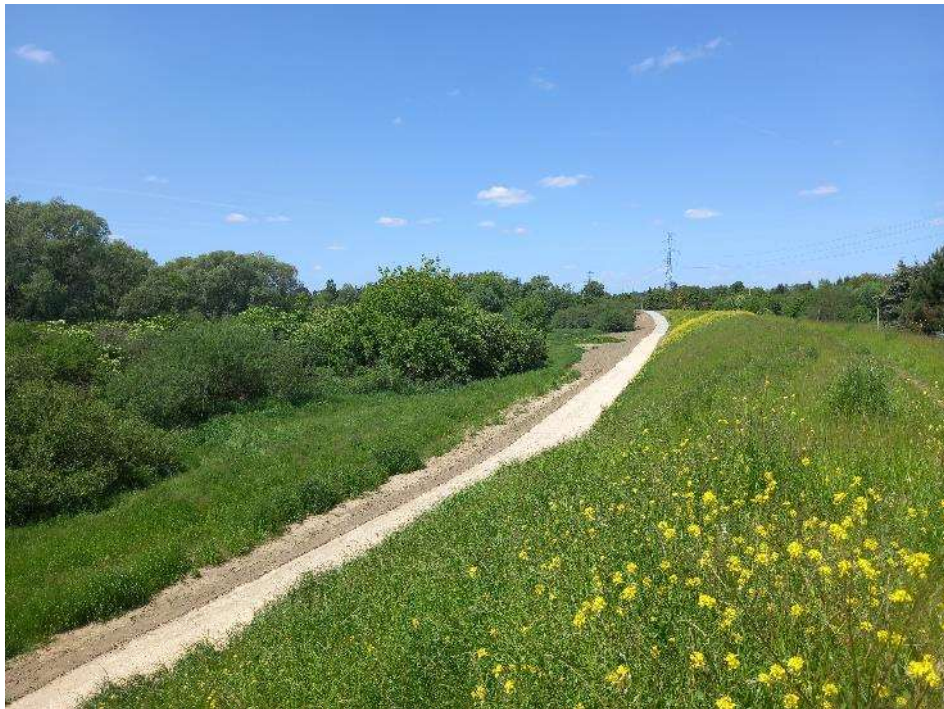
Photo. 23. Right embankment at km approx. 5+700 – site after the completion of works (May 2023).

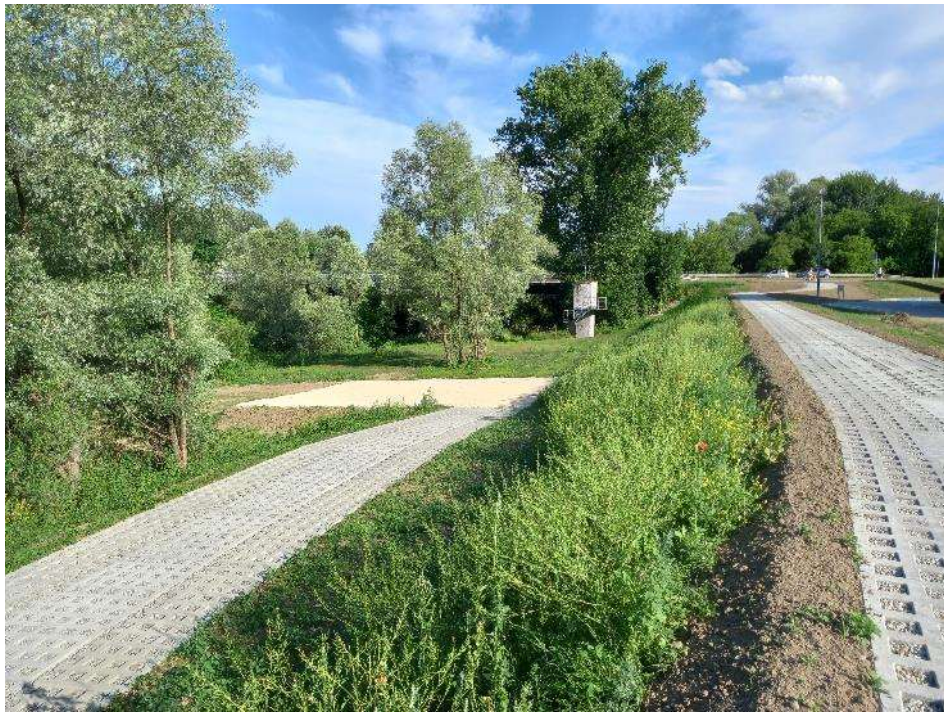
Photo. 24. Left embankment at km approx. 6+000 – site after the completion of works (June 2023).

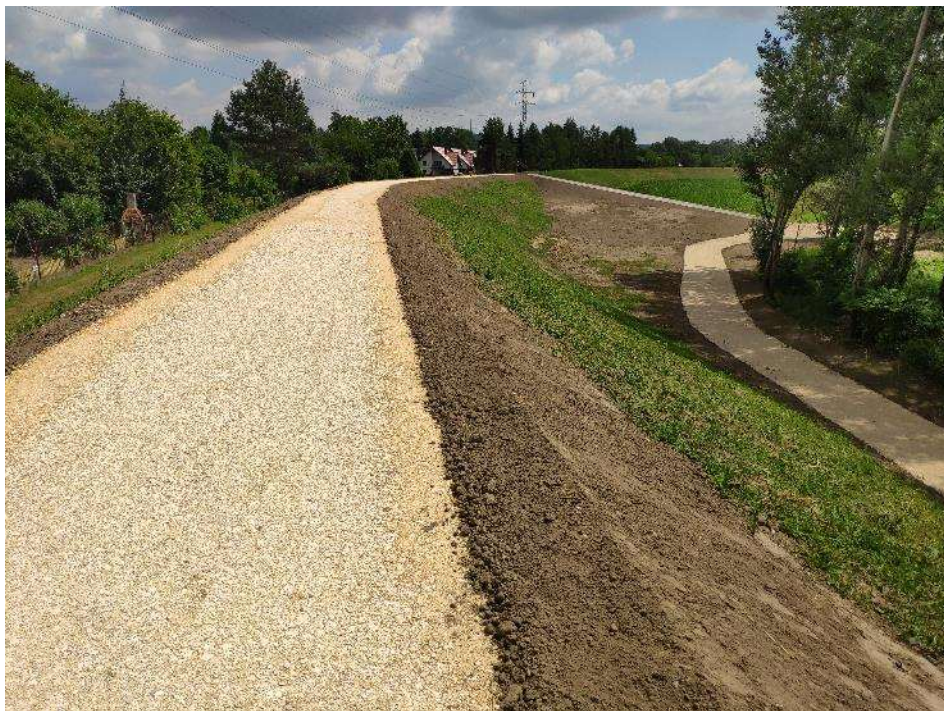
Photo. 25. Right embankment at km approx. 6+000 – site after the completion of works (3rd decade of June 2023).
