STATE COMMISSION ON RAILWAY ACCIDENTS INVESTIGATION
Ministry of the Interior and Administration

REPORT No. PKBWK 02/2025

on the investigation of a railway accident that occurred on 5 October 2023 at 7:00 a.m.
at Gdynia Główna station, track No. 5, turnout No. 45, km 21.522 of railway line
No. 202 Gdańsk Główny – Stargard
area of the infrastructure operator PKP Polskie Linie Kolejowe S.A. Maintenance-of-Way Department
in Gdynia

WARSAW, 25 February 2025

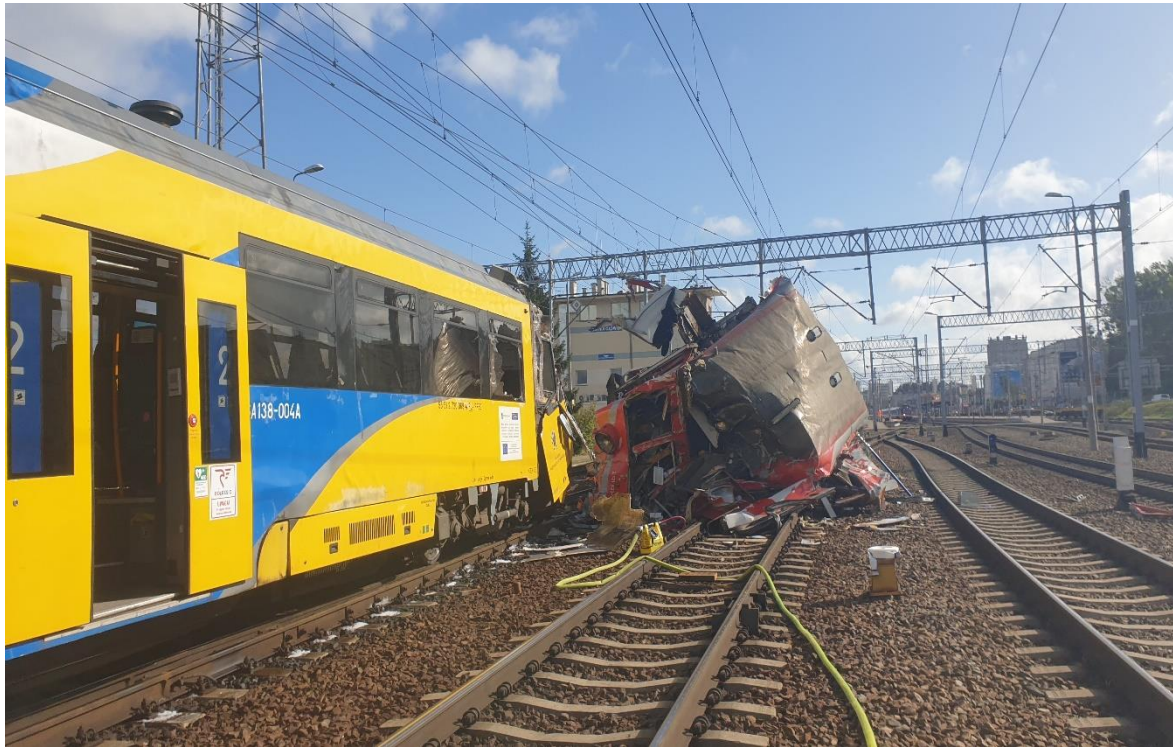
Photo 1 – The site of the occurrence (source: PKBWK documentation)

Car (ra) of the EN57-1248 rail vehicle was completely destroyed and derailed, and car (s) was damaged. The cab of car A of rail vehicle SA138-004 was crushed.

Elements of railway infrastructure at the Gdynia Główna station were damaged.

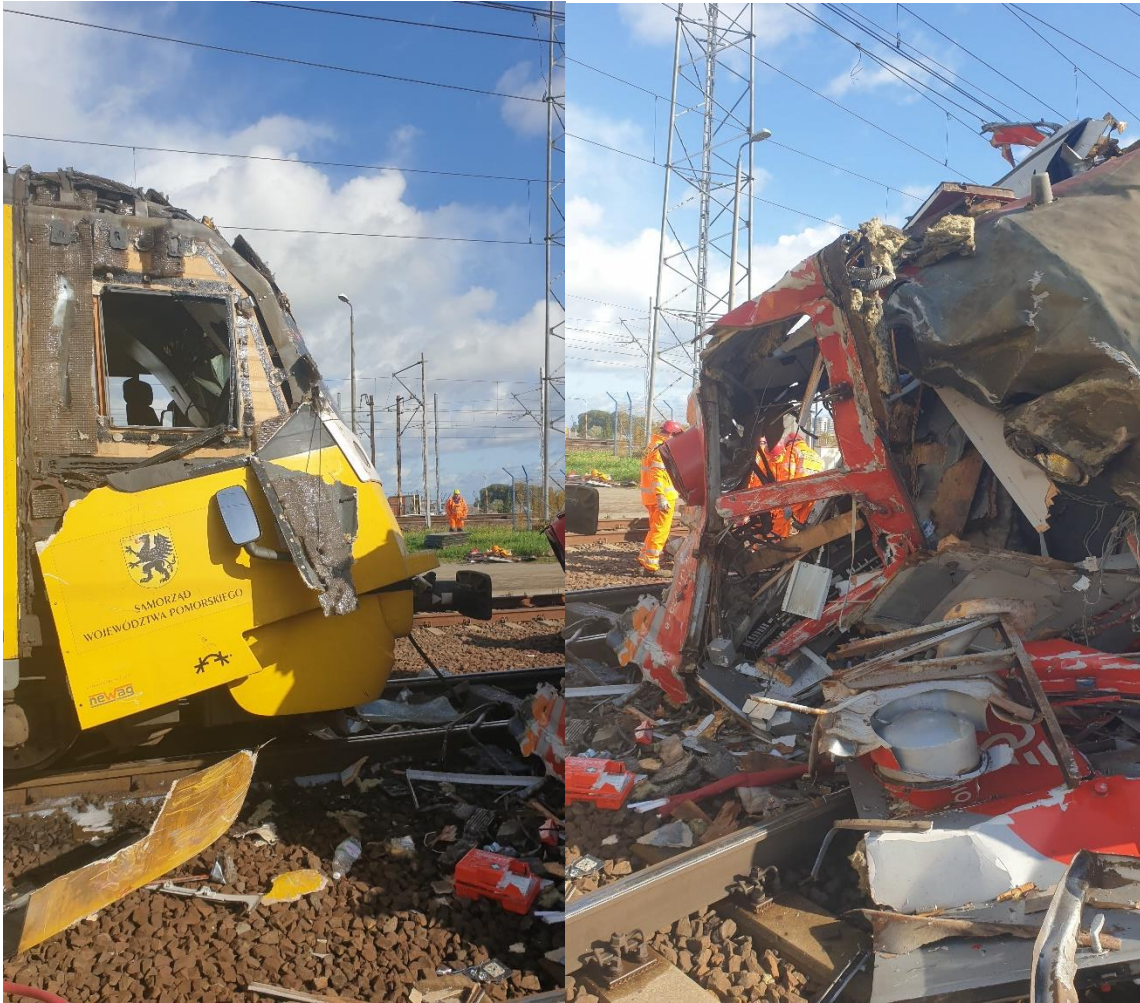
Photo 4 – Damage to rail vehicles after the occurrence (source: PKBWK)

- EN57-1248ra: damaged frame, damaged wheelsets, damaged bogie frames, damaged lead coupler, damaged inter-car coupler, completely destroyed driver's cab and car structure, numerous dents in side wall plating,
- EN57-1248s: damaged frame, damaged wheelsets, damaged bogie frames, dented frame (from the direction of the ra car), bumper plate pressed into the frame, damaged bumper and bumper plate, damaged inter-car coupler (connecting cars s and rb), dented car body plating (right side from the direction of the ra car), dented wall from the direction of the inter-car door, dented wall from the direction of the windows inside the car,
- EN57-1248rb: damaged frame, damaged wheelsets, damaged bogie frames, damaged inter-car coupler (connecting cars s and rb).

SA138-004 railbus, segment A: damaged driver's cab structure, damaged draw and buffer gear, damaged pneumatic half couplings, damaged driver's console, damaged cab heaters, damaged windscreen, damaged side windows, damaged headlights, damaged electrical cabinet, damaged air-conditioning unit and air-conditioning ducts, damaged floor, damaged segment structure, damaged external plating, damaged two pairs of automatic doors, damaged window panes.

POLREGIO S.A. has decided to remove the EN57-1248 vehicle from its inventory, with its final destination being physical liquidation. The SA138-004 railbus, in order to restore the technical performance of the rolling stock unit, was qualified for emergency repair in its entirety.

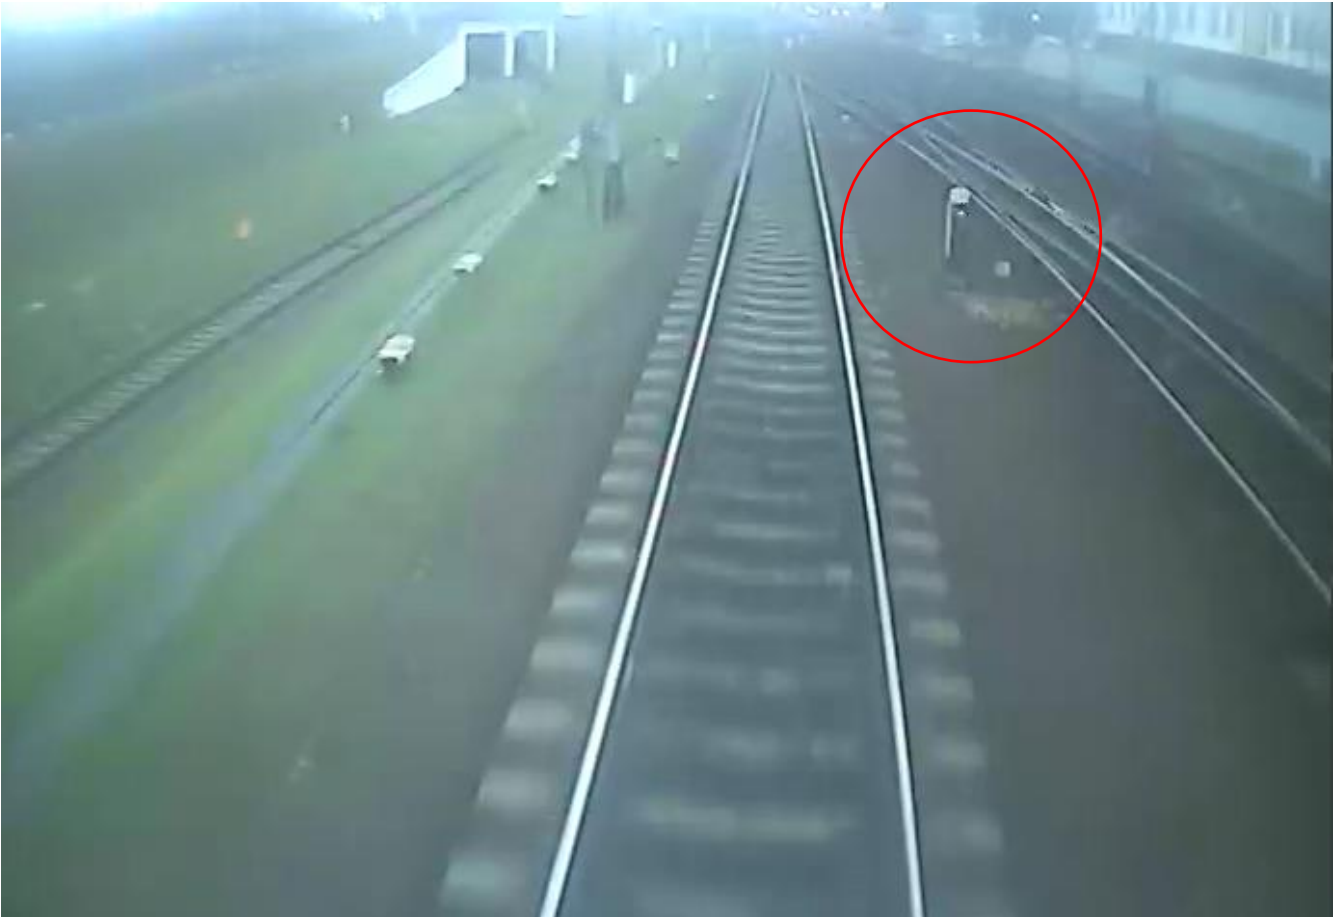
Photo 6 – View from the railbus of the shunt signal Tm30 displaying the Ms1 aspect (source: POLREGIO S.A.)

- 07:00:04 a.m. – the railbus runs past shunt signal Tm30 displaying aspect Ms1;

In accordance with the provisions of the aforementioned instruction, railway safety depends on the visual observation of routes, signals and obstacles and the use of safe running speed depending on the conditions. In this case, the shunting speed should have been 25 km/h but was exceeded and was 39.5 km/h. According to the Investigation Team, adhering to the permitted shunting speed of the railbus, a maximum of 25 km/h, would increase its travel time by about 60 s. Extending the running time could make it possible to avoid the collision or reduce its consequences, even if the SA138-004 rail vehicle had run past the Tm30 shunt signal and onto the switch of turnout No. 64, not aligned with the vehicle’s direction of travel.

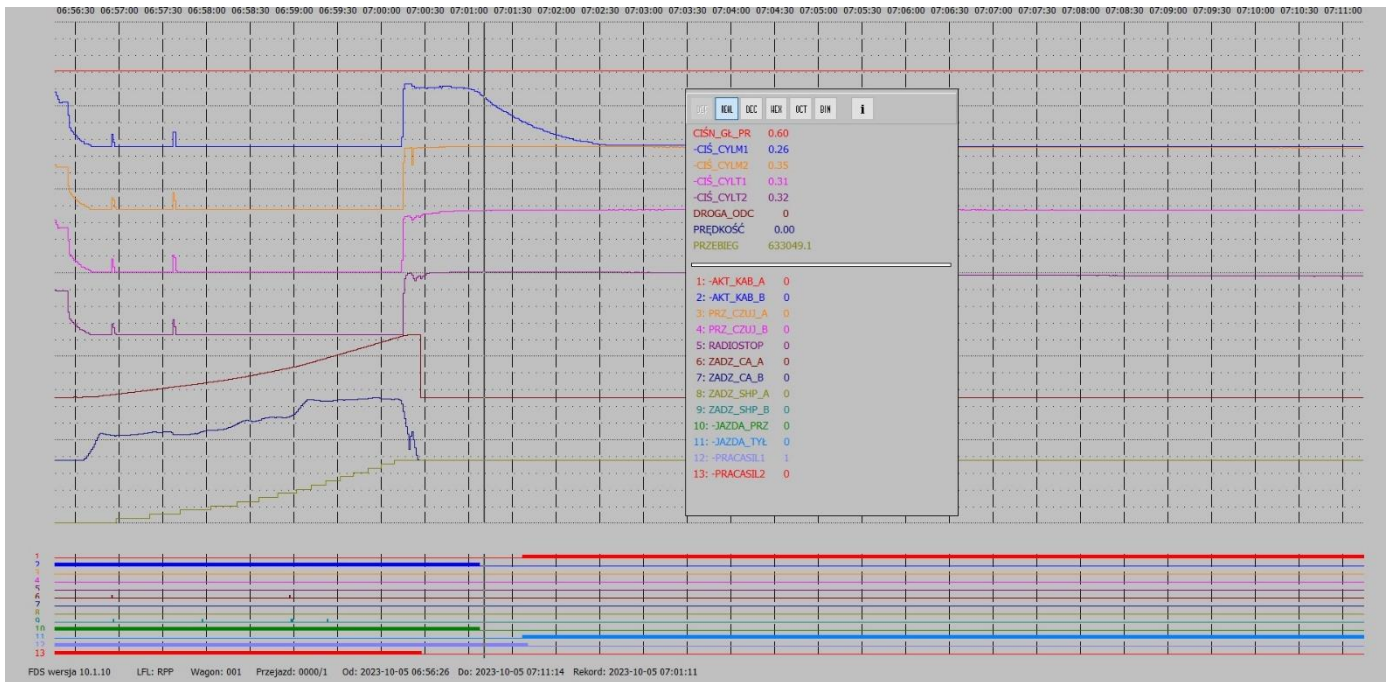
Figure 3 – Diagram of the running data of the SA138-004 rail vehicle (prepared by PKBWK)

The above irregularities, in the opinion of the Investigation Team, may be due to missing or incorrectly connected cables feeding signals from individual devices to the recorder.

- 3) The carrier POLREGIO S.A. will ensure that the running data of powered rail vehicles are correctly recorded in accordance with the real state.
- 4) Railway carriers shall include in their internal rules the need to carry out periodic inspections of the on-board recorders of rail vehicles to the extent and within the periods of time recommended by the manufacturers of the recorders and covering, in particular, the correct recording of the actual operating state of the vehicle. Inspections should be carried out by the recorder manufacturers or entities authorised by the manufacturers.

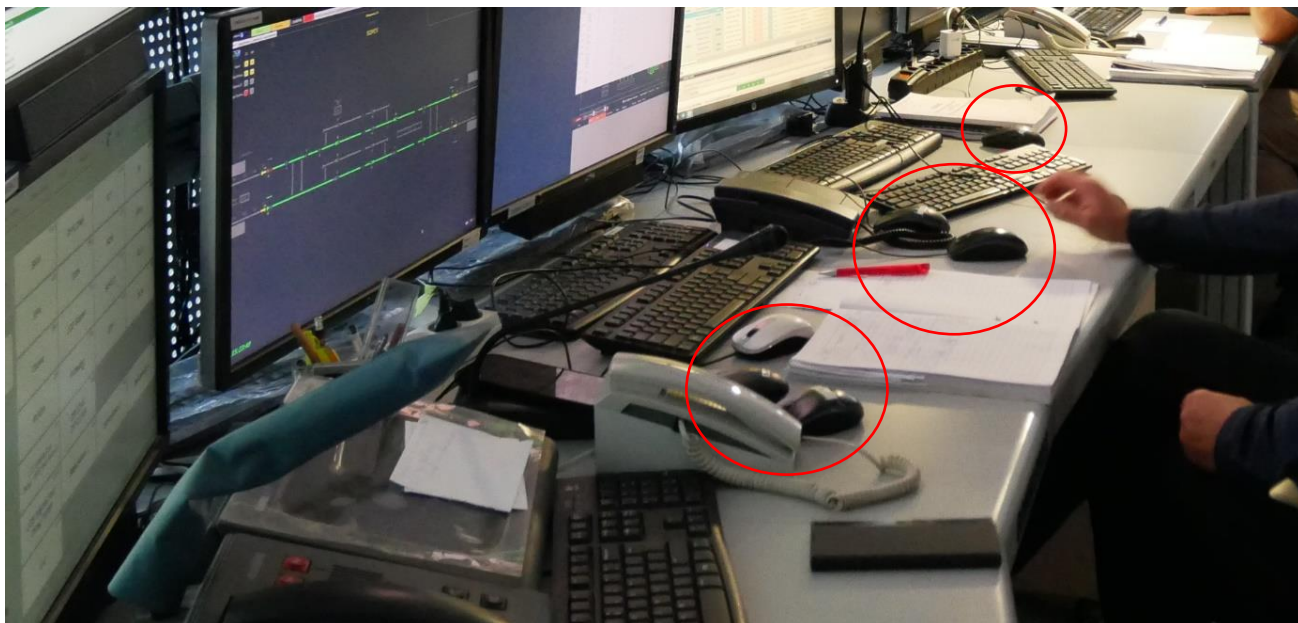
Photo 12 – LCS GO operator's station (materials of PKBWK)

Additionally, the traffic operator at the operator station operates the equipment using several mice with the same appearance and profile, but only one mouse, not marked in any special way, is intended for the operation of the radio communication system and can be used to transmit, in particular, the “ALARM” signal.

- 9) Failure to label computer mice used to operate the radio communication system.
- 10) Improper transmission of train radio messages by the LCS GO traffic operator, not in accordance with the radiogram patterns.

- 6) Infrastructure operator PKP Polskie Linie Kolejowe S.A. will undertake actions aimed at the elimination of irregularities found by the Investigation Team in the course of the investigation, and included in section V.3(6–10).

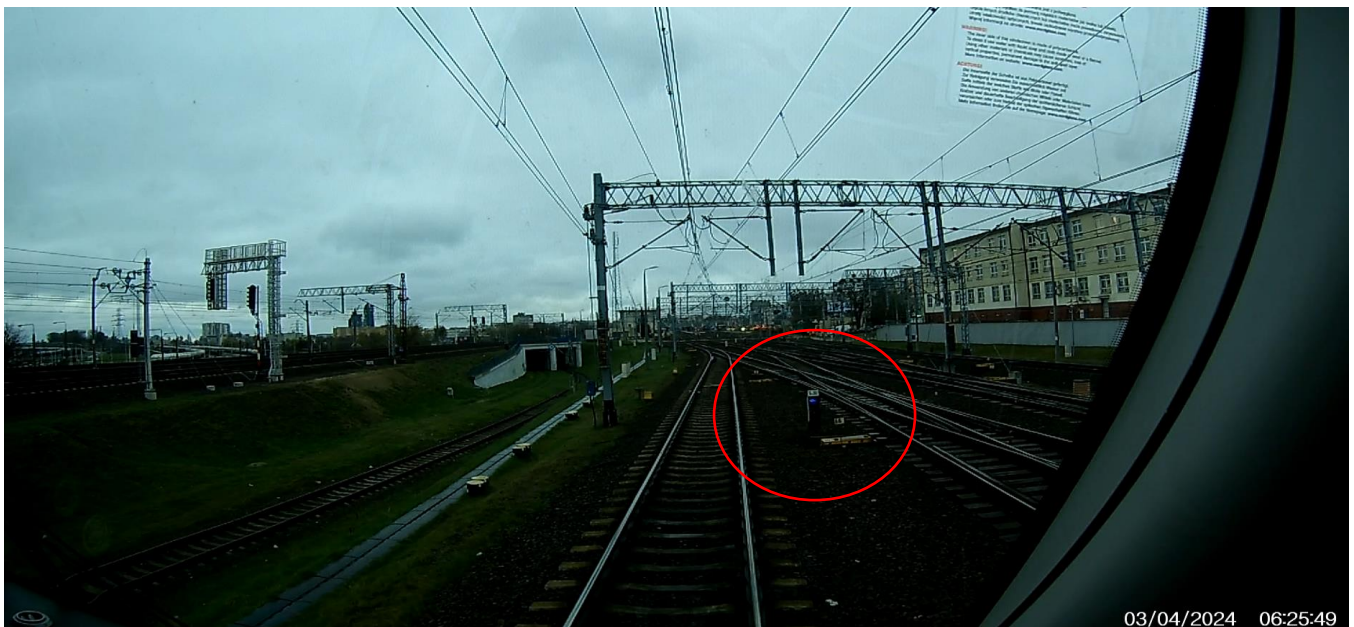
Photo 13 – Visibility of the shunt signal Tm30 displaying signal Ms1. (PKBWK materials)

- 8) Limited ability to recognise the signals displayed in the daytime by the dwarf shunt signal Tm30 in sunny weather.
