**STATE COMMISSION ON RAILWAY ACCIDENT INVESTIGATION**  
**Ministry of the Interior and Administration**

**REPORT No. PKBWK 3/2025**

**on the investigation of a serious railway accident**  
**that occurred on 3 December 2023 at 10:06 hrs at Jaszczów station**  
**at turnout no. 1 on track 1, at km 201.000 of railway line no. 7**  
**Warszawa Wschodnia Osobowa - Dorohusk,**  
the area of infrastructure manager PKP PLK S.A. Railway Line Plant in Lublin

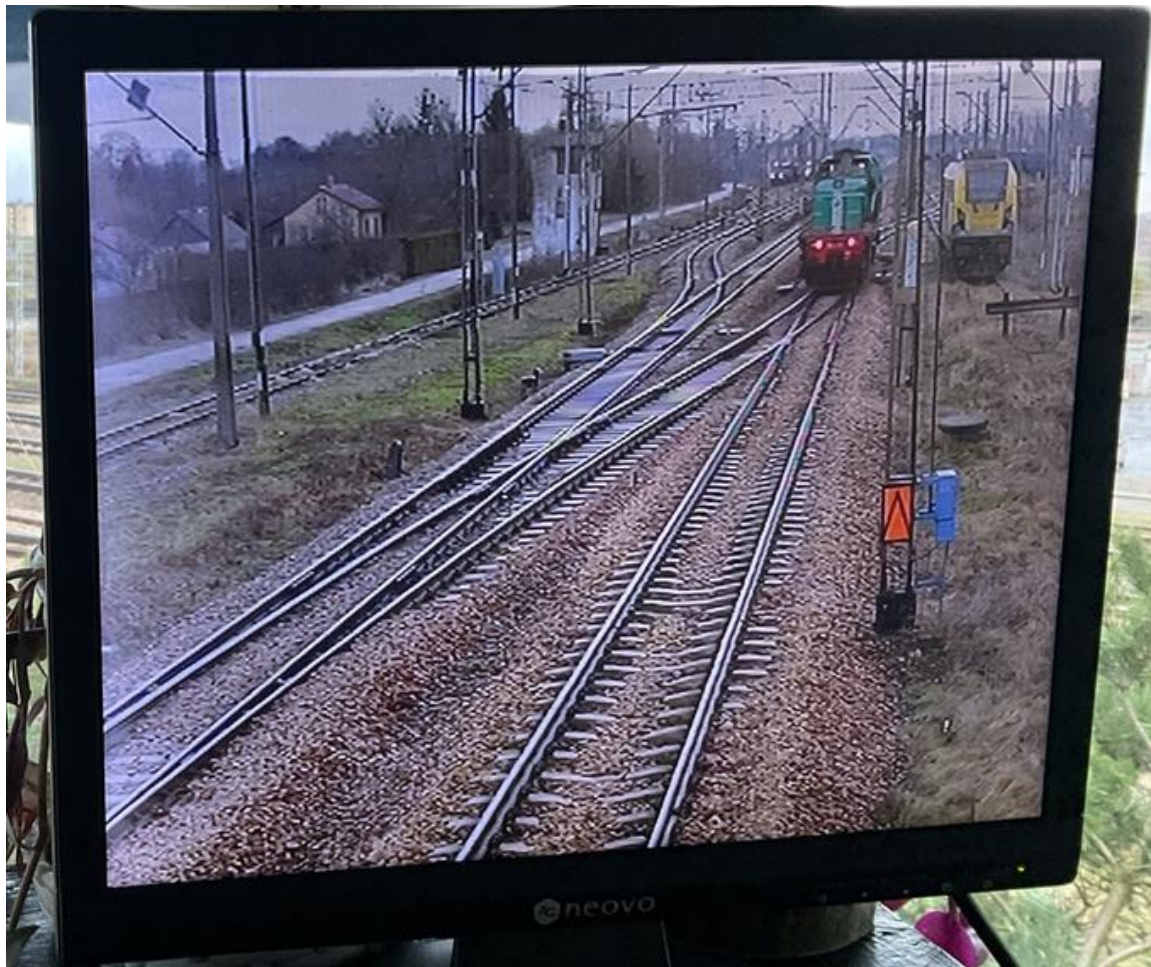
The turnout switch is fitted with an EEA-5 type switch drive. The switch has switch blade control and track occupancy detection, and is electrically heated. A camera is installed at the station at km 201.040 at track 1, and the command box "Jw" has a CCTV monitor for determining the end of trains entering the station from the direction of Minkowice station. The camera does not monitor turnouts no. 1 and 2, where the workers were performing snow clearance.

**Photograph 1** - The signaller's view of turnouts no. 3, 4 and 5.

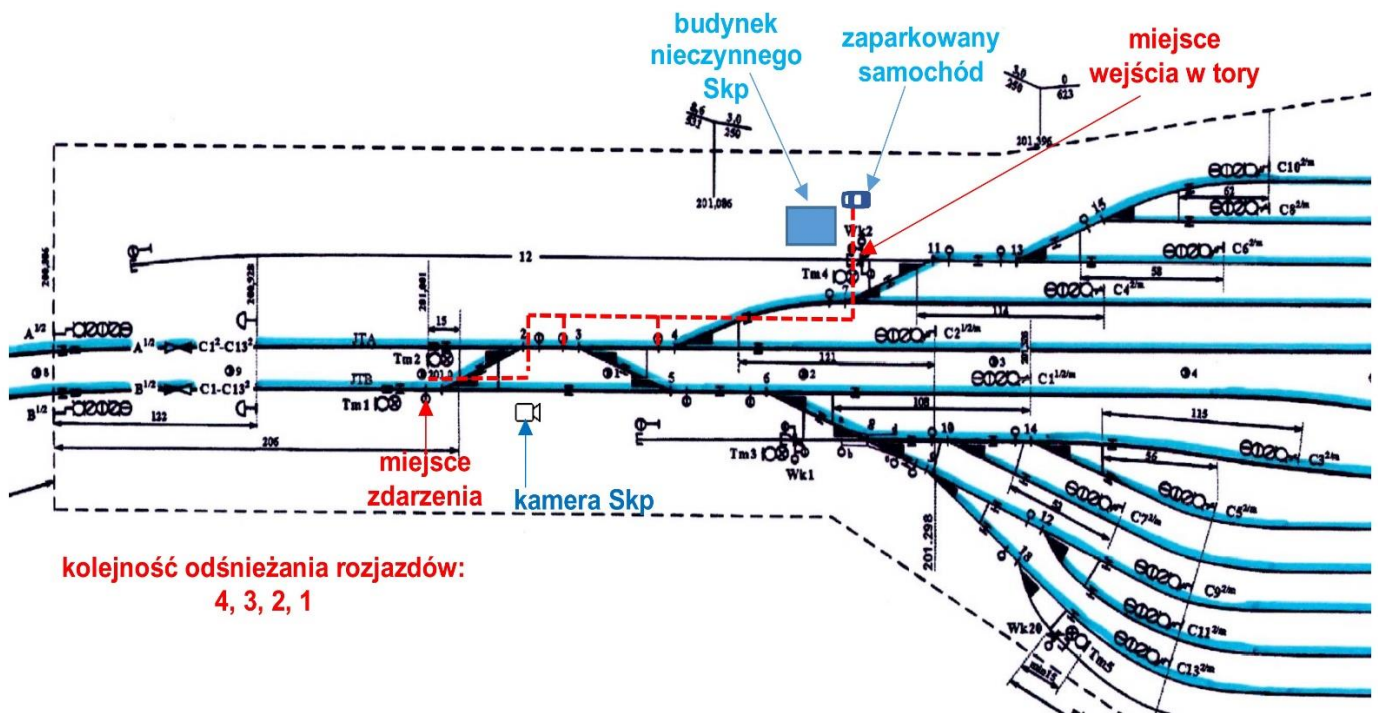
After starting the blower, all three workers made for turnout no. 4 on the intertrack space of tracks 2 and 12. The blower was operated by the specialist craftsman who was blowing snow from the switch section of the turnout, while the switchman was brushing off the channel and setting-up closure. The automation foreman was standing on the side and watching the works at the turnout. Not satisfied with the results, he personally took over the operation of the blower and proceeded to clearing turnouts no. 3 and 2 on track two of snow. Then the automation master with the blower and the specialist craftsman made for turnout no. 1 on track one, and the switchman remained at turnout no. 2 on track two, continuing the cleaning.

Figure 3 - The point of entry onto the tracks and marked locations of snow clearance work

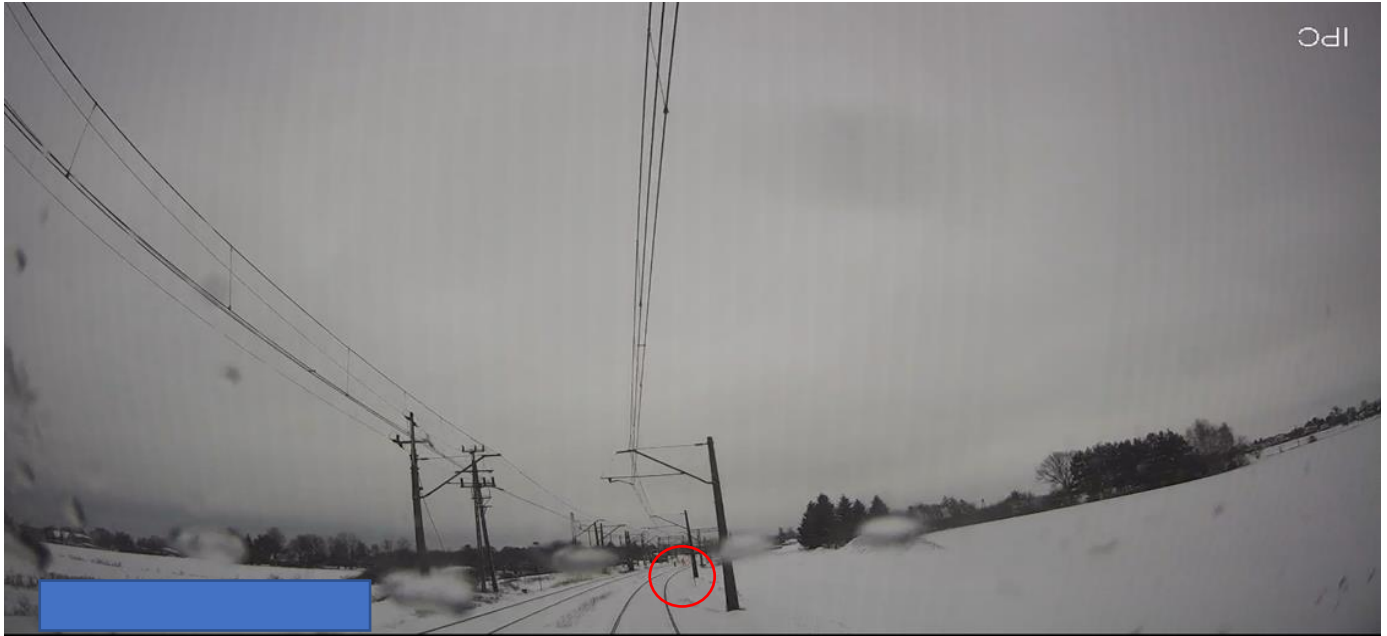
Seeing no reaction from the workers at turnout no. 1, the train driver continued the Rp1 "Attention" signal and implemented emergency braking at 10:05:46 hrs at the speed of 86.75 km/h.

**Photograph 3** - A view of the working group captured by the front camera of SA134-019 (source: POLREGIO S.A.)

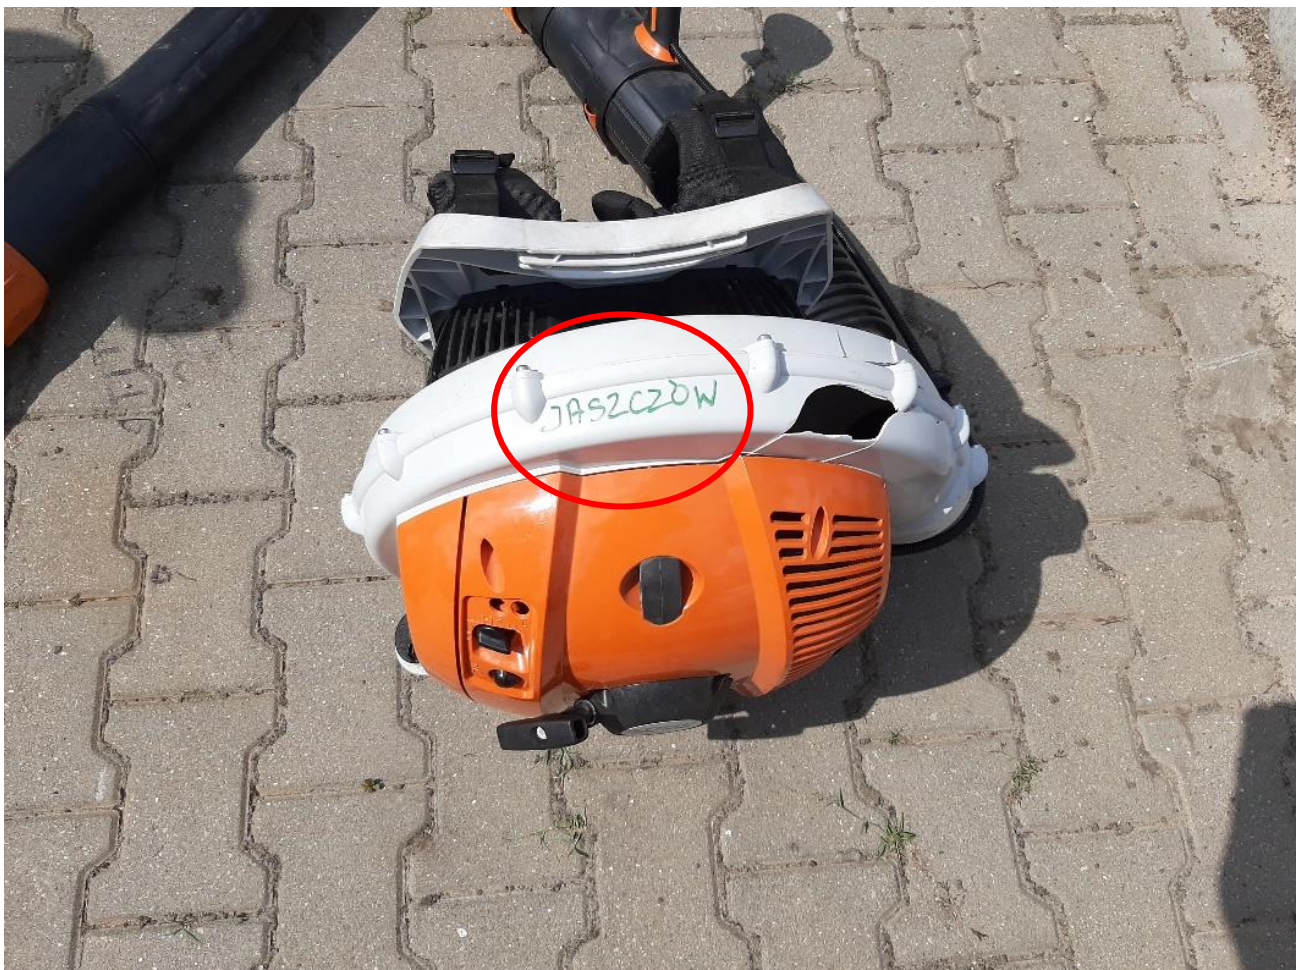
The workers carrying out works on active tracks that involved de-snowing and de-icing of turnout sections were performing those activities in difficult weather conditions. They wore protective winter clothing, and the automation foreman had a hood pulled over his head. When clearing snow, they used a backpack diesel blower which raised clouds of snow, restricting their visibility, and which was a source of noise in excess of 100 dB, making it impossible for them to hear the sound of an approaching train and the driver's continuous Rp1 "Attention" signal. Although the said equipment had been assigned to the work position, no training or workplace instruction had been provided as regard the operation of the diesel blower.

**Photograph 6** - The diesel blower on the equipped list for the Jaszczów station shelter which was in use on the day of the occurrence (source: PKBWK).

The failure to develop an effective system of mutual communication during snow clearance from turnouts with a backpack diesel blower that produced high-intensity noise was also identified by the Investigation Team as a systemic factor contributing to the occurrence.

1. PKP PLK S.A. shall carry out a risk assessment regarding the use of backpack blowers for snow clearing work.
2. PKP PLK S.A. shall promptly develop and communicate to its subordinate organisational units that use backpack blowers for works on or at railway tracks, a set of requirements concerning safety conditions at work with this type of equipment, and shall enhance supervision of compliance with those requirements.
