**STATE COMMISSION ON RAILWAY ACCIDENT INVESTIGATION**  
**Ministry of the Interior and Administration**

**REPORT No. PKBWK 05/2025**

**on the investigation of a serious railway accident that occurred on 1 July 2024 at 09:19 hrs  
on the Ożarów Mazowiecki - Błonie route, track no. 2, category B level crossing at km  
17.211 of railway line no. 3 Warszawa Zachodnia - Kunowice,  
area of infrastructure operator PKP PLK S.A. Railway Line Plant  
in Warsaw**

**WARSAW, 25 June 2025**

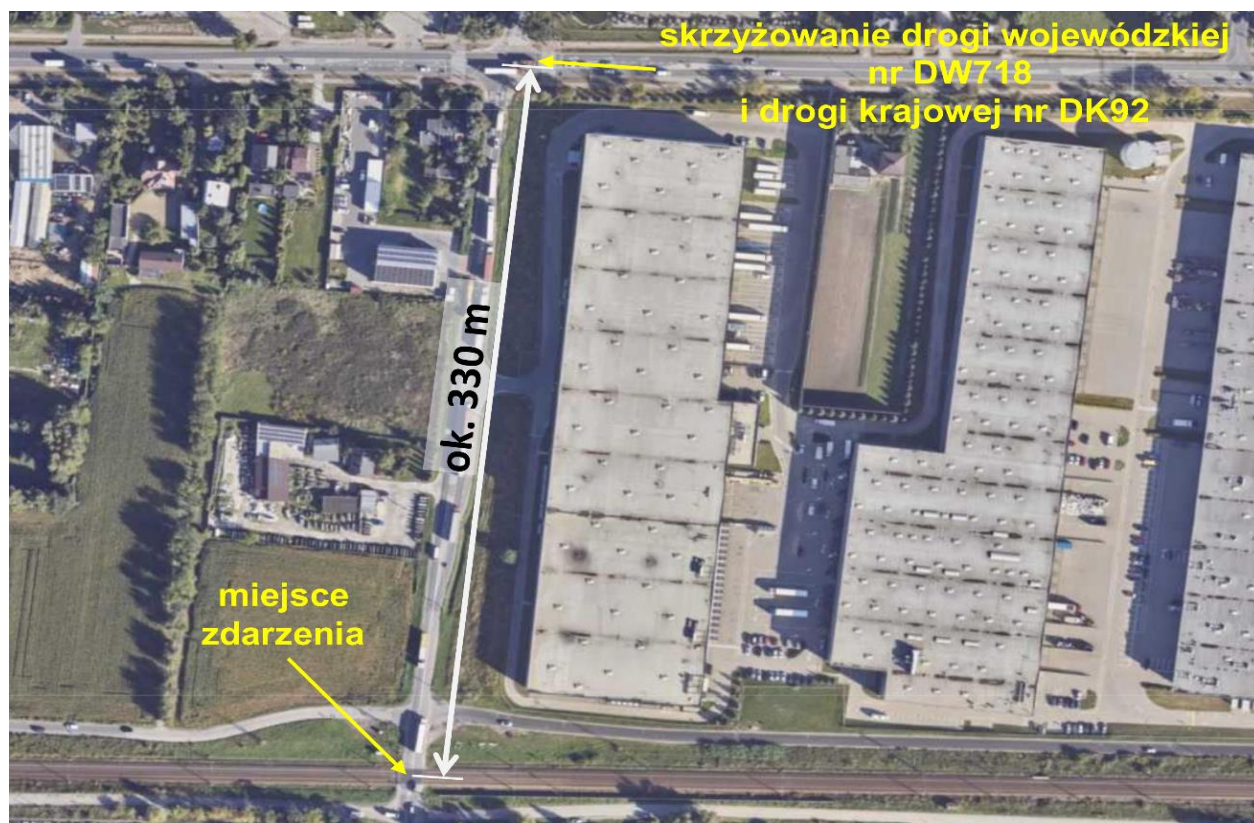
The measures taken after the previous incidents at this crossing were aimed at improving traffic safety at the crossing, but did not address the key cause of the poor traffic organisation in the area of the crossing, generated by the location of road junctions on the roads parallel to the railway line and situated right next to the barrier devices, which constitutes non-compliance with the provisions of the Regulation of the Minister of Infrastructure of 20 October 2015 on the technical conditions to be met by crossings of railway lines and sidings with roads, and on their positioning (design solutions within the crossing to ensure efficient exit of road vehicles from the crossing (Journal of Laws, item 1744, as amended).

Figure 2 - Location of the crossing relative to the junction of DW718 and DK92 (source: Geoportal)

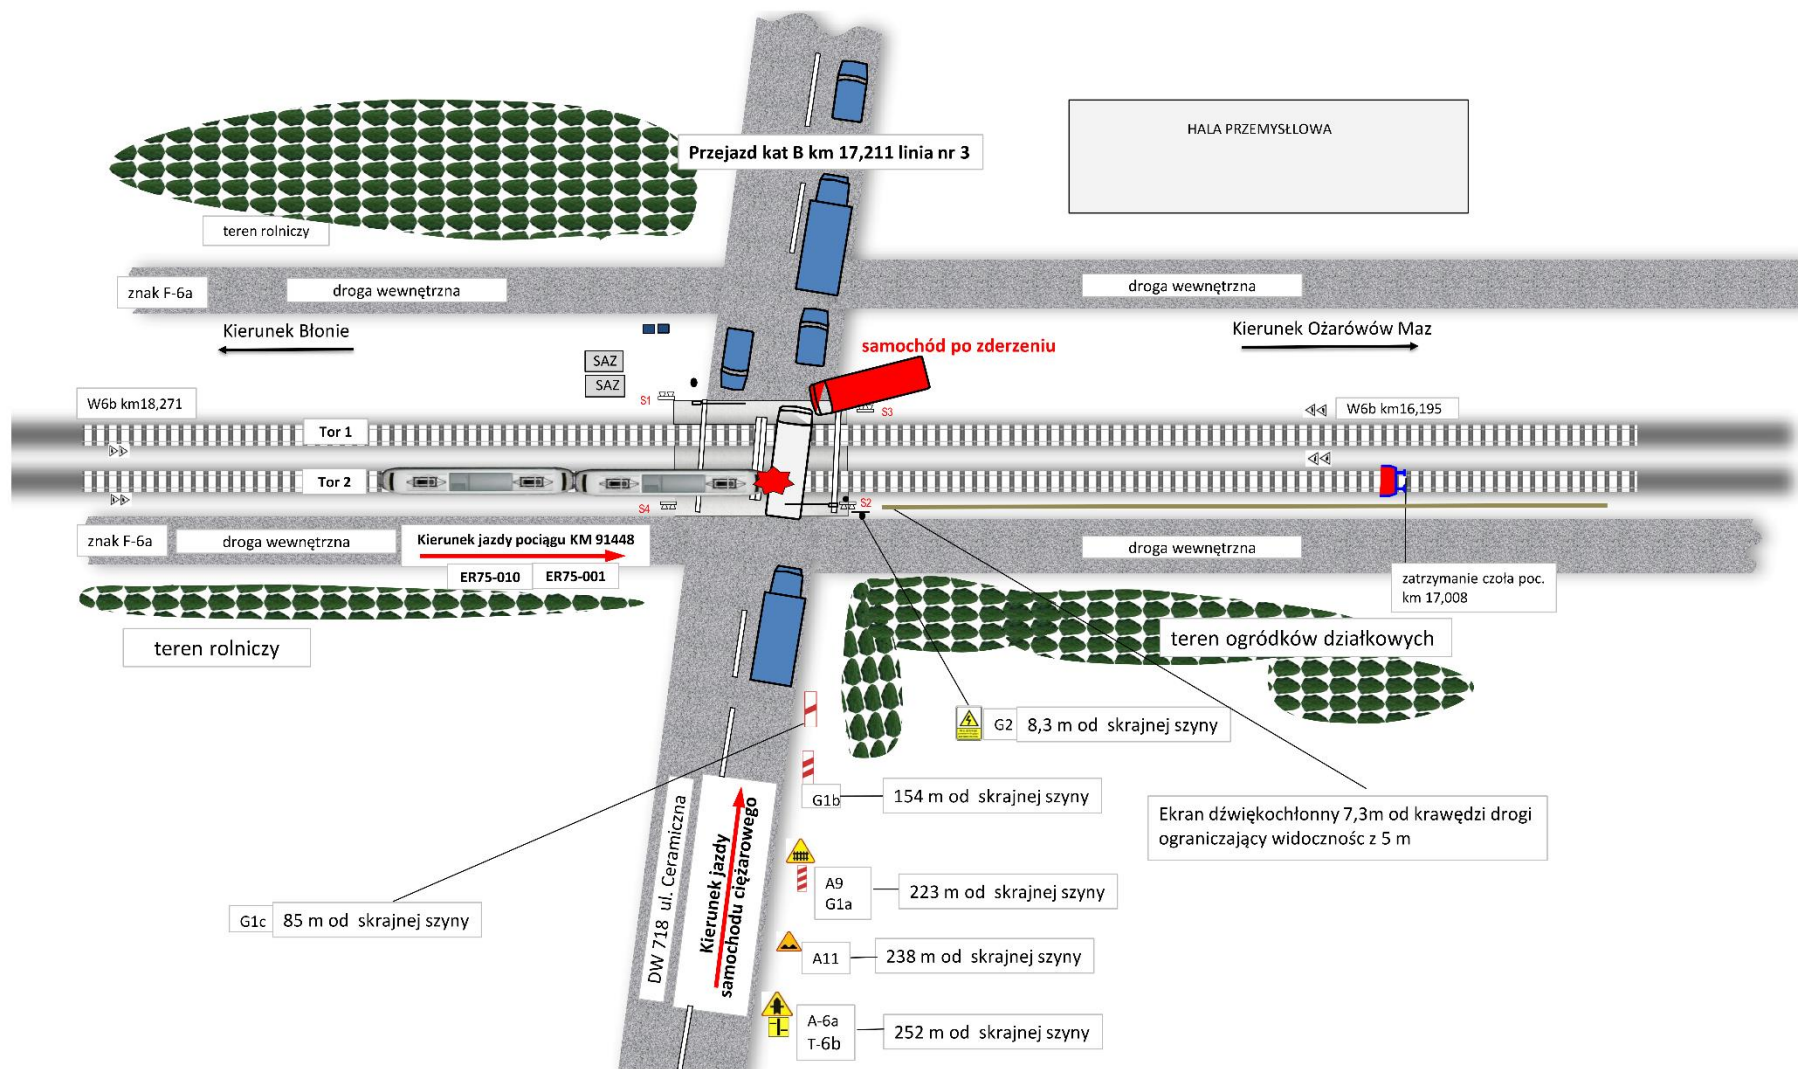
Figure 3 - Sketch drawing of the serious accident

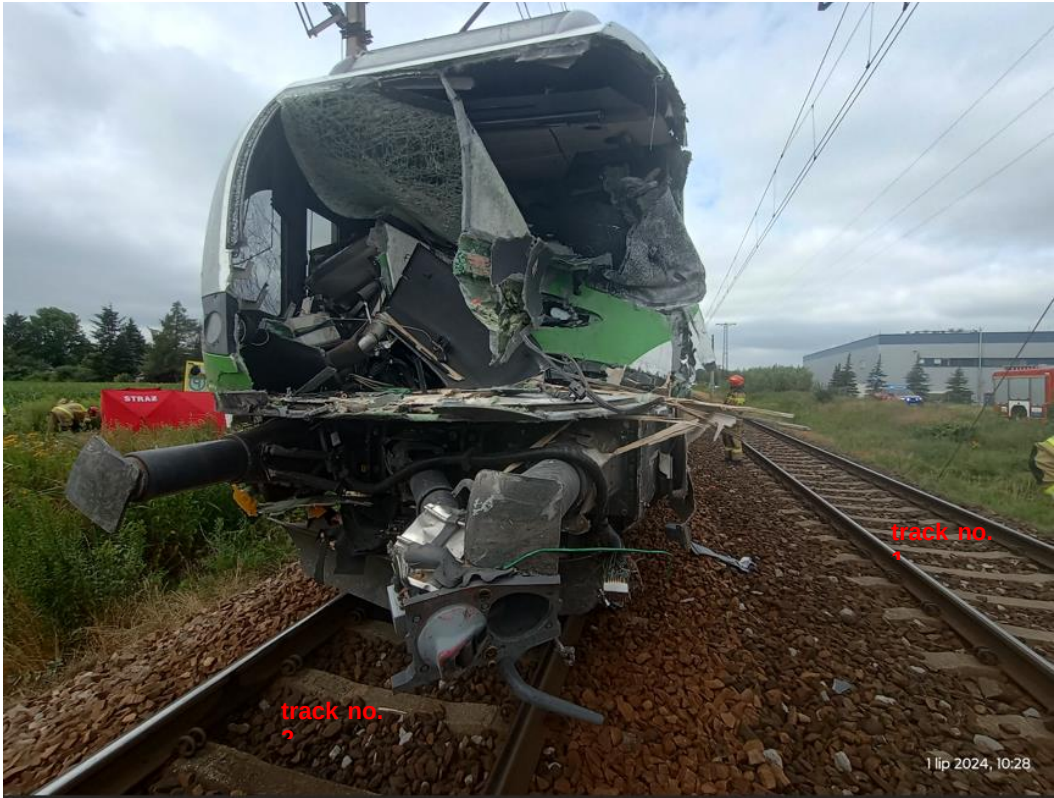
Train 91448 was not derailed. The collision resulted in very significant damage to rail vehicle ER75-001, namely:

- completely destroyed front cabin of the A section, including skin and windscreen,
- destroyed automatic coupling,
- destroyed front information display,
- destroyed two front bumpers,
- damaged side body of the vehicle,
- damaged bogies of the A section,
- damaged recorders,
- damage to the A section body frame.

Photograph 6 - View of the damaged front wall of railway vehicle ER75-001 (source: KM)
