STATE COMMISSION ON RAILWAY ACCIDENT INVESTIGATION
Ministry of the Interior and Administration

REPORT No. PKBWK 04/2025

**on the investigation of a railway accident
that occurred on 1 May 2024 at 10:34 hrs
at Rudna Gwizdanów station, on track 1 on turnout no. 2,
at km 38.973 of railway line no. 289 Legnica - Rudna Gwizdanów**

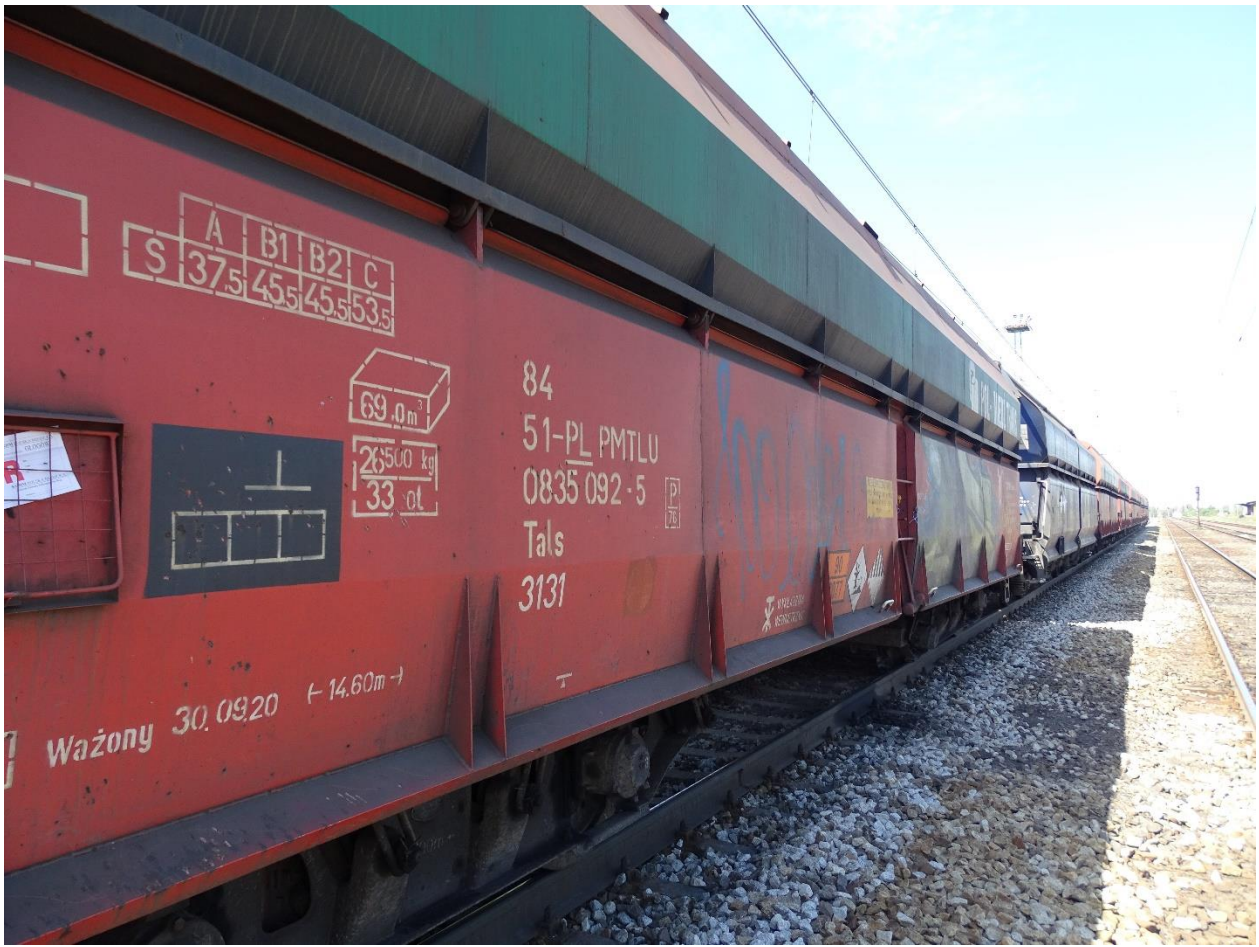
Photograph 1 - A view of the wagon with the fractured axle following the accident (source: materials provided by the railway commission)

The accident involved a derailment of a loaded Tals type wagon No. 84 51 0835 092-5, the ninth wagon in freight train TME 664015 operated by carrier POL-MIEDŹ TRANS Sp. z o.o., as a result of a fracture of the axle of the second wheel set in the first bogie. Furthermore, five freight wagons were derailed, i.e. the tenth, fourteenth, fifteenth, sixteenth and seventeenth wagons behind the locomotive.

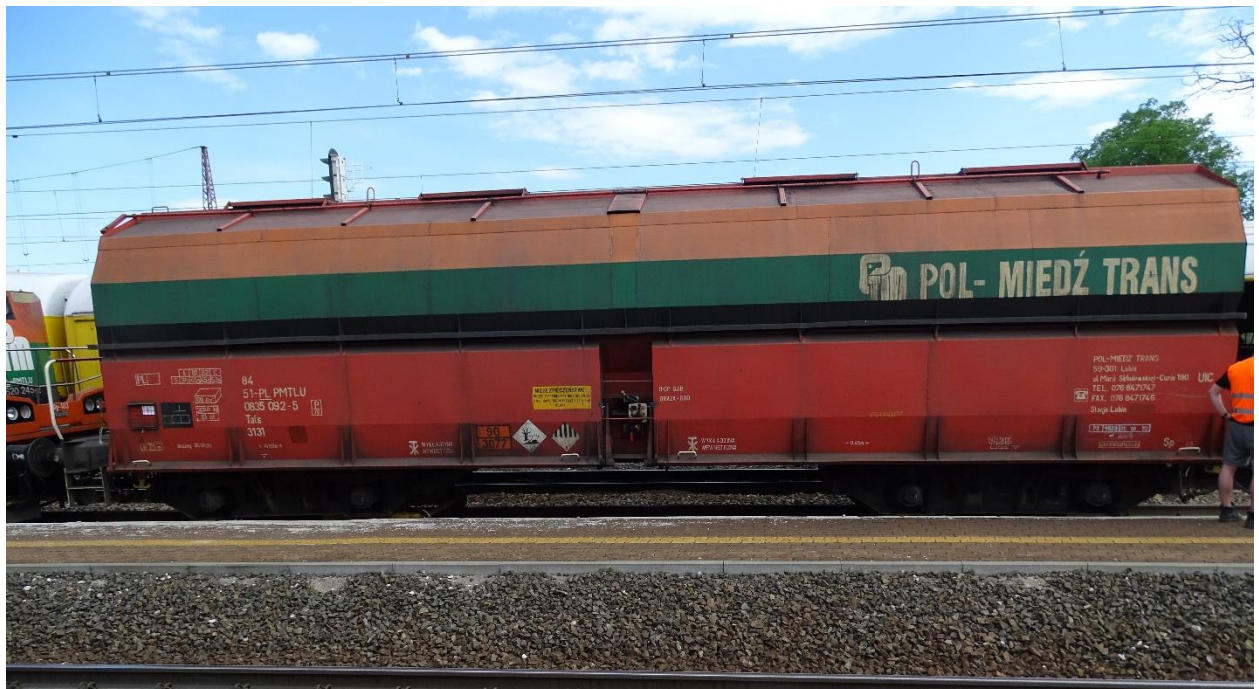
Photograph 2 - A view of the wagon with the fractured axle following the accident (source: materials provided by the railway commission)

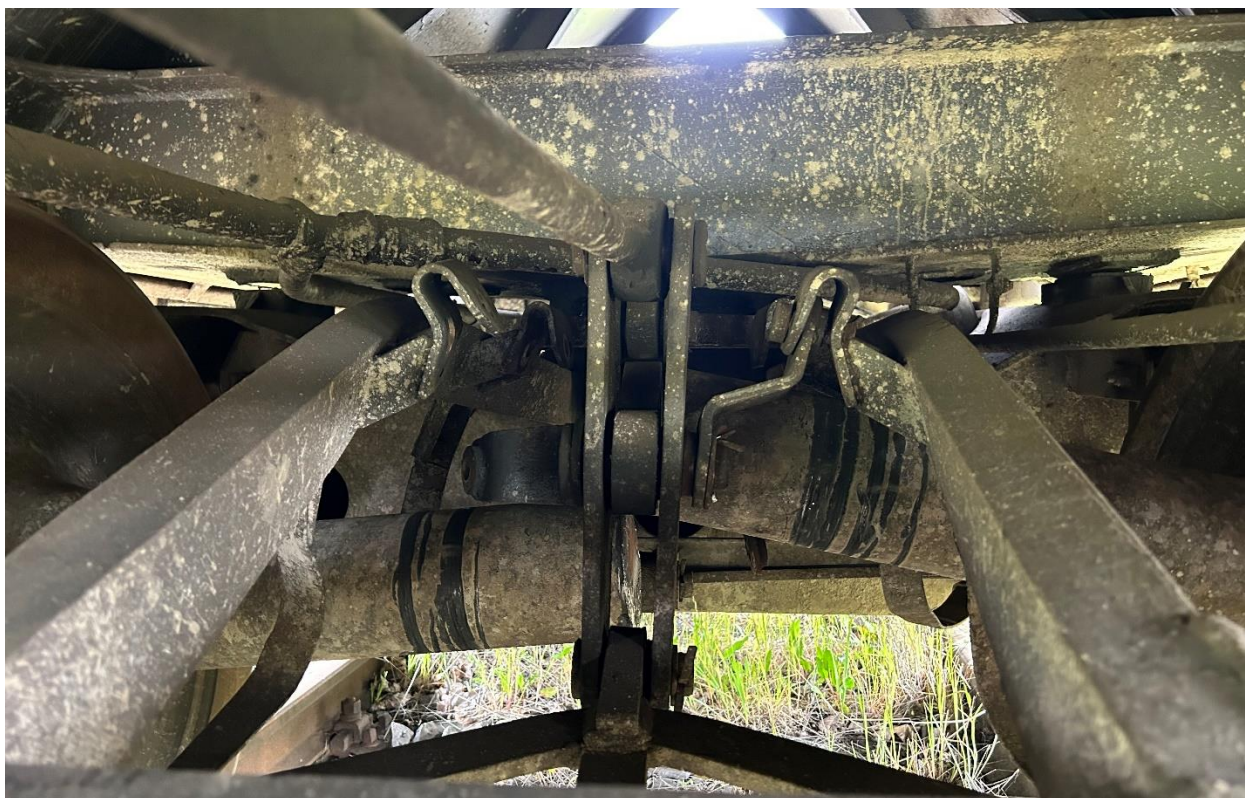
Photograph 3 - A view of the fractured axle (source: PKBWK's own material)

During tensile strength testing of three samples from the fractured axle, the samples failed at 245, 259 and 268 MPa. While the PN-64/H-84027 norm did not specify a yield strength value, the subsequent norms and the ones currently applicable specify the minimum yield point at 320 MPa.

When examining the material structure of the fractured axle, roughness on the surface of the axle was found to be between 4.2 and 6.1 micrometres, with the permitted value set in the MSD at 3.2 micrometres. The expert examination showed that the axle fracture had had a fatigue character and propagated for a long time. The expert examination did not determine how long the crack had propagated over time. The fracture location (centre of the axle) is where the highest stresses occur due to rotational bending of the axle.

- exceeded sulphur concentration limit for the steel from which the fractured axle was made,
 - excessively low yield strength of the steel from which the axle was made,
 - presence of corrosion on the axle surface in the area of the fracture,
 - exceeded permitted surface roughness of the central part of the axle,
- relative to the applicable norms.

1. Entities in charge of maintenance of freight wagons (ECMs) shall update their maintenance system documentation (MSD) as regards the model document (report) for non-destructive testing (NDT) to identify the area covered by the axle test, in accordance with Appendix 1 to the Recommendation of the President of UTK of 29 December 2024 regarding NDT testing of axles of wheel sets in freight wagons.

2. Entities in charge of maintenance of freight wagons (ECMs) shall make it obligatory from now on to carry out documented detailed¹⁾ non-destructive testing of axles of wheelsets before they are put back into service in accordance with Recommendation No. 6 in PKBWK Report no. 02/2024.

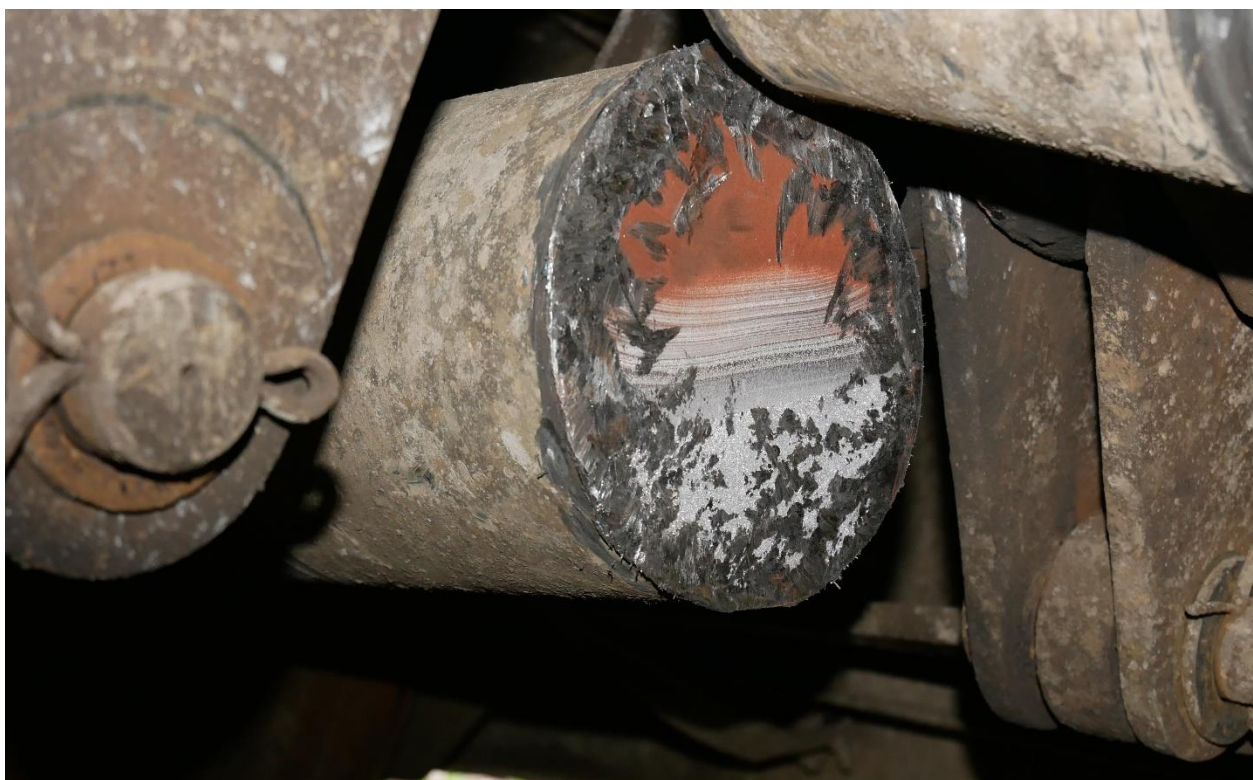
Photograph 4 - A view of the fractured axle (source: PKBWK's own material)

The Investigation Team concluded that the causal factor of the accident was the fracture of the second axle of wheelset no. 018808849 in the first bogie of wagon no. 84 51 0835 092-5, during the entry of train TME 664015 to Rudna Gwizdanów station, which resulted in a derailment of the said wagon to the left side in the direction of travel.

- exceeding the sulphur concentration limit for the steel from which the fractured axle was made, relative to the applicable norms,
- excessively low yield strength of the steel from which the axle was made, relative to the applicable norms,
- presence of corrosion on the axle surface in the area of the fracture,
- exceeded permitted surface roughness of the central part of the axle, relative to the applicable norms.

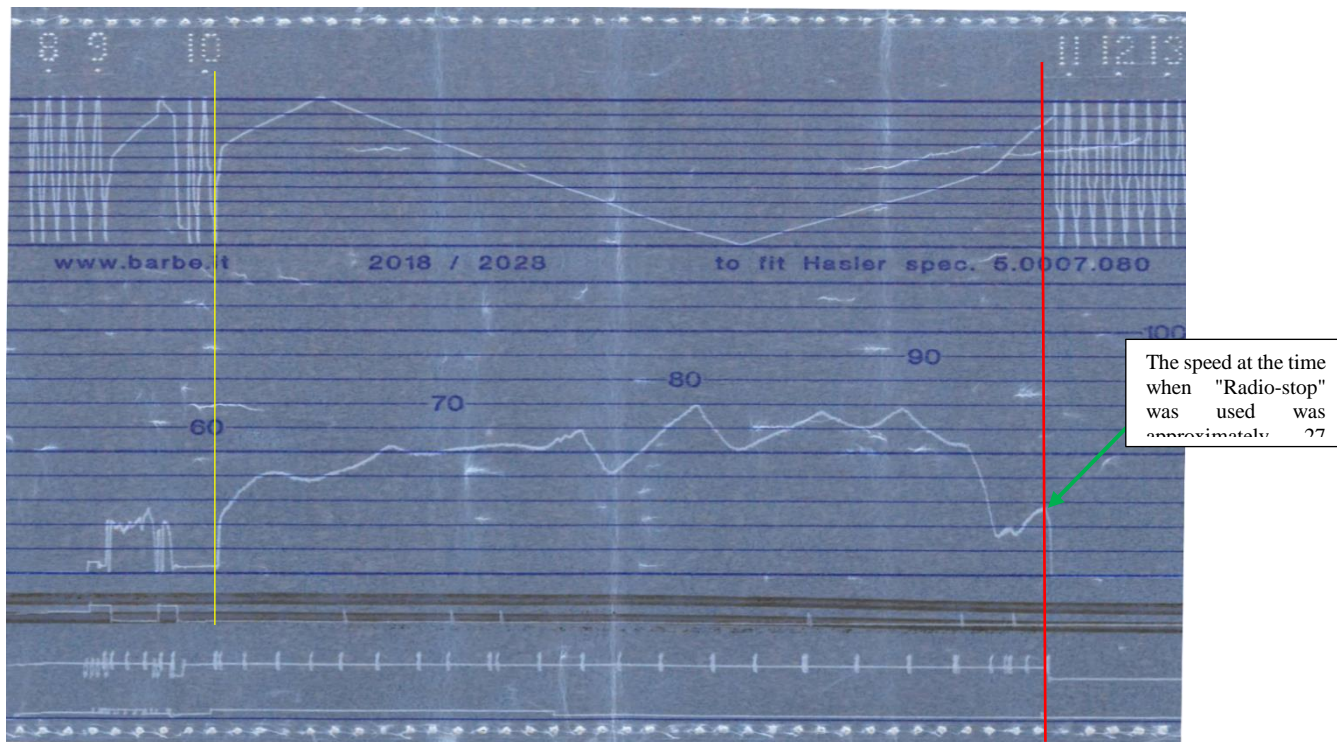
Figure 2 - A diagram showing driving parameters of locomotive 3E/1M 201, recorded on the HASLER BERN Rt9 speedometer tape (compiled by PKBWK)

10 34:08 hrs - "Radio-stop" is used, rapid drop in speed (emergency braking), drop in speed from 27 km/h to 0 km/h over a distance of 10 metres
