## PHOTOGRAPHIC DOCUMENTATION

### Appendix no. 2

to the Final Report on the implementation of the measures listed under the EMP  
for Contract 2A.2/1

#### Odra-Vistula Flood Management Project

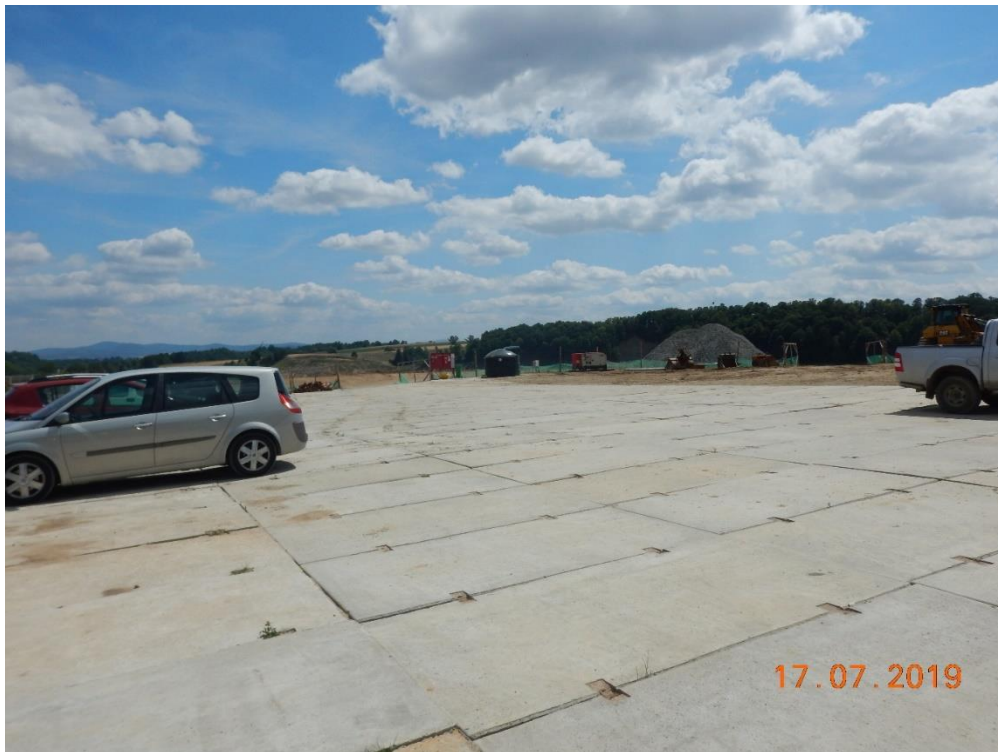
Phot. 1. Construction site facilities – site facilities' area was sealed from the ground (item no. 85 of EMP).

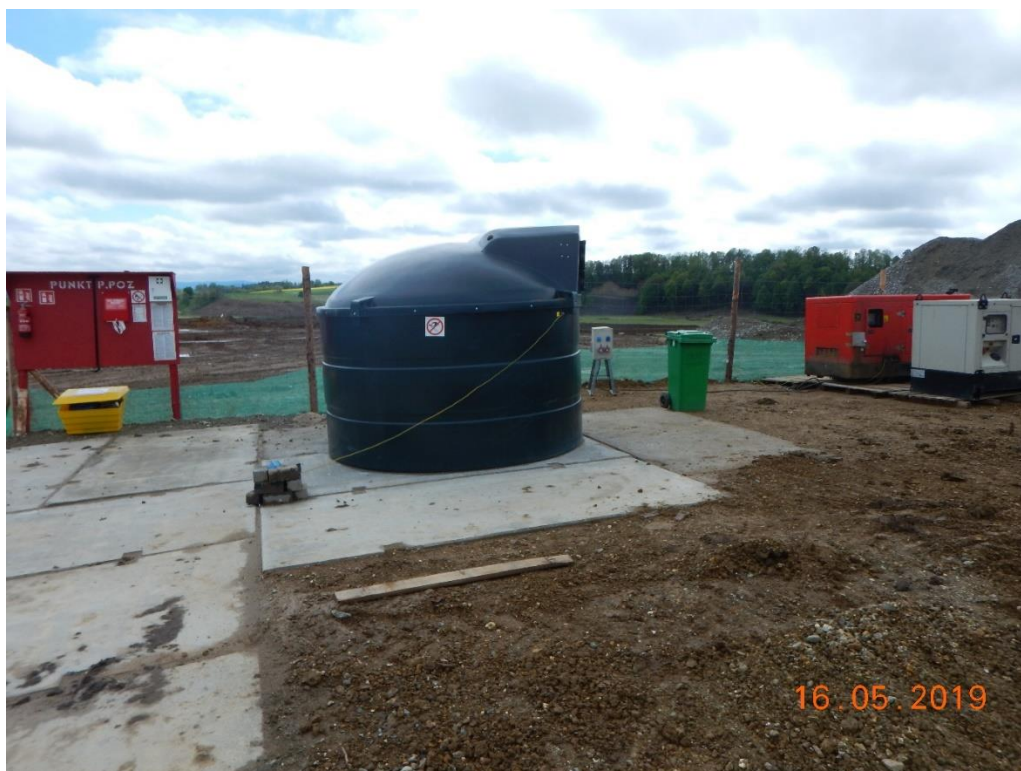
Phot. 2. Area for refuelling vehicles and machinery working on the site secured against spillage of petroleum-based substances to the soil (item no. 85 of EMP).

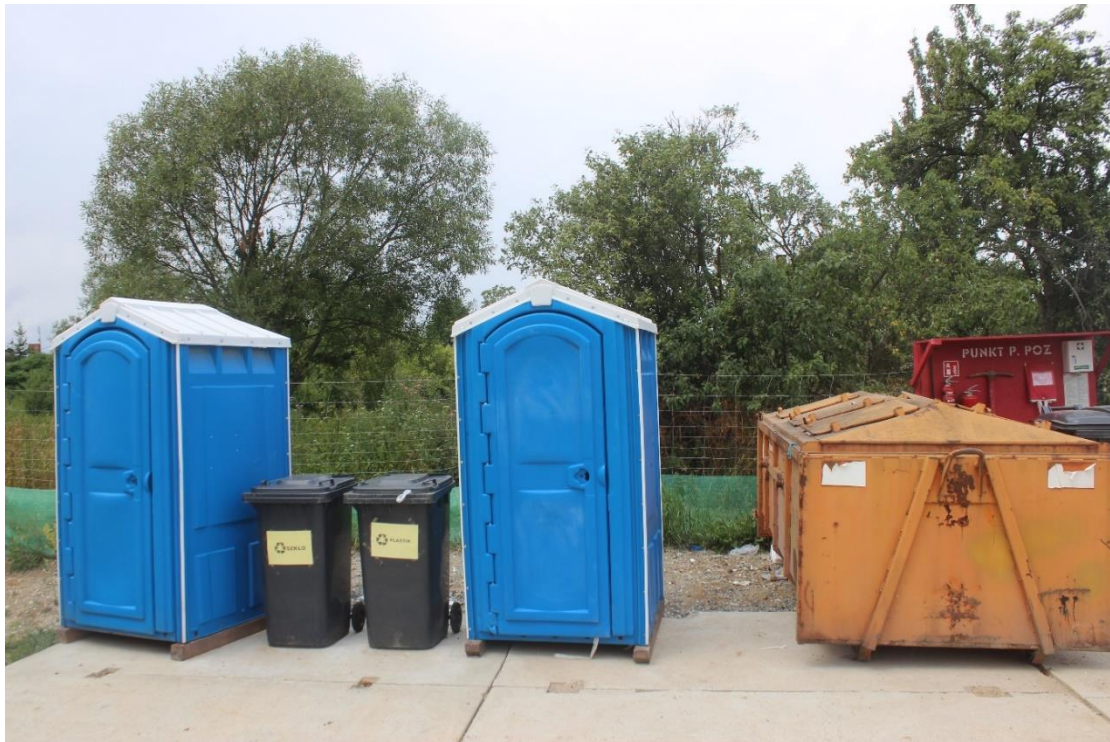
Phot. 3. Portable toilets located at the construction site facilities (item no. 110 of EMP).

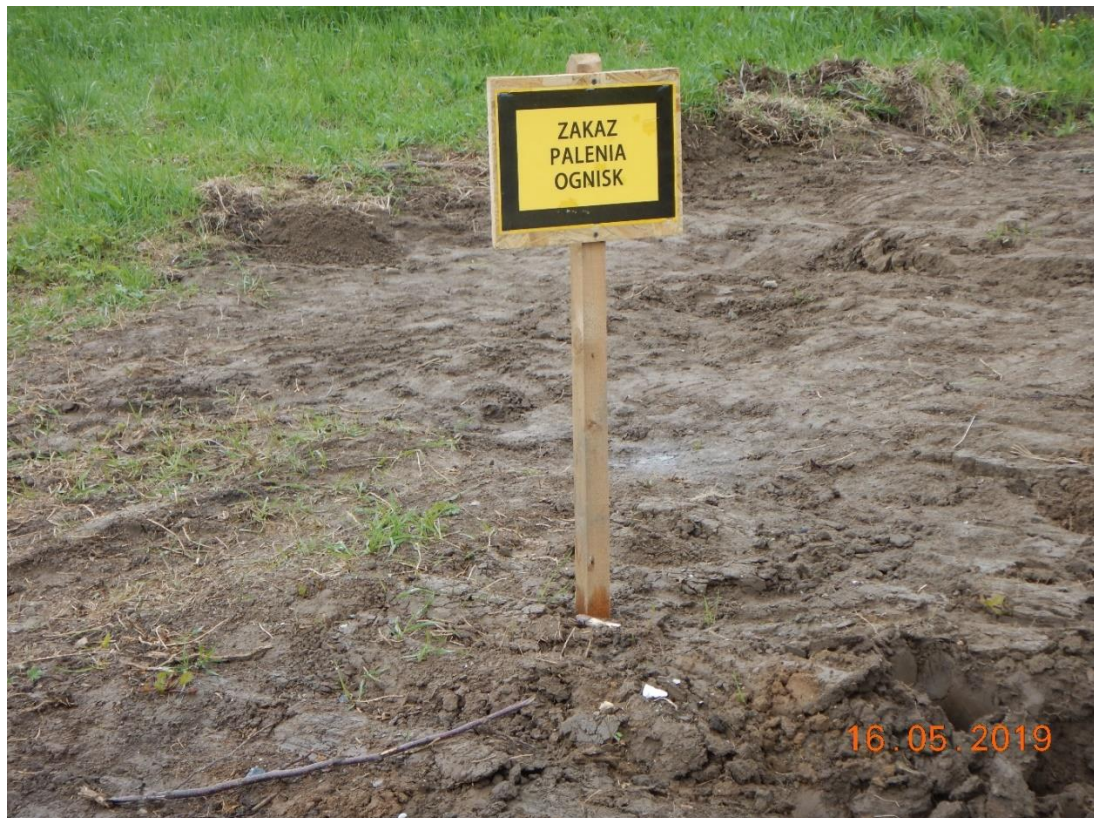
Phot. 4. Board erected at the Construction Site indicating that bonfires are prohibited (item no. 100 of EMP).

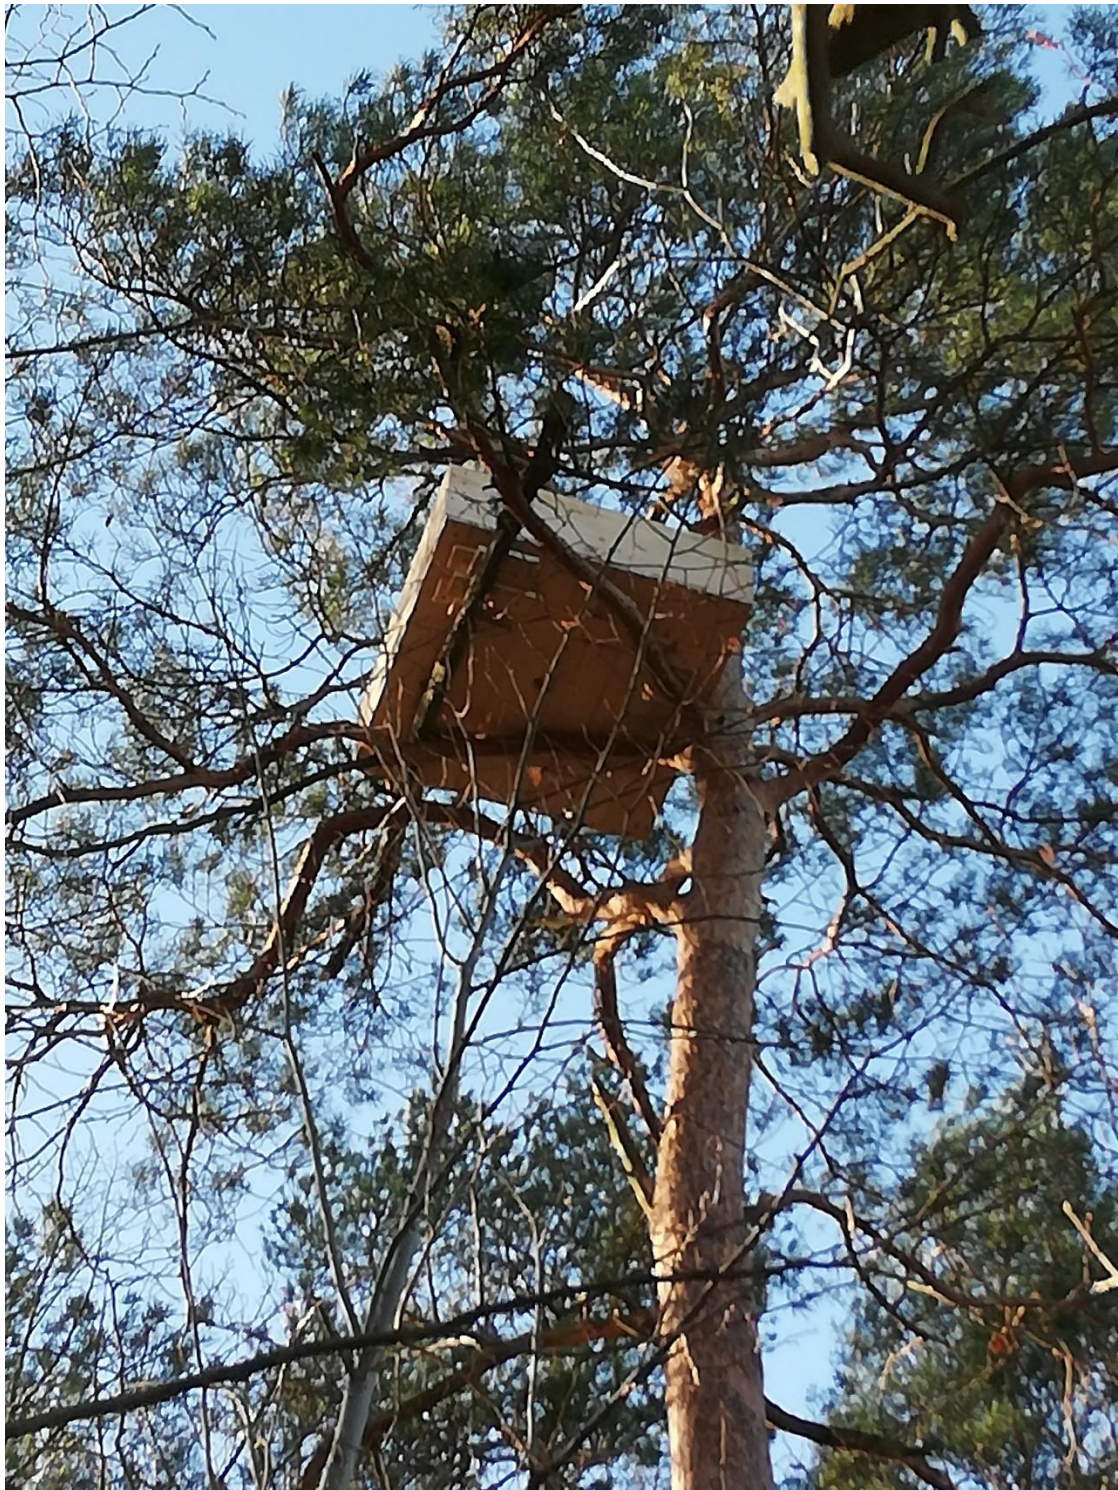
Phot. 5. Nesting platform for eagle owl *Bubo bubo* installed (item no. 123 of EMP).

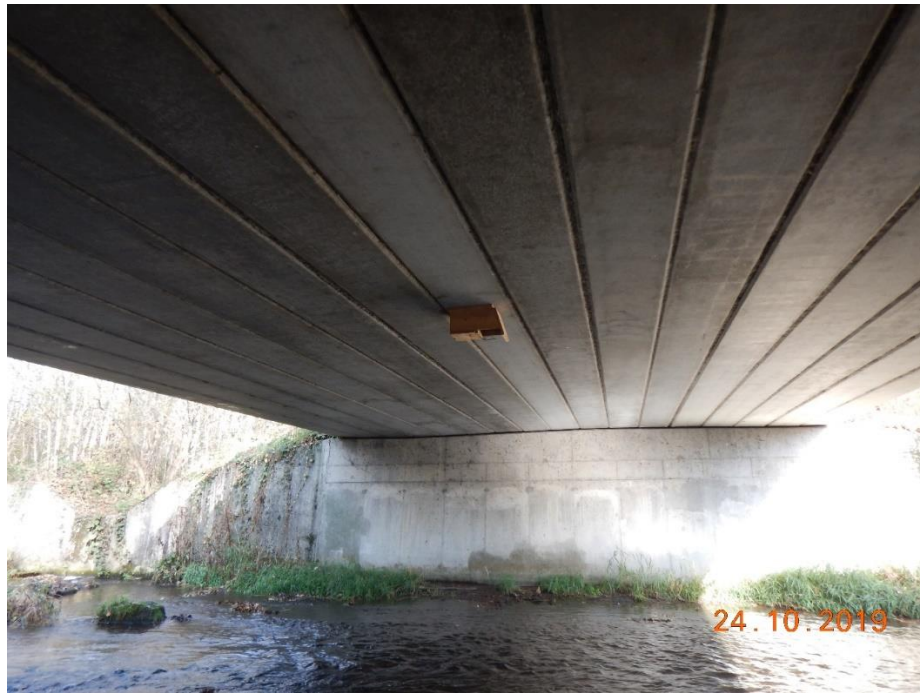
Phot. 6. Nesting box for White-Throated Dipper *Cinclus cinclus* (item no.121 of EMP).

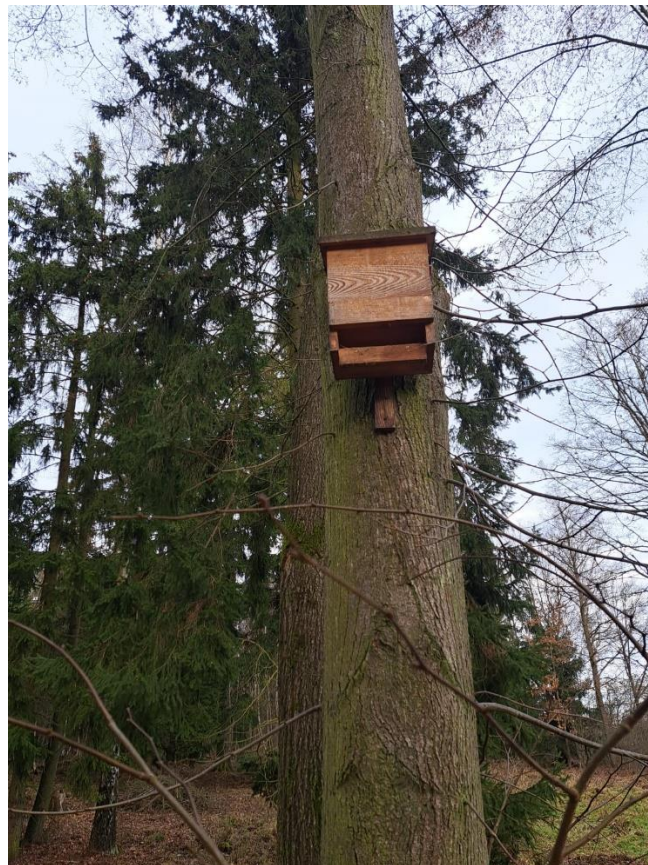
Phot. 7. Box installed for bats (item no. 124 of EMP).

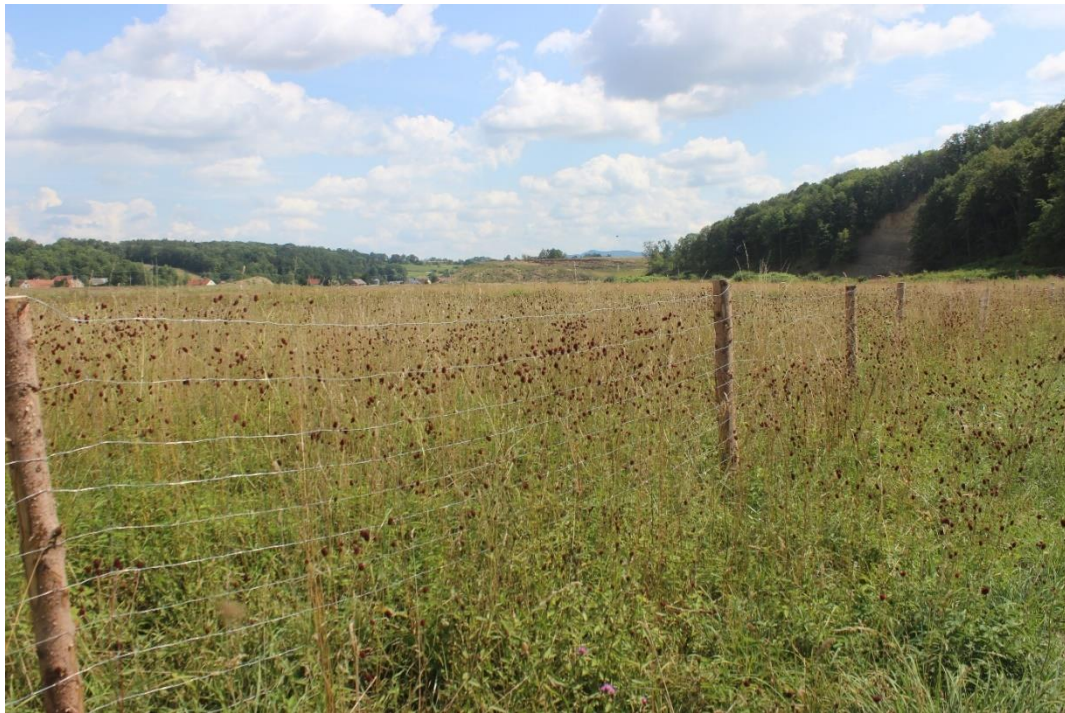
Phot. 8. Protection of patches of naturally valuable meadow at the Construction Site (item no. 29 of EMP).

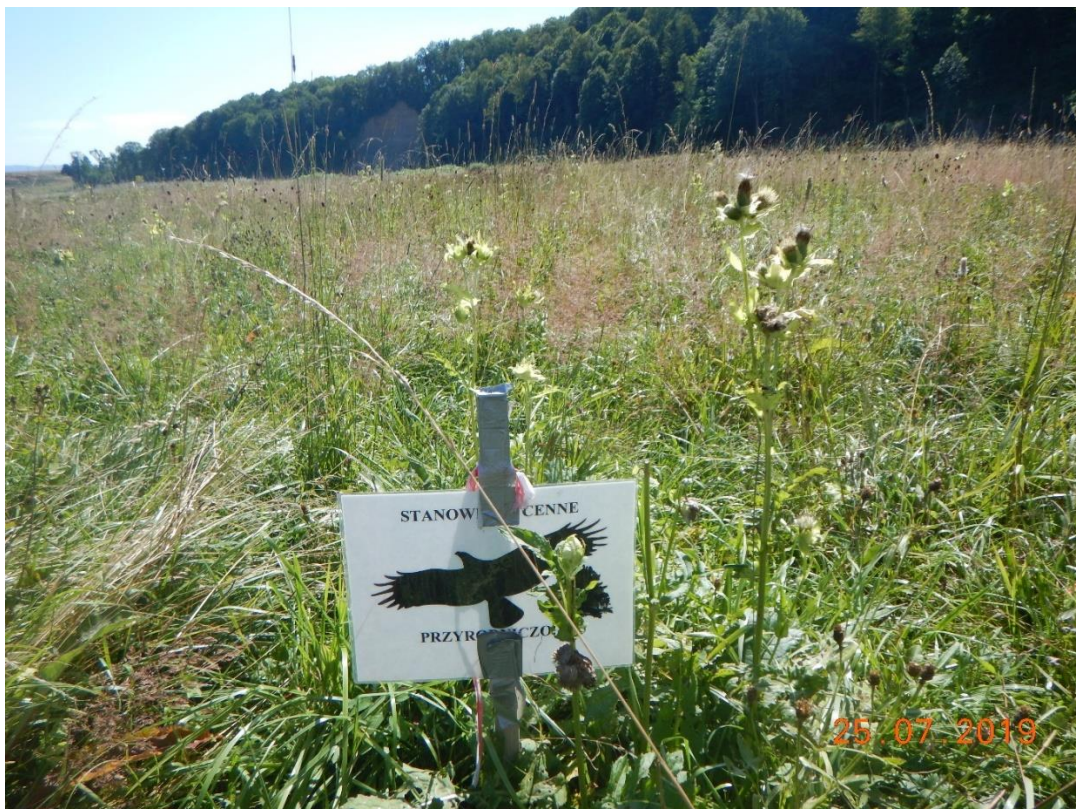
Phot. 9. Marking of naturally valuable meadow at the Construction Site (item no. 29 of EMP).

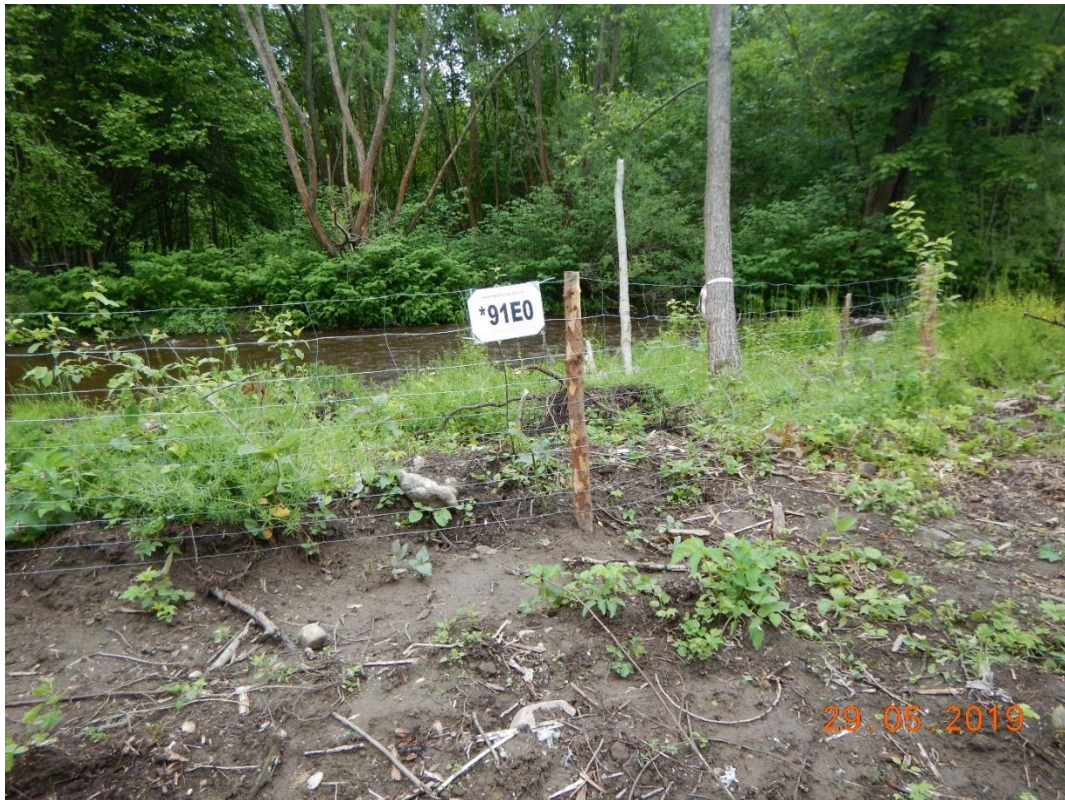
Phot. 10. Secured and marked patch of the nature habitat at the Construction Site (item no. 29 of EMP).

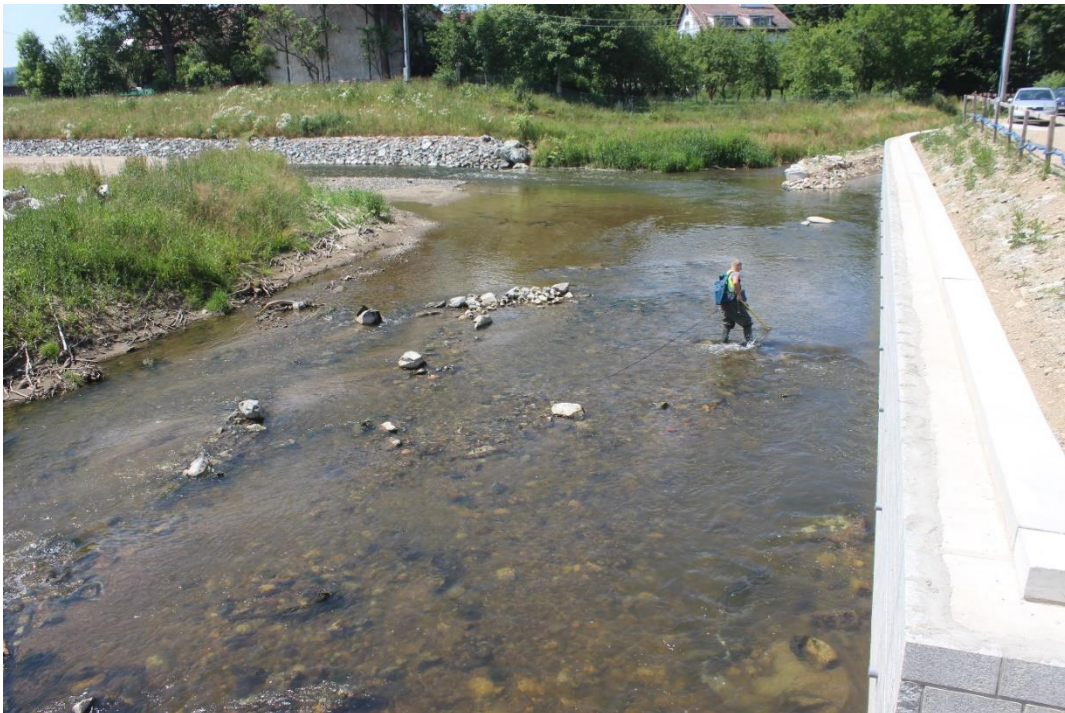
Phot. 11. Catching of fish and lampreys in the bed of the Bystrzyca Dusznicka by expert ichthyologist (item no. 37 of EMP).

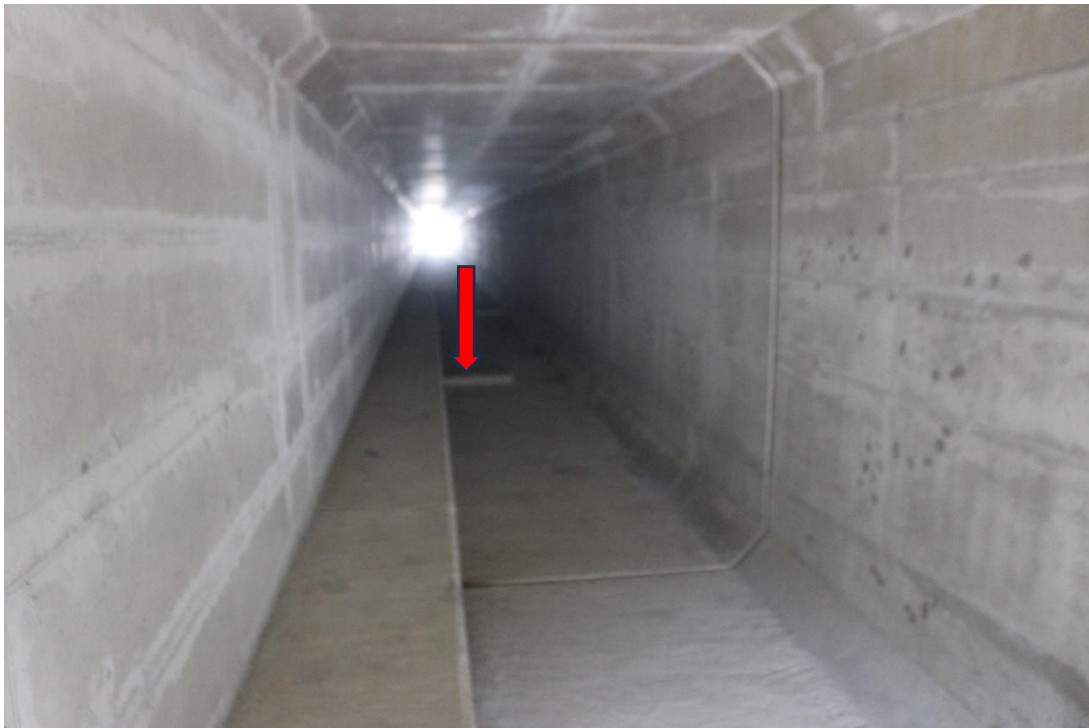
Phot. 12. Sills constructed in the sluice channel bottom – red arrow (item no. 56 of EMP).

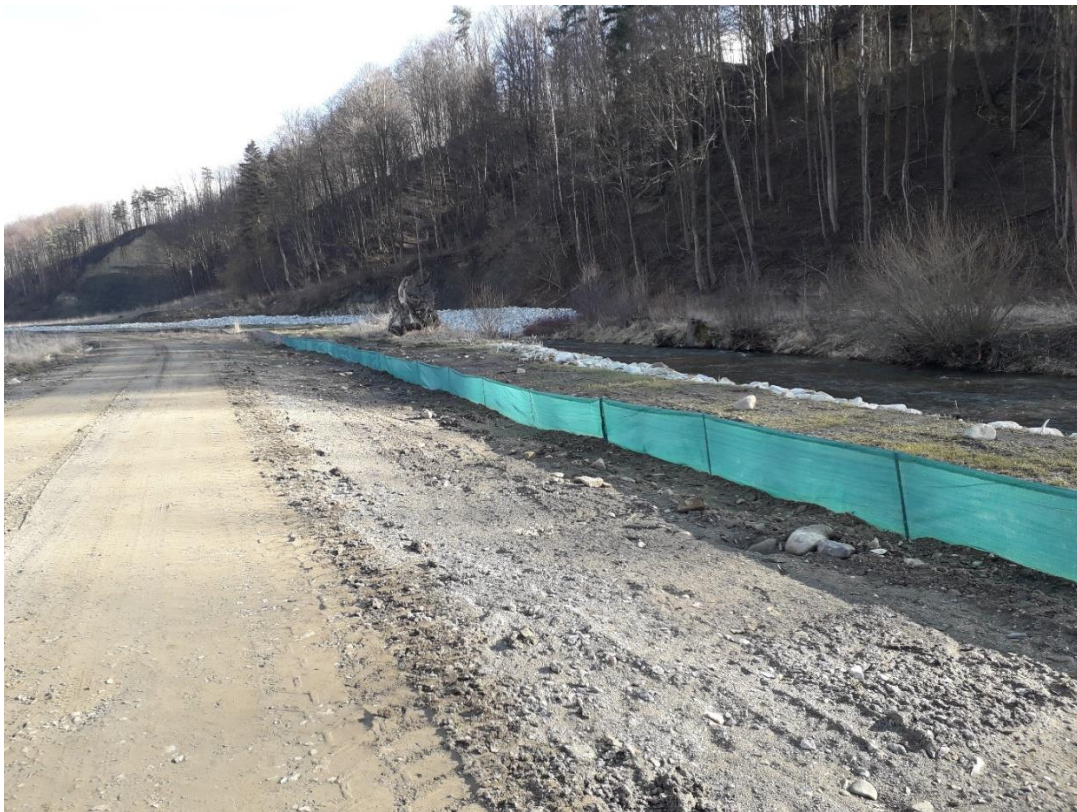
Phot. 13. Protection provided against entry of amphibians to the site (item no. 33 of EMP).

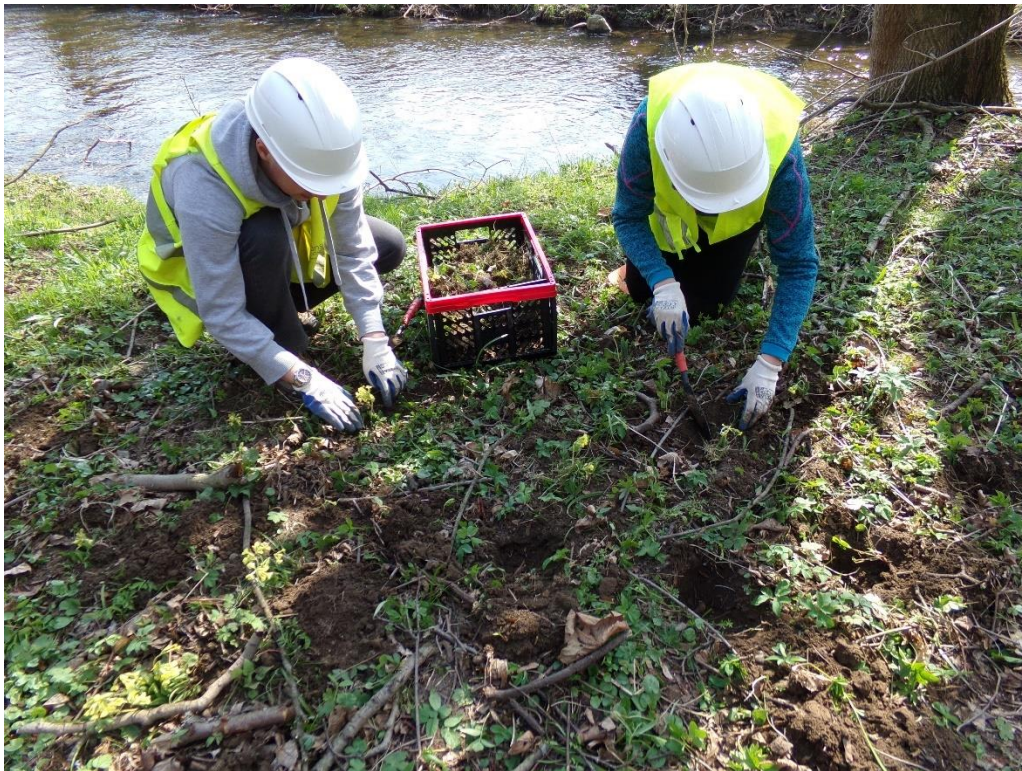
Phot. 14. Replanting of Oxlip *Primula elatior* from the investment area – works conducted by expert phytosociologist (item no. 30 of EMP).

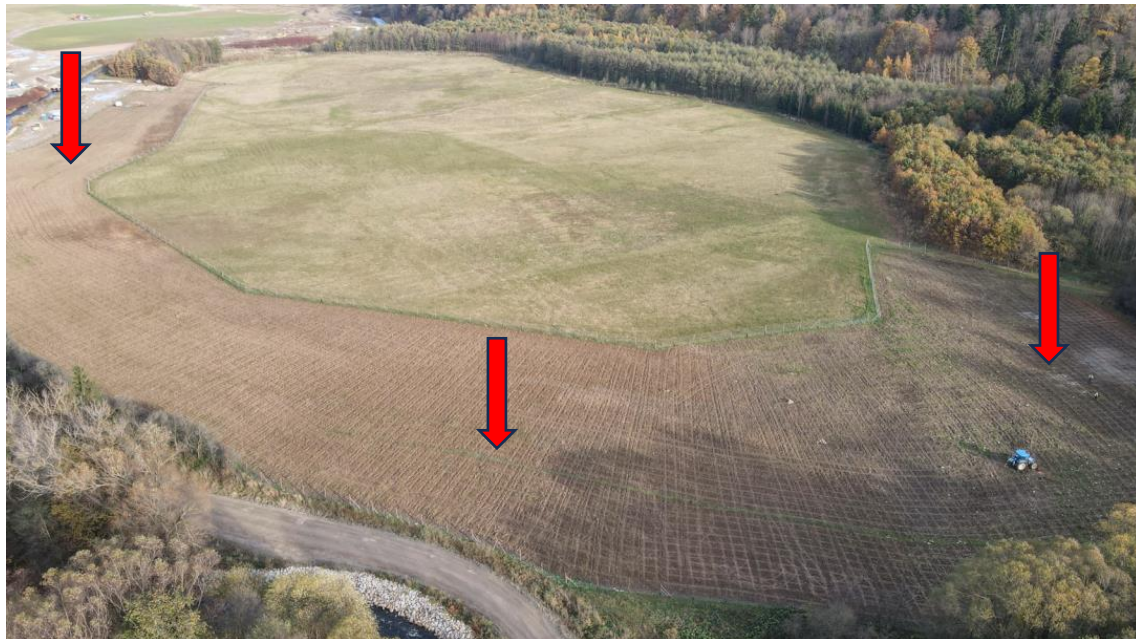
Phot. 15. Compensation areas at the reservoir area – red arrows (item nos. 119 and 120 of EMP)

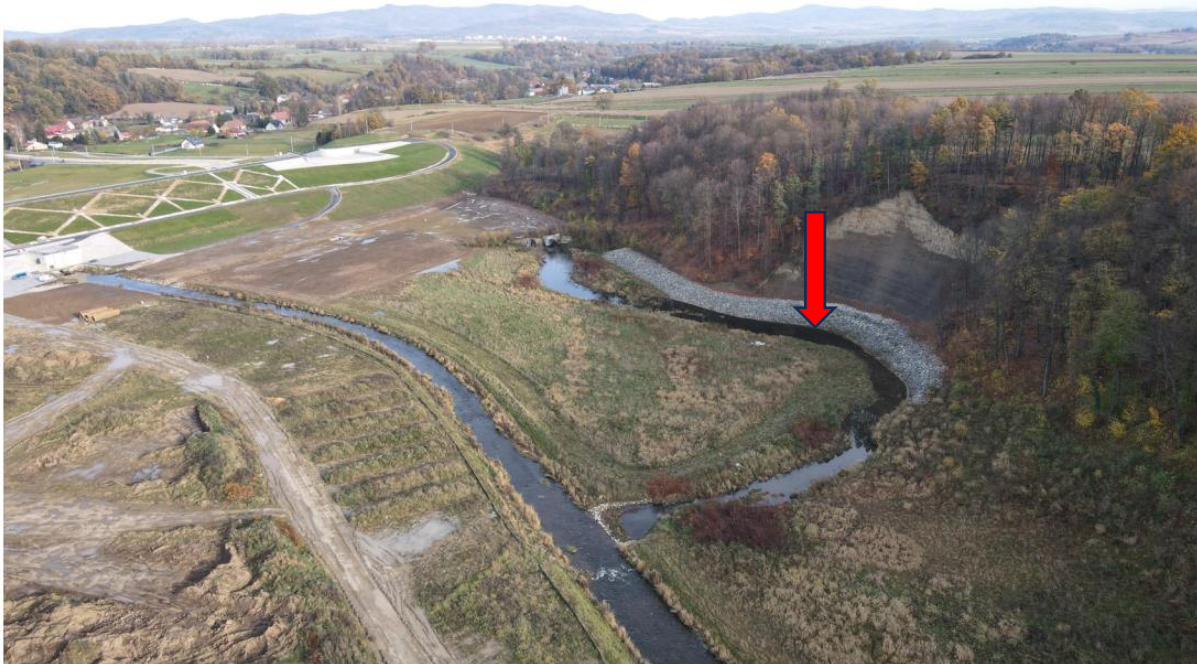
Phot. 16. Visible new section of the inflow channel to the reservoir's dam and preserved section of the Bystrzyca Dusznicka riverbed above the historic bridge (red arrow) (item no. 53 of EMP).

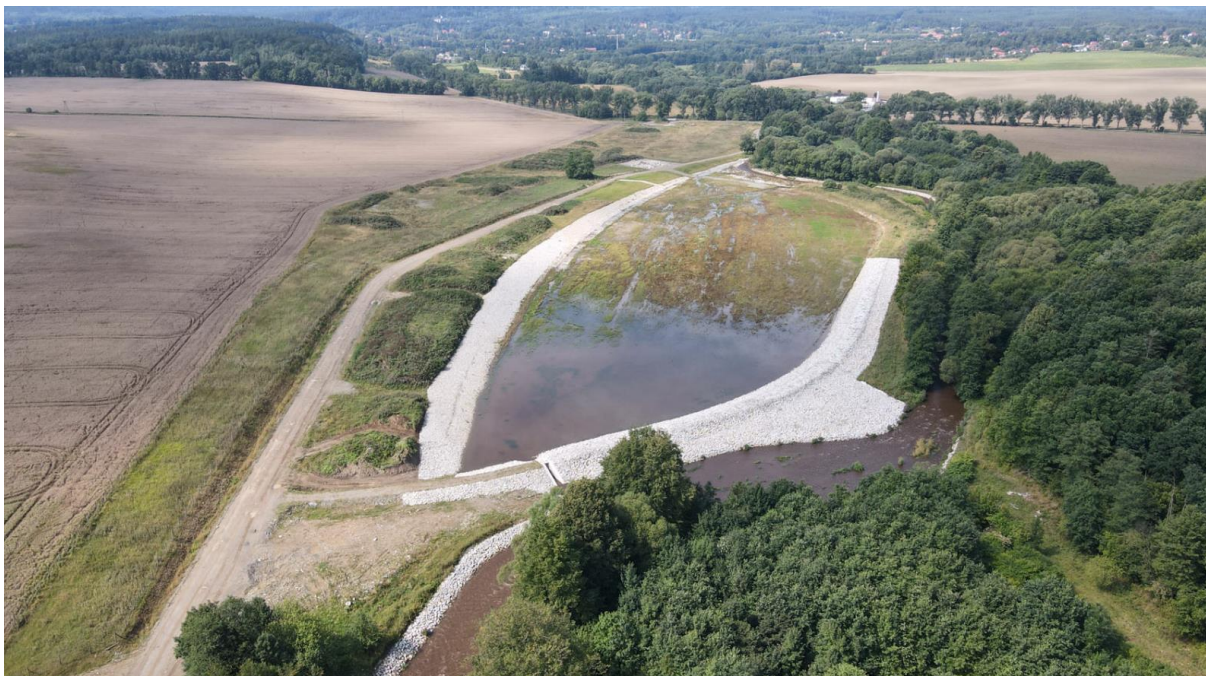
Phot. 17. Rubble trap constructed on the reservoir area.

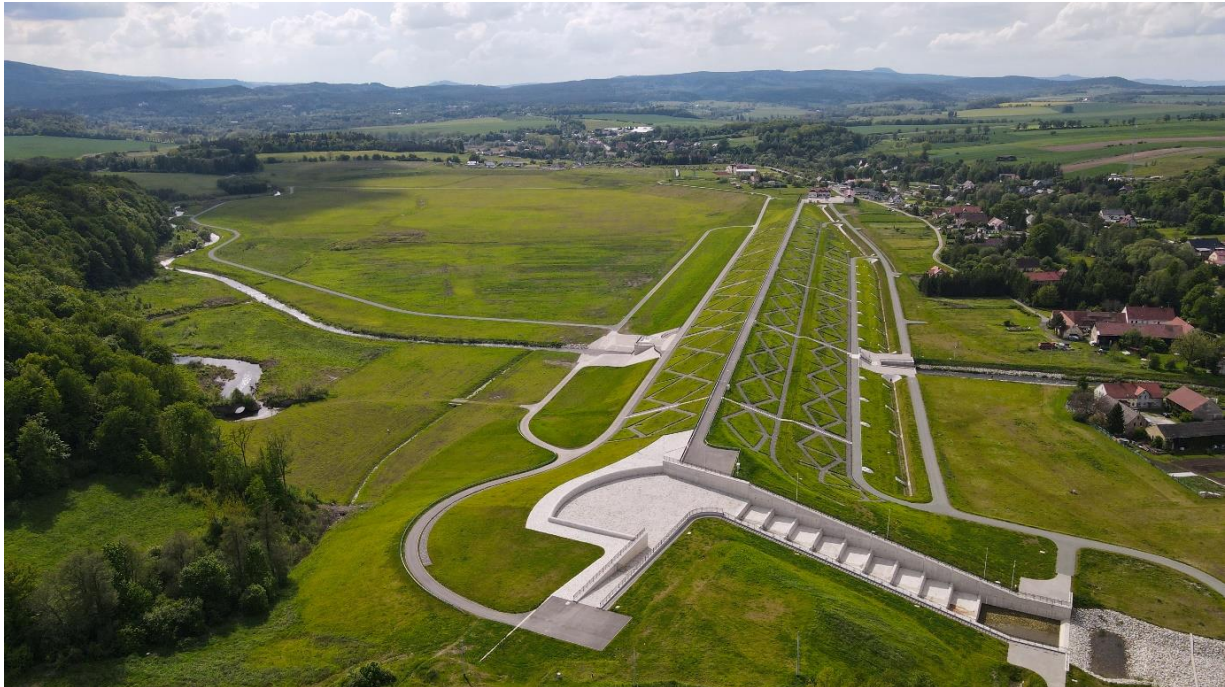
Phot. 18. Development of the area within the reservoir bowl after completion of construction works (item no. 76 of EMP).
