PHOTO DOCUMENTATION

Appendix no. 2

to the Final Report on implementation of measures determined in EMP
for the Contract 3A.5

Odra-Vistula Flood Management Project

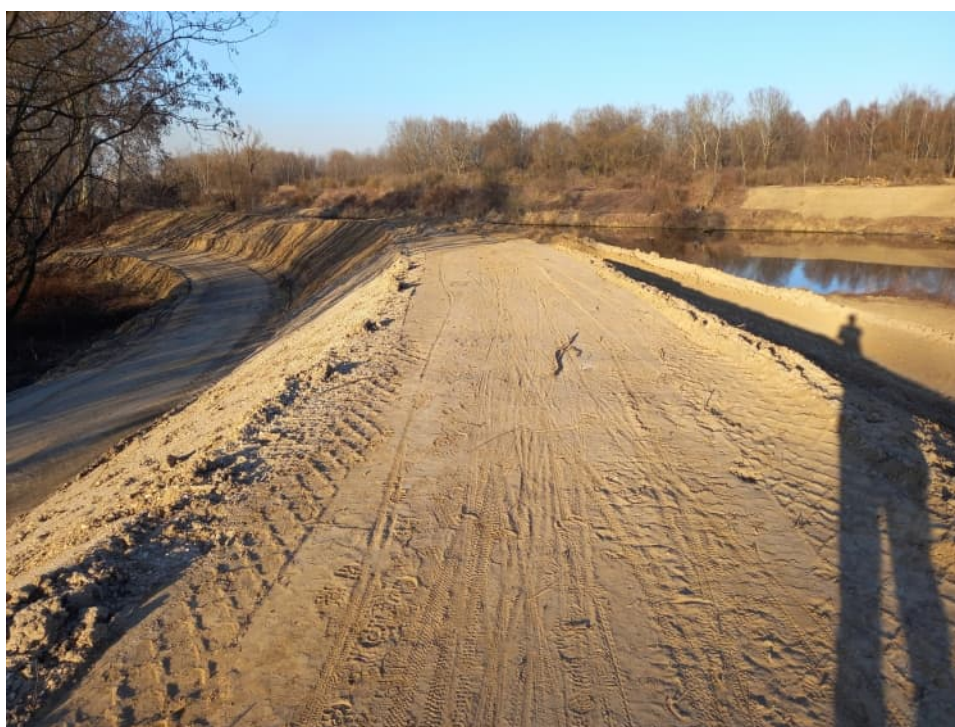
Fig. 1. Site condition in the first month of the works implementation period – flood embankment on the western bank of the Kujawy port channel, status in the third decade of March 2022 (view towards the north).

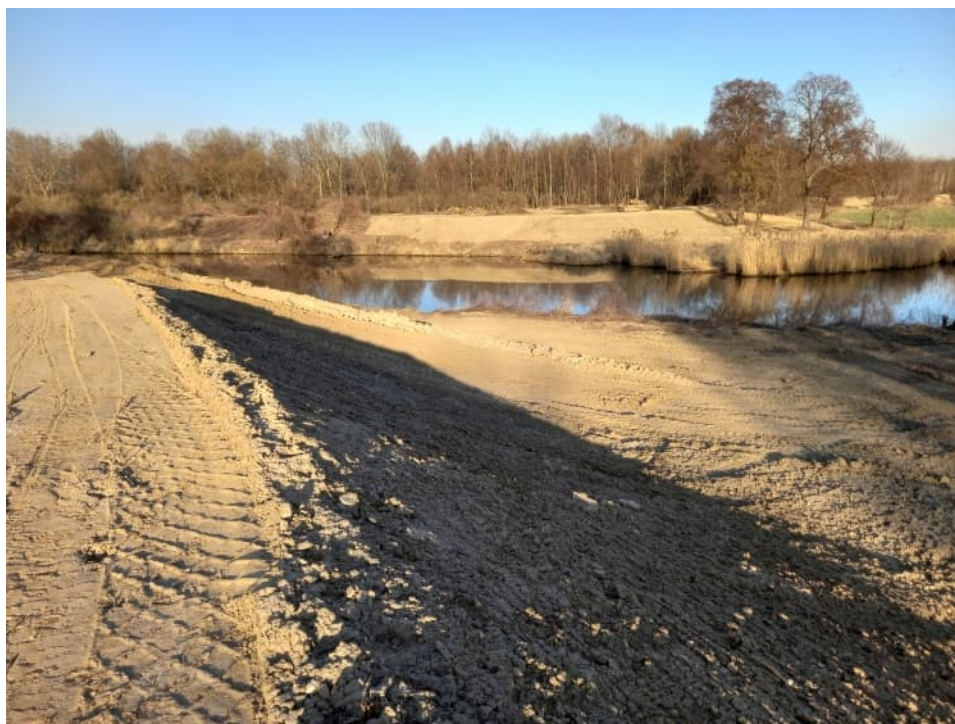
Fig. 3. Site condition in the first month of the works implementation period – construction site of flood gate on the Kujawy port channel – southern part, status in the third decade of March 2022 (view towards the east).

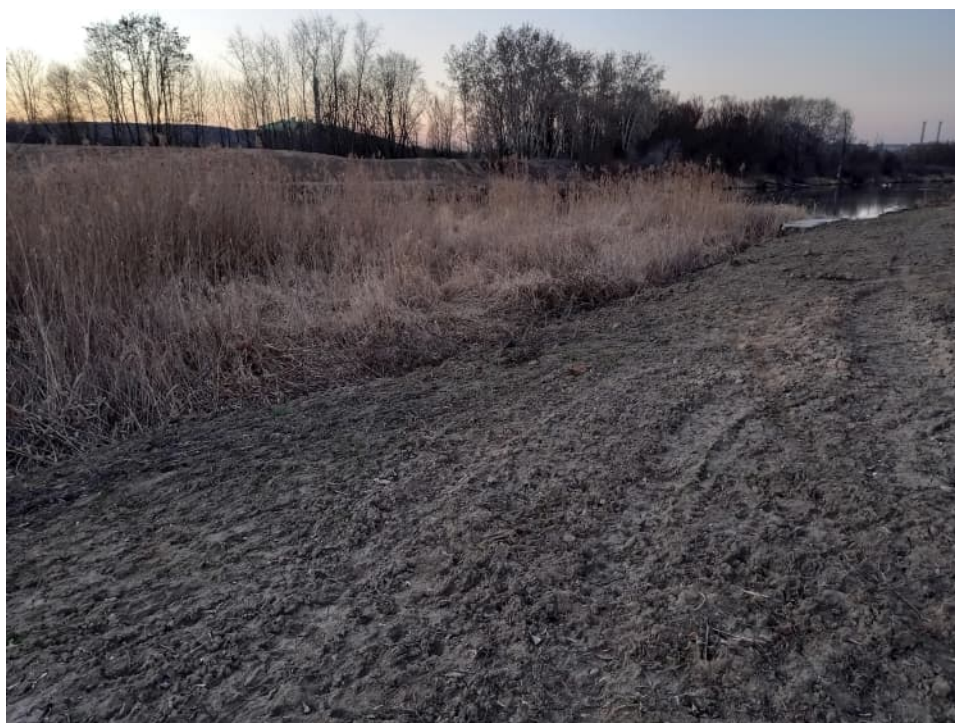
Fig. 4. Site condition in the first month of the works implementation period – construction site of flood gate on the Kujawy port channel – southern part, status in the third decade of March 2022 (view towards the north-west).

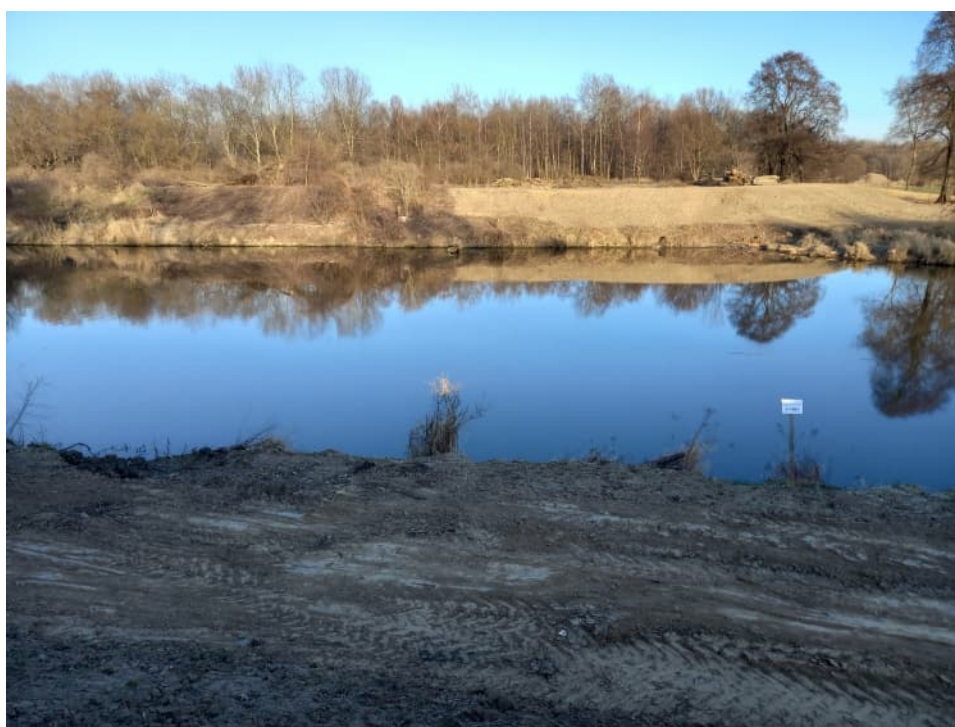
Fig. 5. Site condition in the first month of the works implementation period – construction site of flood gate on the Kujawy port channel – central part, status in the third decade of March 2022 (view towards the east).

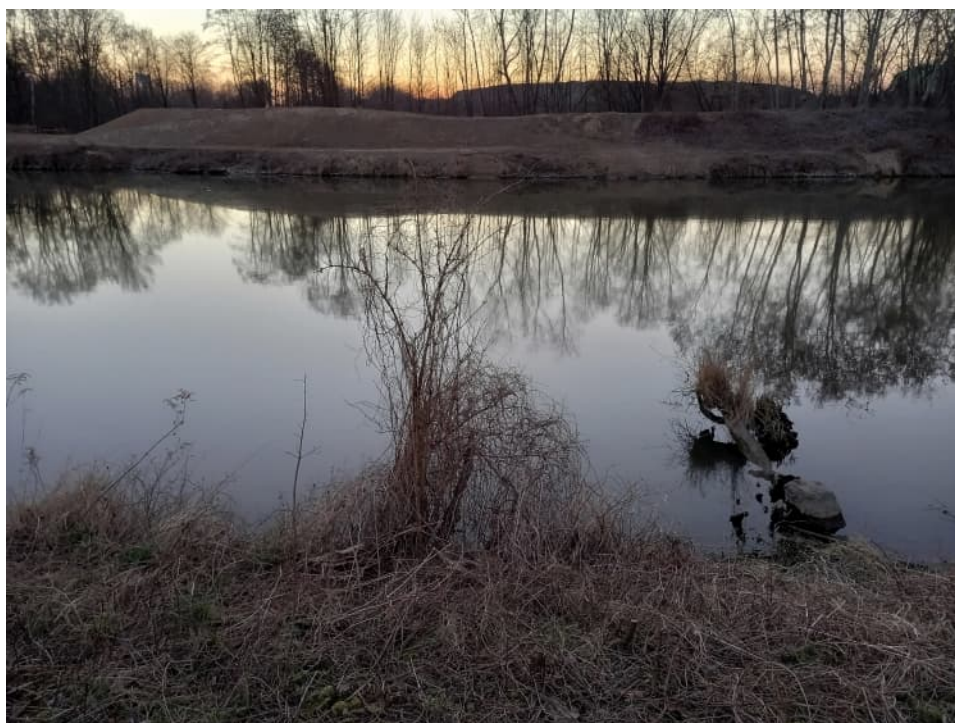
Fig. 8. Site condition in the first month of the works implementation period – construction site of flood gate on the Kujawy port channel – northern part, status in the third decade of March 2022 (view towards the west).

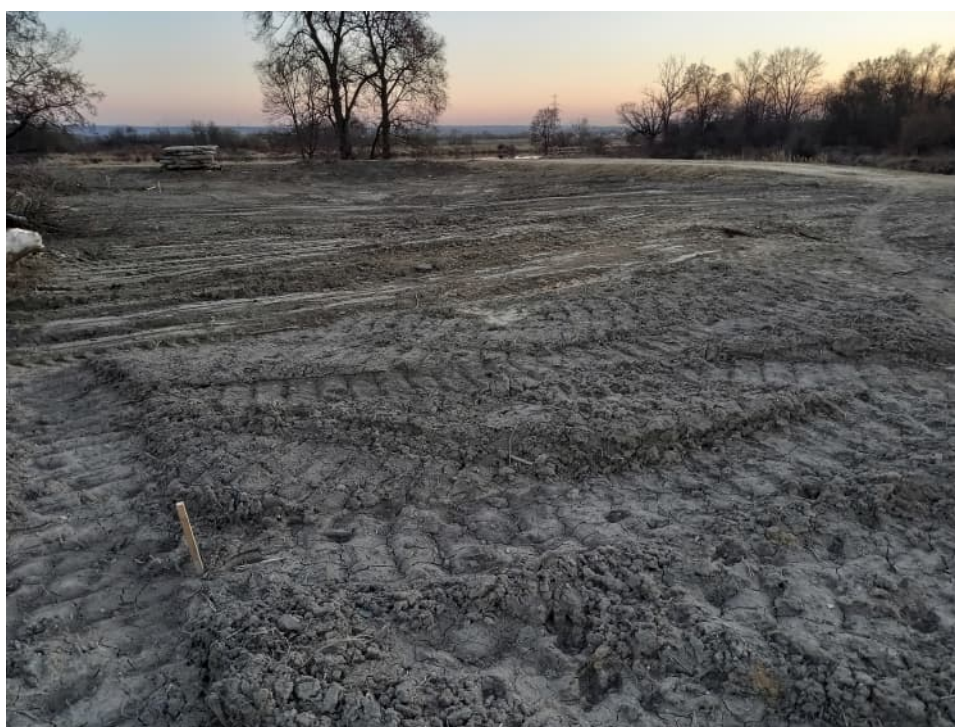
Fig. 9. Site condition in the first month of the works implementation period – construction site of maneuvering yard on the eastern bank of the Kujawy port channel, status in the third decade of March 2022 (view towards the south).

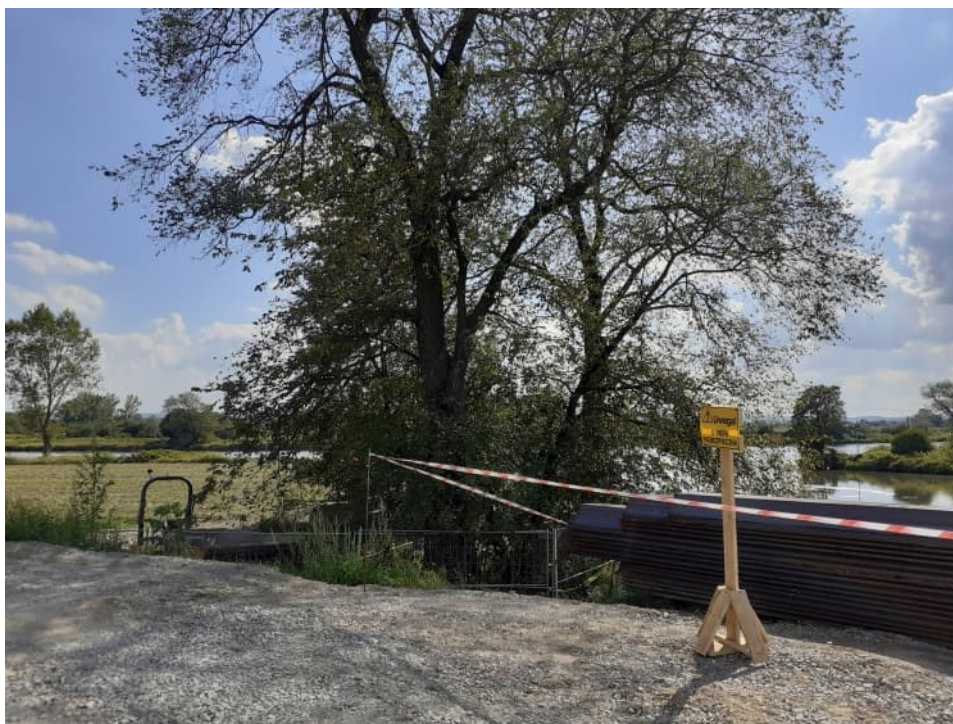
Fig. 17. Protection of hazardous sites,
status in the third decade of August 2022 (view towards the south).

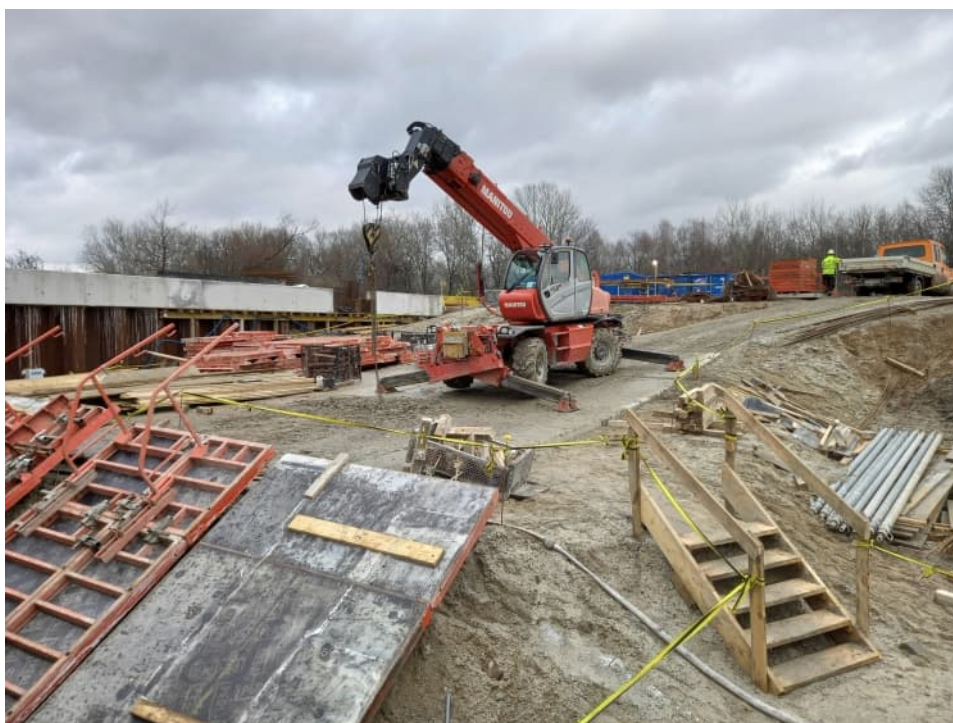
Fig. 18. Protection of hazardous sites,
status in the third decade of January 2023 (view towards the north-east).

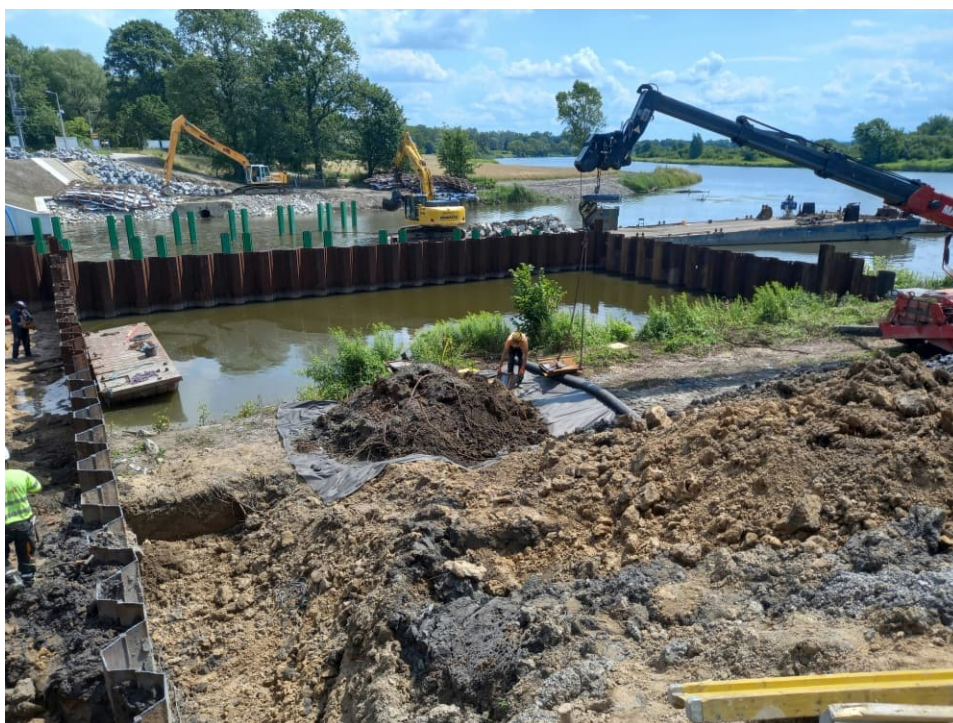
Fig. 22. Preventing the spread of foreign invasive plant species
– protection of earth masses containing excavated knotweed roots,
status in the second decade of July 2023 (view towards the east).

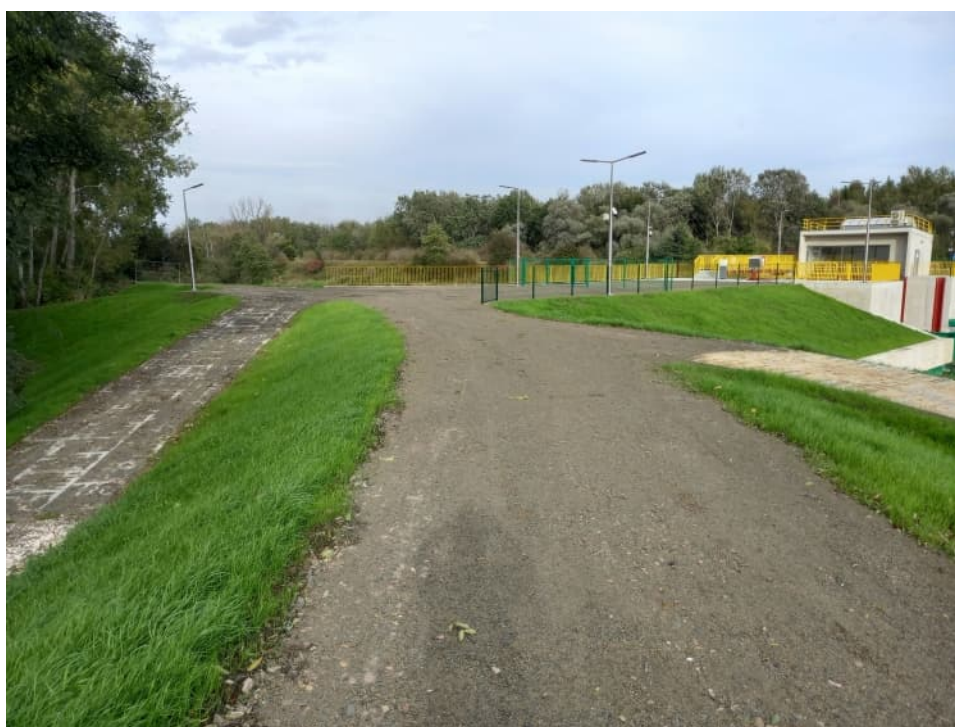
Fig. 51. Site condition in the first month of the defects notification period
– flood embankment on the western bank of the Kujawy port channel,
status in the second decade of October 2023 (view towards the north).

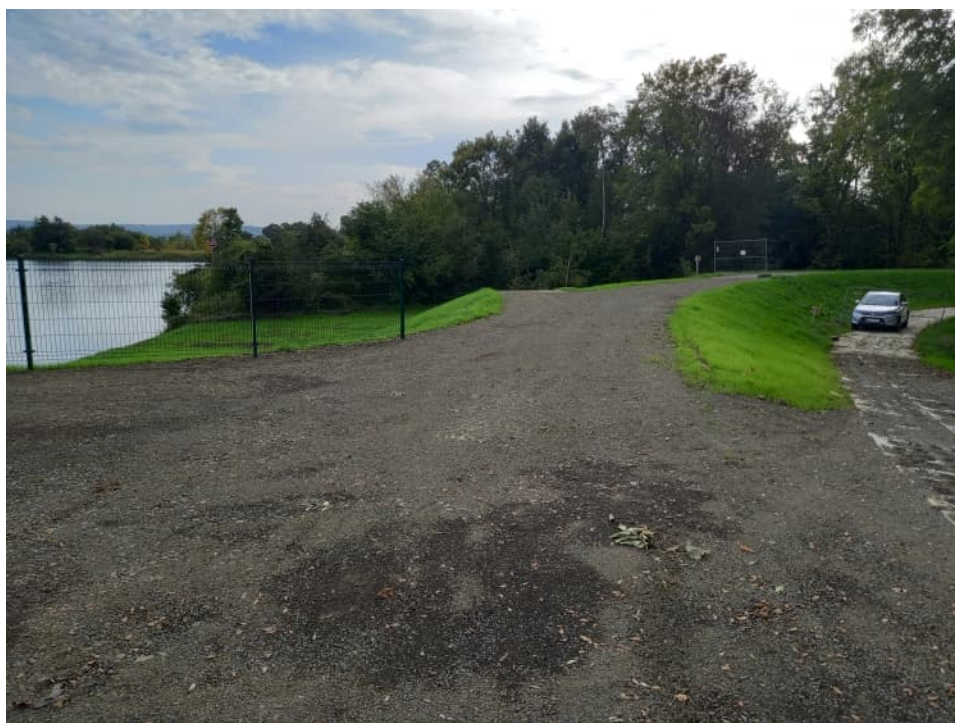
Fig. 52. Site condition in the first month of the defects notification period
– flood embankment on the western bank of the Kujawy port channel,
status in the second decade of October 2023 (view towards the south).

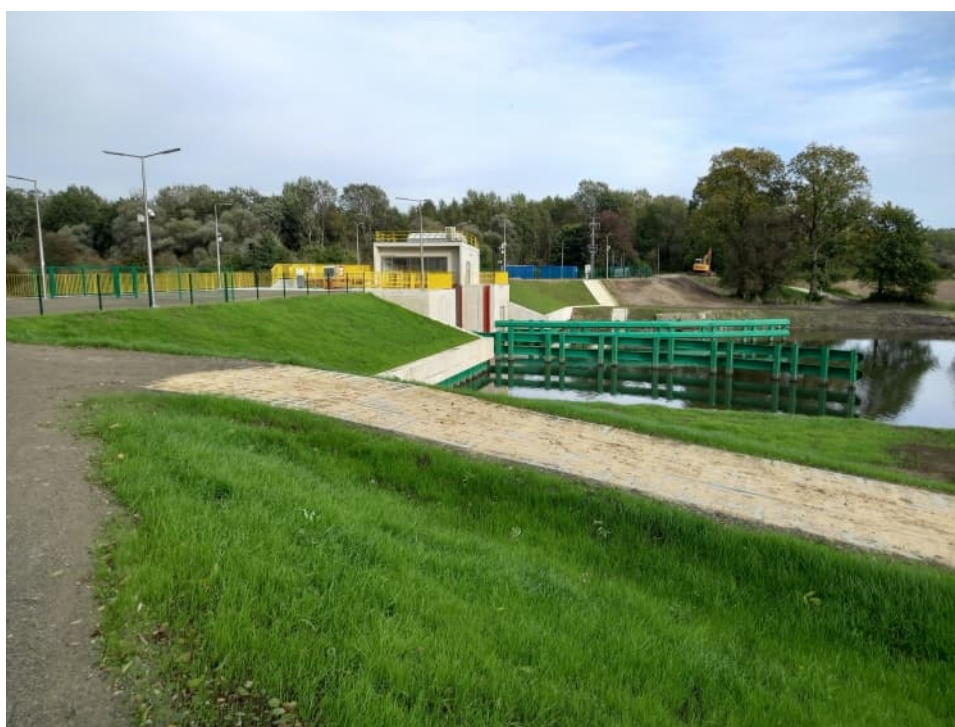
Fig. 53. Site condition in the first month of the defects notification period
– flood gate on the Kujawy port channel – southern part,
status in the second decade of October 2023 (view towards the east).

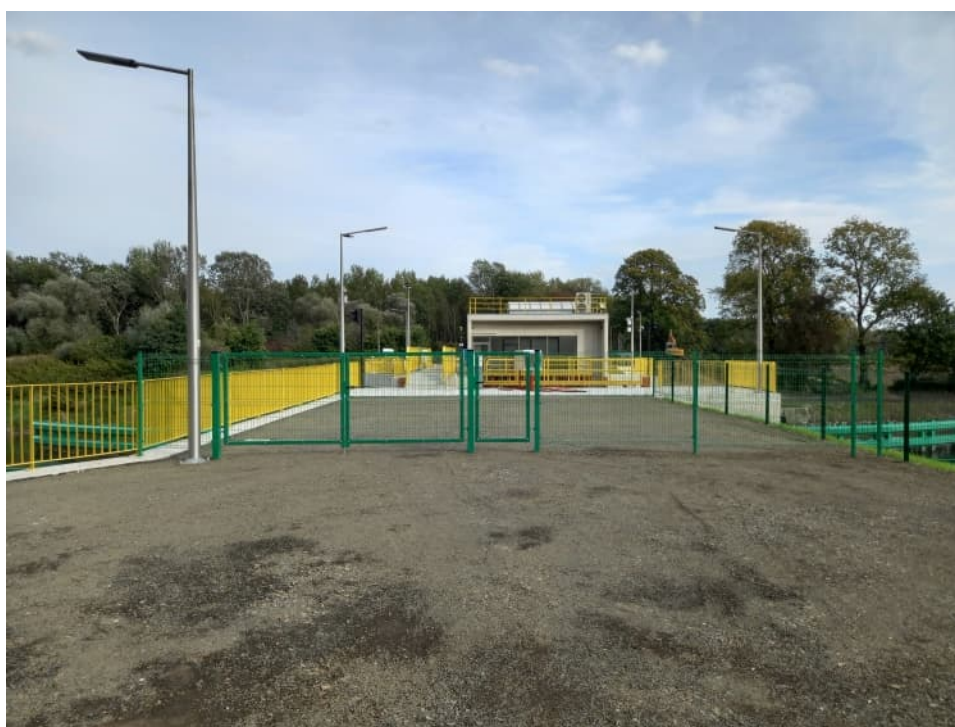
Fig. 55. Site condition in the first month of the defects notification period
– flood gate on the Kujawy port channel – central part,
status in the second decade of October 2023 (view towards the east).

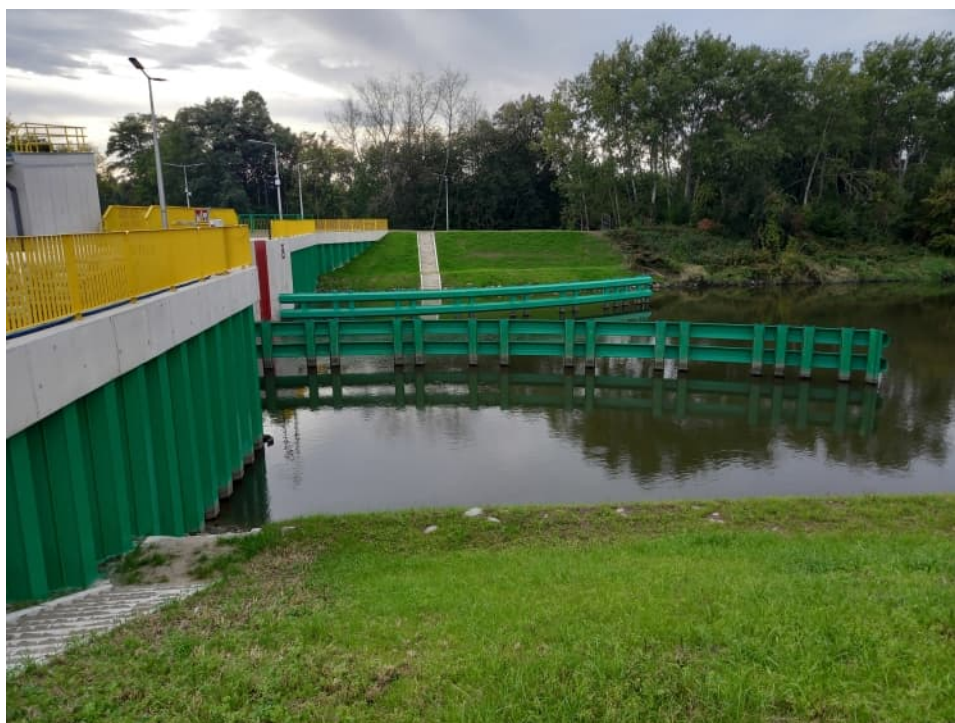
Fig. 58. Site condition in the first month of the defects notification period
– flood gate on the Kujawy port channel – northern part,
status in the second decade of October 2023 (view towards the west).
