Appendix no. 6 to the Interim Report on Implementation of the Land Acquisition and Resettlement Action Plan (LARAP) for Contract 3A.1
Construction of Vistula embankments in Cracow covering the implementation of 2 Works Contracts:

- **3A.1/1 – *Construction of Vistula embankments in Cracow - Section 1, Section 2***
- **3A.1/2 – *Construction of Vistula embankments in Cracow - Section 3***

PART A: 3A.1/1 – Construction of Vistula embankments in Cracow - Section 1, Section 2

PART B: 3A.1/2 – Construction of Vistula embankments in Cracow - Section 3

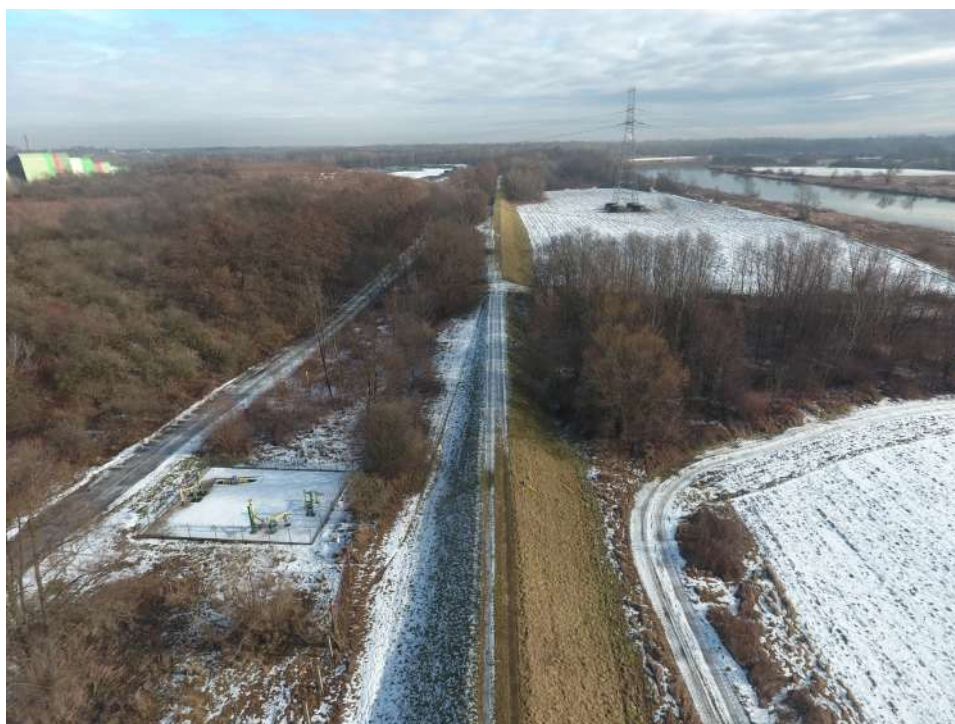
Foto. 1. Condition of the area before the commencement of works – the left Vistula embankment planned for reconstruction *on section 1.1*, condition in the first decade of February 2021 (view downstream).

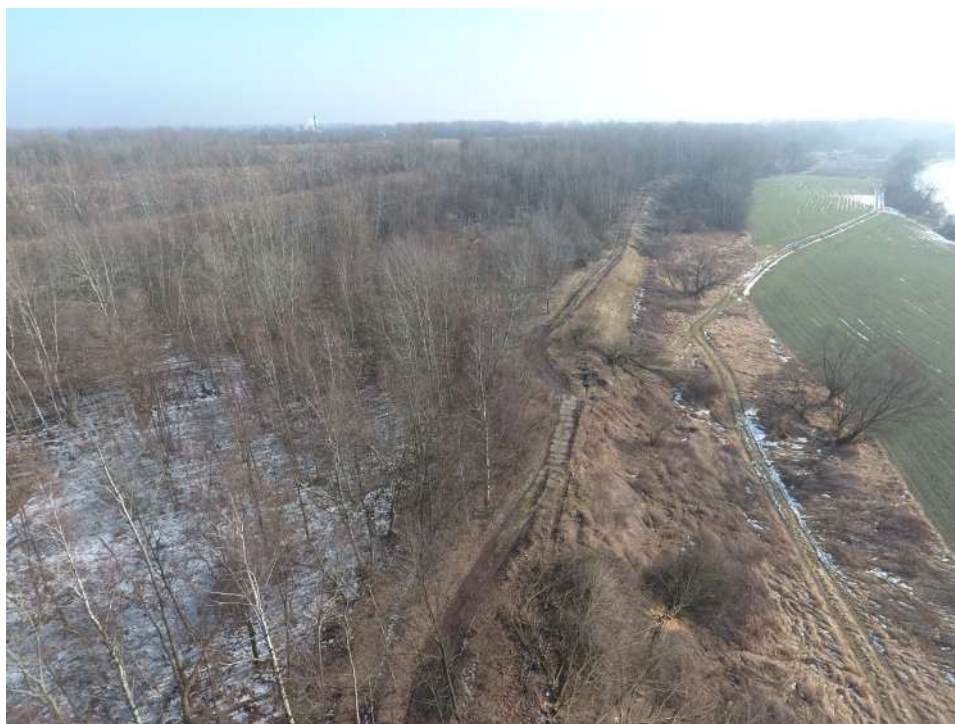
Foto. 2. Condition of the area before the commencement of works – the left Vistula embankment planned for reconstruction *on section 1.2*, condition in the first decade of February 2021 (view downstream).

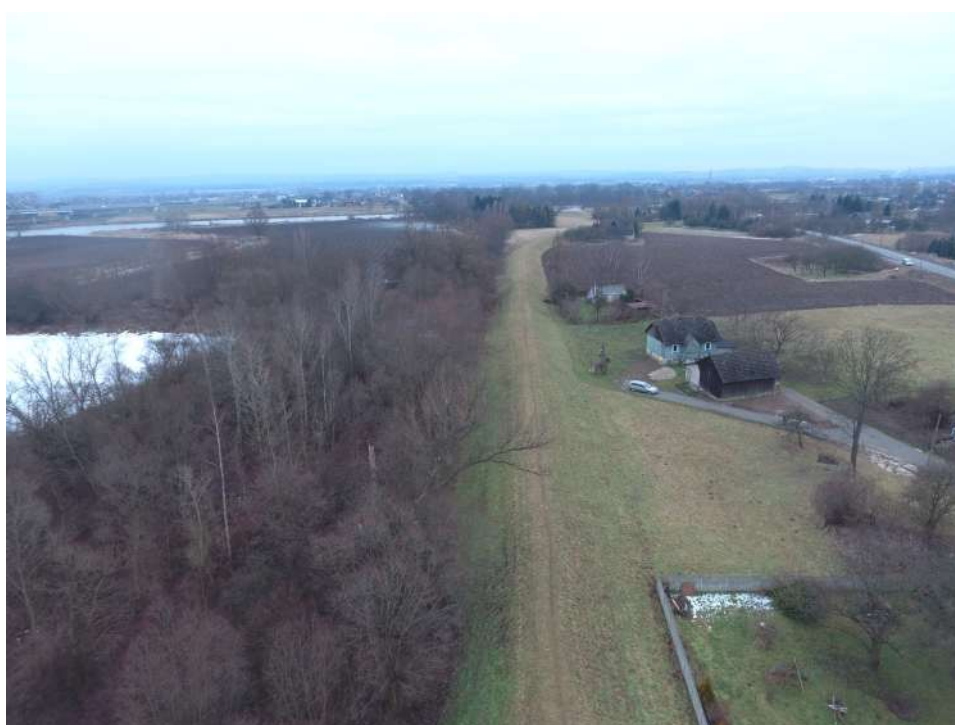
Foto. 3. Condition of the area before the commencement of works – the left Vistula embankment planned for reconstruction *on section 1.3*, condition in the third decade of February 2021 (view downstream).

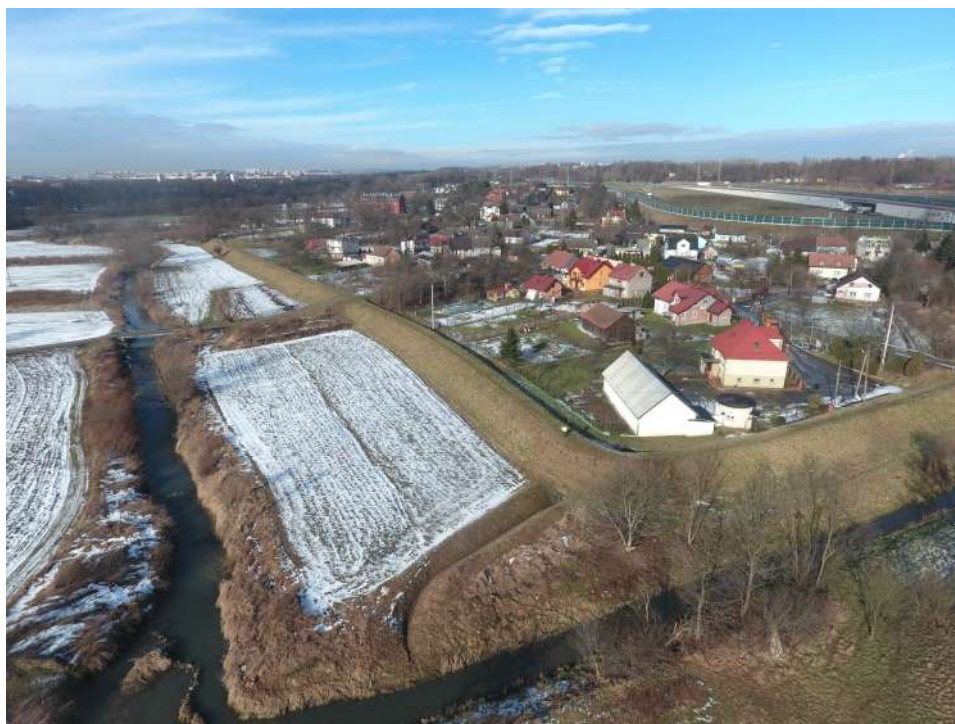
Foto. 4. Condition of the area before the commencement of works – the right embankment of Dłubnia planned for reconstruction *on section 1.4*, condition in the first decade of February 2021 (view downstream).

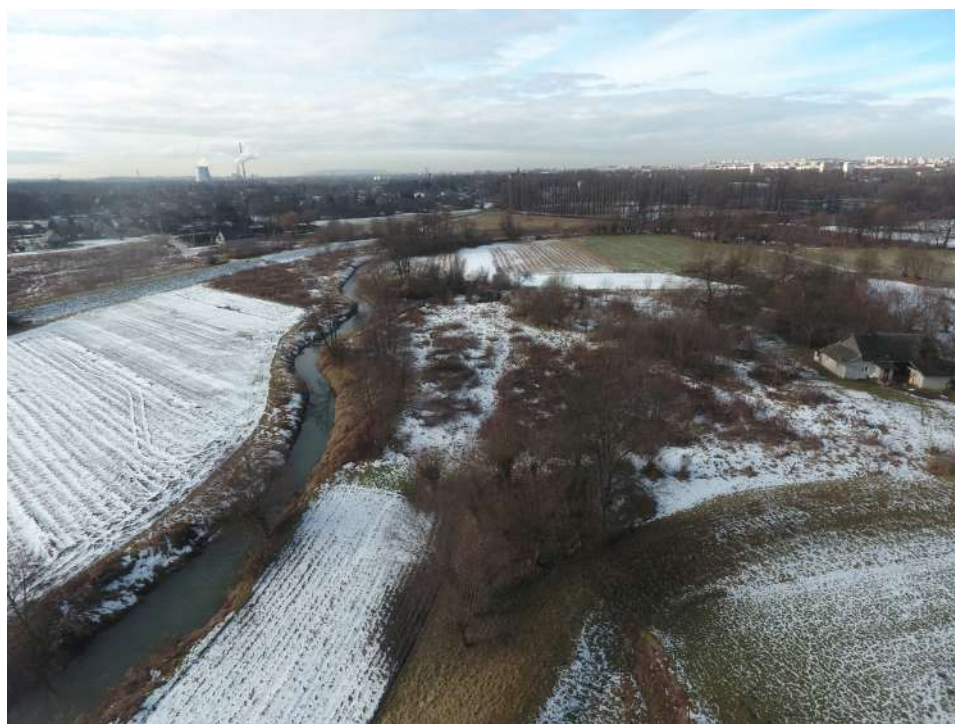
Foto. 5. Condition of the area before the commencement of works – left embankment of Dłubnia planned for reconstruction *on section 1.5*, condition in the first decade of February 2021 (view upstream).

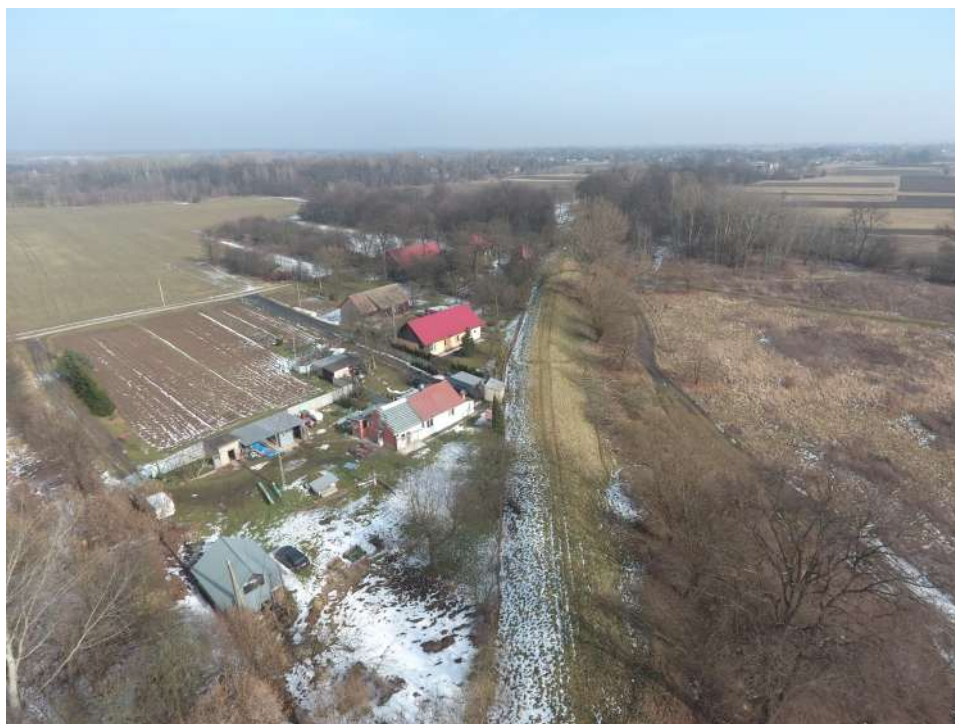
Foto. 6. Condition of the area before the commencement of works – area of planned construction of the left embankment of Dłubnia *on section 1.6*, condition in the first decade of February 2021 (view upstream).

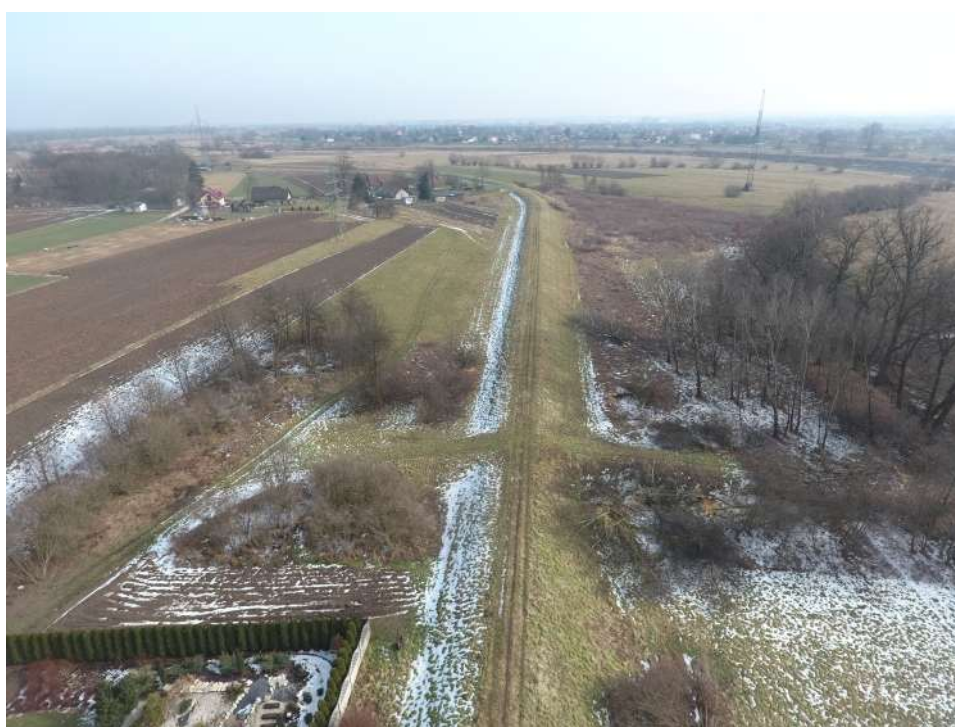
Foto. 7. Condition of the area before the commencement of works – the left Vistula embankment planned for reconstruction *on section 2* – upper part, condition in the third decade of February 2021 (view downstream).

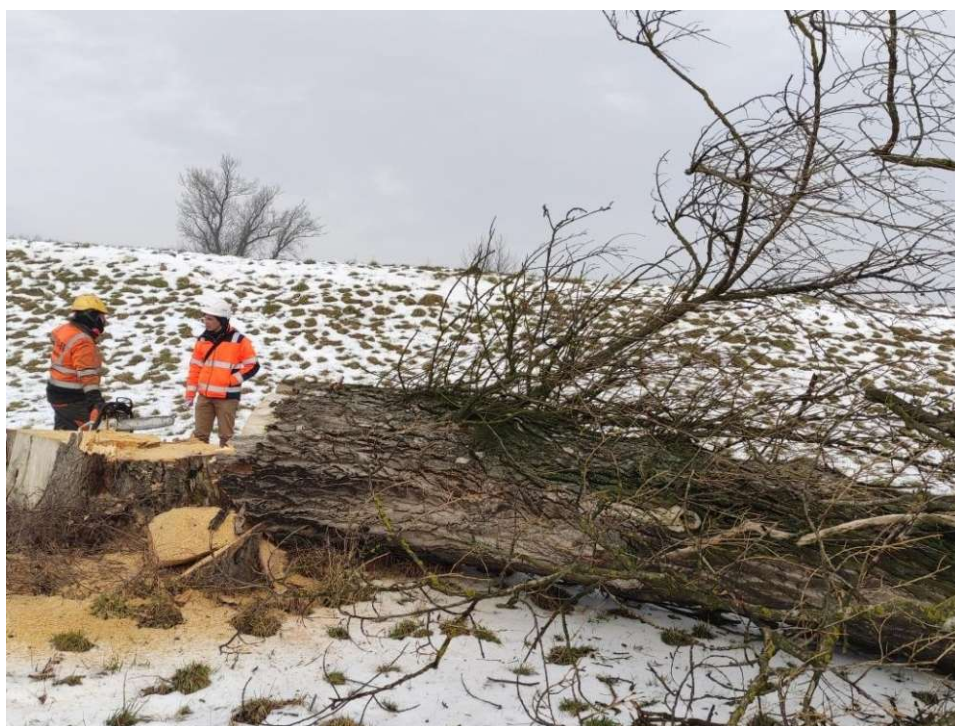
Foto. 8. Condition of the area before the commencement of works – left Vistula embankment planned for reconstruction *on section 2* – lower part, condition in the third decade of February 2021 (view downstream).

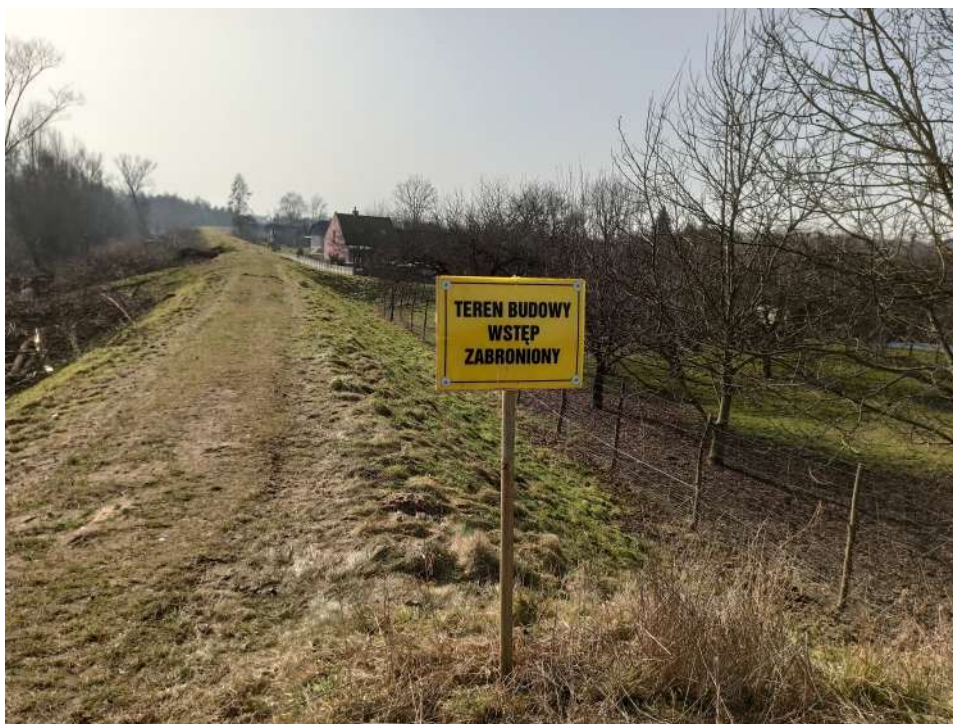
Foto. 12. Storage yard on the left bank of the Vistula embankment – left bank of the Vistula *on section 2*, state in the third decade of October 2021 (view downstream).

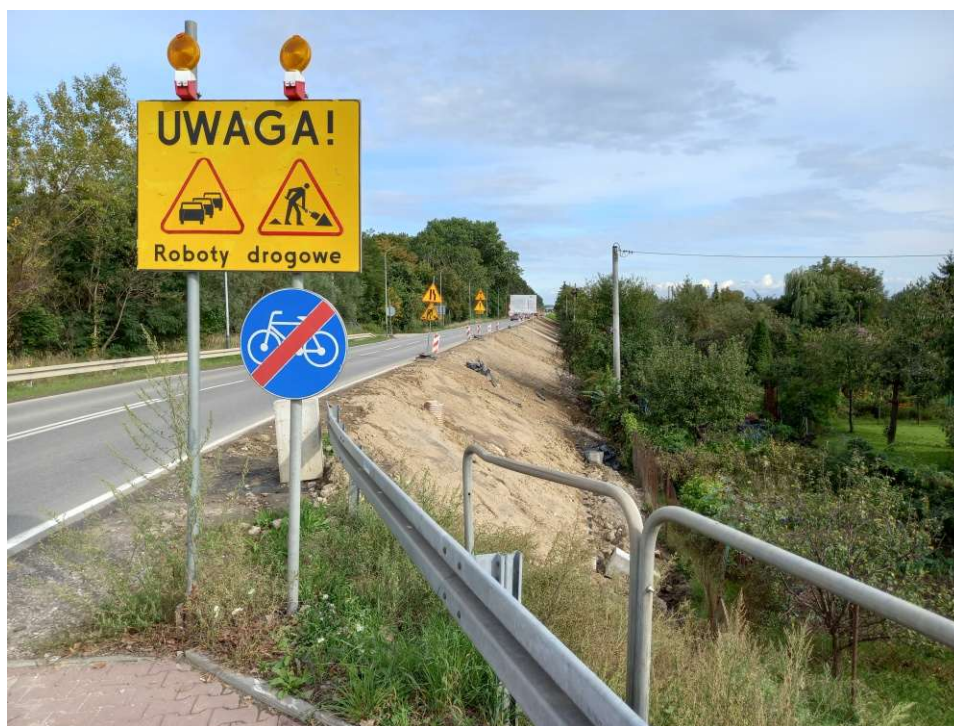
Foto. 14. Construction site marking – right embankment of Dłubnia *on section 1.4*, condition in the third decade of May 2022 (view upstream).

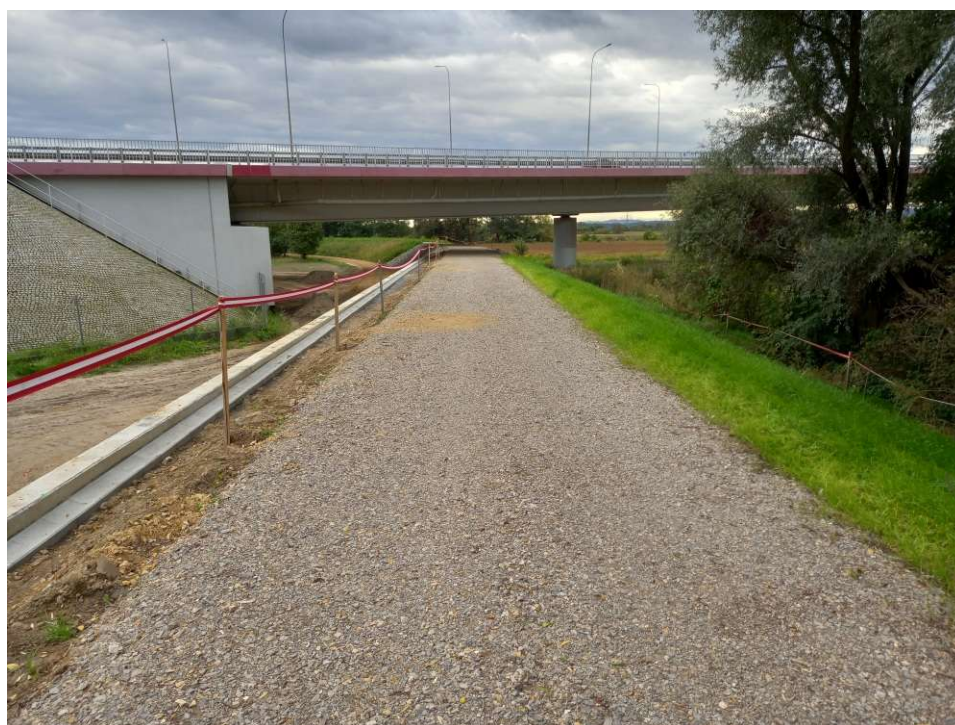
Foto. 17. Securing dangerous places - right bank of Dłubnia *on section 1.4*, condition in the second decade of October 2022 (view downstream).

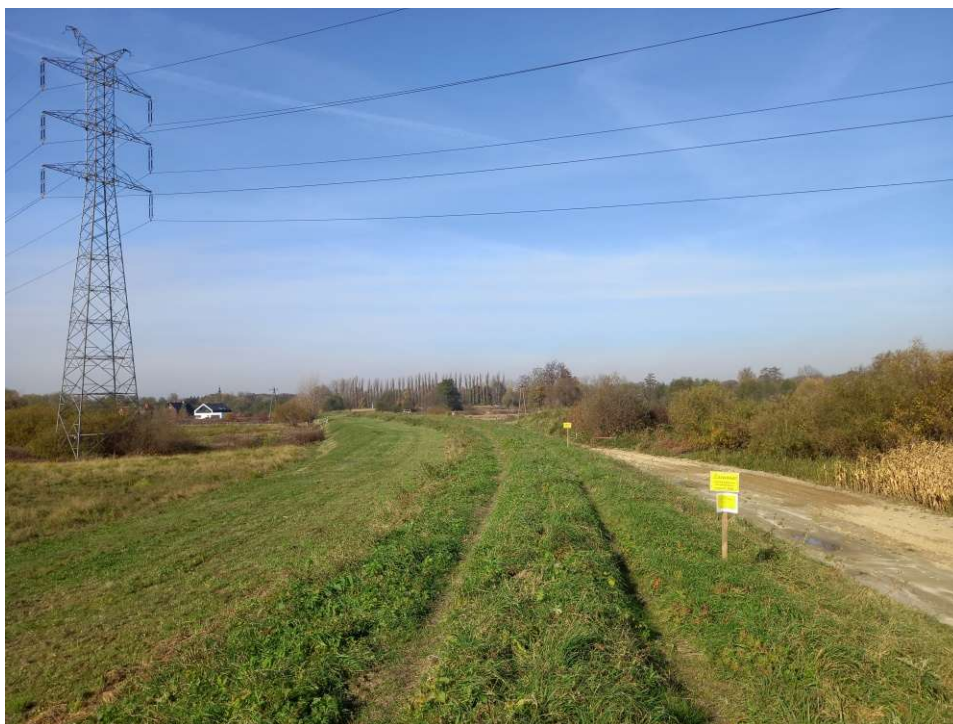
Foto. 18. Securing dangerous places – left embankment of Dłubnia *on section 1.5*, condition in the third decade of September 2022 (view downstream).

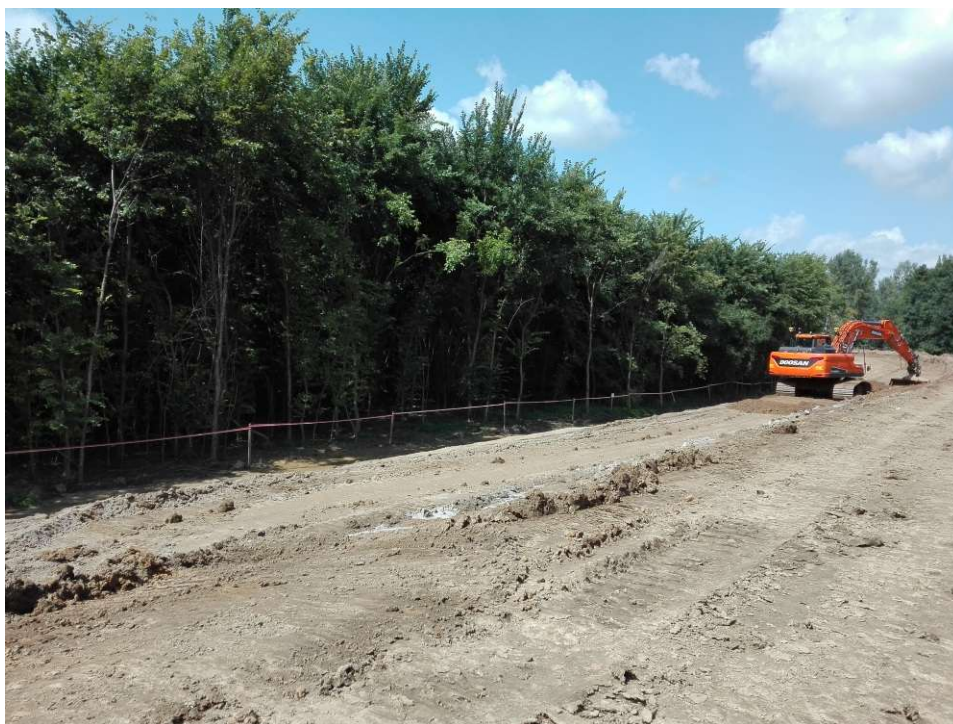
Foto. 20. Securing dangerous places under the power line – left Vistula embankment *on section 2*, state in the third decade of October 2022 (view downstream).

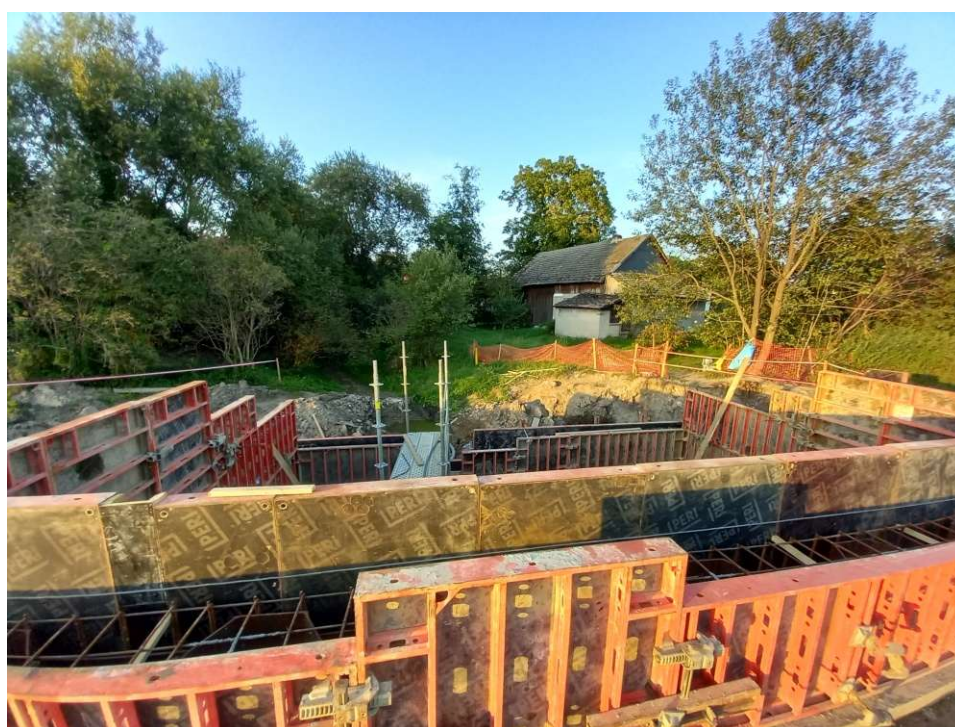
Foto. 33. Reconstruction of the embankment culvert - left embankment of the Vistula River *on section 2*, condition in the second decade of May 2022 (view towards the inter-embankment area).

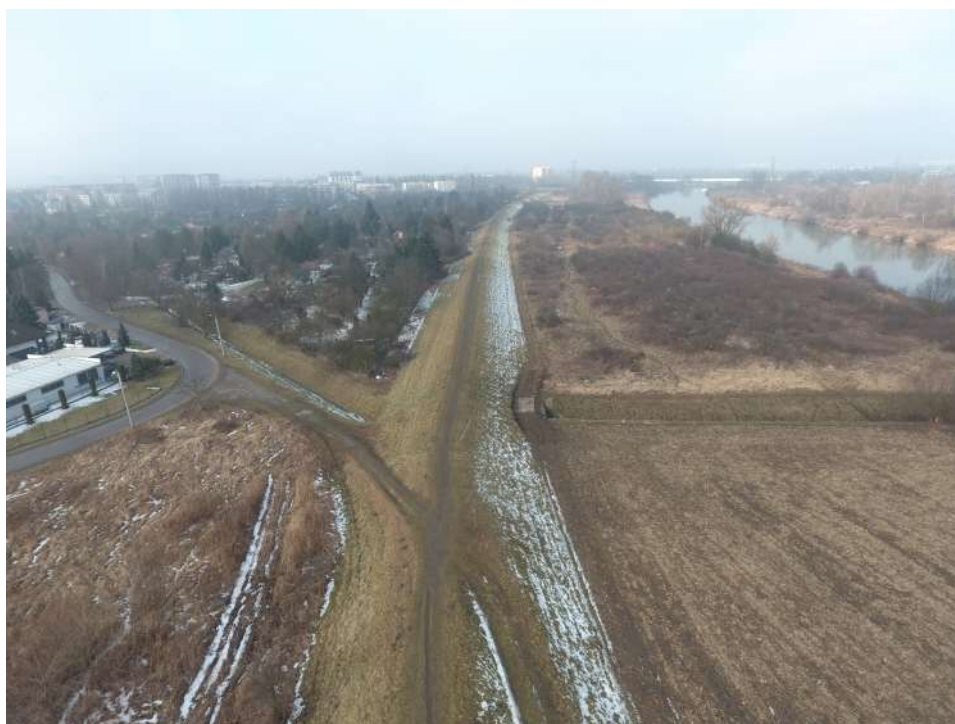
Foto. 57. Condition of the area before the commencement of works – the right Vistula embankment planned for reconstruction *on section 3.1*, condition in the first decade of February 2021 (view upstre).

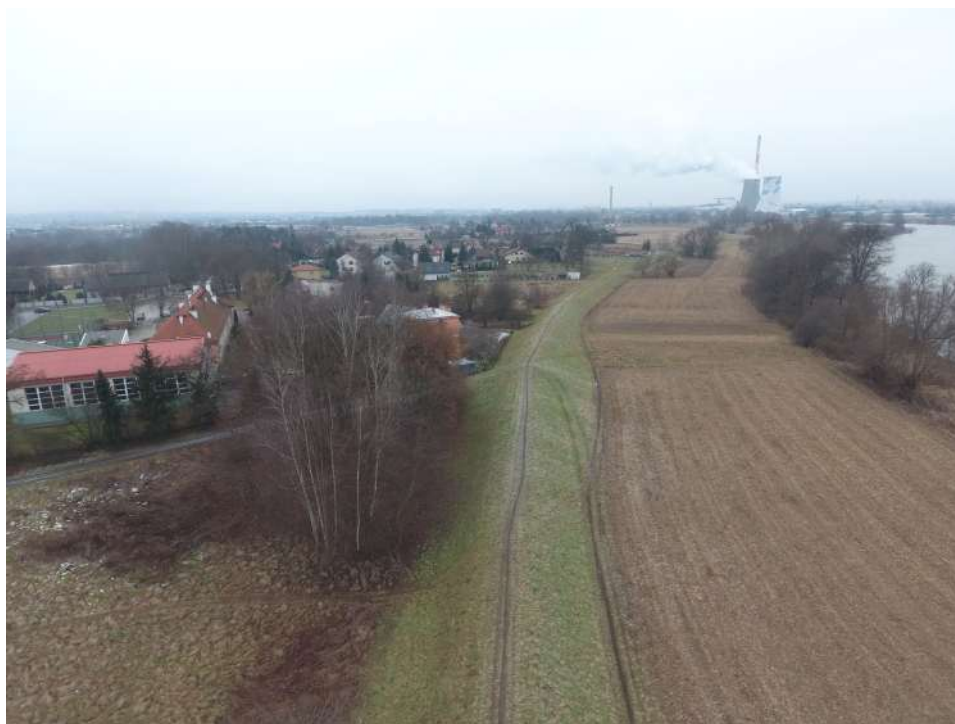
Foto. 58. Condition of the area before the commencement of works – the right Vistula embankment planned for reconstruction *on section 3.2a*, condition in the first decade of February 2021 (view upstream).

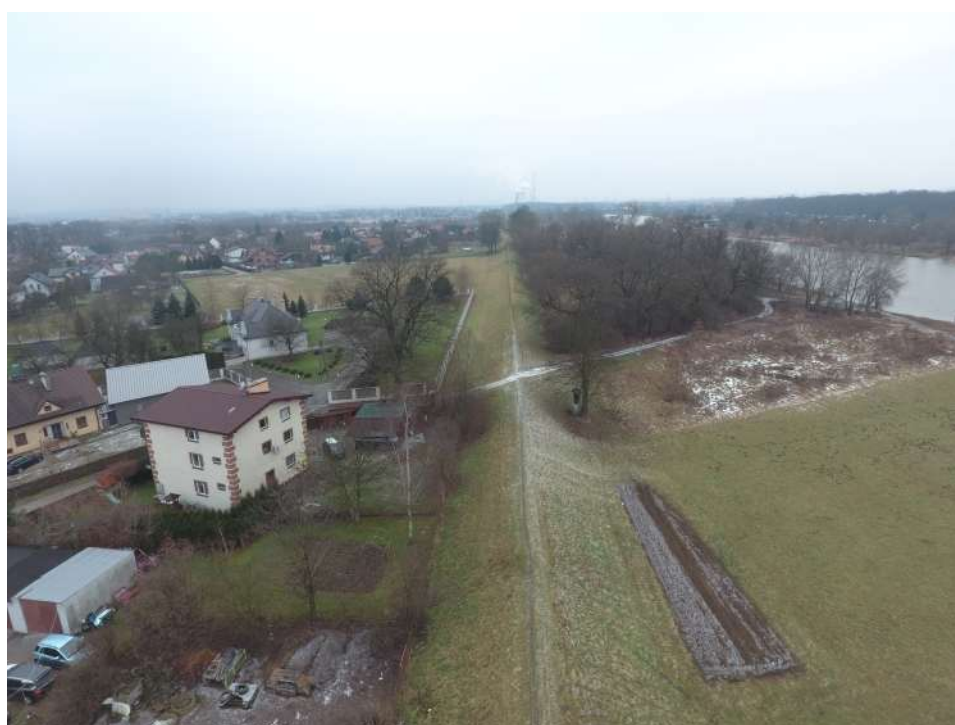
Foto. 59. Condition of the area before the commencement of works – the right Vistula embankment planned for reconstruction *on section 3.2b*, condition in the first decade of February 2021 (view upstream).

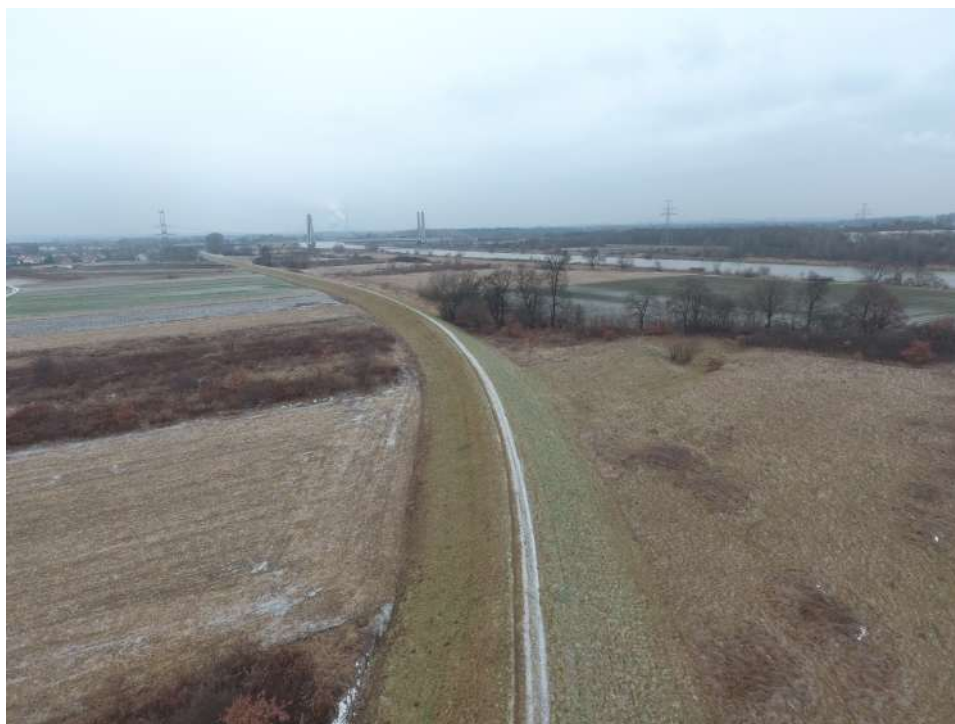
Foto. 60. Condition of the area before the commencement of works – the right Vistula embankment planned for reconstruction *on section 3.3* – upper part, condition in the first decade of February 2021 (view upstream).

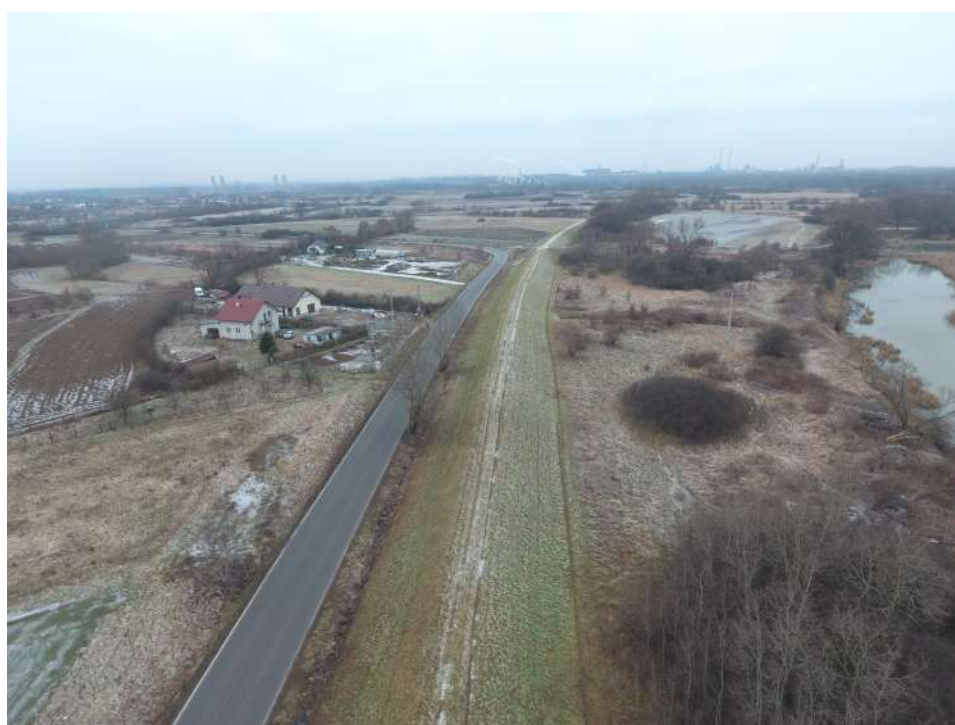
Foto. 61. Condition of the area before the commencement of works – the right Vistula embankment planned for reconstruction *on section 3.3* – lower part, condition in the first decade of February 2021 (view upstream).

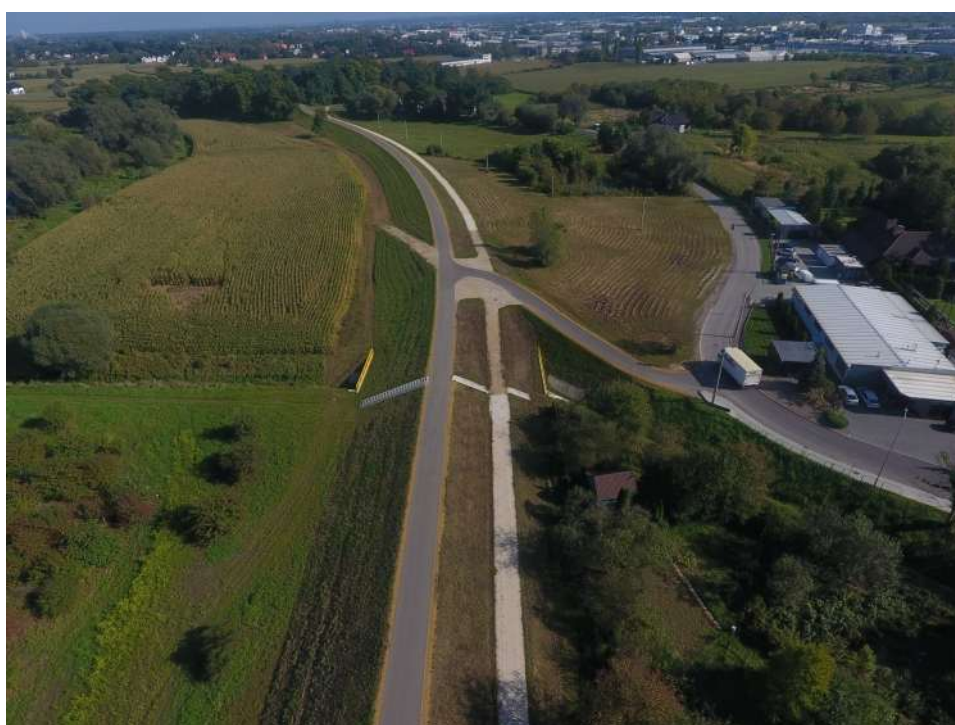
Foto. 113. Condition of the construction site in the last quarter of the works implementation period – rebuilt right Vistula embankment *on section 3.1*, condition in the third decade of September 2023 (view downstream).

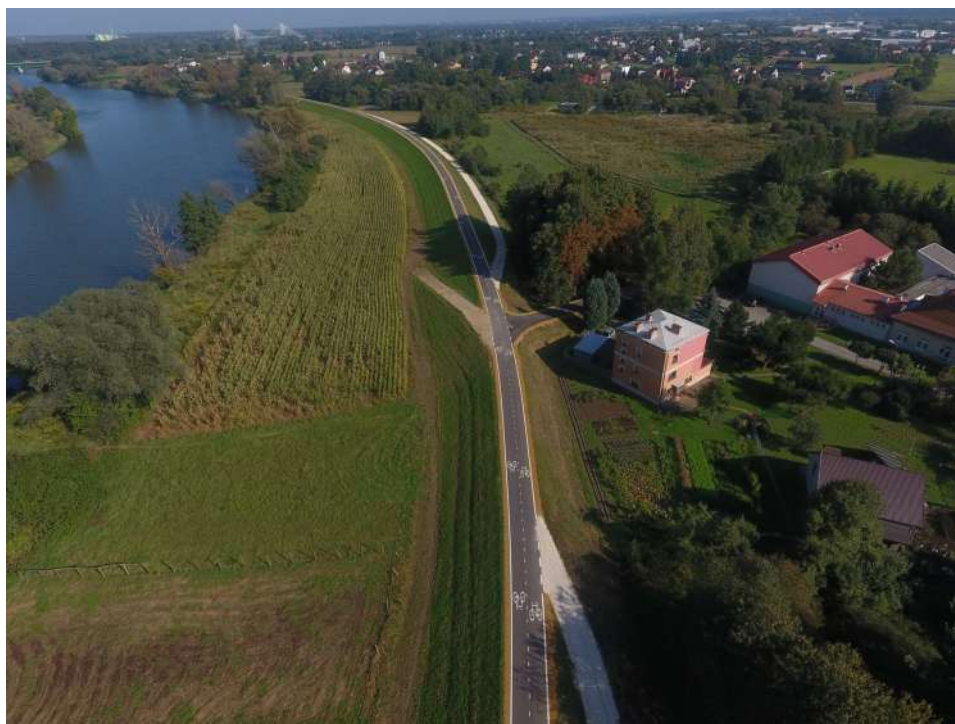
Foto. 114. Condition of the construction site in the last quarter of the works implementation period – rebuilt right Vistula embankment *on section 3.2a*, condition in the third decade of September 2023 (view downstream).

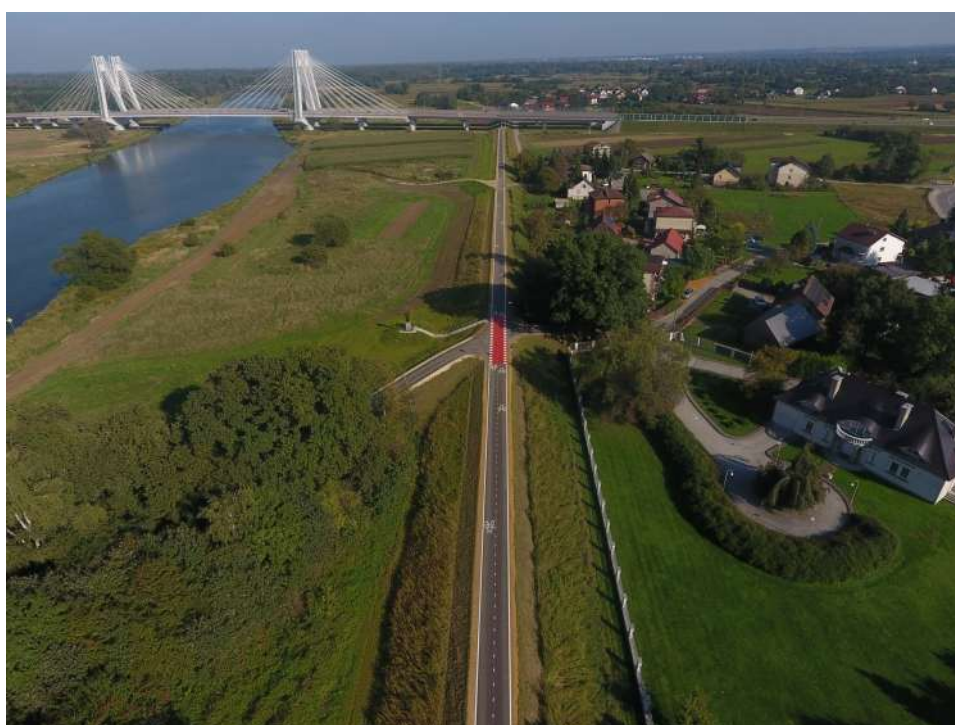
Foto. 115. Condition of the construction site in the last quarter of the works implementation period – rebuilt right Vistula embankment *on section 3.2b*, condition in the third decade of September 2023 (view downstream).
