**Aircraft Accident and Incident
Investigation Agency**
10002 Zagreb, Prisavlje 14

FINAL REPORT

OF AIRCRAFT SKYLEADER 500 ACCIDENT WHICH OCCURRED ON SEPTEMBER 25th 2010 IN THE AREA OF BUDAČKA RIJEKA

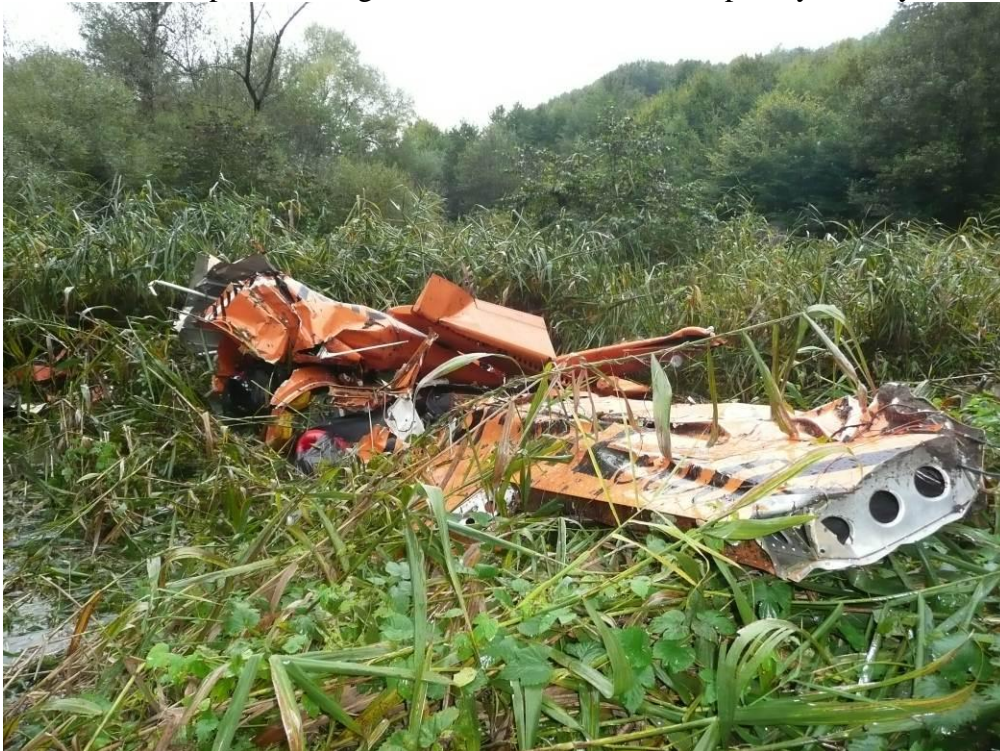
Image 11

After the impact on the ground, the aircraft was completely destroyed.

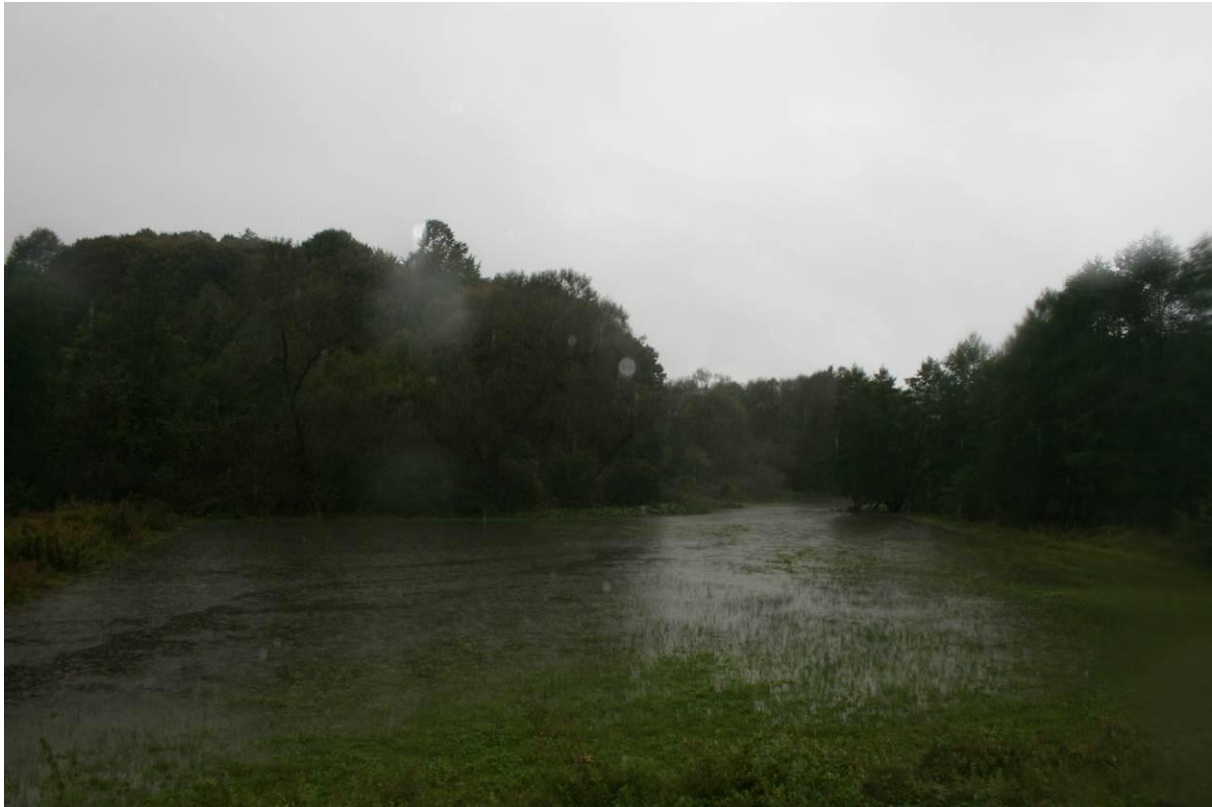
The location of the crash site was covered with water due to heavy rains that led to the outpouring of the stream (Image 30).

Image 30 Location of the crash site

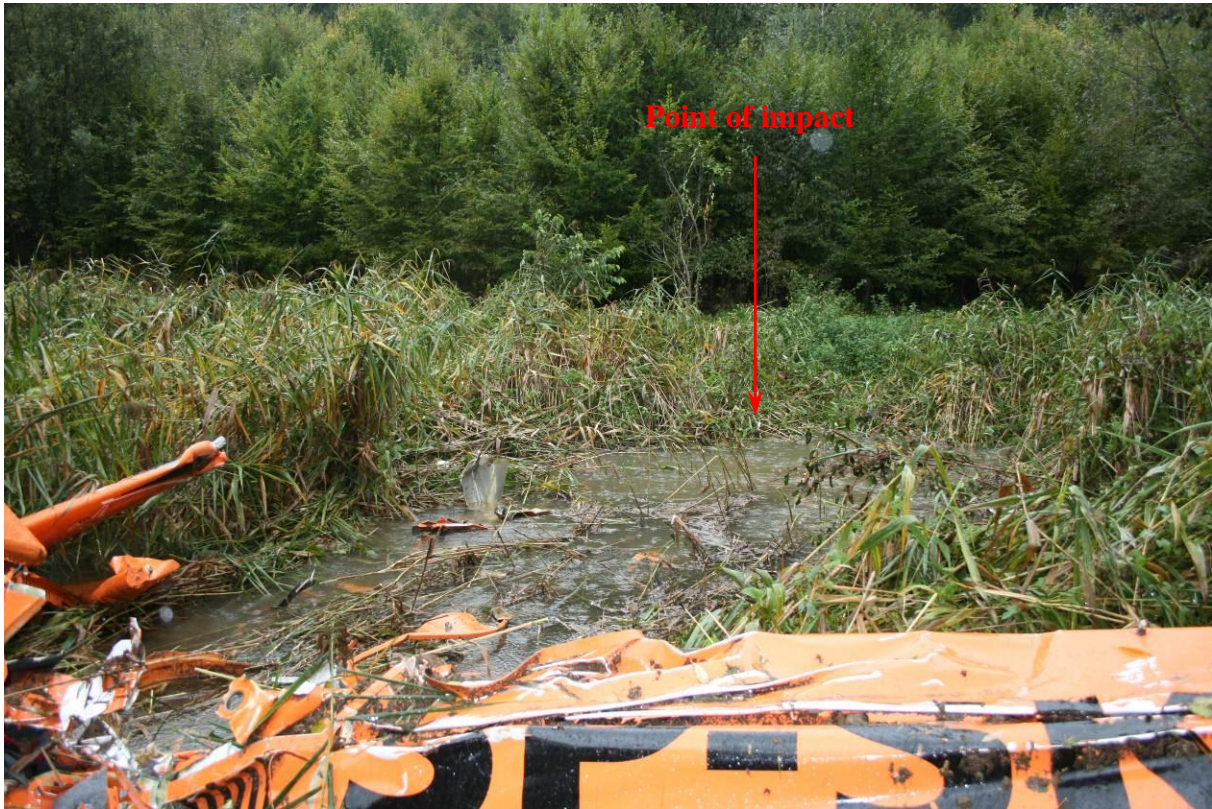
Scene investigation of the crash site revealed that the aircraft was completely destroyed from the force of impact (Image 11) and that the engine has, due to soft ground and the force of impact, buried in the ground. The point of impact was located approximately 2-3 m from where the wreckage was found (Image 31).

Image 31 Point of impact in the ground

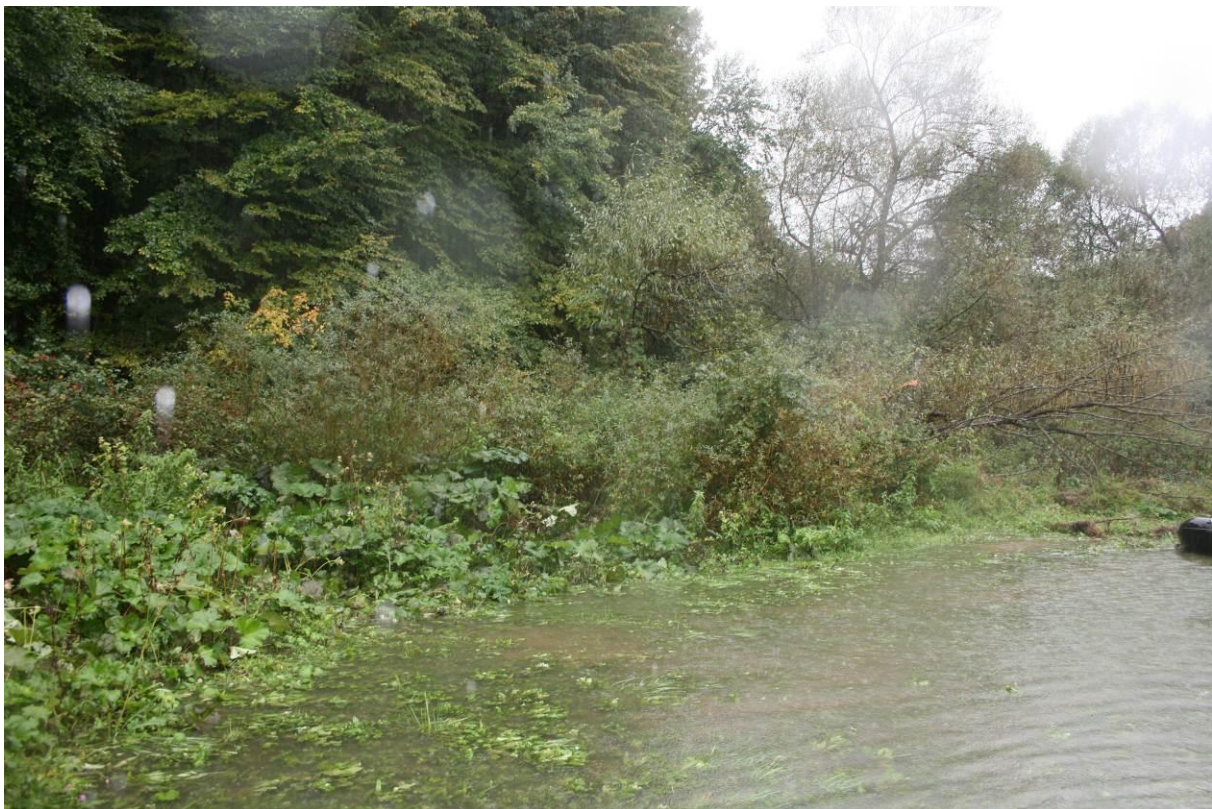
Canopy (Image 34) and the left wing were found approx 100 -150 m away from the wreckage. The left wing didn't show any greater damage beside deformations on the wing root (Images 32 and 33).

Image 32 Location of left wing recovery

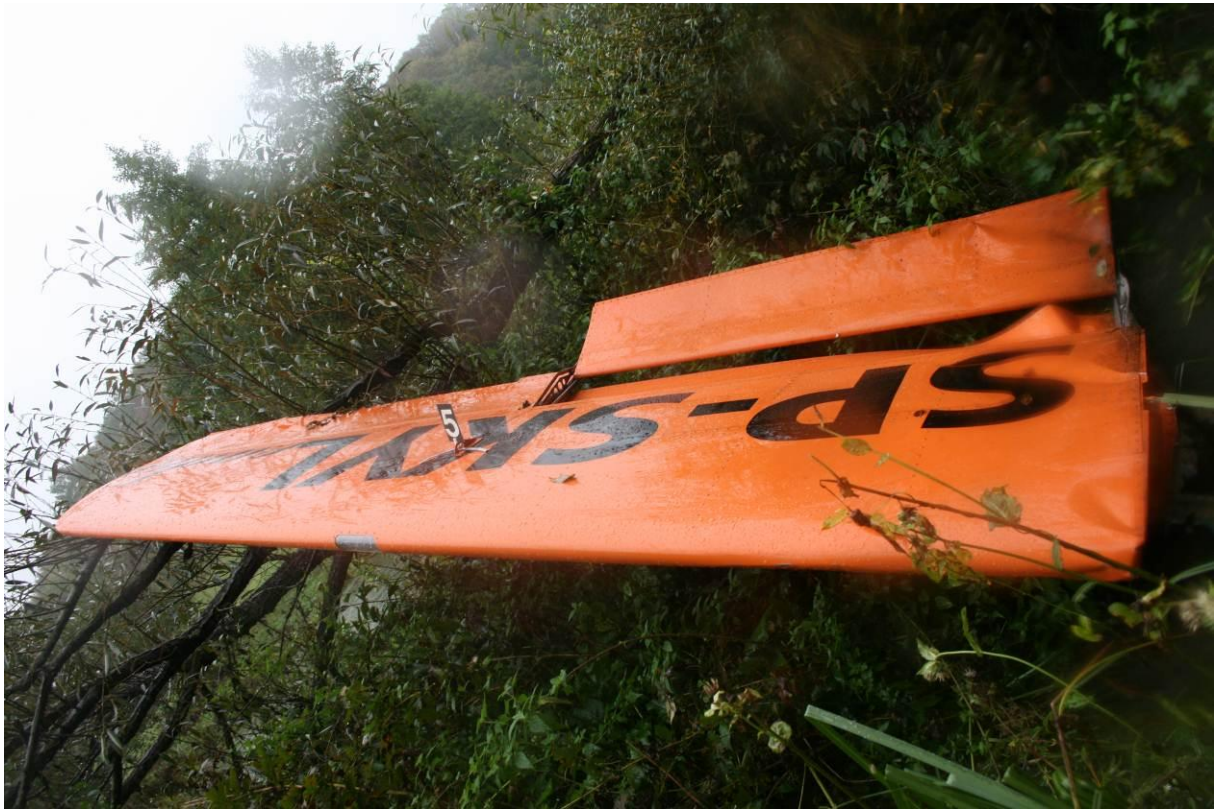
Image 33 Left wing

On October 12th 2010 in the premises of Karlovac Police department in Erjavec, a detailed analysis of the aircraft wreckage was conducted. The analysis showed that the left wing hasn't sustained considerable damage beside deformations at the root, which were formed by wing separating from the center section and cracking of wing spar (Image 38), suggesting that the wing was cut off during the flight and, at a low speed, fell on the trees (1.12, Image 33).

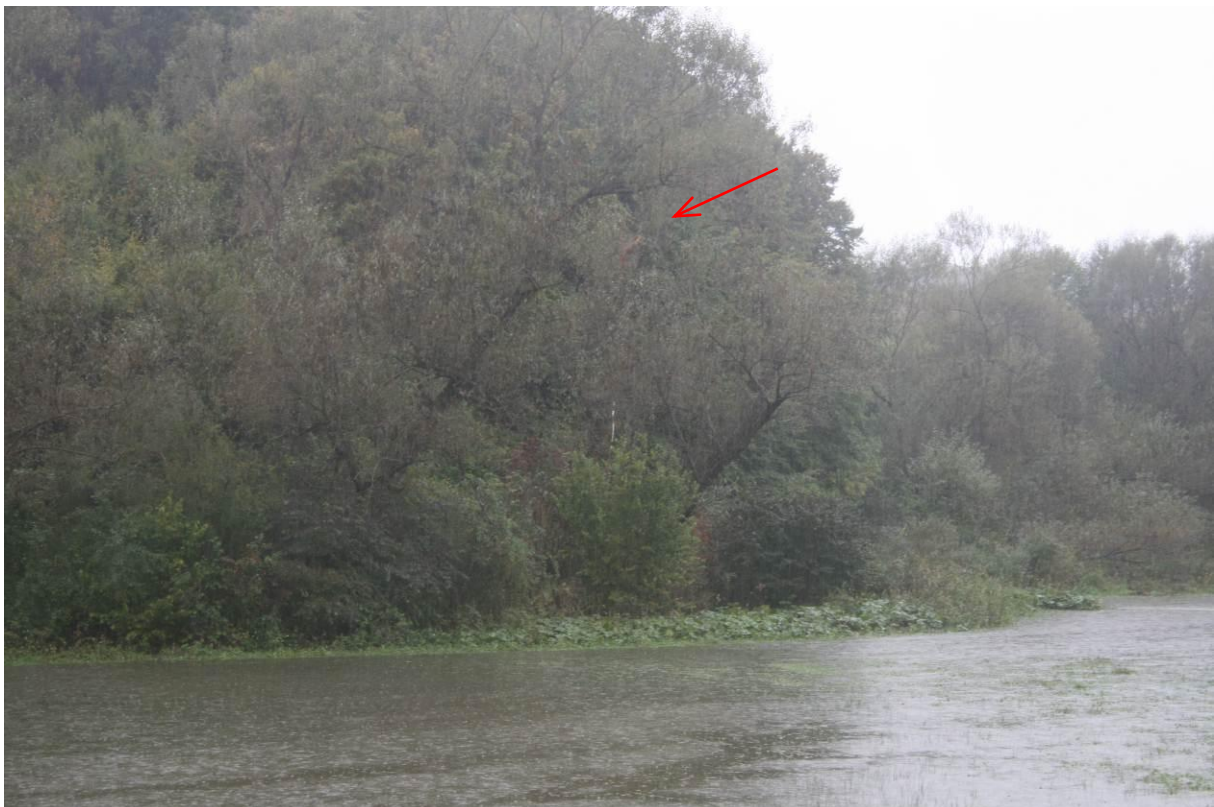
Image 34 Canopy

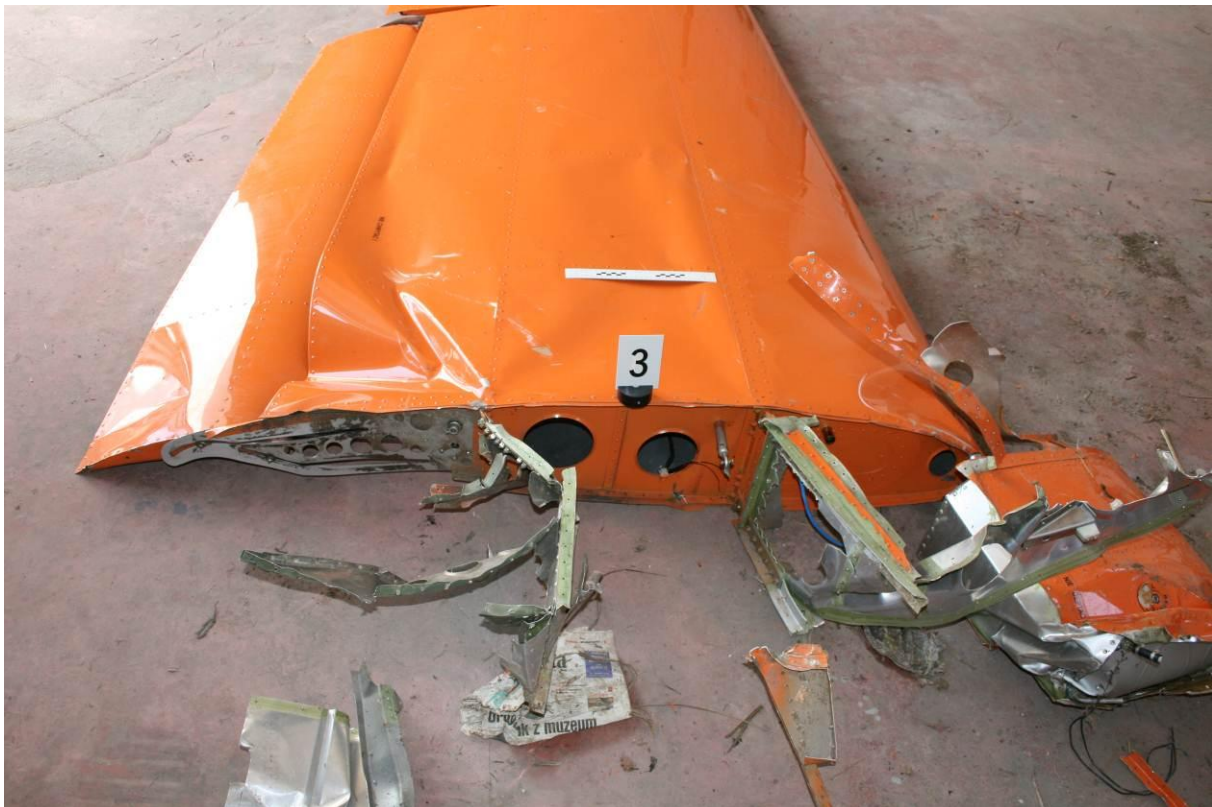
Image 38 Deformations on the left wing and wing span

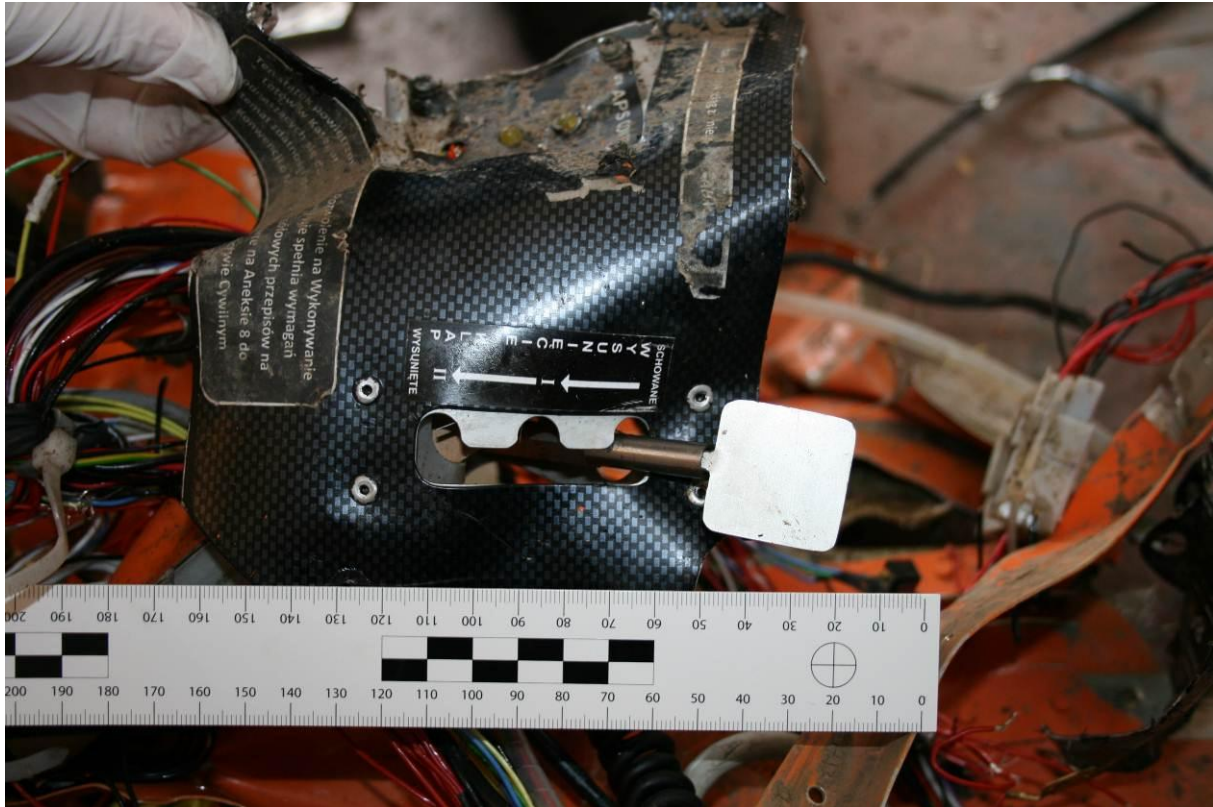
Flaps on the left wing were found in the extracted position, while the right wing flap was found in the retracted position. Found remains of the lever for flaps extraction show that the lever was in a position for retraction (Image 39). Also, the electric actuator for flaps activation was in the retracted position (Image 40). Based on this, it can be assumed that the flaps were in the retracted position during flight and that the flap on the left wing fell out after the wing fracture and braking of strings which keep it in the retracted position.

Image39 Lever for flaps extraction

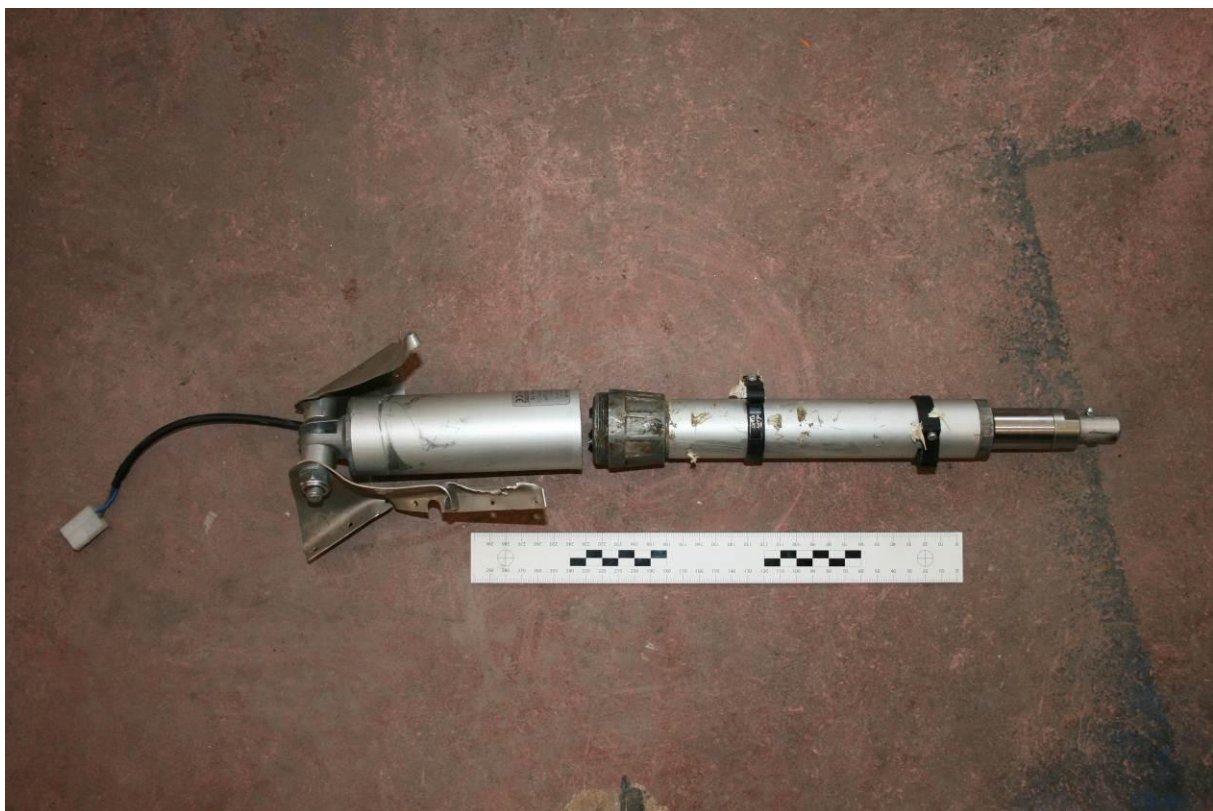
Image 40 Actuator for flaps activation

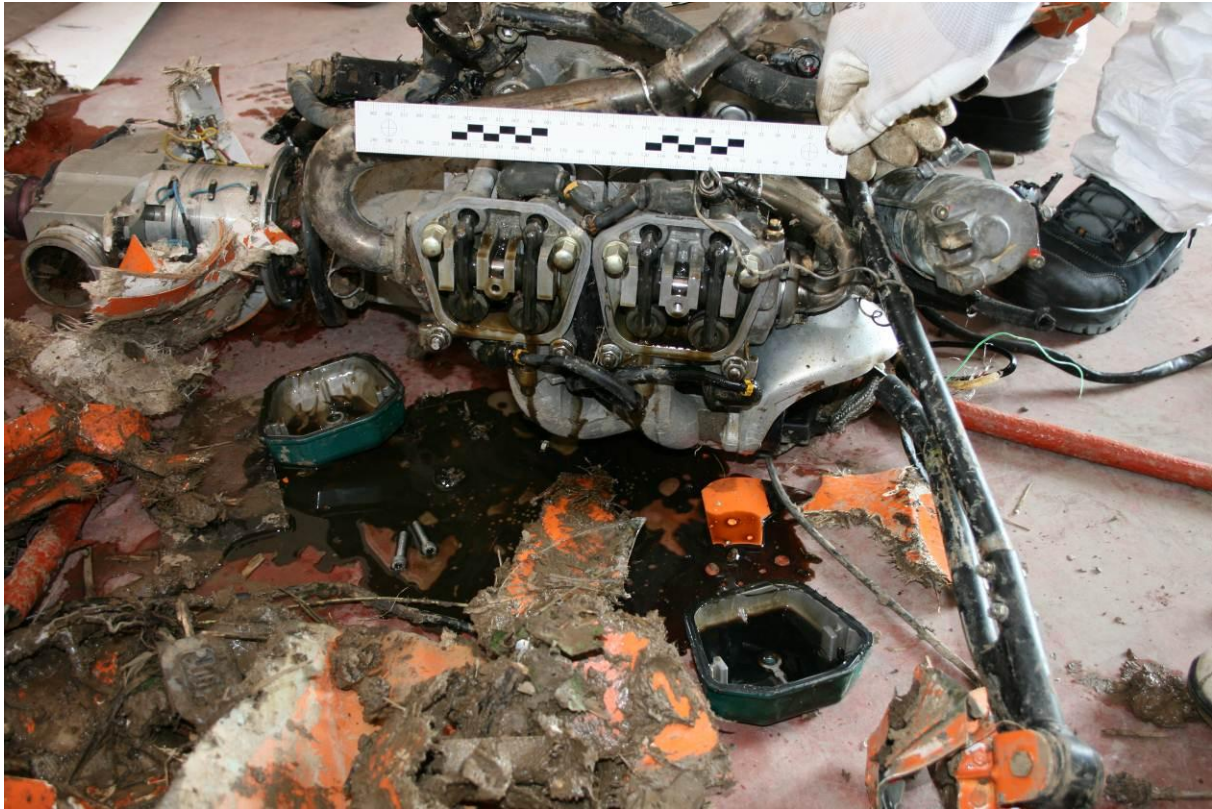
Engine and propeller were also examined and it was found that all the damage to the engine was during impact on the ground. In the carburettor float bowl, a mixture of water and fuel was found. Since the engine was found stuck in the marshy ground, it was concluded that the water entered the system after the crash (Image 41). Both propeller blades were broken and by the damage on the blades it can be concluded that the blades cracked during the impact on the ground (Images 42 and 43).

Image 41 Engine

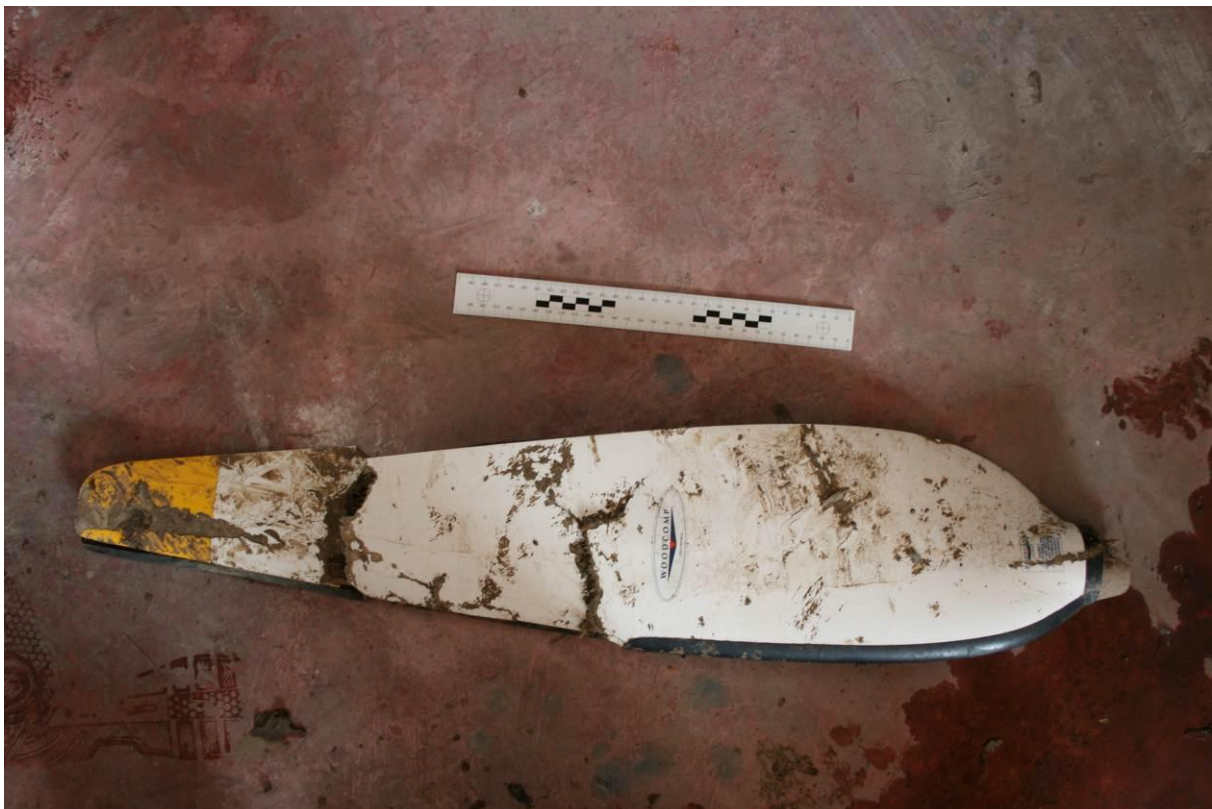
Image 42 Propeller 1

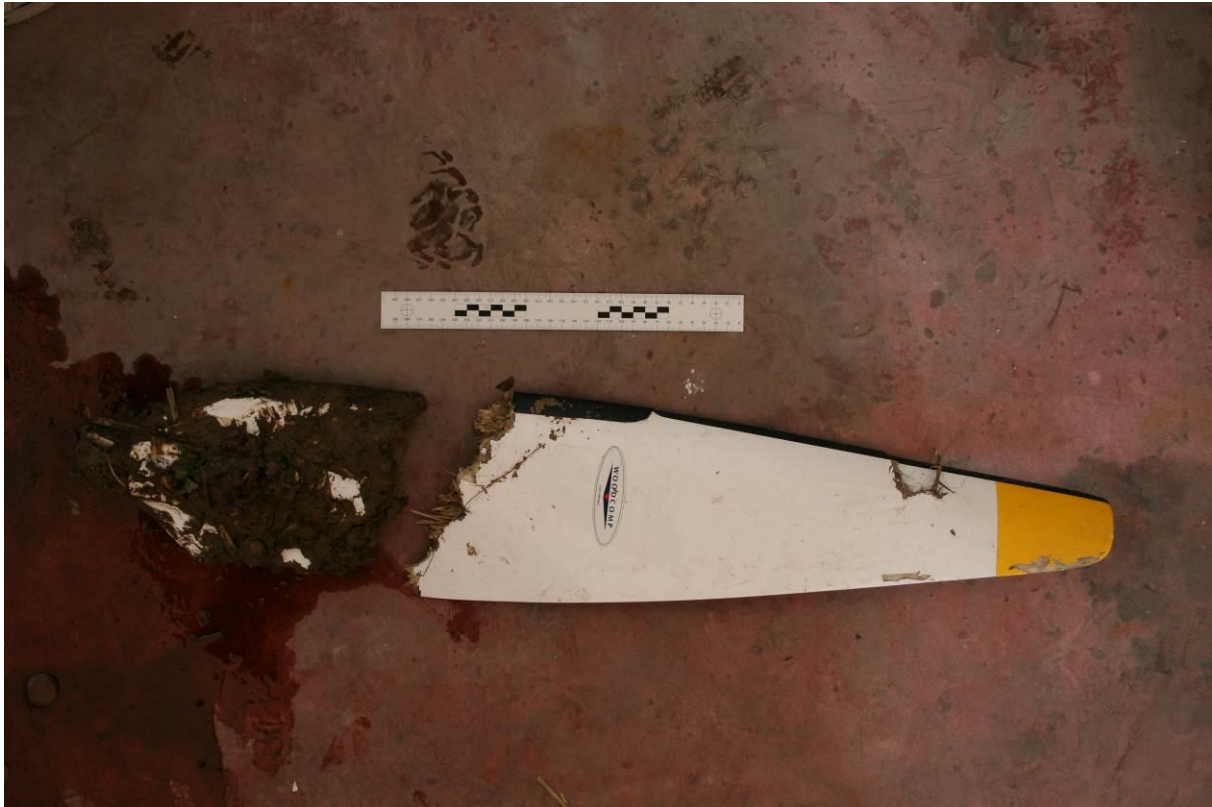
Image 43 Propeller 2

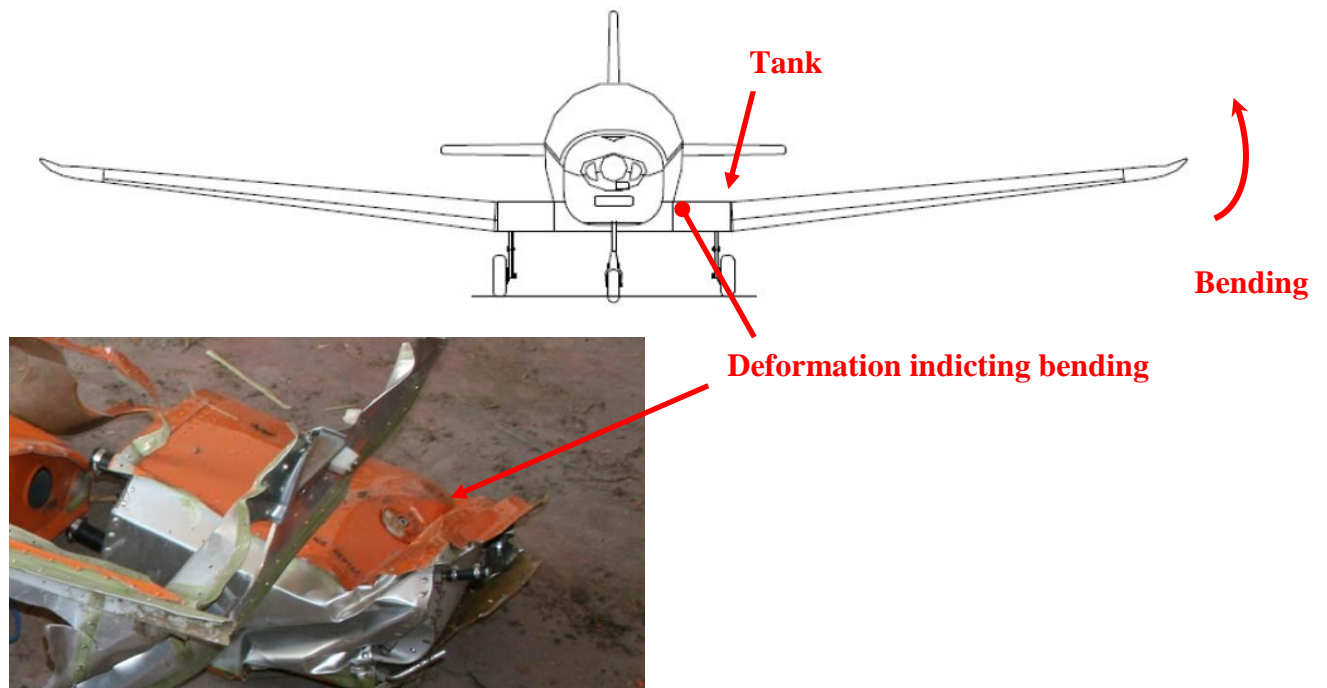
It is our opinion that the key moment was $t=350$ s in the right turn in which the structure was specifically loaded because the load factor reached a value of 4.5, and the speed at that point was above V_{ne} . In this turn, the left wing is more aerodynamically loaded than the right wing. By deformations visible on the tank which is located in the center section and the deformation at the root of the wing, it can be assumed that during the flight at the observed time, ie $t=350$ s, when the right turn came, the bending of the left wing and the center section up occurred (Image 52), after which the supporting wing structure weakened. By weakening the structure, the wing began to move back and forth (Image 53) and at one point, the supporting structure could not hold the aerodynamic loads. Furthermore, the wing (which free fell on the trees) separated from the aircraft center section, after which the aircraft was vertically falling and hit the ground.

Image 52 Bending of the wing

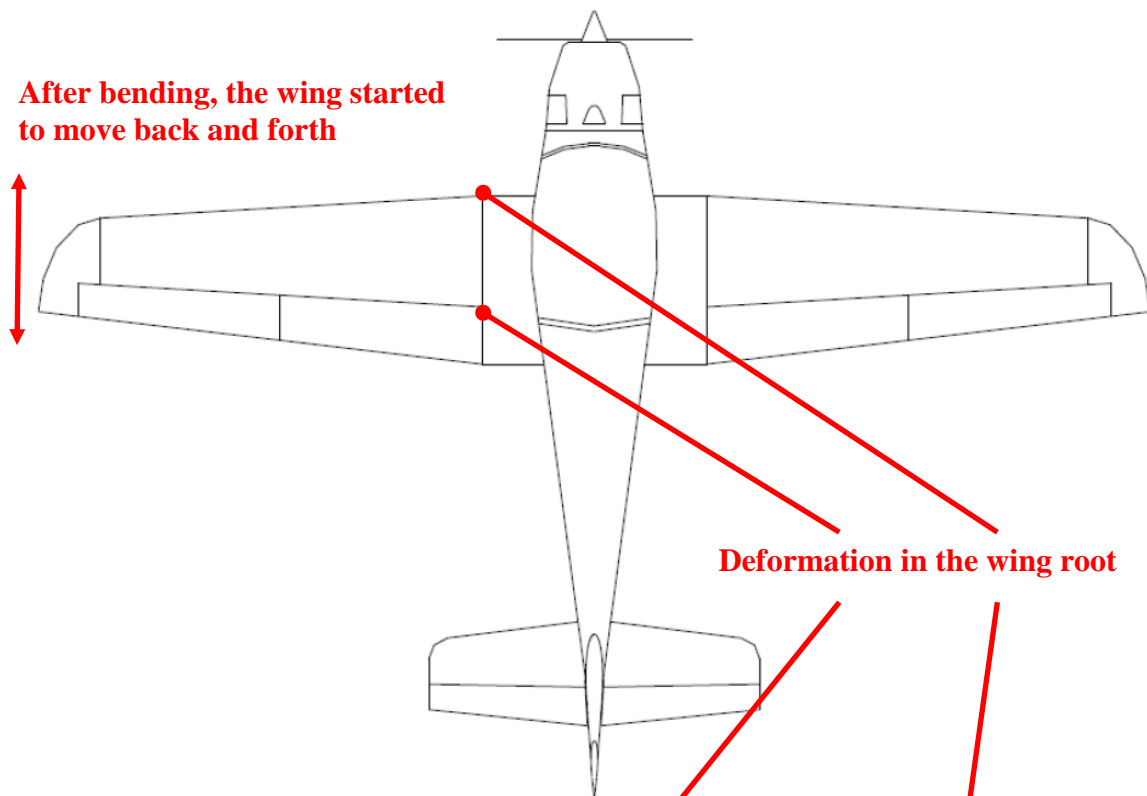
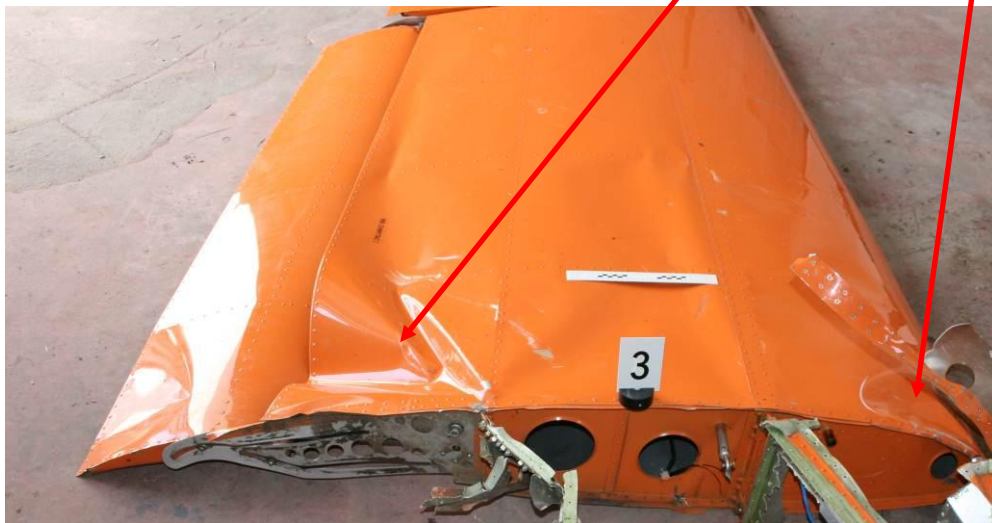
Image 53 Deformations in the wing root
