## STATE COMMISSION ON AIRCRAFT ACCIDENTS INVESTIGATION

# PRELIMINARY REPORT

### Occurrence No: 1860/14

**aircraft: airplane, Embraer EMB-500 Phenom 100,  
SP-AVP**

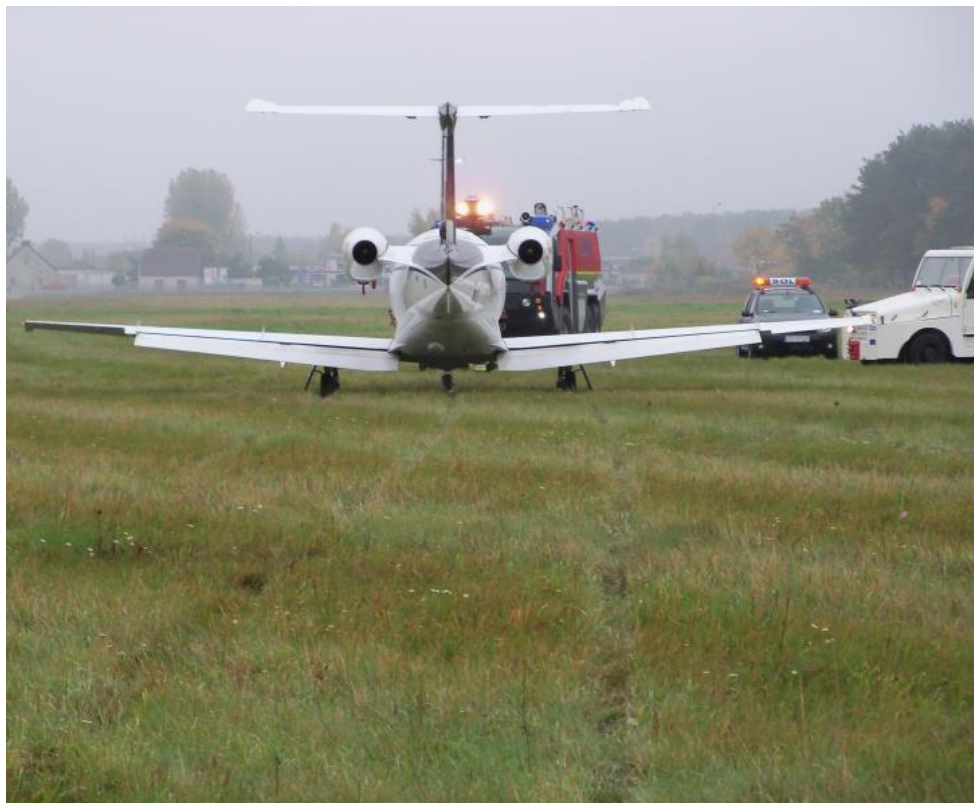
On 15 October 2014 the crew of Embraer EMB-500 airplane performing flight FYJ30 from Geneva (LSGG) to Bydgoszcz (EPBY) landed on RWY 08 and completed the landing roll at the distance of 253[m] from the runway end and 116[m] to the right from its centre line.

**Photo 1. Landing roll traces and Embraer EMB-500 airplane after completing the landing roll.**

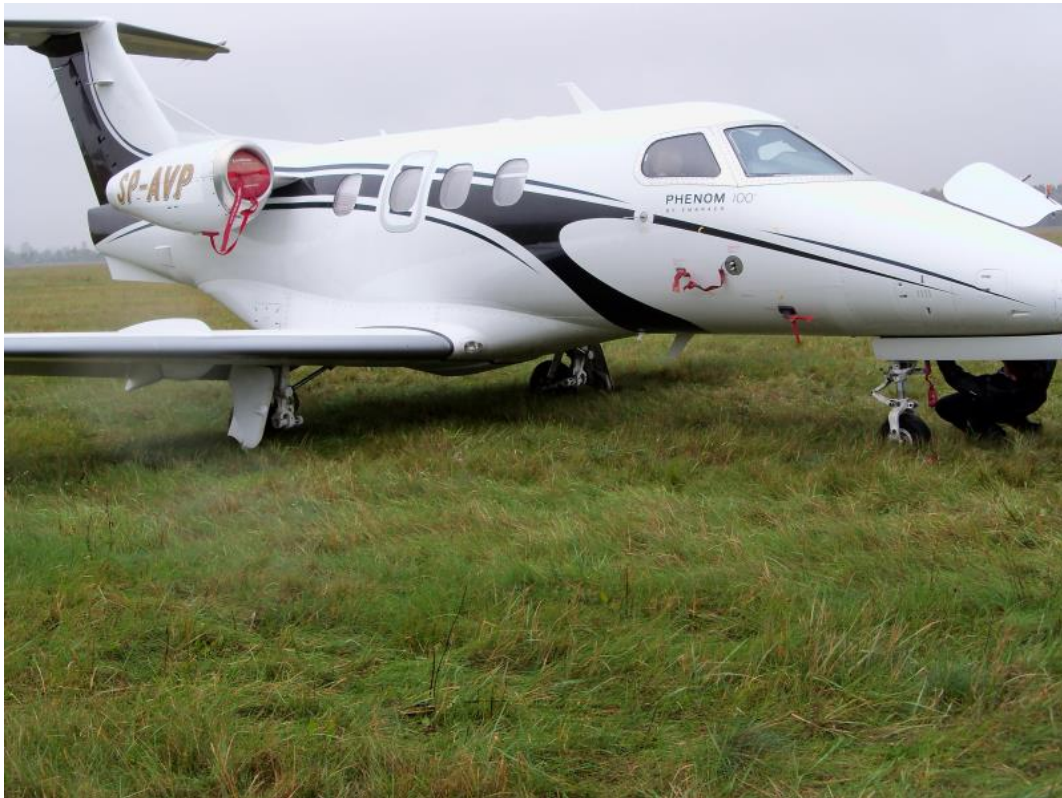
**Photo 2. Embraer EMB-500 airplane on the scene.**

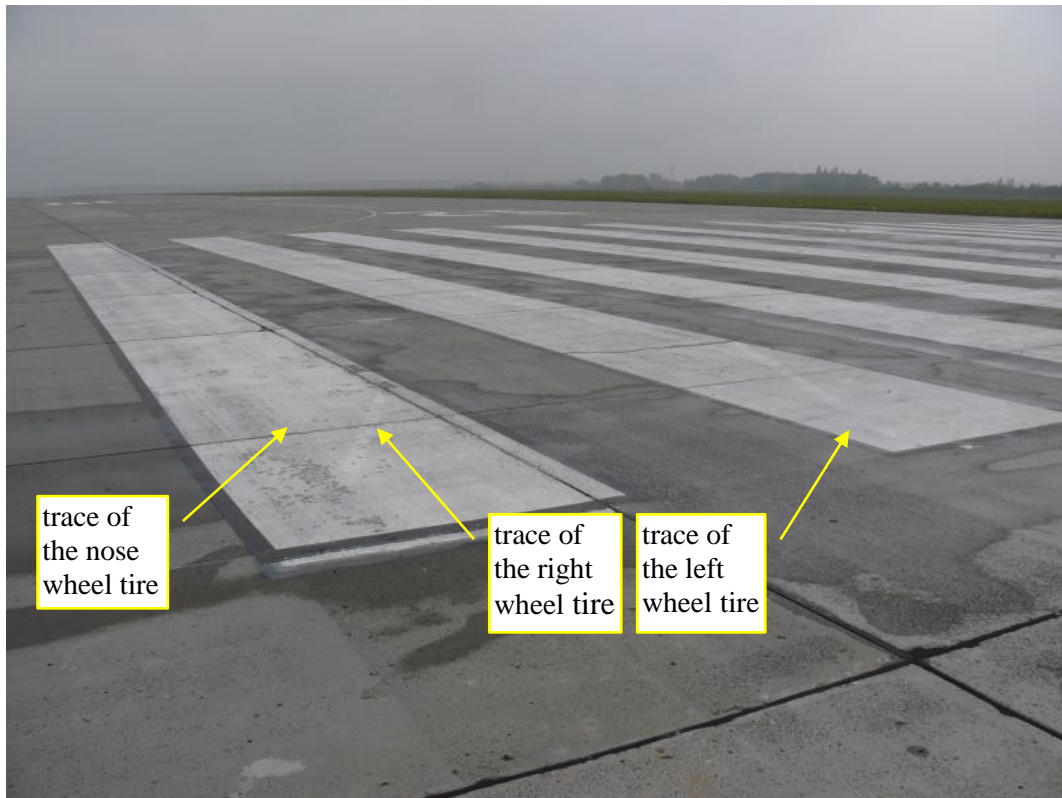
**Photo 2. Landing roll traces near THR 26 (view opposite to the landing direction).**

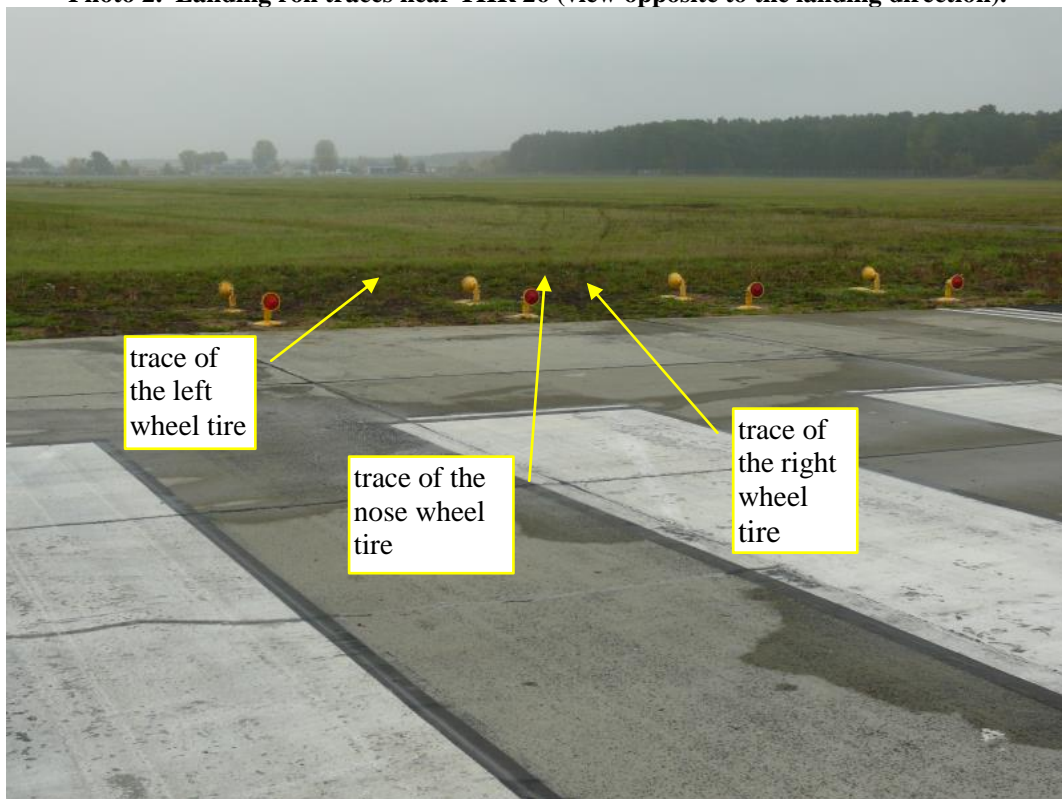
**Photo 3. Landing roll traces on the runway and on the grass near THR 26.**

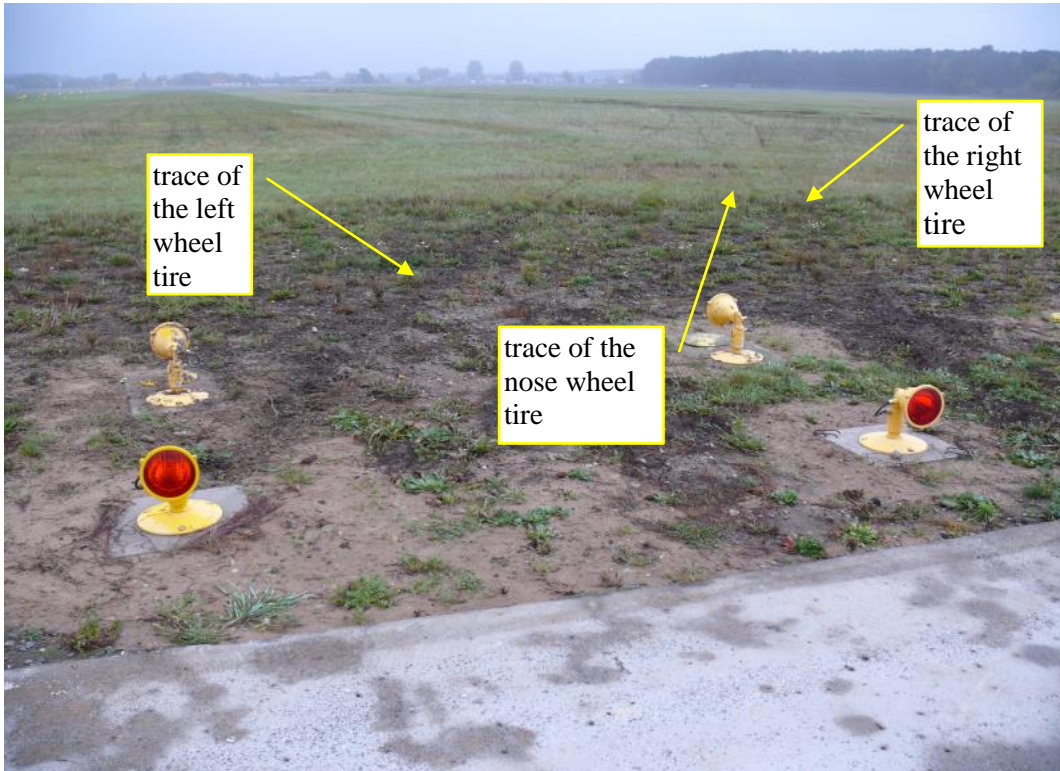
Photo 5. Landing roll traces on the grass near THR 26.

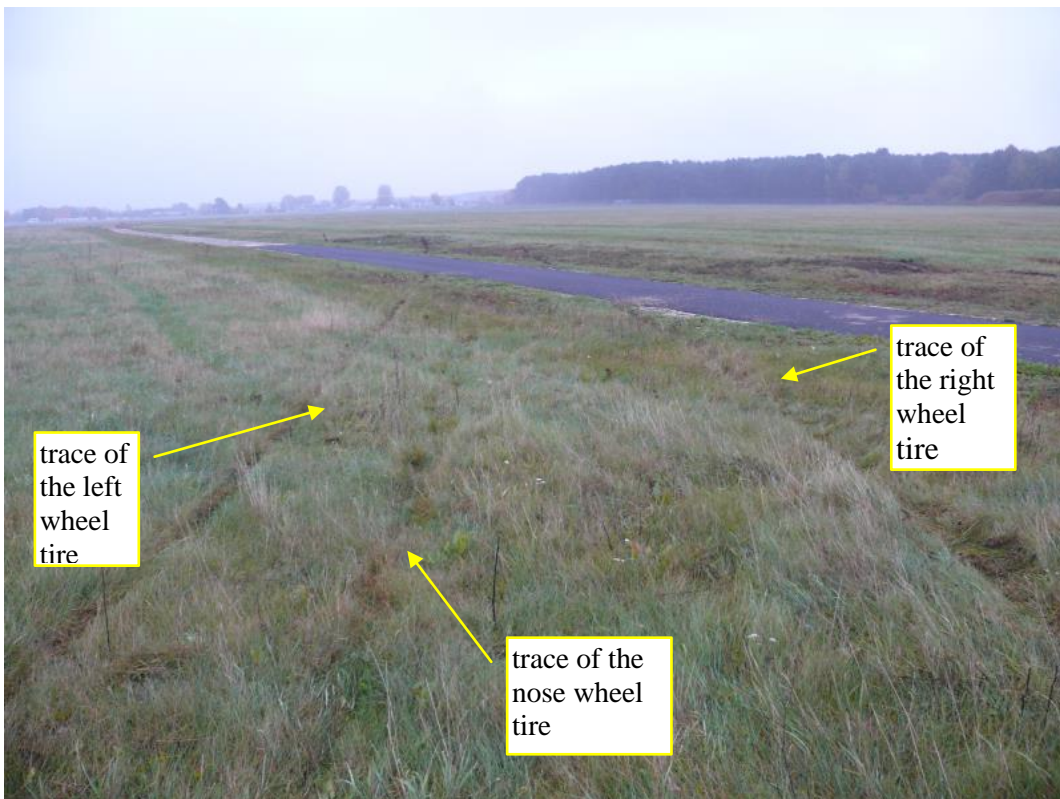
Photo 6. Landing roll traces crossing a service road situated in a valley near THR 26.

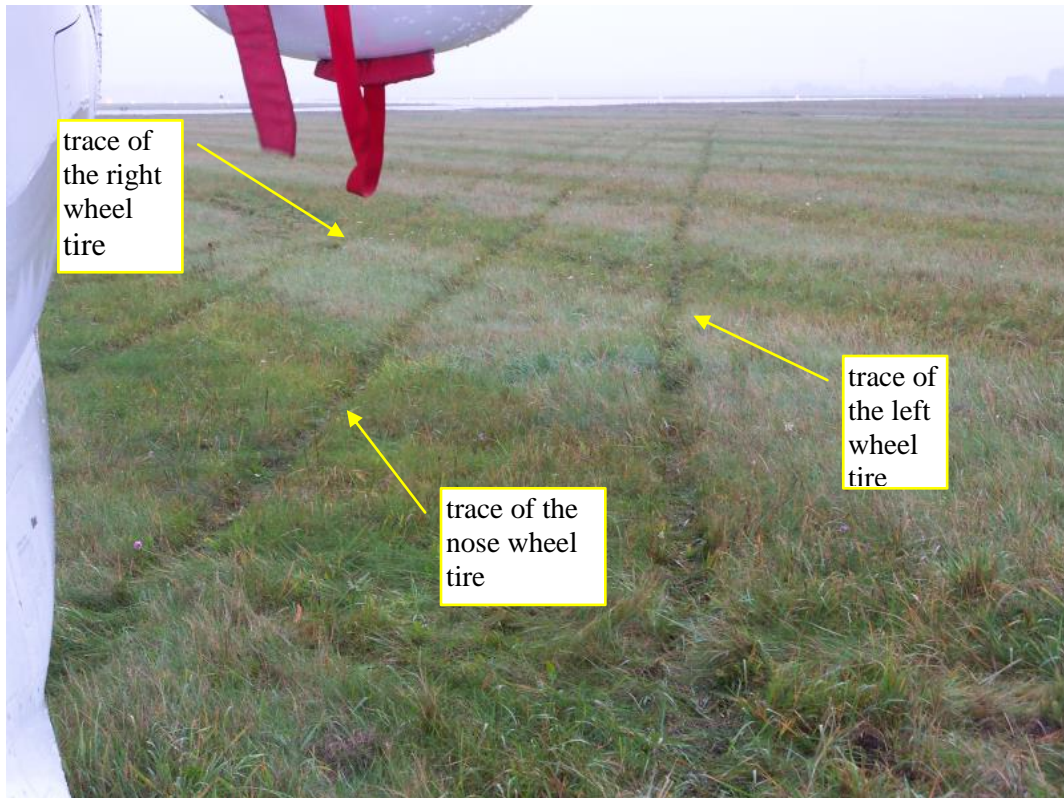
Photo 7. Landing roll traces on the airplane stopping place (view opposite to the landing direction).

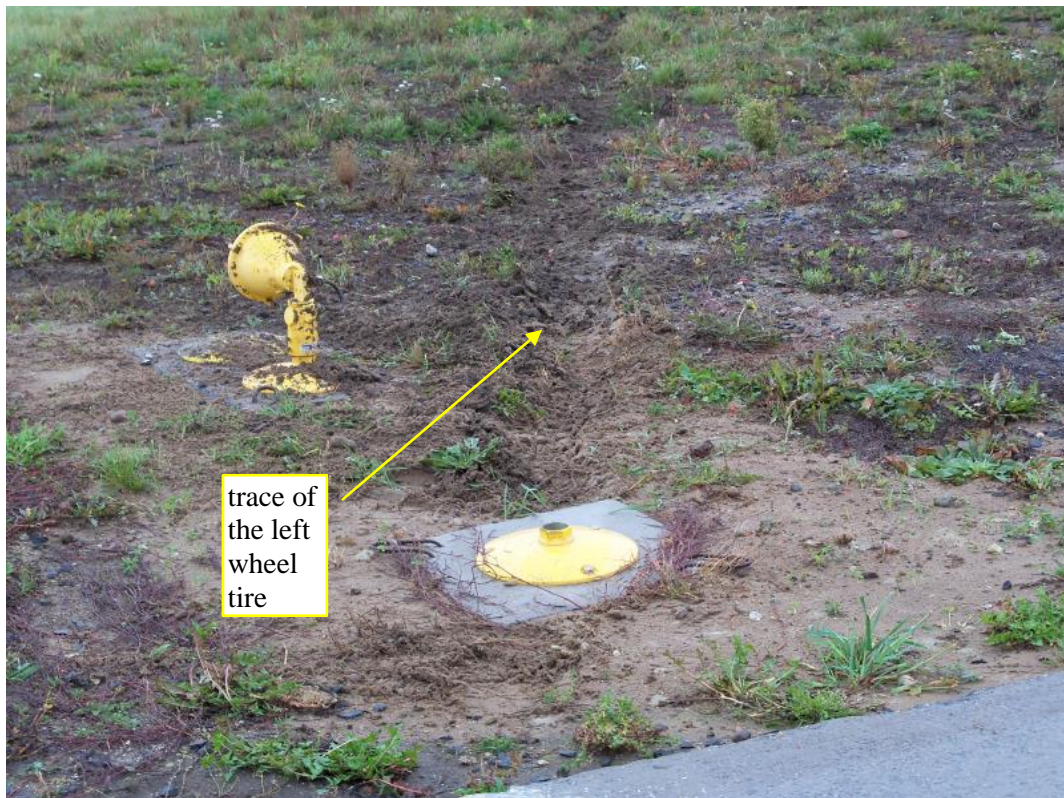
Aerodrome damage: **destroyed runway end light**

Photo 8. Damaged runway end light and trace of the left wheel of the main landing gear near THR 26.

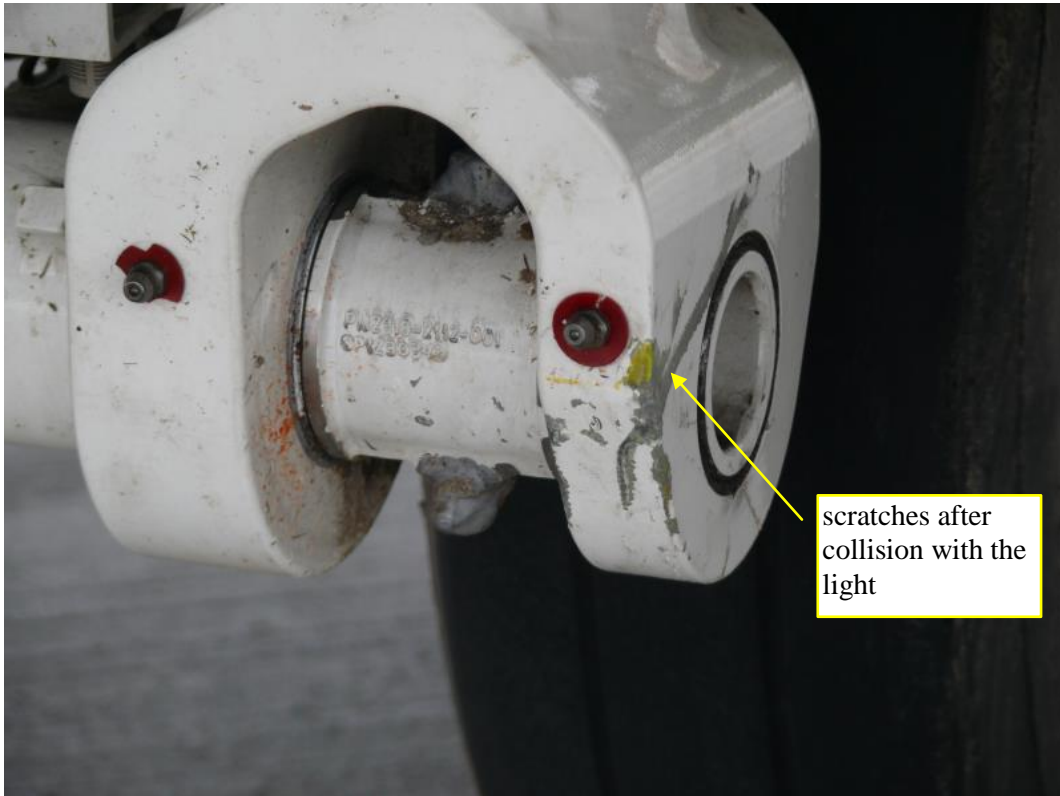
Aircraft Damage: **Scratches on the left leg of the main landing gear**

visual inspection only traces of a collision with the Runway 08 end light were found on the left leg of the main landing gear of the aircraft. Its tire was torn.

**Photo 9. Traces of collision with the runway end light on the left leg of the main landing gear.**

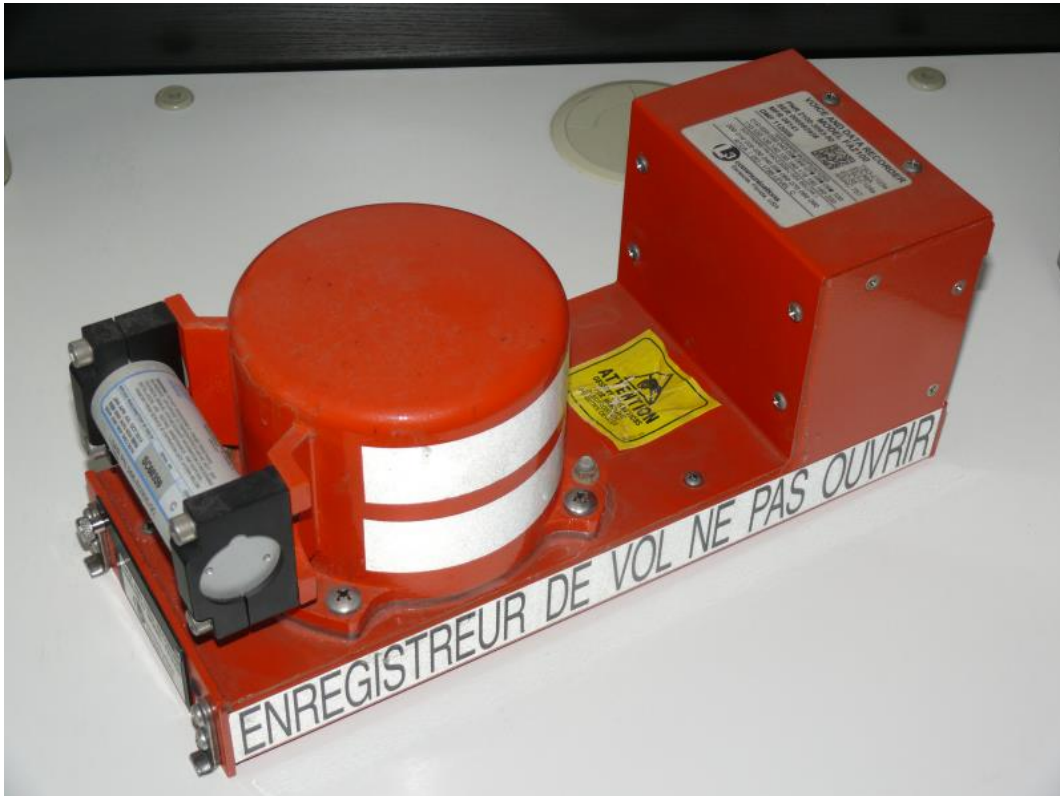
Photo 10. CVDR of Embraer EMB-500.

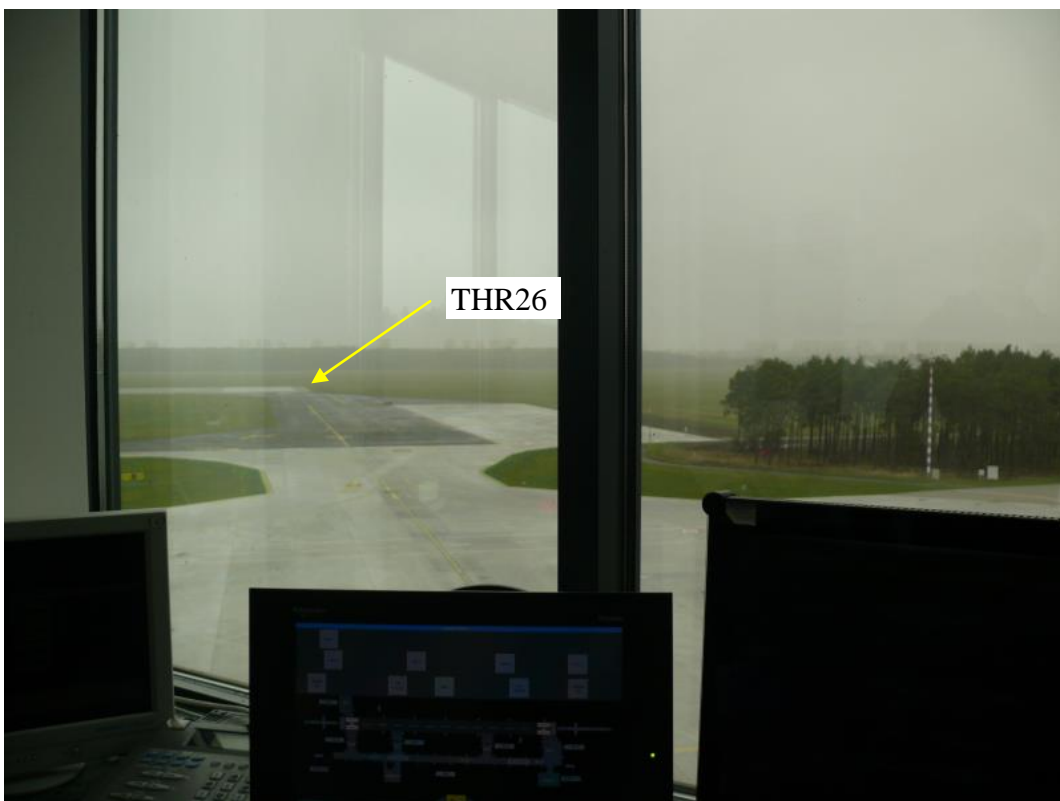
Photo 11. View from the EPBY TWR at the end of the RWY 08 and THR 26.
