FINAL REPORT

on investigation of accident

of glider type **ASW 27-18E**

Registration No. **SP-3769**

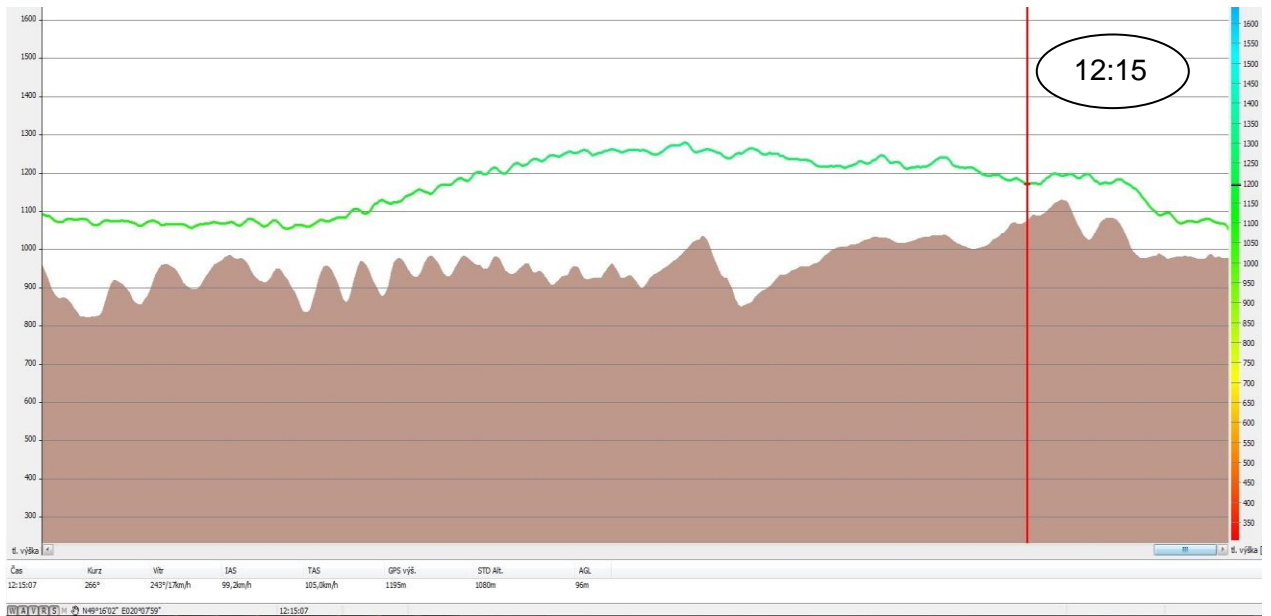
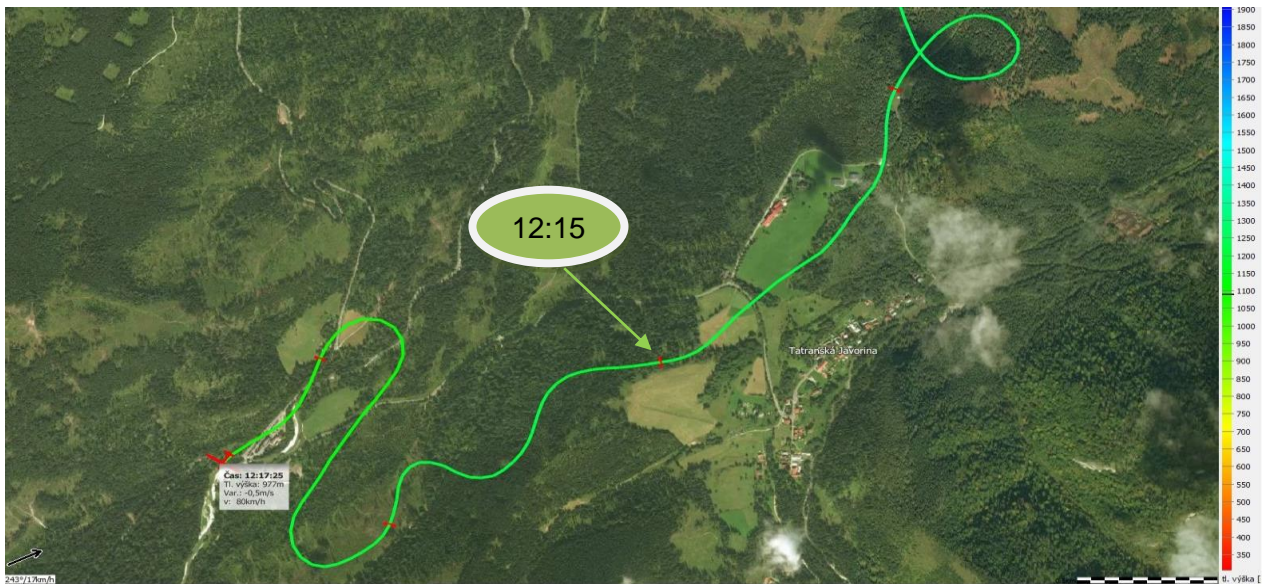
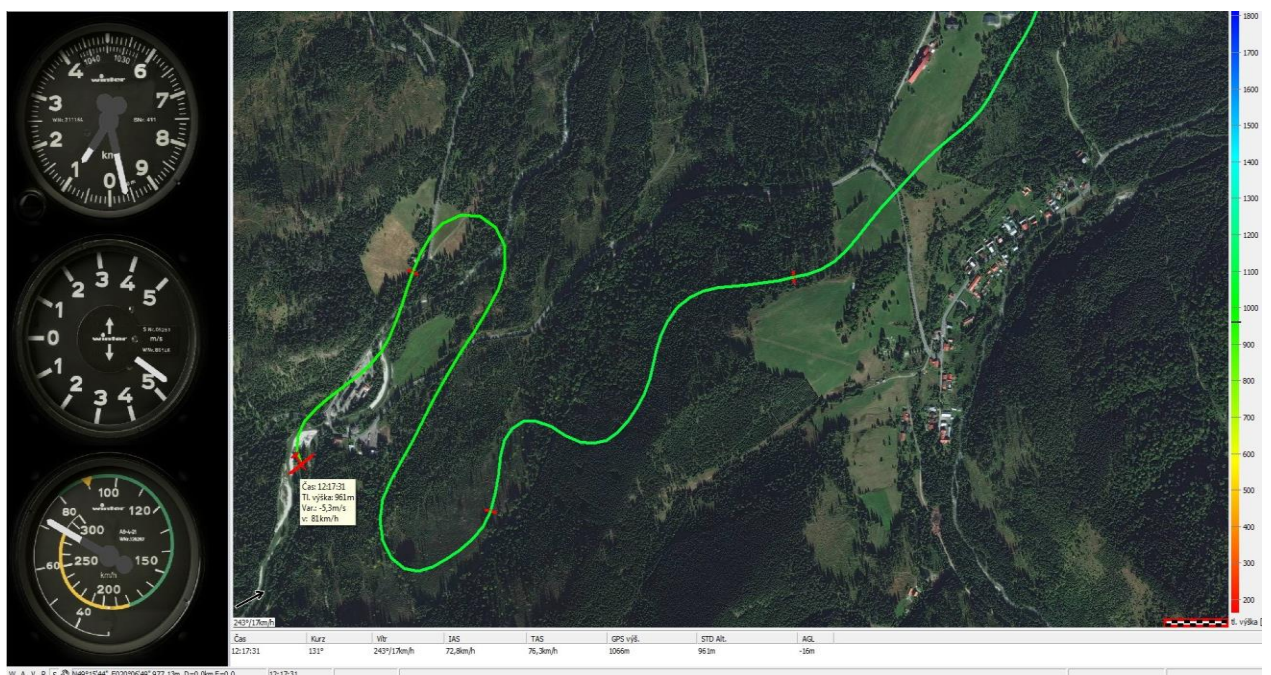
At 12:15 the pilot again achieved the altitude below 100 m above ground level with limited possibility of forced ground landing on a suitable surface; in some sections he descended below the surrounding ground level. At this moment he probably decided to search for a landing area.

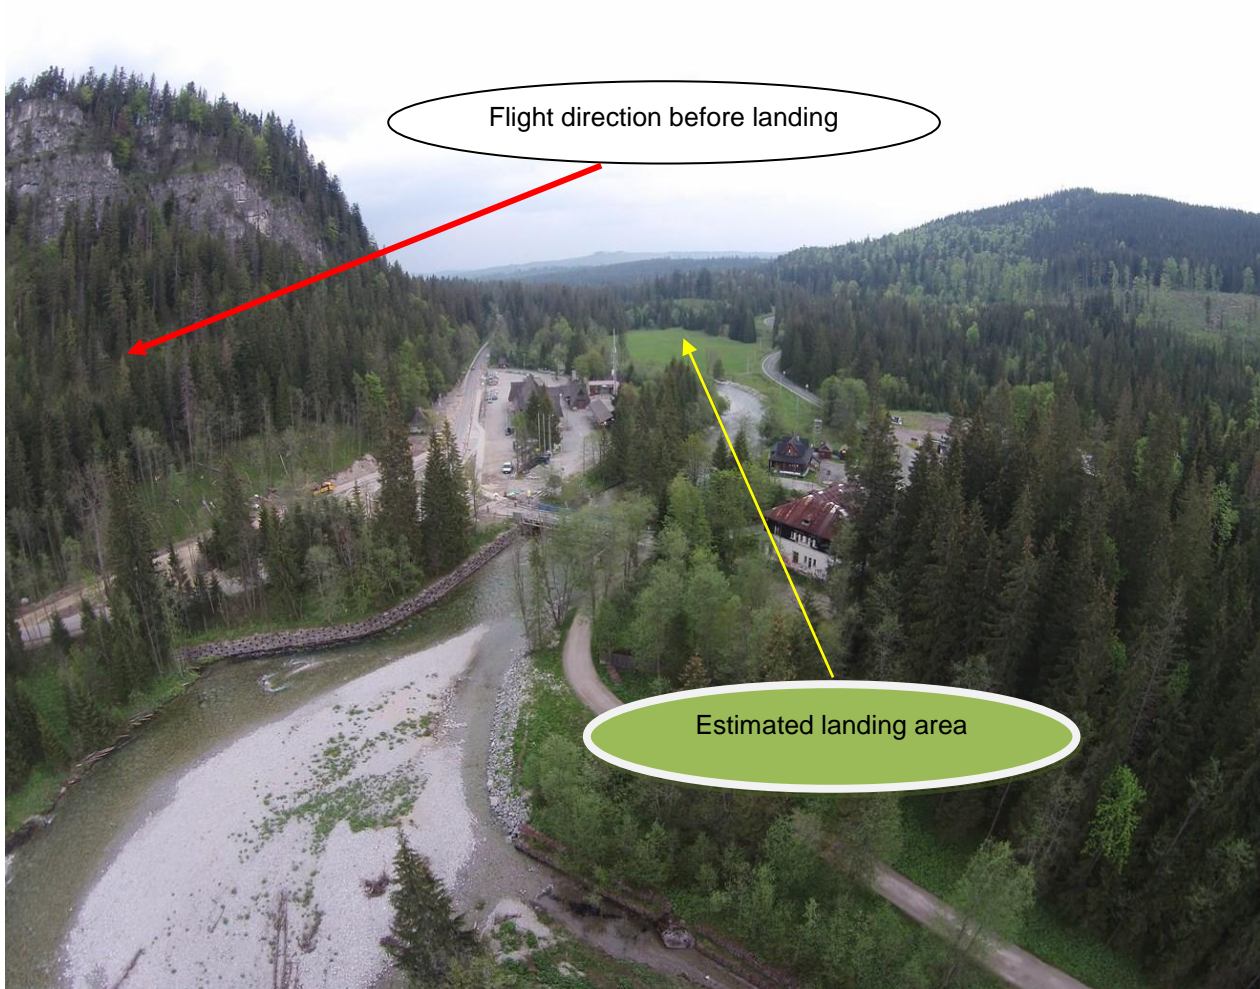
At the attempted landing approach the glider crashed at 12:17:31.

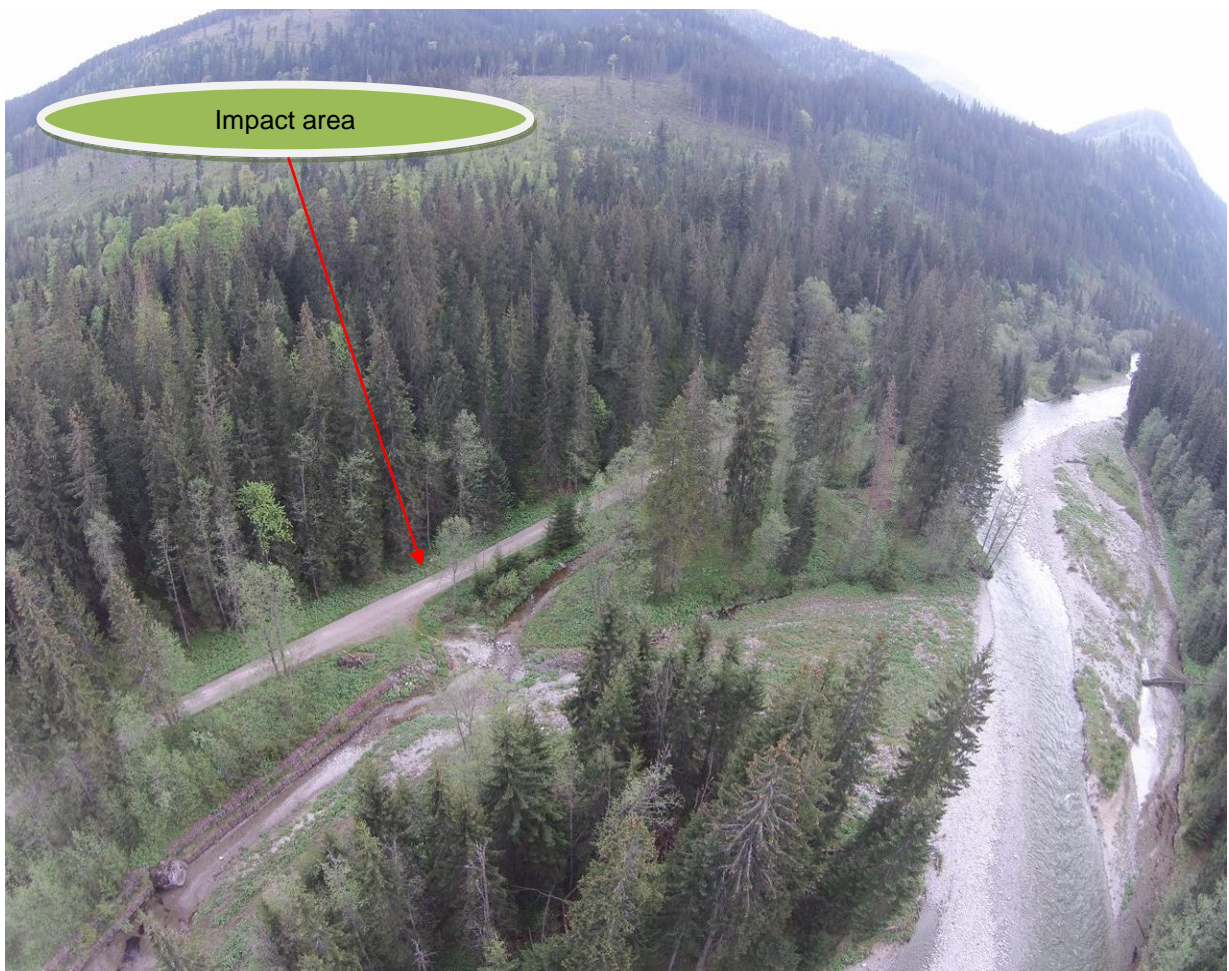
The glider was destroyed in the accident.

The glider crashed near a country road situated on the bank of river Biela voda in altitude of 970 m above sea level and 130 m south-west of the border crossing Lysá Poľana – between the Slovak Republic and Poland.

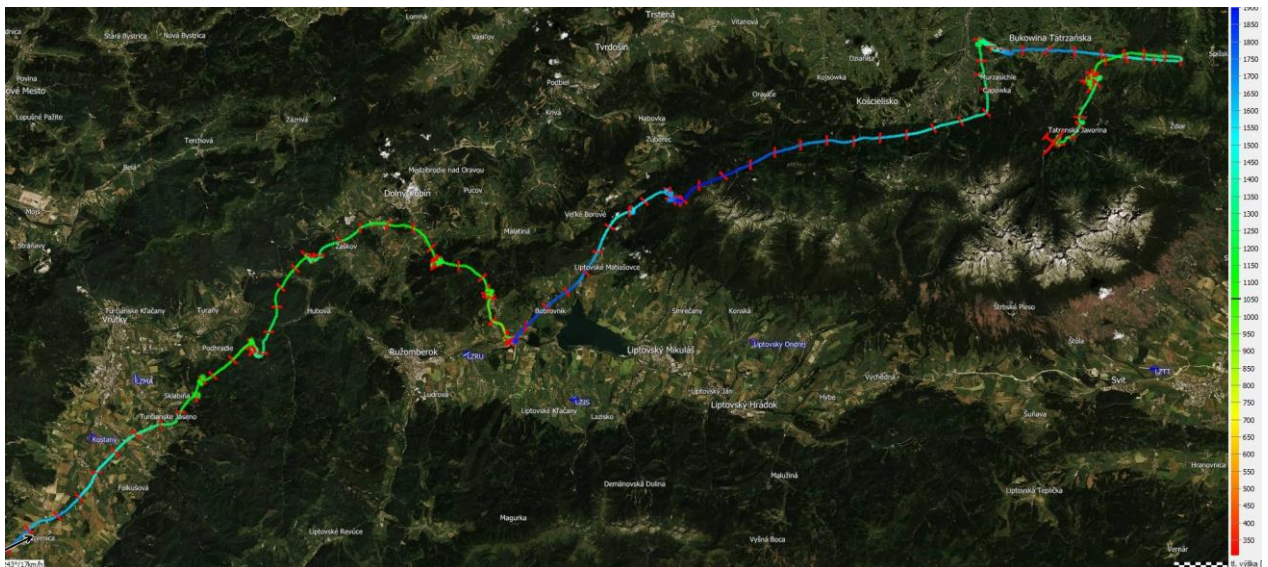
The evaluation of the flight record revealed that the pilot had not interrupted the competition flight timely above the ground level and had not attempted to use auxiliary built-in engine for return to the aerodrome of take-off LZPE in safe altitude. In spite of this fact, he continued the flight without engine until he was unable to start the engine due to the lack of height. Afterwards, he flew into airspace above a mountain area with limited choice of suitable landing surface, hoping to find uplift currents and achieve the required altitude for further flight. In his search he was unable to find any uplift current and the glider continuously lost height. Finally the pilot reached a narrow valley and created conditions where he had not enough time to find a suitable surface for ground landing. He steered the glider until the final phase – wingstall with hard impact of the nose to the ground.
