FINAL REPORT

Occurrence No: 129/15

Airplane, De Havilland Canada DHC-8 Dash 8 (DH8D)

1 February, 2015

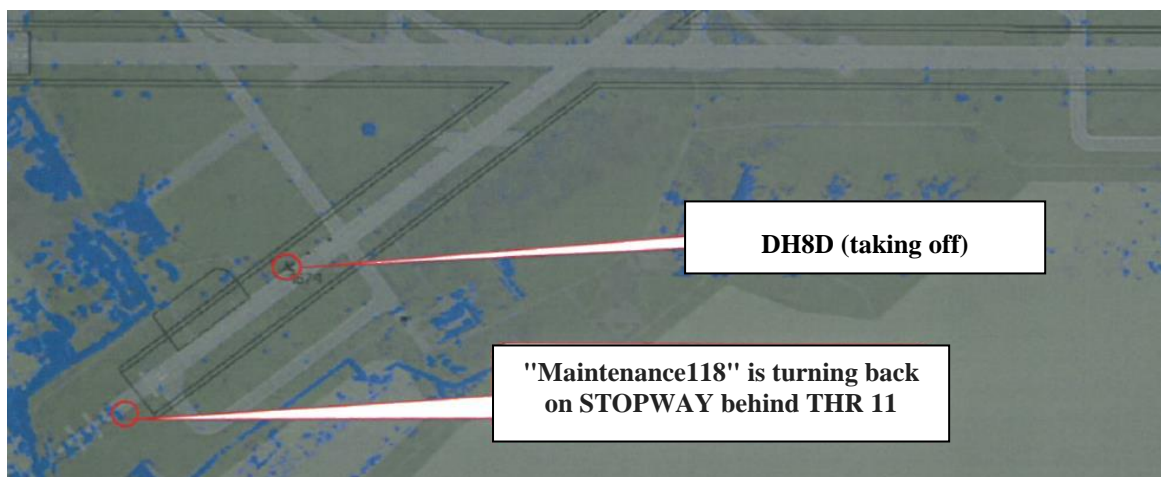
An operator of the airport maintenance services (operator) confused thresholds (THR) of runways (RWY), which led to the presence of a vehicle on THR of an active runway during DH8D takeoff. EPWA TWR personnel noticed this fact only during the second entry of the operator in the area of Stopway (SWY) behind RWY 11 THR and ordered to leave the aerodrome maneuvering area.

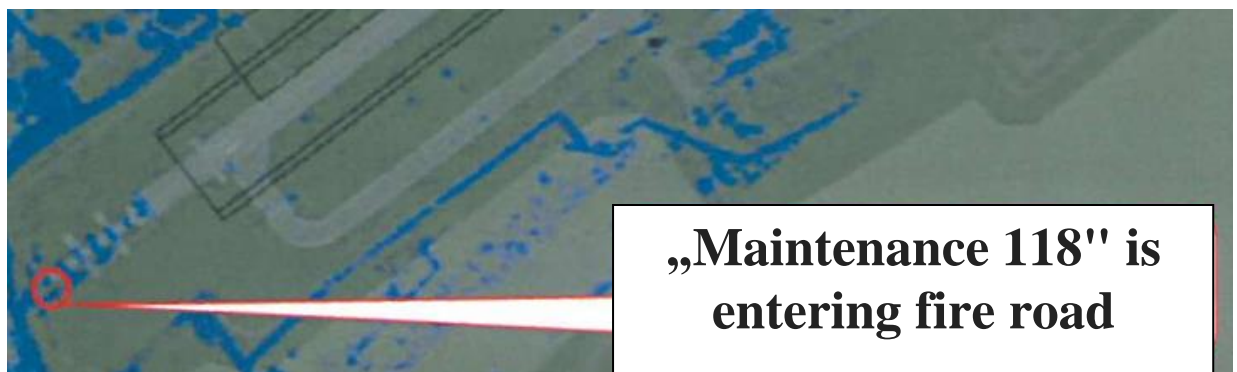
Based on analysis of the airport radar imaging (from 13:40:40 to 13:41:41 hrs UTC) it was found that indefinite radar echo was moving from so called fire road in the direction of the RWY 11 THR.

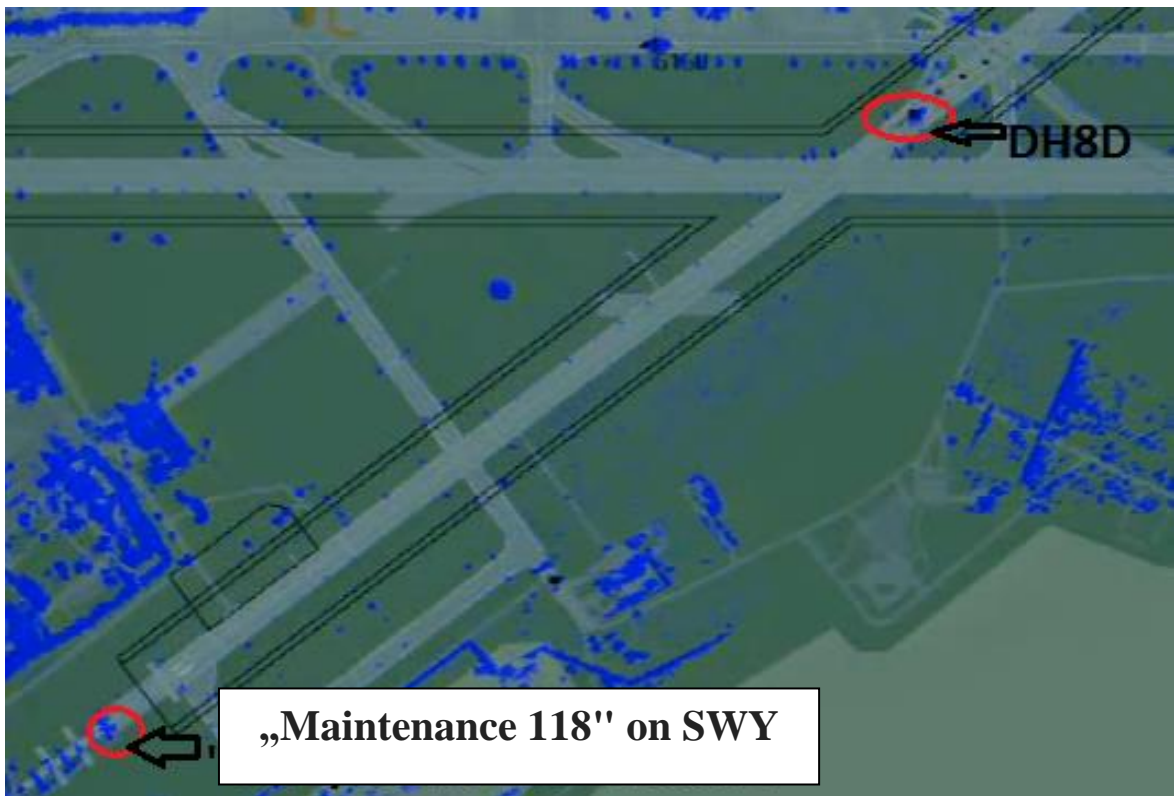
Taking into account the recorded radio communication between the TWR assistant Controller and the "Maintenance 118" operator, and the airport radar recording it can be confirmed that the "Maintenance 118" vehicle reached the RWY 11 THR SWY when DH8D was approaching the intersection of runways during its takeoff.
