PHOTO DOCUMENTATION

Appendix no. 2

to the Final Report on implementation of measures determined in EMP
for the Contract 3A.4

Odra-Vistula Flood Management Project

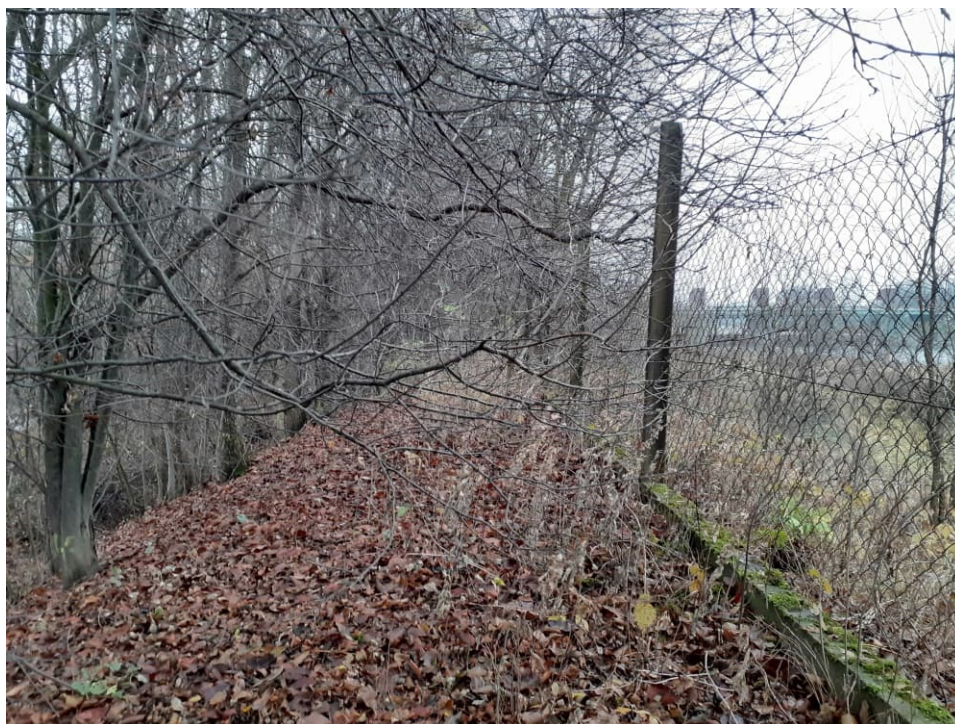
Fig. 3. Site condition in the first quarter of the works implementation period – the right Vistula embankment upstream of the Płaszów port – lower part, status in the third decade of November 2021 (view towards the west).

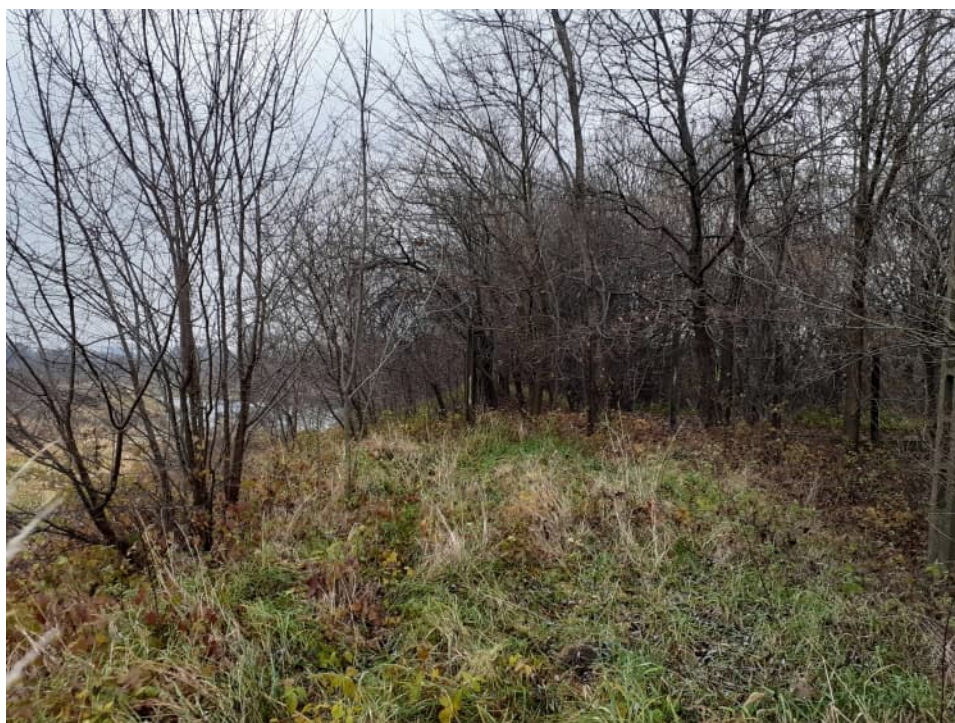
Fig. 4. Site condition in the first quarter of the works implementation period – the right Vistula embankment upstream of the Płaszów port – lower part, status in the third decade of November 2021 (view towards the east).

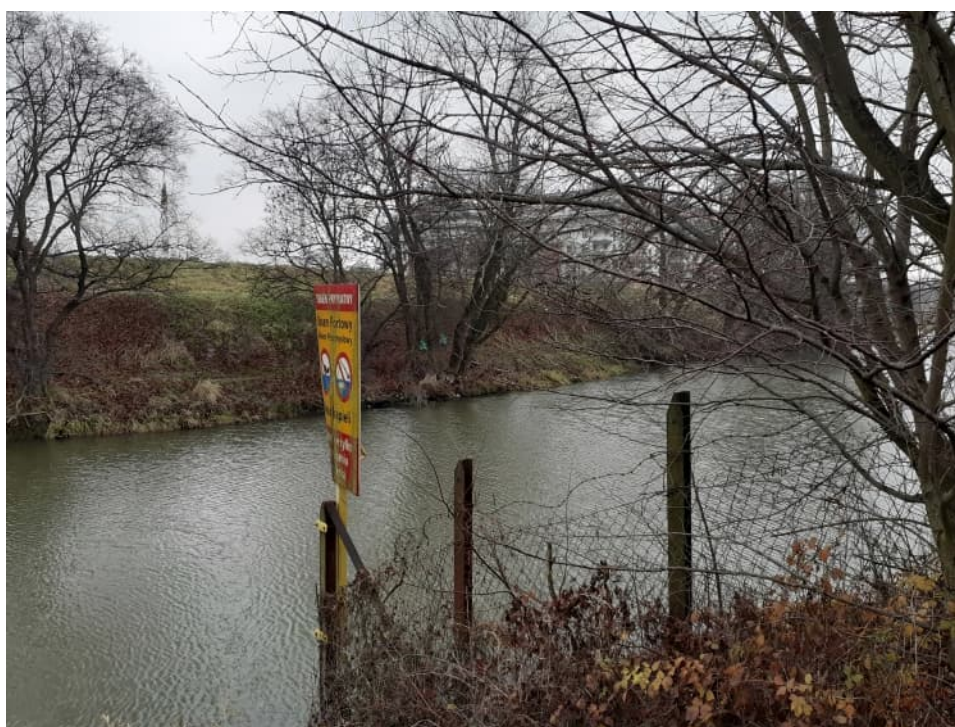
Fig. 9. Site condition in the first quarter of the works implementation period – Płaszów port channel south of the flood gate construction site, status in the third decade of November 2021 (view towards the south).

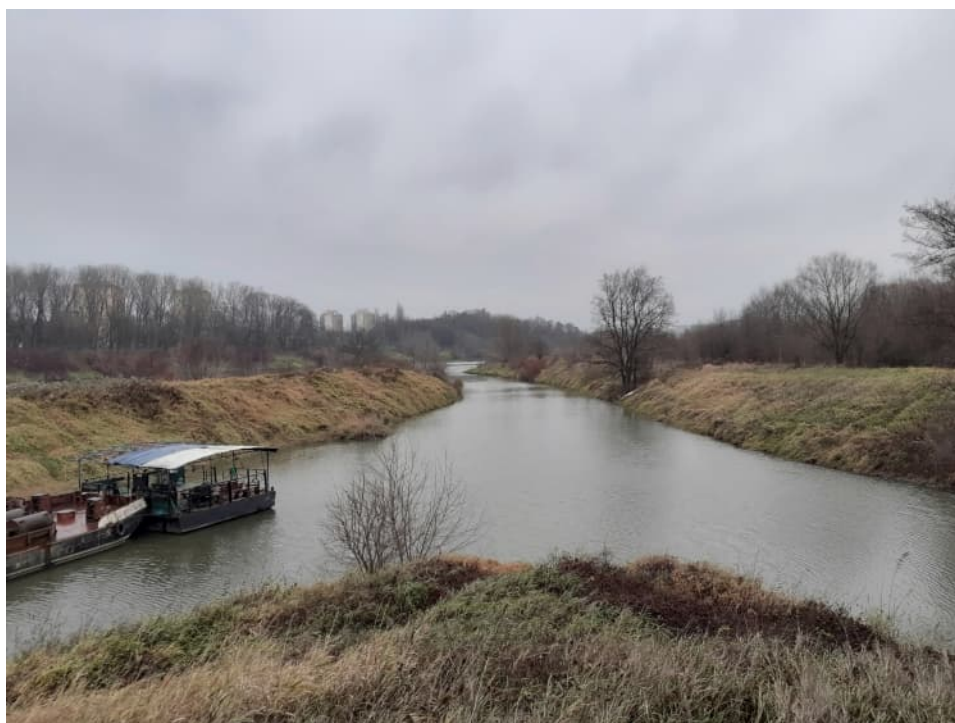
Fig. 10. Site condition in the first quarter of the works implementation period – Płaszów port channel north of the flood gate construction site, status in the third decade of November 2021 (view towards the north).

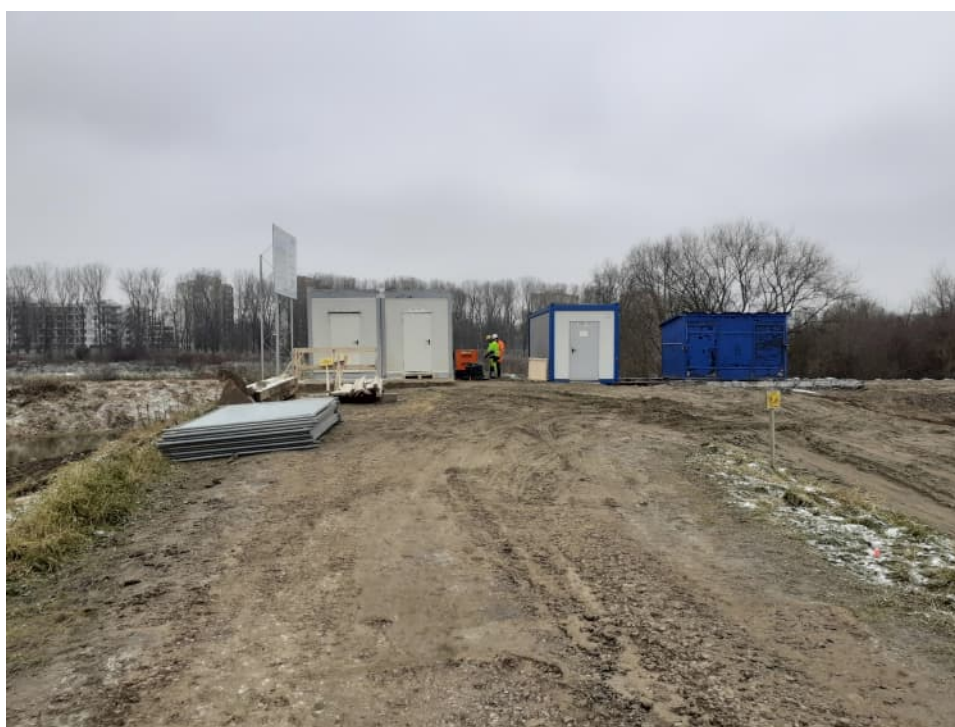
Fig. 12. Site condition in the first quarter of the works implementation period – construction site of maneuvering yard east of the flood gate, status in the first decade of December 2021 (view towards the north).

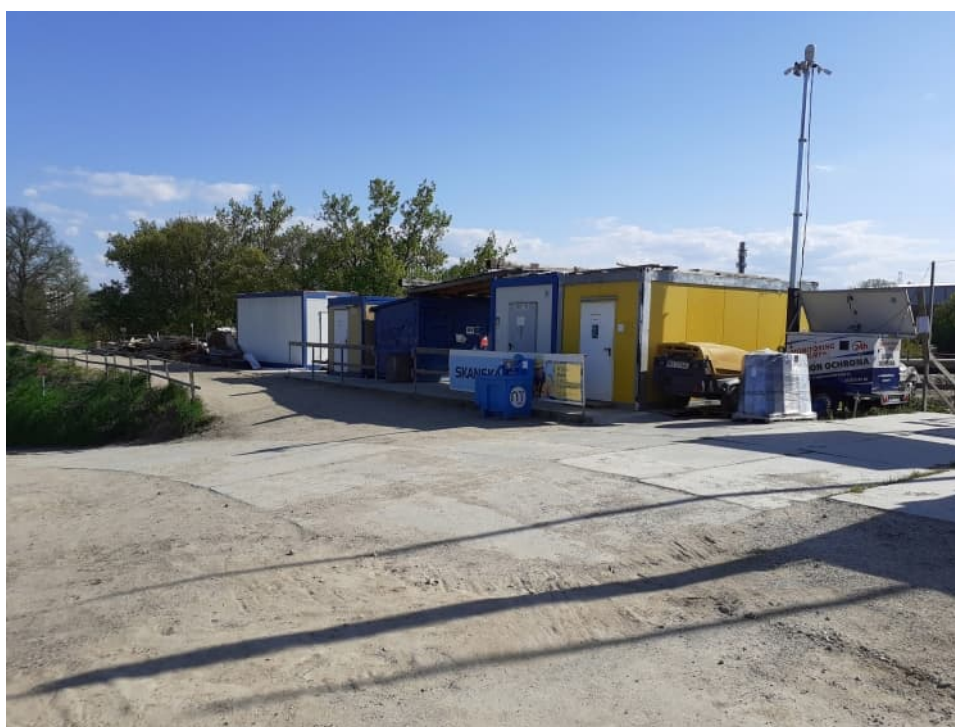
Fig. 17. Site facilities on the eastern bank of the Płaszów port channel, status in the first decade of May 2023 (view towards the west).

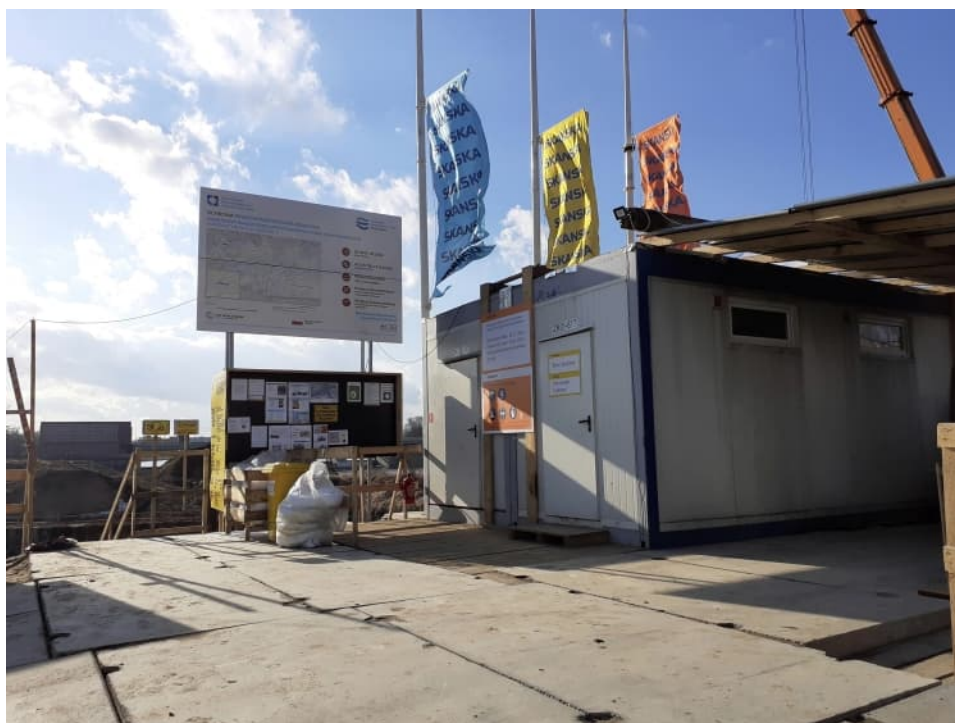
Fig. 18. Site facilities on the eastern bank of the Płaszów port channel, status in the third decade of February 2022 (view towards the west).

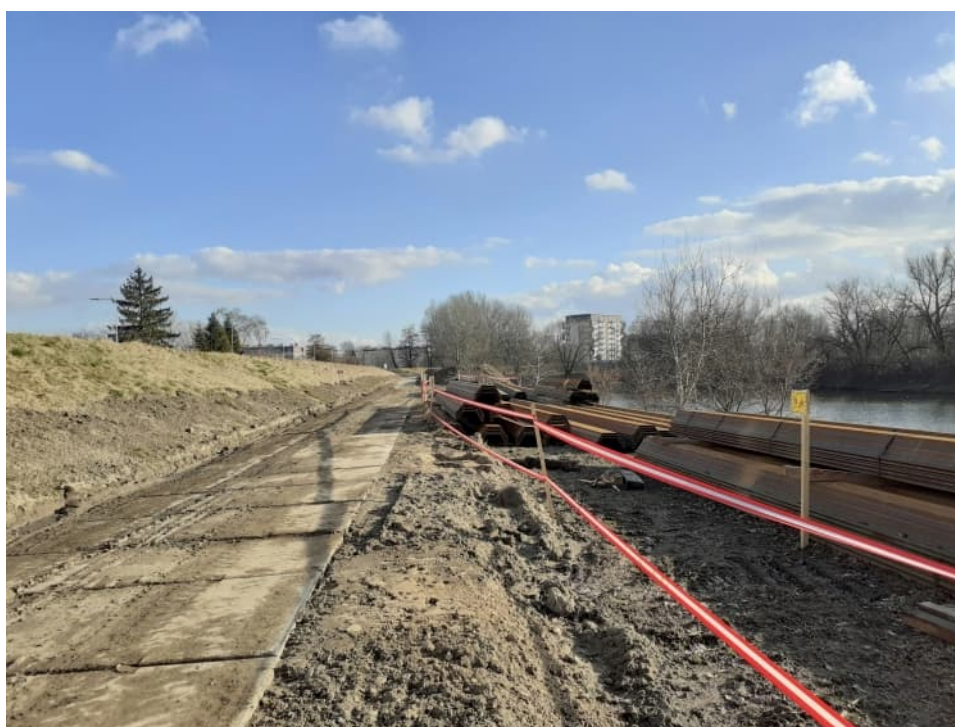
Fig. 19. Access road to the construction site on the eastern bank of the Płaszów port channel, status in the third decade of February 2022 (view towards the south).

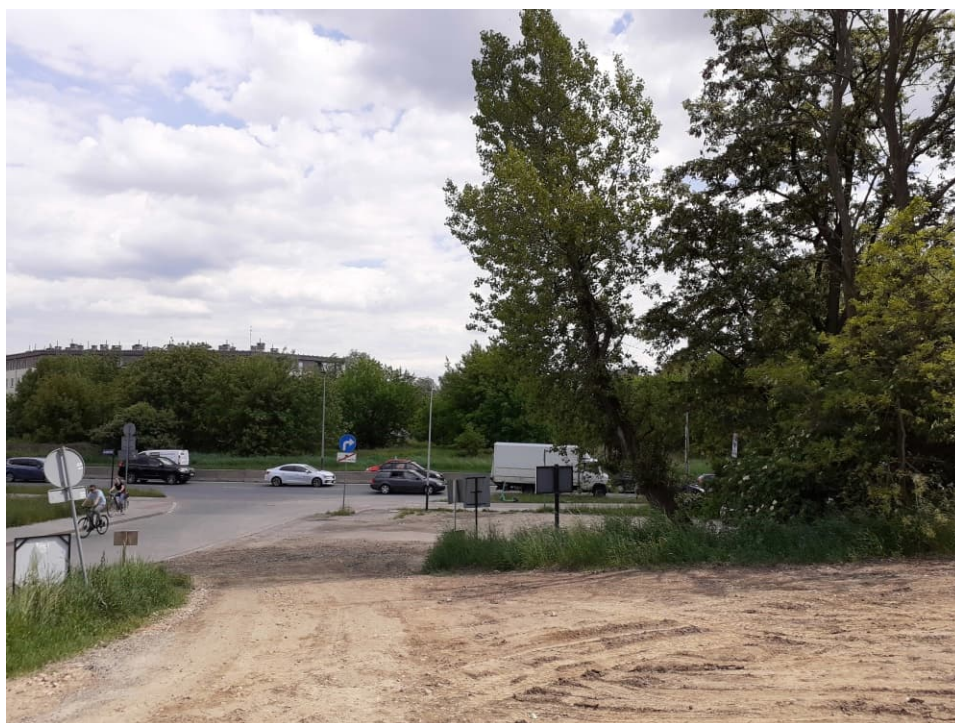
Fig. 20. Connection of the access road to the construction site with public roads, status in the third decade of May 2022 (view towards the south).

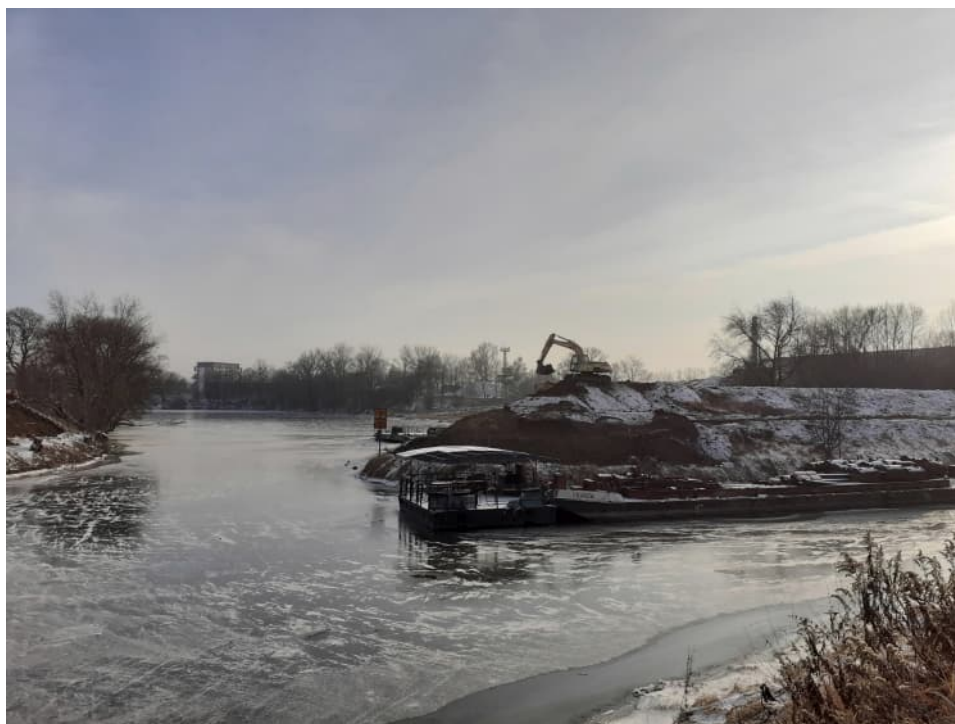
Fig. 31. Removal of a top soil layer,
status in the third decade of December 2021 (view towards the south).

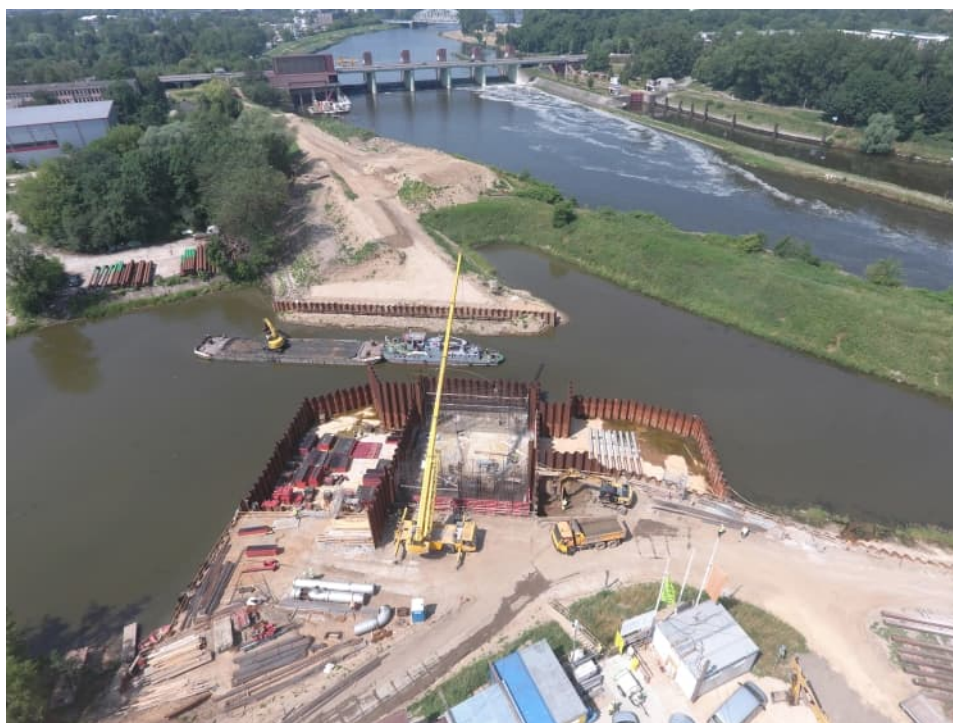
Fig. 34. Dredging of the Płaszów port channel bed south of the flood gate, status in the third decade of June 2022 (view towards the west).

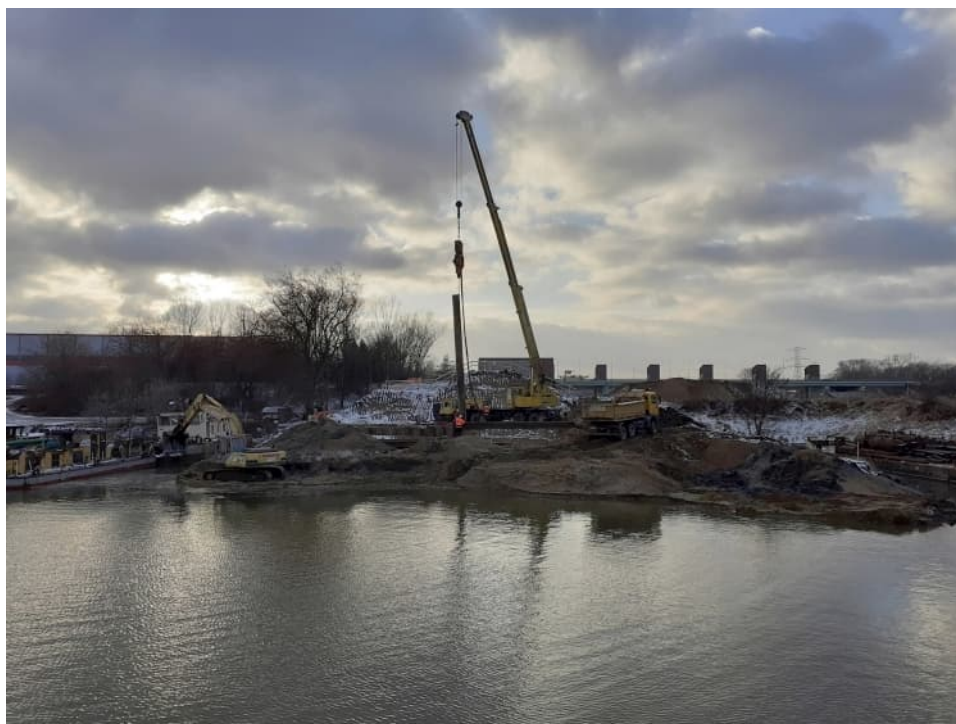
Fig. 35. Driving the sheet piles on the western bank of the Płaszów port channel, status in the second decade of January 2022 (view towards the west).

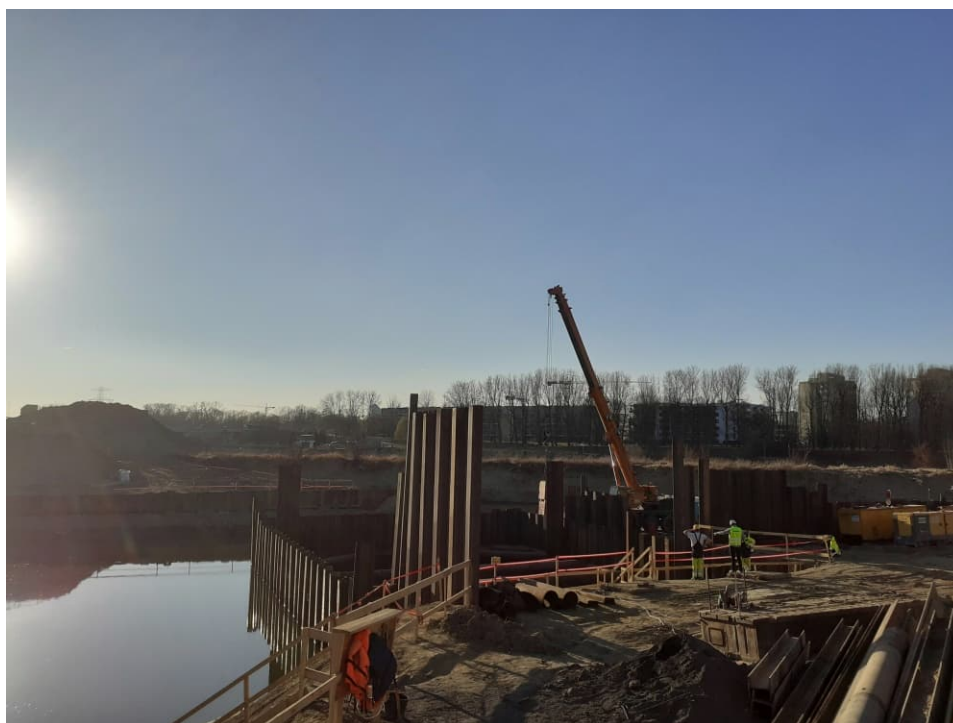
Fig. 36. Driving the sheet piles on the eastern bank of the Płaszów port channel, status in the third decade of March 2022 (view towards the west).

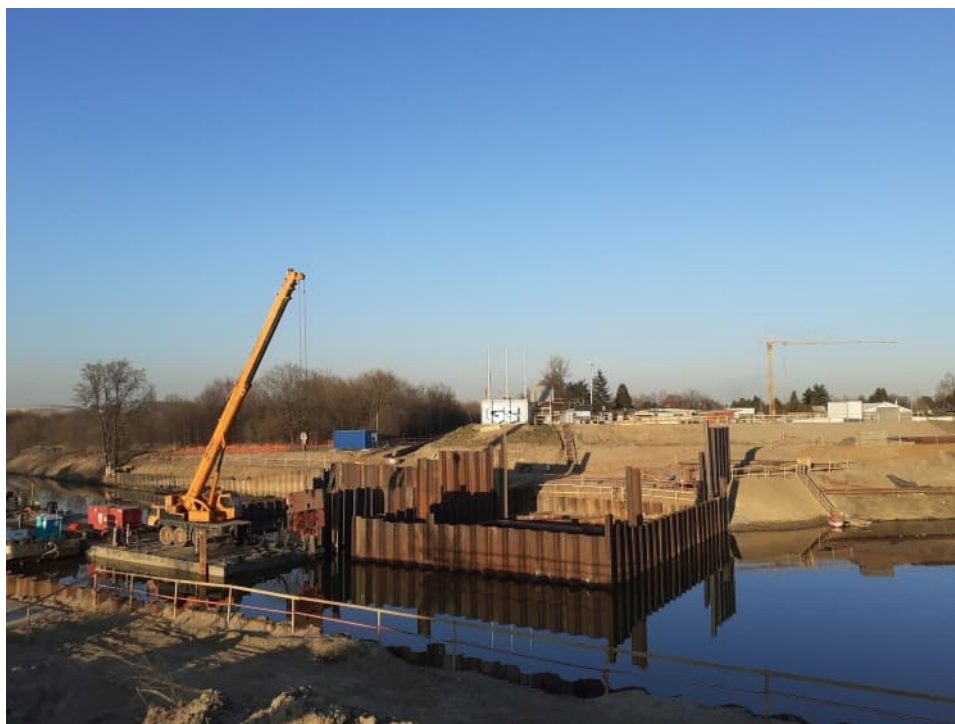
Fig. 39. Construction site of flood gate in the Płaszów port channel,
status in the third decade of March 2022
(view from the western bank of the channel, towards the east).

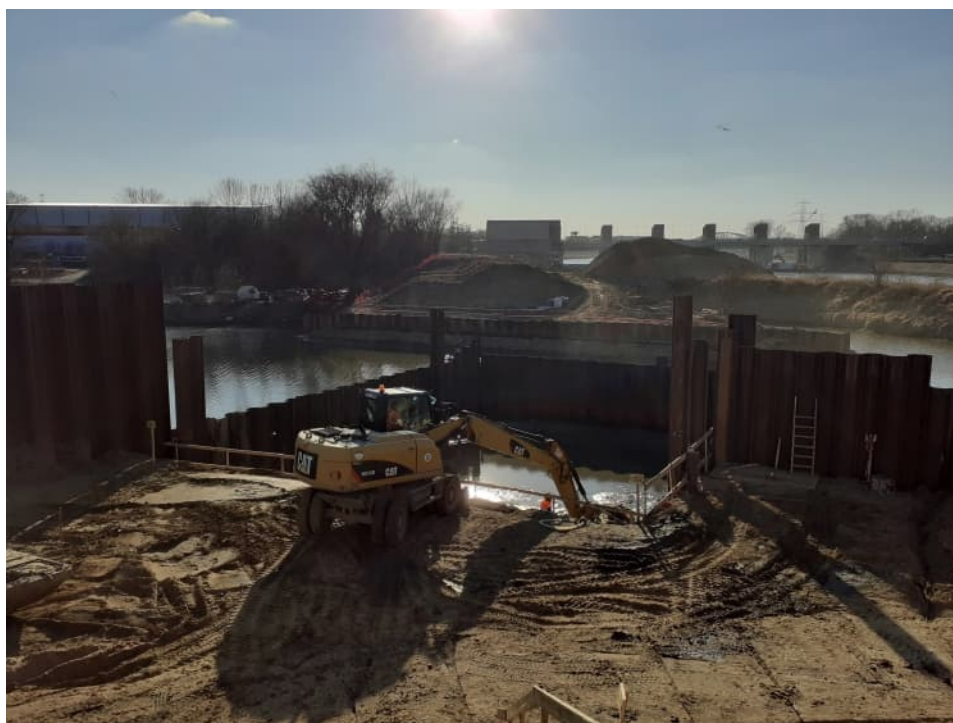
Fig. 40. Construction site of flood gate in the Płaszów port channel,
status in the first decade of March 2022
(view from the eastern bank of the channel, towards the west).

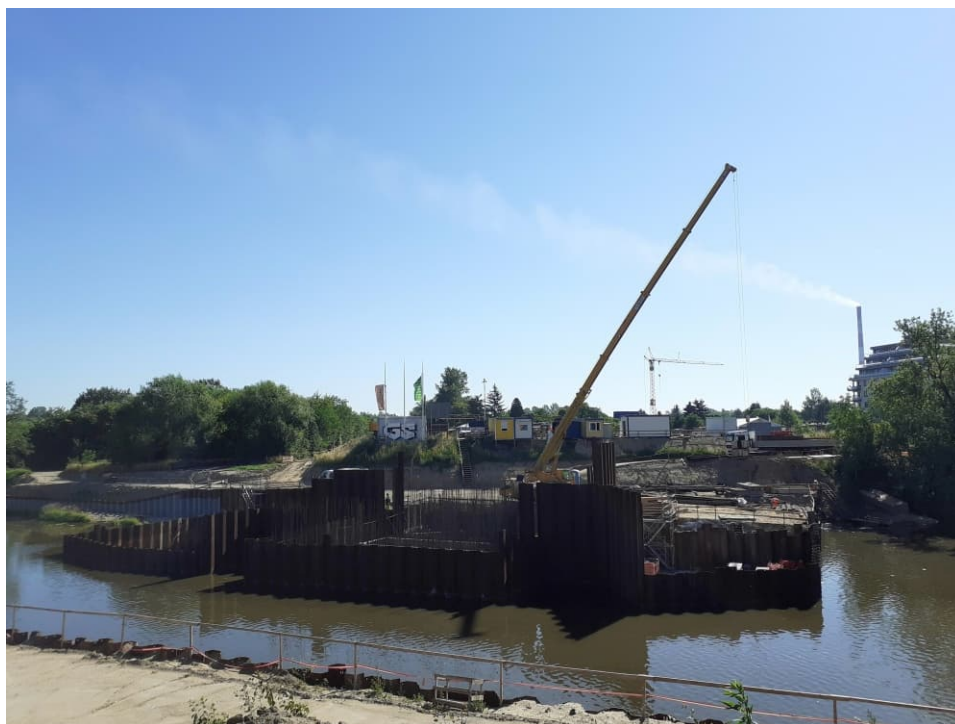
Fig. 41. Construction site of flood gate in the Płaszów port channel,
status in the third decade of June 2022
(view from the western bank of the channel, towards the east).

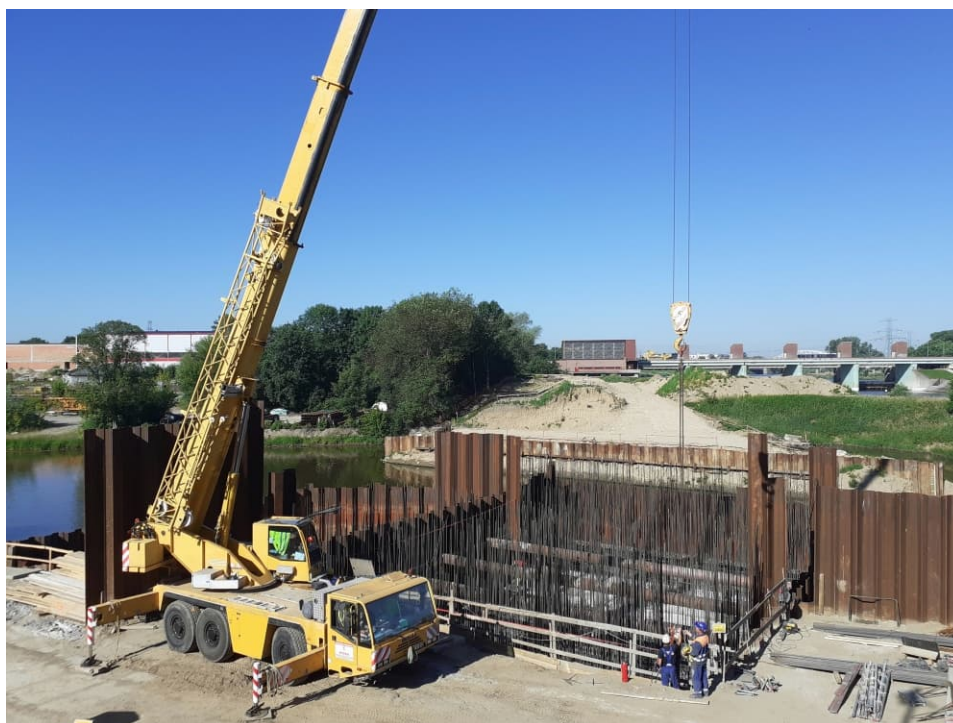
Fig. 42. Construction site of flood gate in the Płaszów port channel,
status in the first decade of June 2022
(view from the eastern bank of the channel, towards the west).

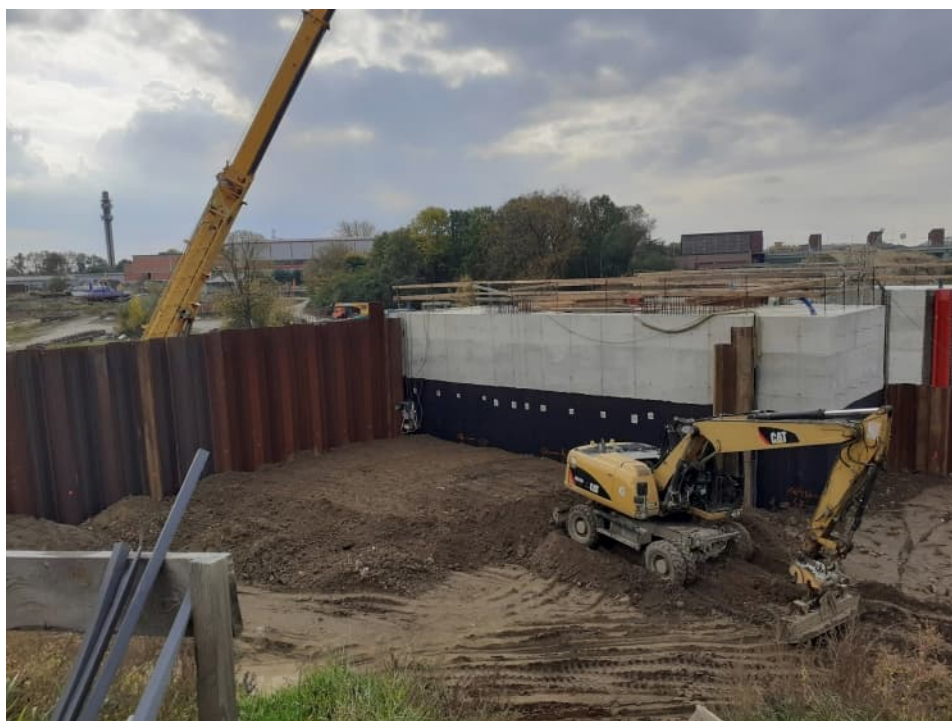
Fig. 44. Construction site of flood gate in the Płaszów port channel,
status in the first decade of October 2022
(view from the eastern bank of the channel, towards the west).

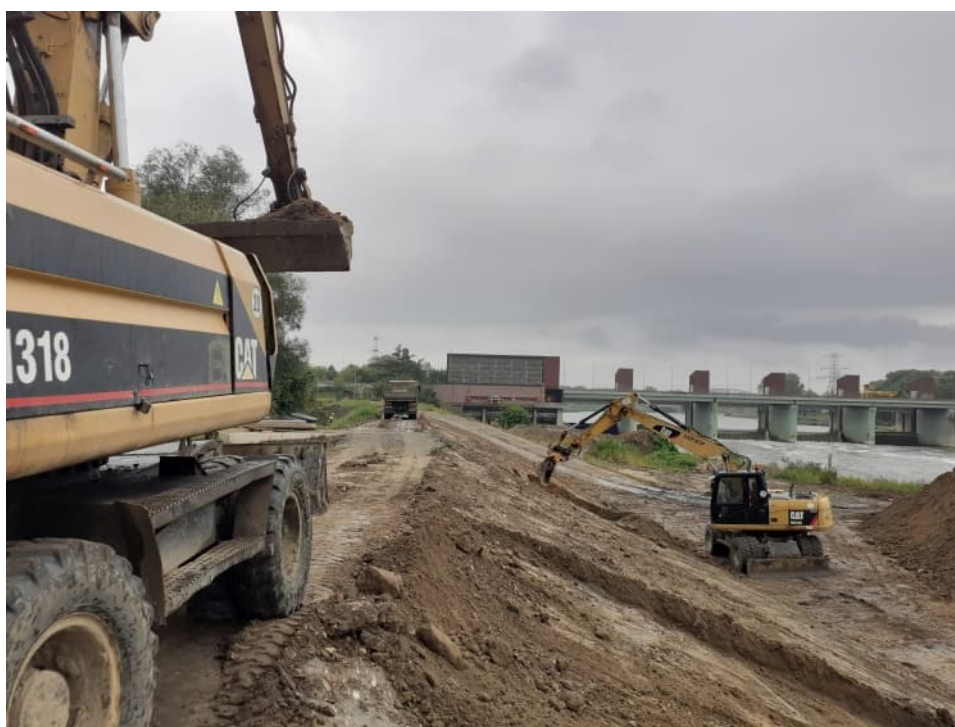
Fig. 53. Shaping slopes of the Vistula flood embankment upstream of the Płaszów port, status in the third decade of August 2023 (view towards the west).

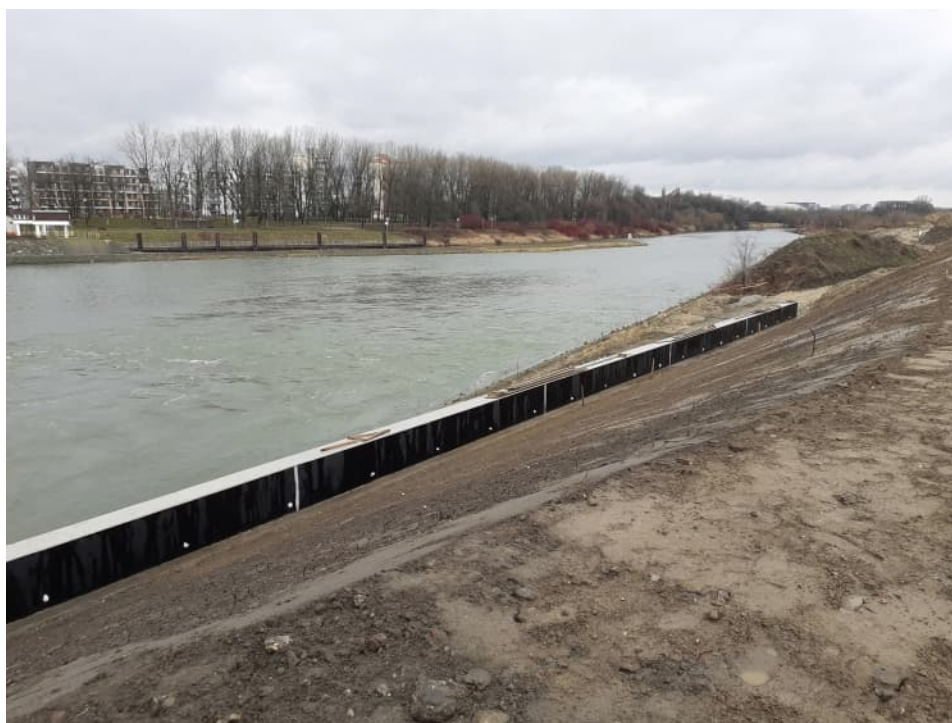
Fig. 54. Shaping slopes of the Vistula flood embankment upstream of the Płaszów port, status in the first decade of March 2023 (view towards the east).

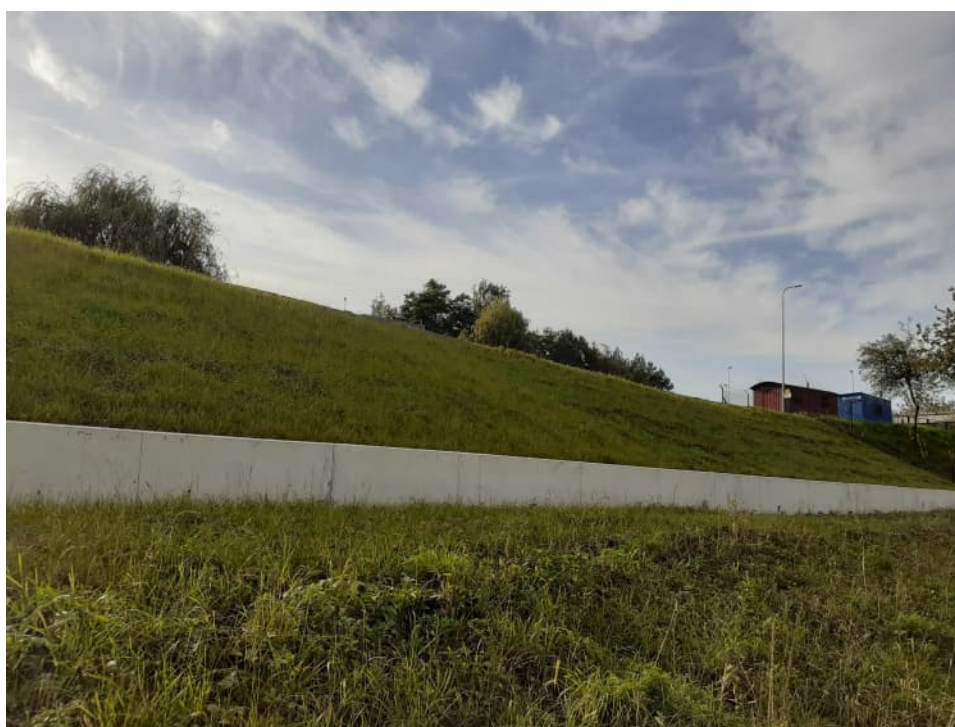
Fig. 59. Site condition in the last quarter of the works implementation period – the right Vistula embankment upstream of the Płaszów port – upper part, status in the second decade of October 2023 (view towards the west).

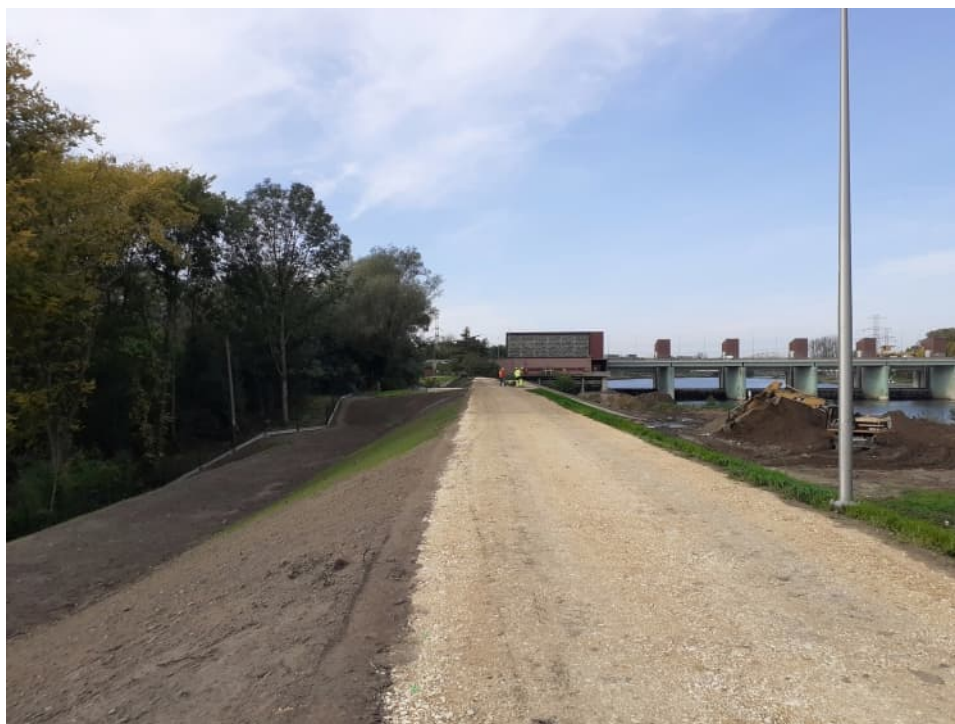
Fig. 61. Site condition in the last quarter of the works implementation period – the right Vistula embankment upstream of the Płaszów port – lower part, status in the second decade of October 2023 (view towards the west).

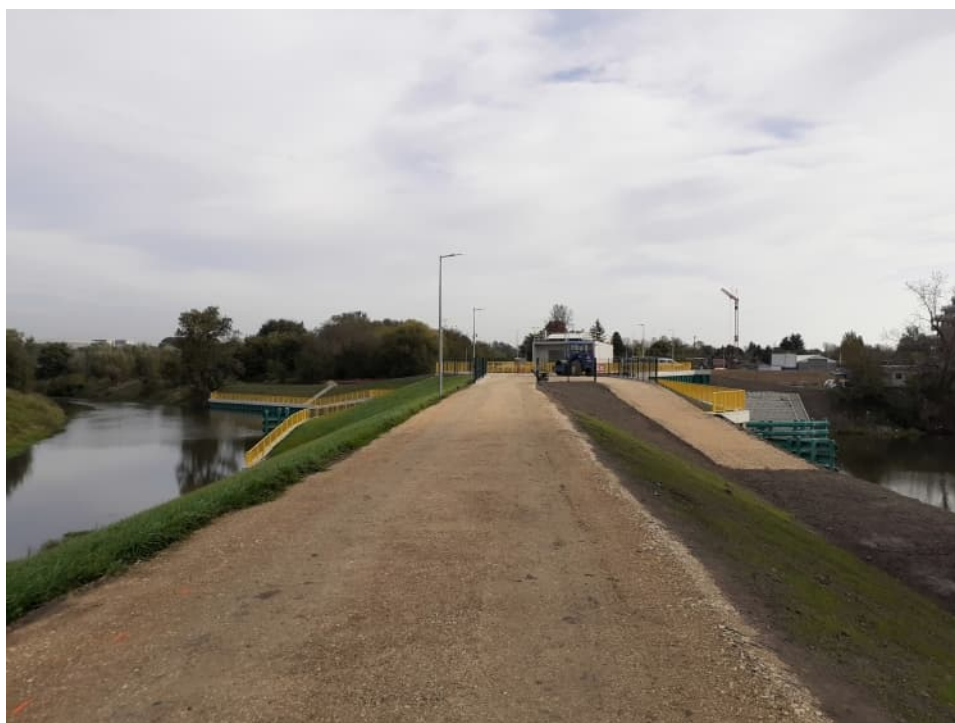
Fig. 62. Site condition in the last quarter of the works implementation period – the right Vistula embankment upstream of the Płaszów port – lower part, status in the second decade of October 2023 (view towards the east).
