**STATE COMMISSION ON RAILWAY ACCIDENT INVESTIGATION**  
**Ministry of the Interior and Administration**

**REPORT No. PKBWK 05/2025**

**on the investigation of a serious railway accident that occurred on 1 July 2024 at 09:19 hrs  
on the Ożarów Mazowiecki - Błonie route, track no. 2, category B level crossing at km  
17.211 of railway line no. 3 Warszawa Zachodnia - Kunowice,  
area of infrastructure operator PKP PLK S.A. Railway Line Plant  
in Warsaw**

**WARSAW, 25 June 2025**

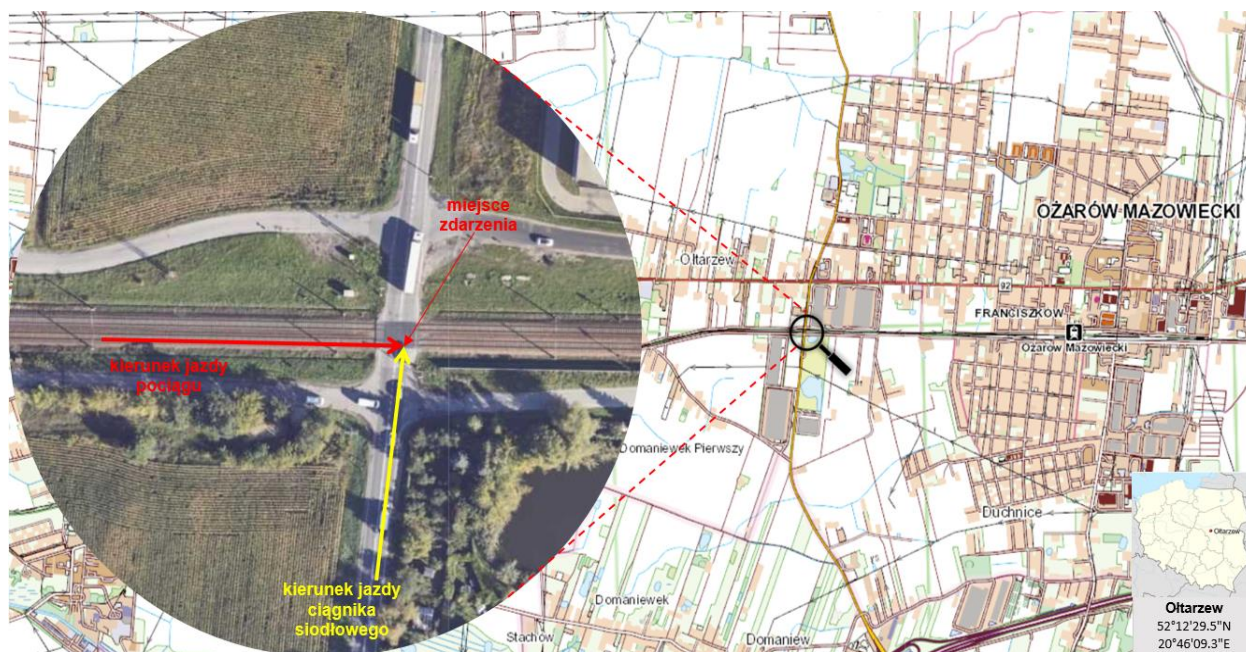
Figure 1- General view of the occurrence site (source: Geoportal)

The occurrence took place on 1 July 2024 at 09:19 hrs, track no. 2 of the Ożarów Mazowiecki - Błonie route, Cat. B level crossing, km 17.211, the area of infrastructure manager PKP PLK S.A. Railway Line Plant in Warsaw. Geographical location of the crossing: 52°12'29.5"N 20°46'09.3"E.
