PHOTO DOCUMENTATION

Appendix no. 2

to the Final Report on implementation of measures determined in EMP
for the Contract 3A.5

Odra-Vistula Flood Management Project

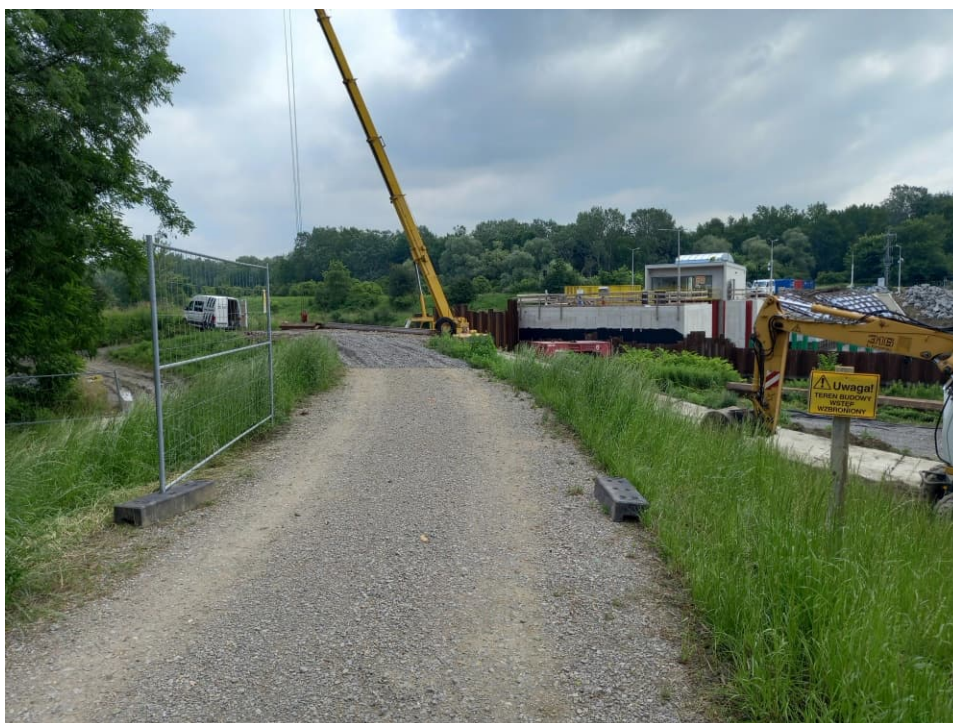
Fig. 16. Marking of the construction site on the western bank of the Kujawy port channel, status in the third decade of June 2023 (view towards the north-east).

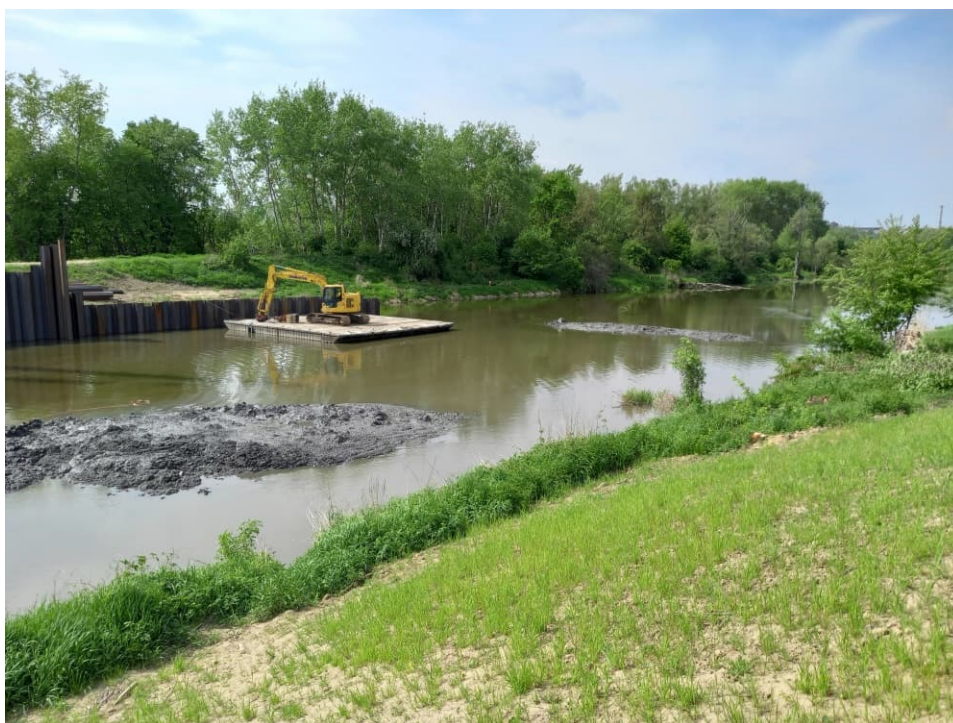
Fig. 26. Dredging of the Kujawy port channel bed north of the flood gate, status in the second decade of May 2022 (view towards the north).

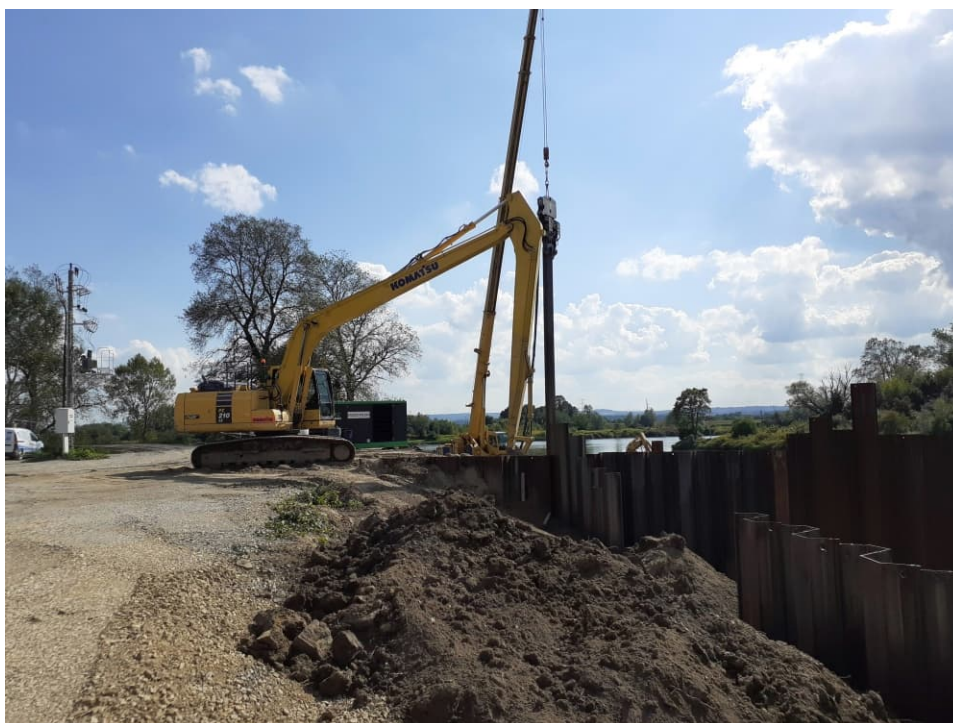
Fig. 28. Driving the sheet piles in the Kujawy port channel bed,
status in the third decade of August 2022 (view towards the south).

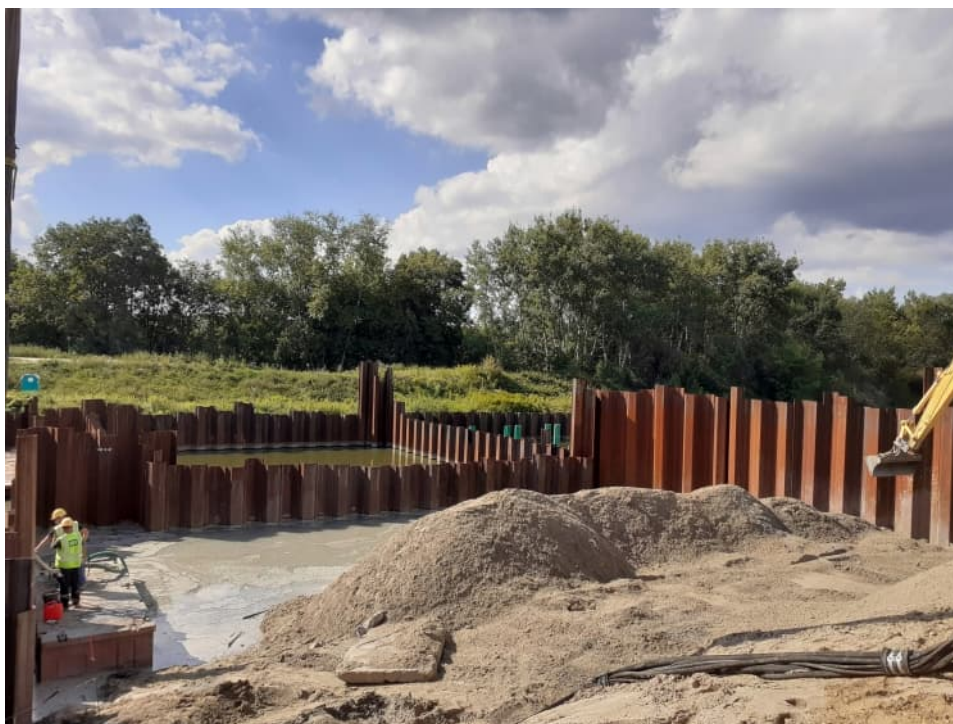
Fig. 29. Construction site of flood gate with a section of embankment connection on the eastern bank of the Kujawy port channel, status in the third decade of August 2022 (view towards the west).

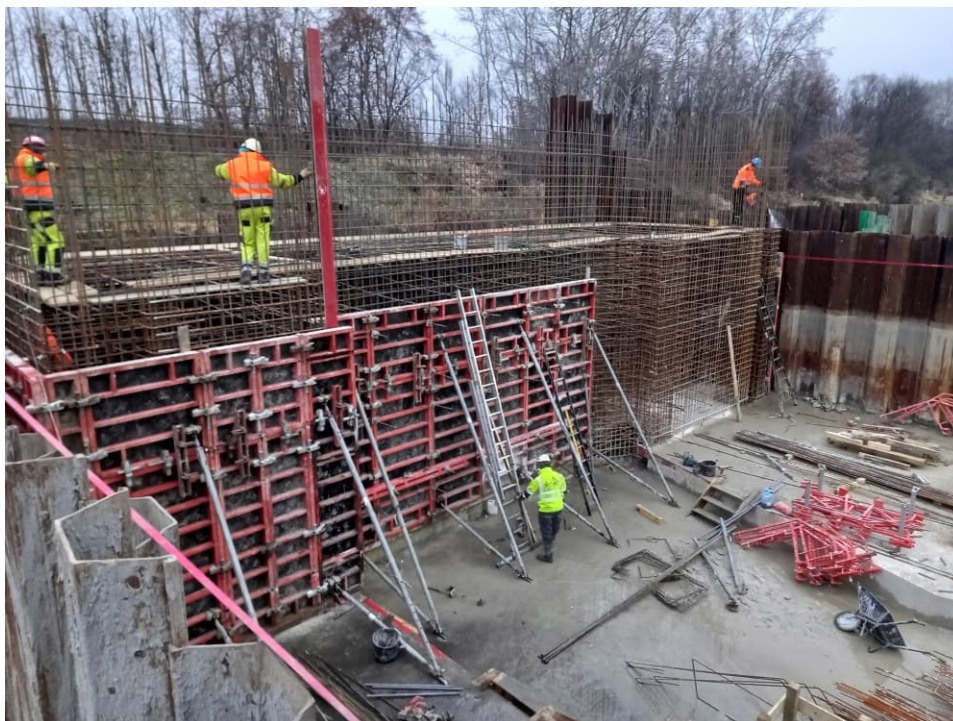
Fig. 30. Construction site of flood gate in the Kujawy port channel bed, status in the third decade of November 2022 (view towards the west).

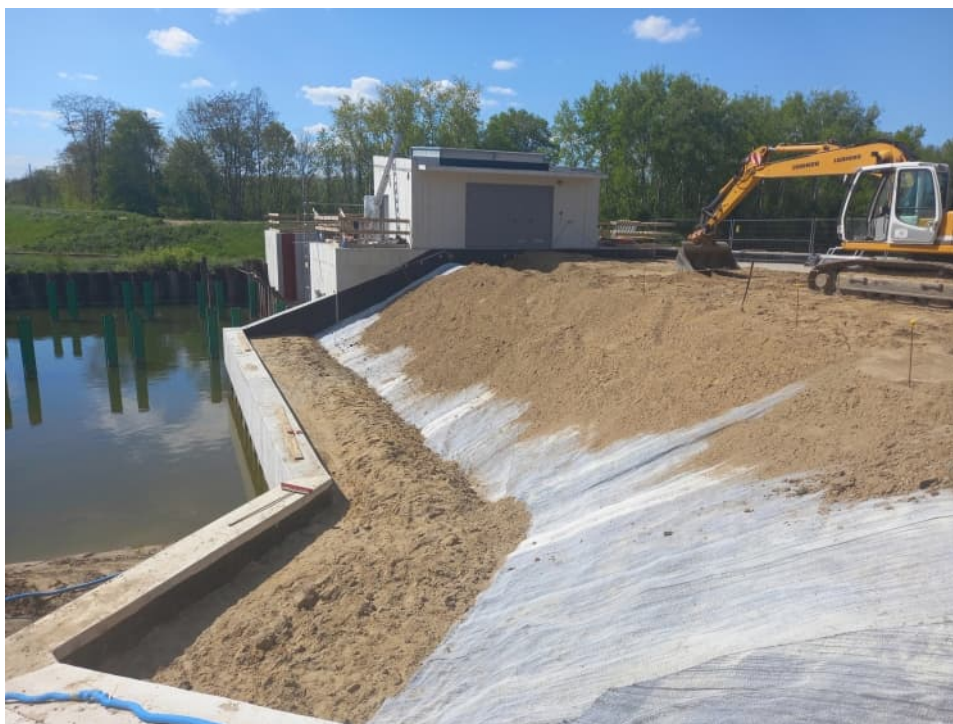
Fig. 33. Construction site of flood gate with a section of embankment connection on the eastern bank of the Kujawy port channel, status in the second decade of May 2023 (view towards the west).

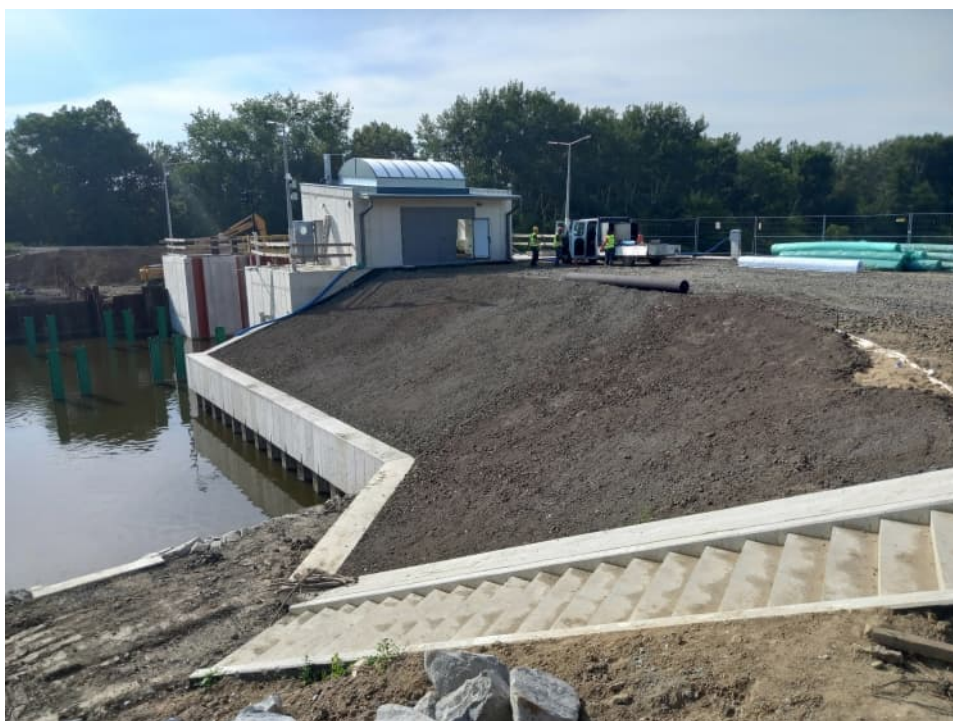
Fig. 34. Construction site of flood gate with a section of embankment connection on the eastern bank of the Kujawy port channel, status in the second decade of July 2023 (view towards the west).

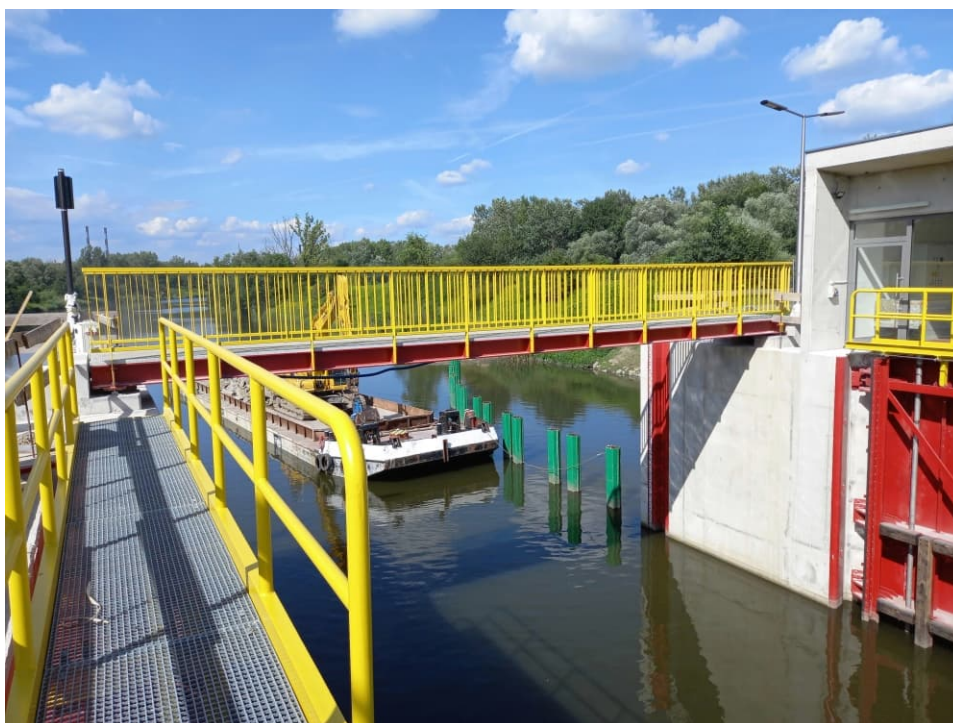
Fig. 40. The activated flood gate chamber in the Kujawy port channel, status in the third decade of July 2023 (view towards the north).

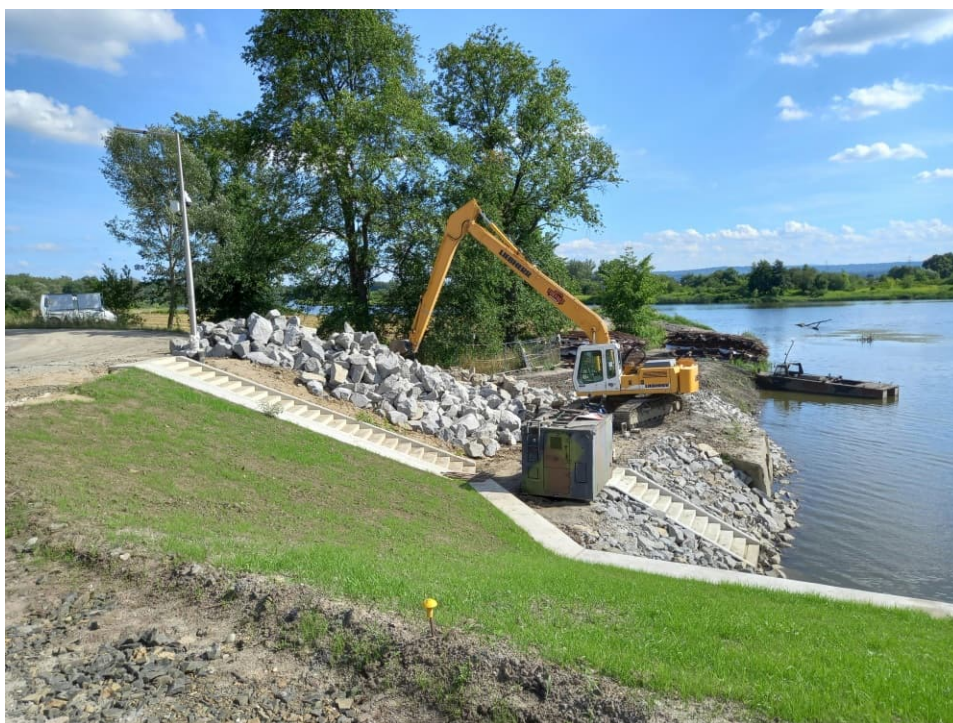
Fig. 42. A stone riprap for securing the bottom and slopes of the Kujawy port channel, status in the third decade of July 2023 (view towards the south).

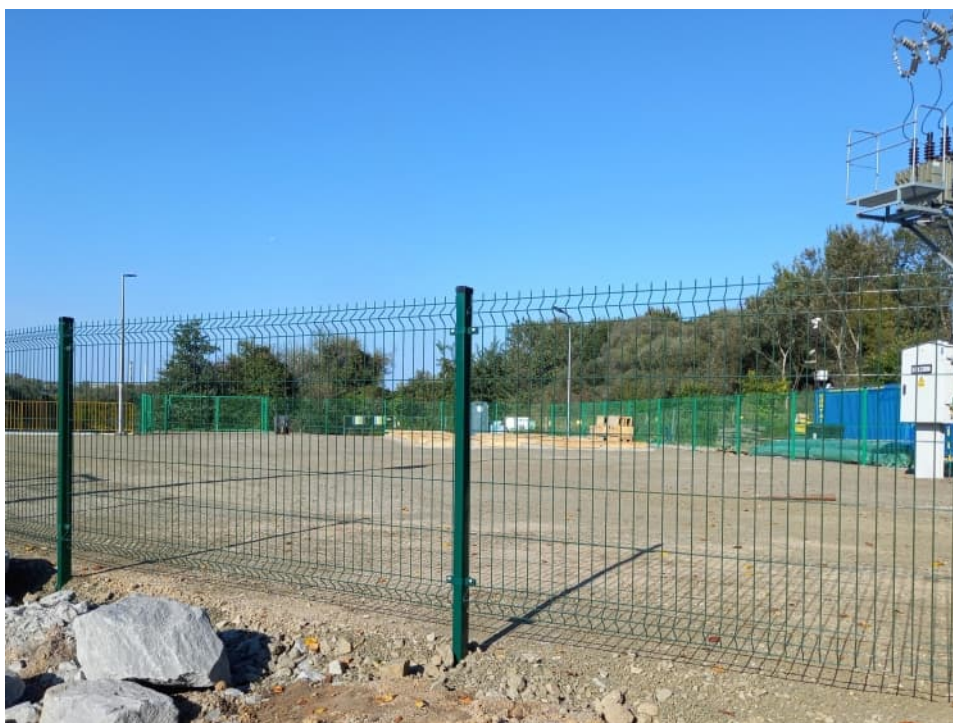
Fig. 48. A built and fenced maneuvering yard
on the eastern bank of the Kujawy port channel,
status in the third decade of September 2023 (view towards the north-east).
