Appendix no. 6 to the Interim Report on Implementation of the Land Acquisition and Resettlement Action Plan (LARAP) for Contract 3A.1
Construction of Vistula embankments in Cracow covering the implementation of 2 Works Contracts:

- **3A.1/1 – *Construction of Vistula embankments in Cracow - Section 1, Section 2***
- **3A.1/2 – *Construction of Vistula embankments in Cracow - Section 3***

PART A: 3A.1/1 – Construction of Vistula embankments in Cracow - Section 1, Section 2

PART B: 3A.1/2 – Construction of Vistula embankments in Cracow - Section 3

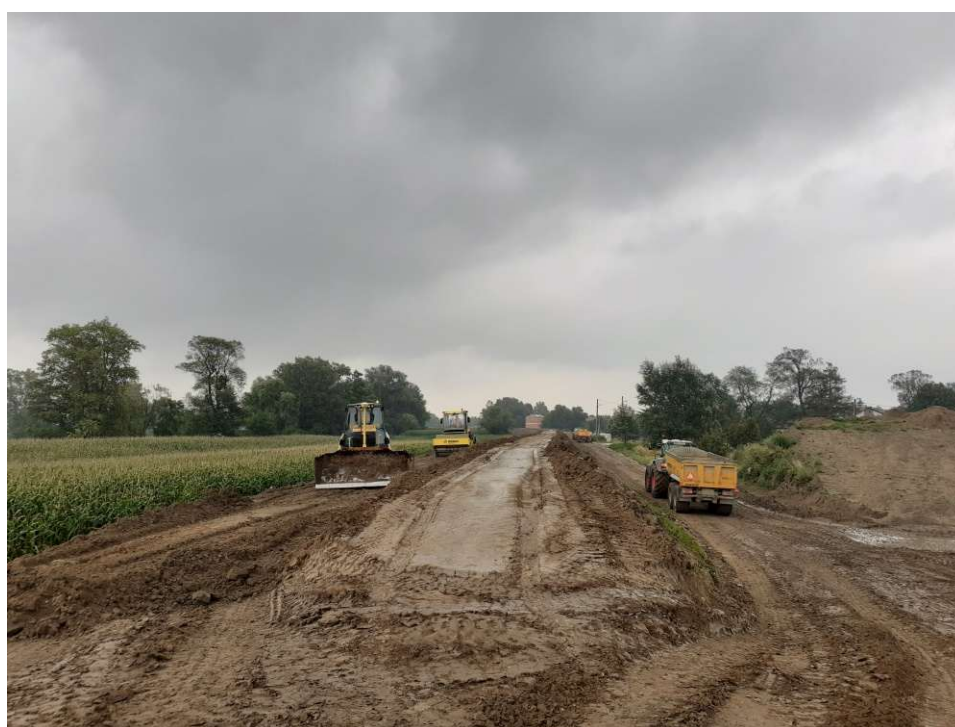
Foto. 99. Transport of earth masses for the reconstruction of the flood embankment – the right embankment of the Vistula River *on section 3.2a*, state in the first decade of July 2022 (view downstream).

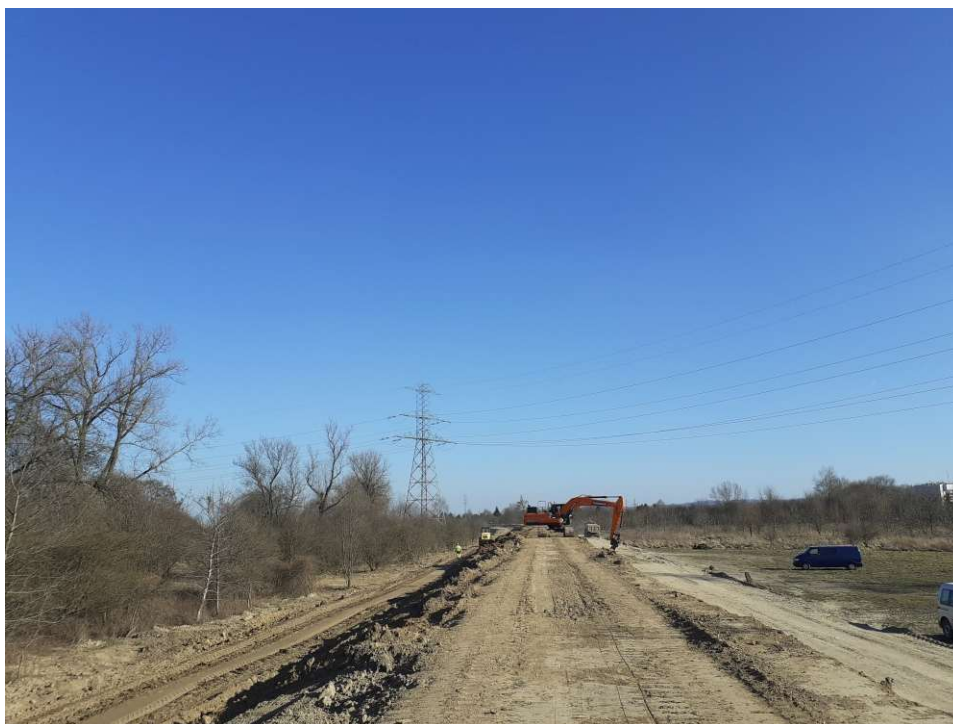
Foto. 100. Transport of earth masses for the reconstruction of the flood embankment – the right embankment of the Vistula River *on section 3.2b*, condition in the third decade of July 2022 (view downstream).

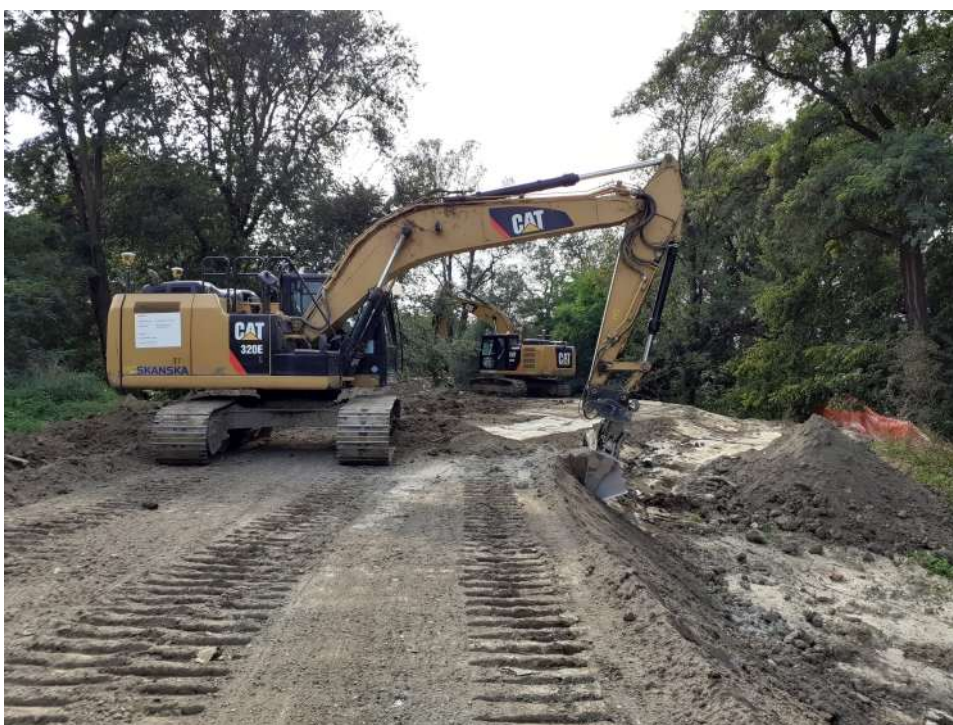
Foto. 101. Formation of flood embankment slopes – right Vistula embankment *on section 3.2a*, state in the third decade of March 2022 (view downstream).

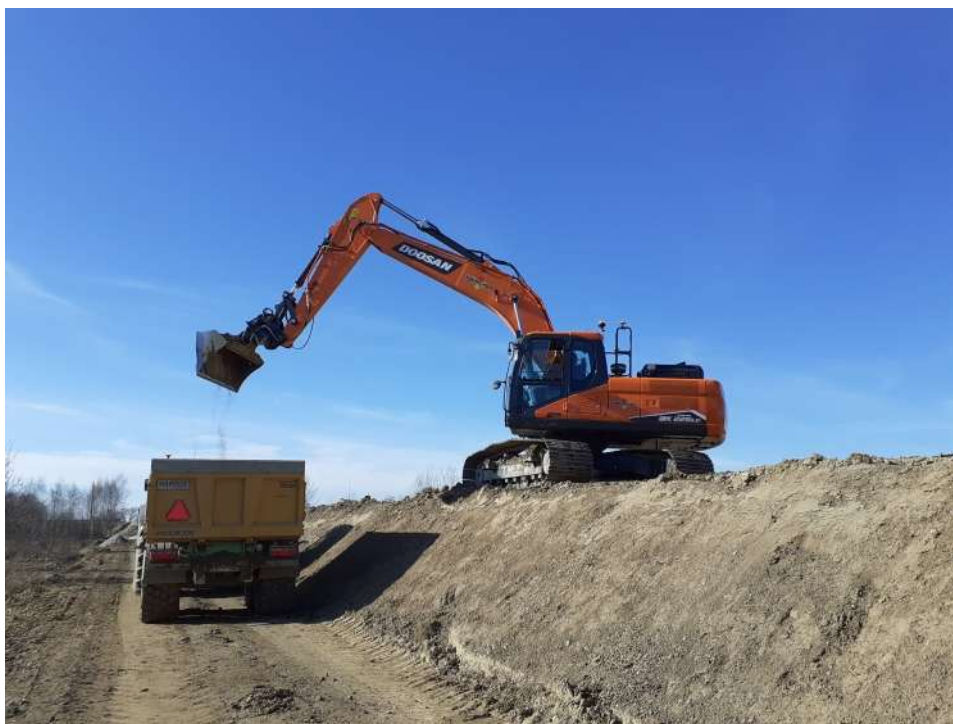
Foto. 102. Formation of flood embankment slopes – right Vistula embankment *on section 3.2a*, state in the first decade of September 2022 (view downstream).

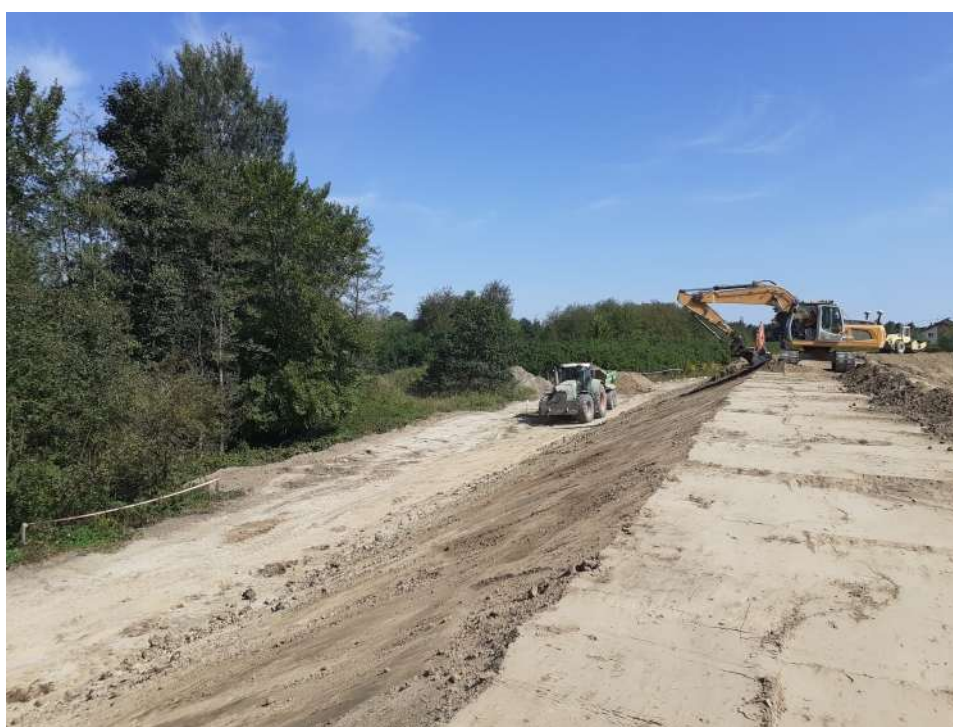
Foto. 103. Leveling the slopes of the flood embankment – the right embankment of the Vistula River *on section 3.3*, state in the third decade of February 2022 (view upstream).

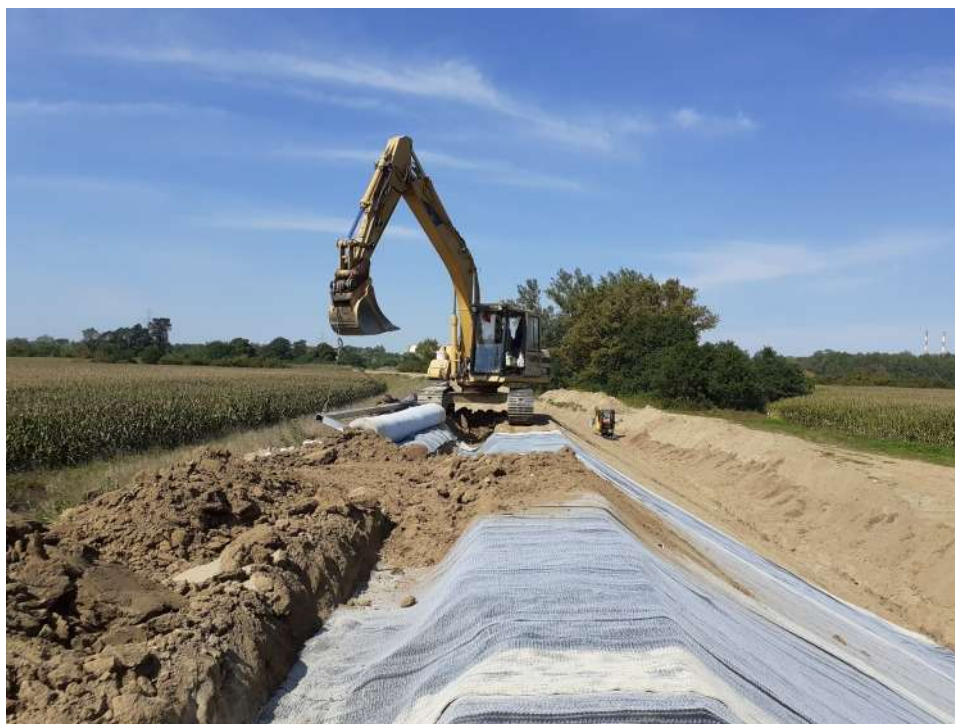
Foto. 104. Leveling the slopes of the flood embankment – the right embankment of the Vistula River *on section 3.4*, state in the first decade of September 2022 (view downstream).

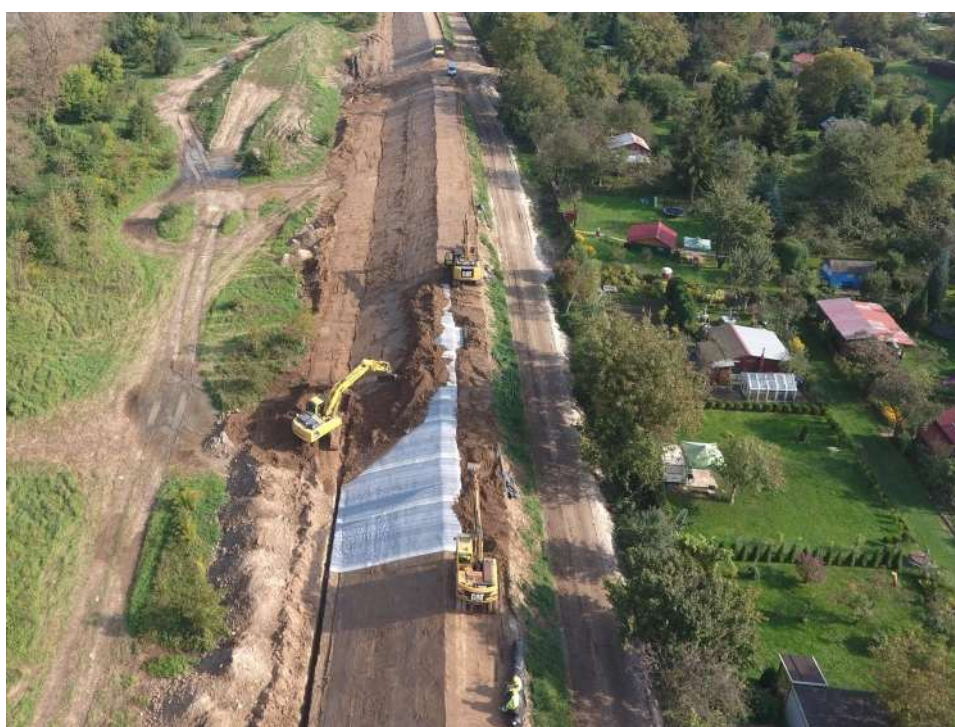
Foto. 105. Laying bentomat on the slope of the flood embankment – the right embankment of the Vistula River *on section 3.3*, state in the first decade of September 2022 (view upstream).

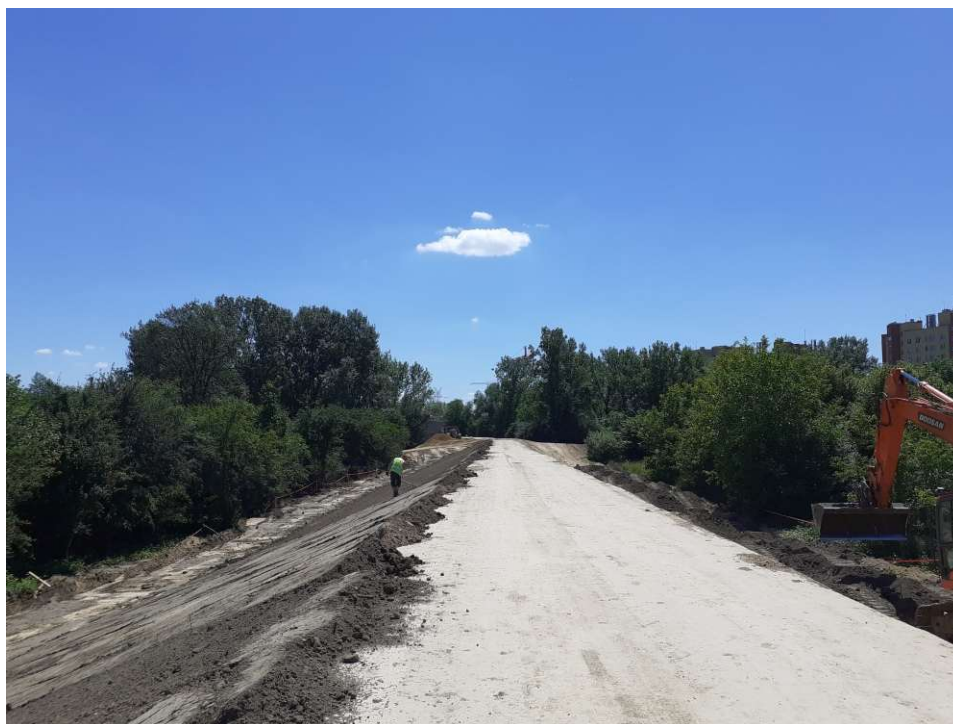
Foto. 106. Laying bentomat on the slope of the flood embankment – the right embankment of the Vistula River *on section 3.2a*, condition in the third decade of September 2021 (view downstream).

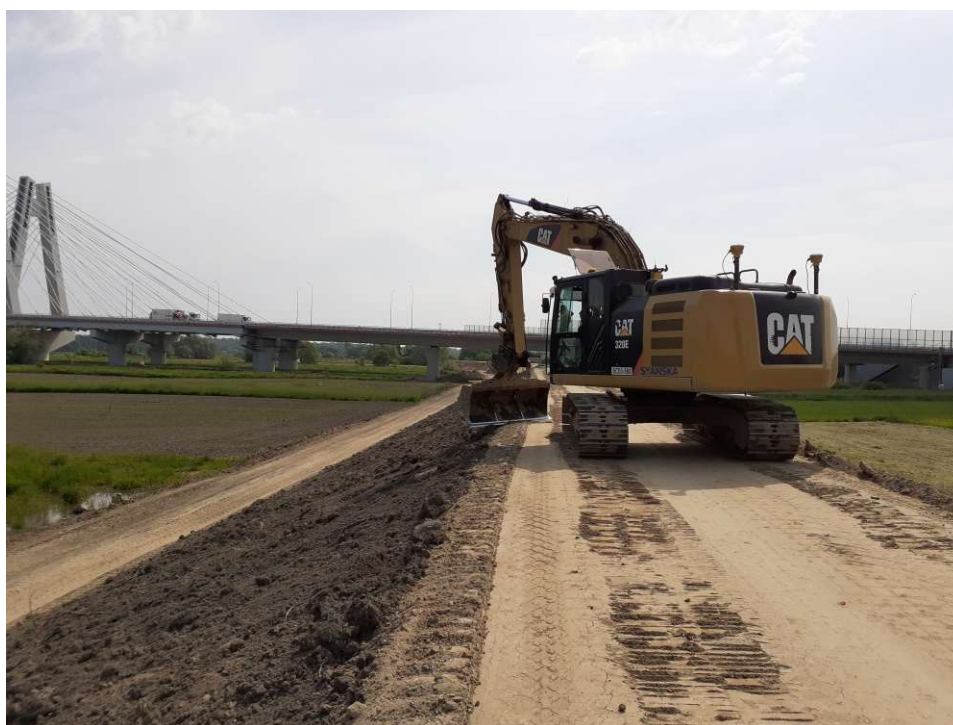
Foto. 107. Topsoiling of flood embankment slopes – right Vistula embankment *on section 3.2a*, condition in the third decade of June 2022 (view downstream).

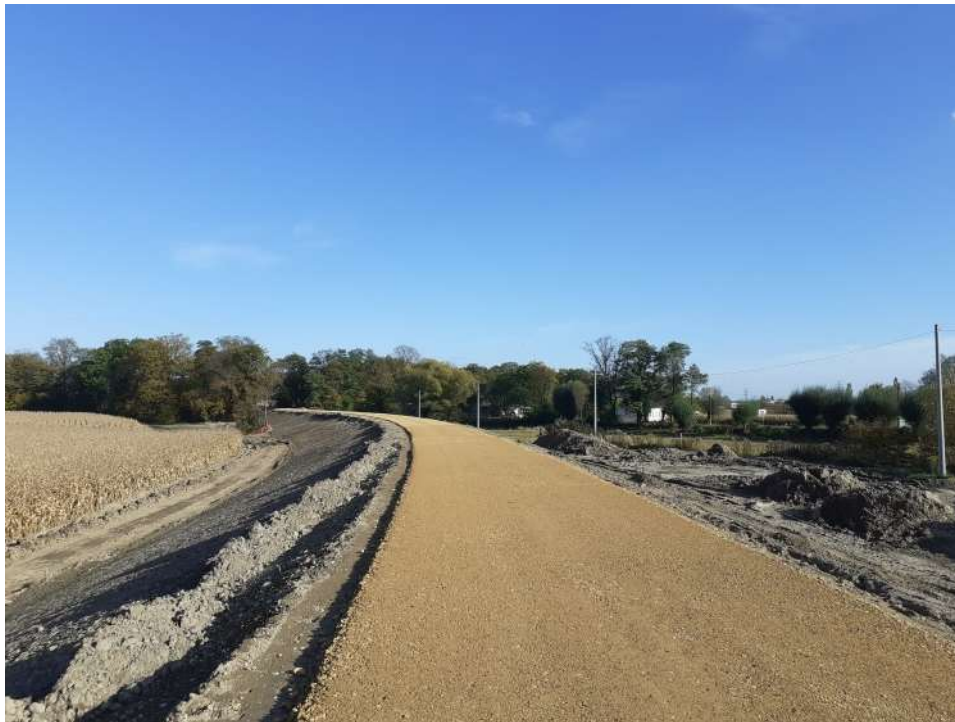
Foto. 108. Topsoiling of flood embankment slopes – right Vistula embankment *on section 3.3*, condition in the third decade of May 2023 (view downstream).

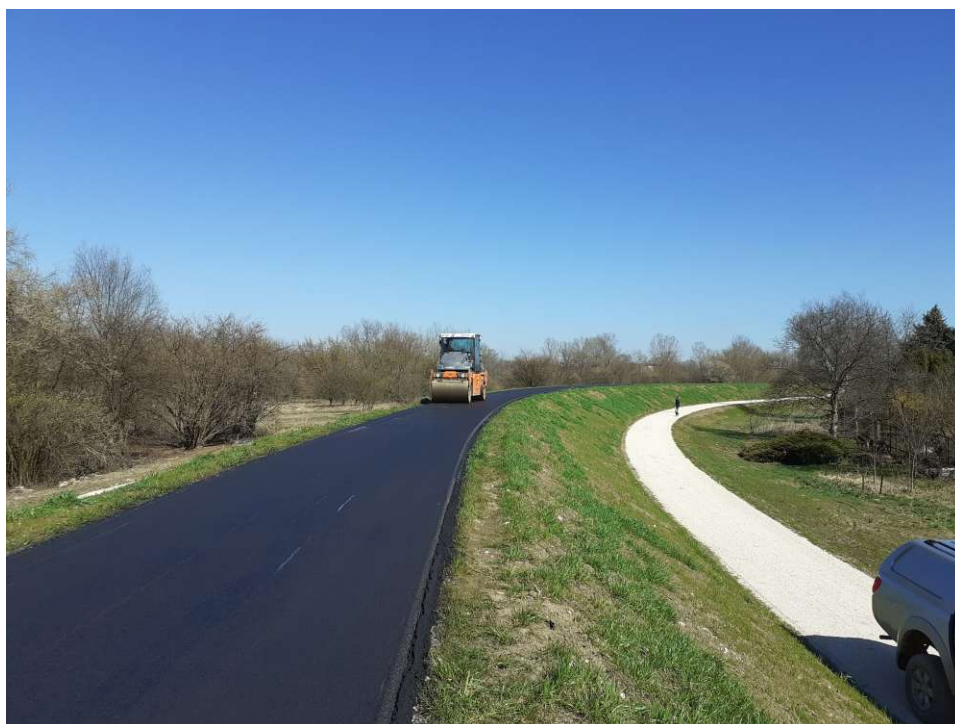
Foto. 109. Construction of a road on the top of the flood embankment – the right embankment of the Vistula River *on section 3.2a*, condition in the second decade of October 2022 (view downstream).

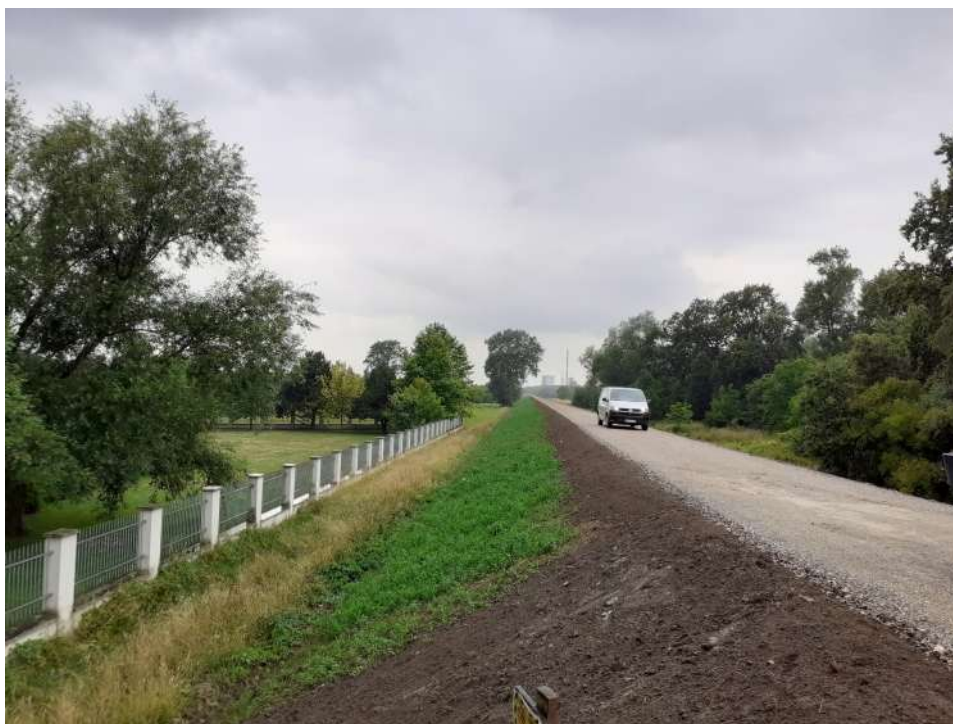
Foto. 110. Construction of a road on the top of the flood embankment – the right embankment of the Vistula River *on section 3.1*, state in the third decade of March 2023 (view downstream).

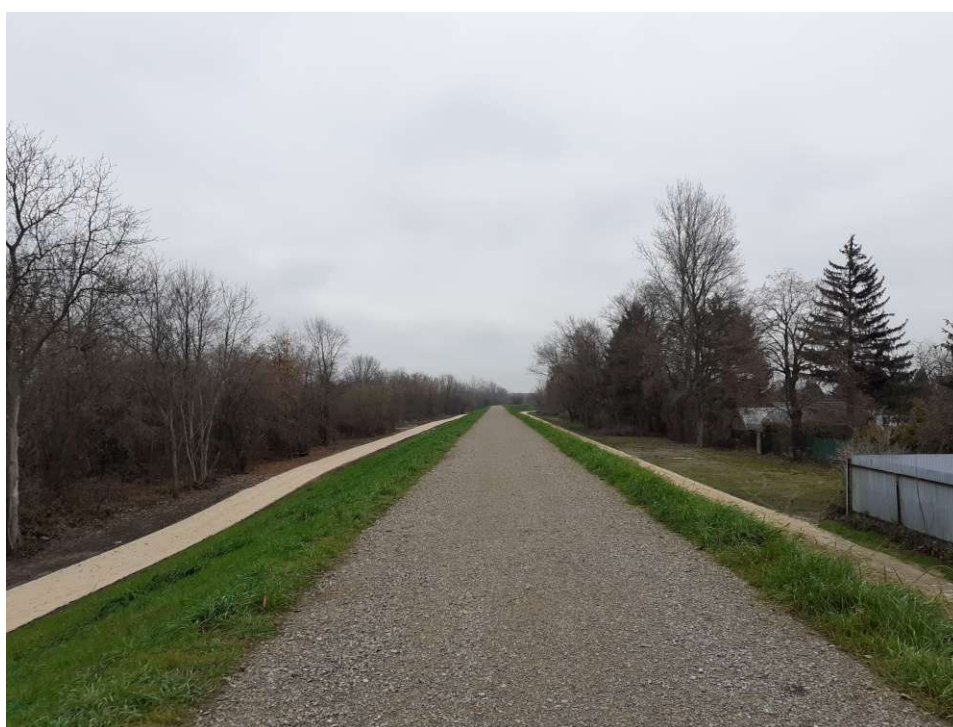
Foto. 111. Growth of grasses sown on the slope of the flood embankment – the right embankment of the Vistula River *on section 3.3*, state in the second decade of July 2023 (view upstream).

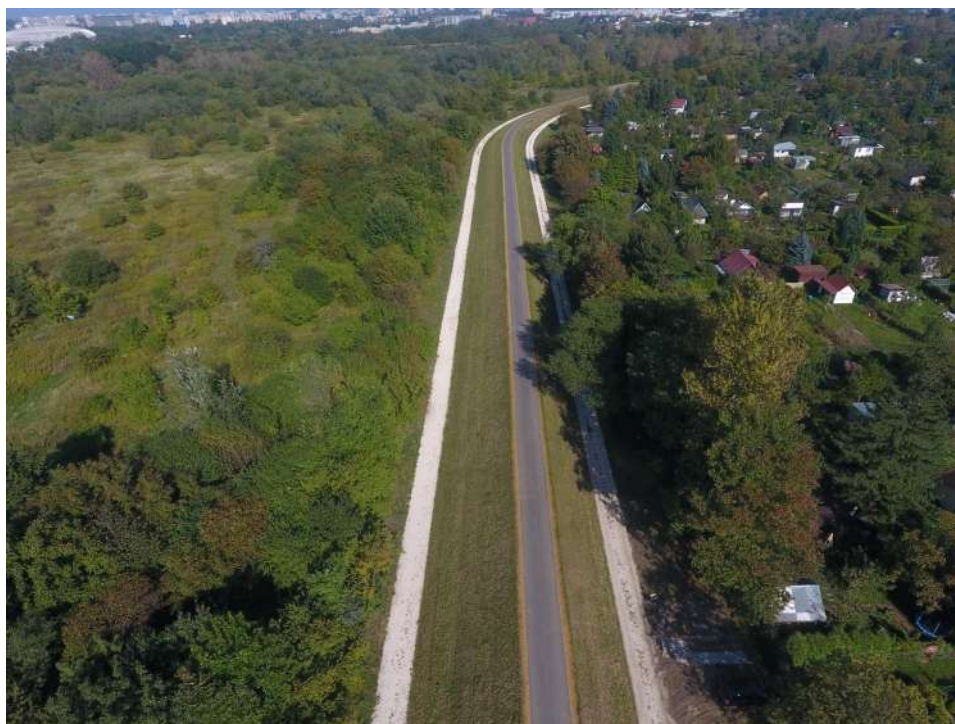
Foto. 112. Growth of grasses sown on the slope of the flood embankment – the right embankment of the Vistula River *on section 3.1*, state in the third decade of November 2022 (view downstream).

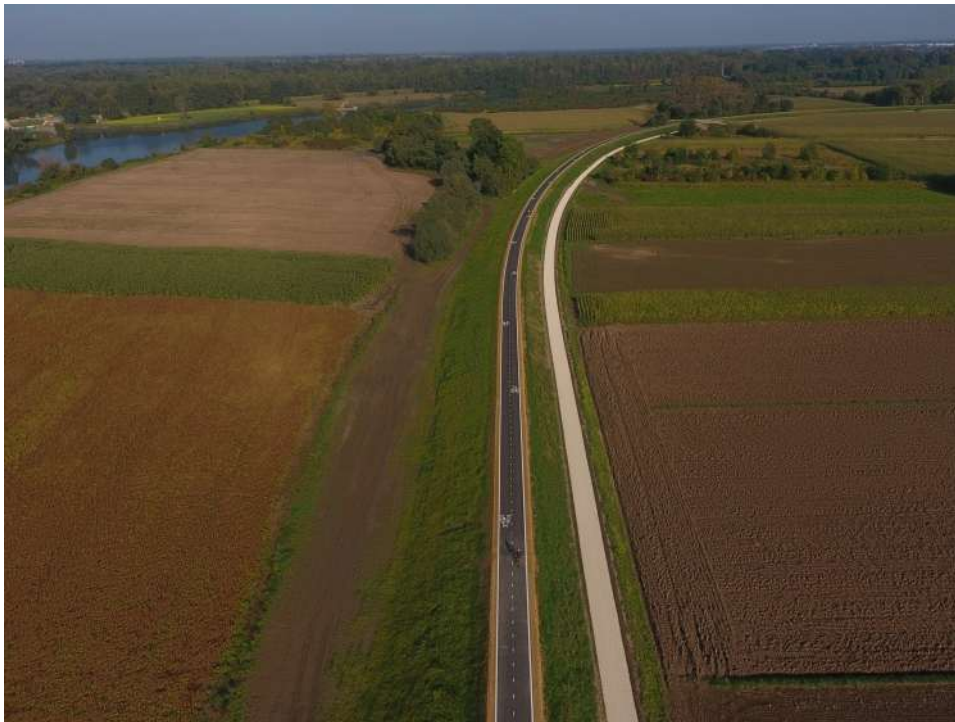
Foto. 116. Condition of the construction site in the last quarter of the works implementation period – rebuilt right Vistula embankment *on section 3.3 – upper part*, condition in the third decade of September 2023 (view downstream).

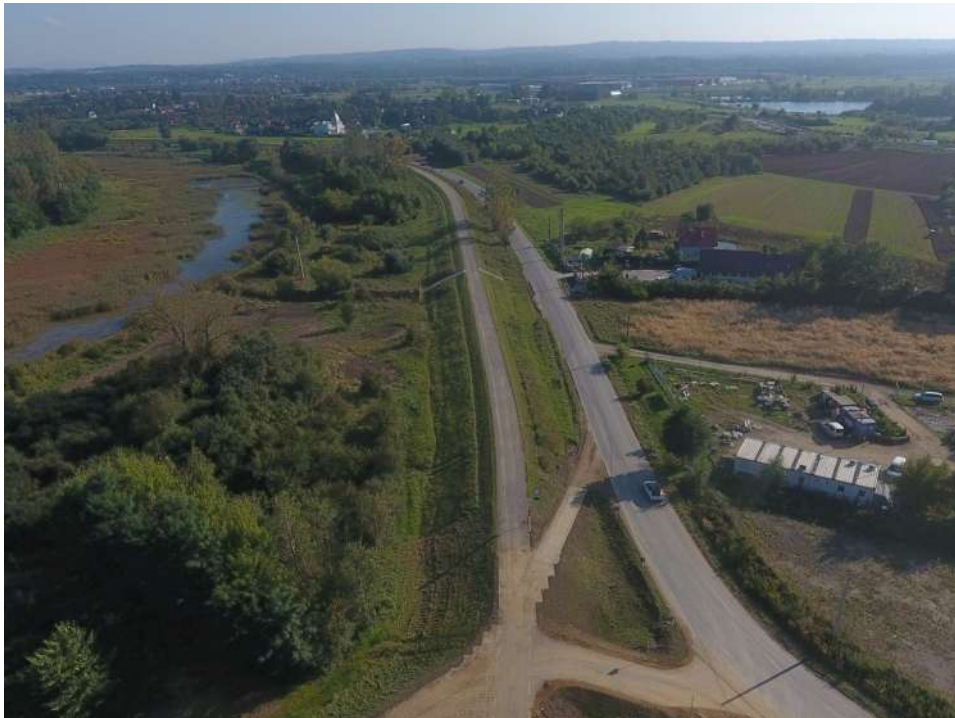
Foto. 117. Condition of the construction site in the last quarter of the works implementation period – rebuilt right Vistula embankment *on section 3.3* – lower part, condition in the third decade of September 2023 (view downstream).
