**Aircraft Accident and Incident
Investigation Agency**
10002 Zagreb, Prisavlje 14

FINAL REPORT

OF AIRCRAFT SKYLEADER 500 ACCIDENT WHICH OCCURRED ON SEPTEMBER 25th 2010 IN THE AREA OF BUDAČKA RIJEKA

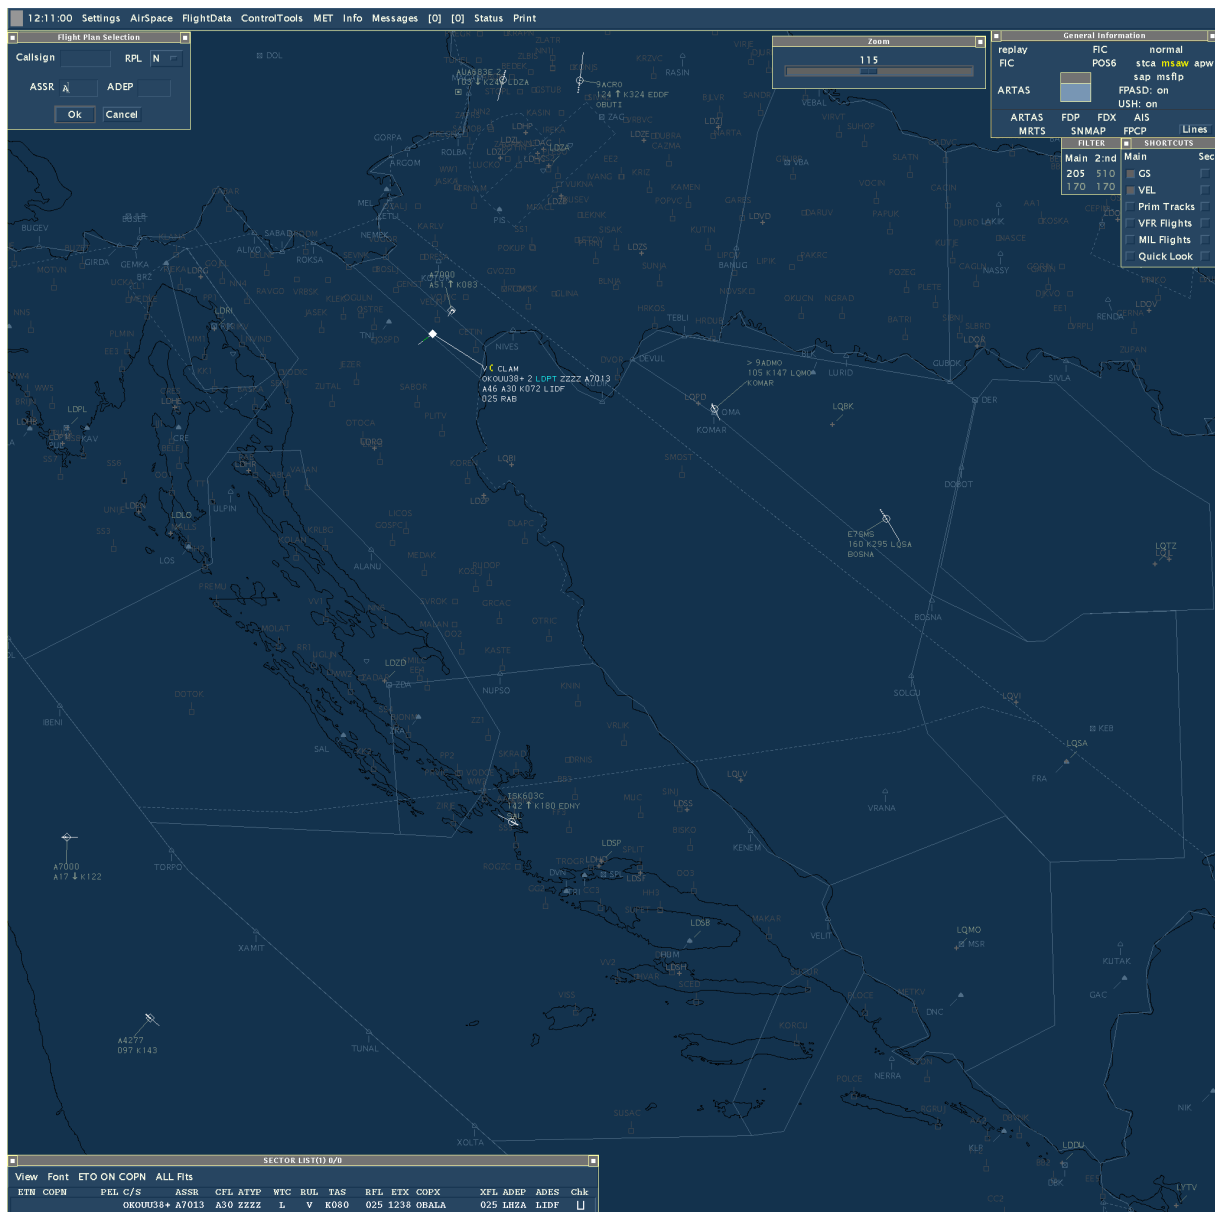
Image 6 Radar records; time: 12:11:00 UTC

Radar images show that aircraft SP-SKYL at 12:08:00 UTC was in formation with the group leader. At around 12:11:00 UTC (Image 6) the mentioned aircraft begins to fall behind the leading aircraft and at 12:13:20 UTC (Image 8) the Air Traffic Control loses its reflection on the screen.

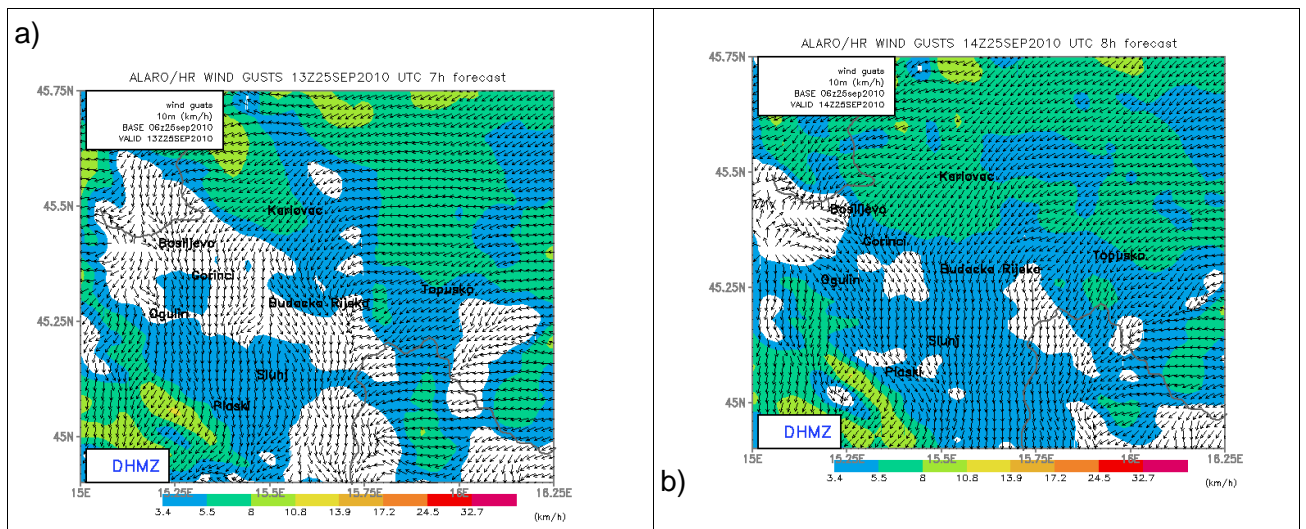
Image 17 Wind gusts (shaded) and wind direction (arrows) obtained by model Aladin with 2 km horizontal resolution, for 15 (a) and 16 (b) hours LT (13 and 14 UTC) on September 25th 2010.

The pressure was falling at a moderate speed which indicates a passing of an atmospheric front. The wind was weak and changeable, except in Topusko and Gorinci where it was moderate. Topusko recorded north and Gorinci northwest wind, which is consistent to predicted wind direction at these two locations (Image 17). Air temperature has slightly

Wind charts near the ground resulting by model Aladin (Image17) show the variability of wind direction and intensity of gusts in the area. Measured mean 10-min wind speed in time is weak and variable (Image 19, dark blue line) at stations Ogulin, Slunj and Gorinci in the period from 10 to 17 hours (8-15 UTC) on September 25th 2010. Mean wind speed and gusts were slightly stronger at stations Zavižan and Karlovac. It is also evident that at these stations, during the observed period, besides the low to moderate wind speed (up to 10 km/h), stronger gusts are present, even up to 25 km/h (red line on Image 19). Before 13 hours (11 UTC) northeast wind is dominant at stations Gorinci, Karlovac and Ogulin, and then the wind direction changes to northwest (green dots in Image 19). At station Slunj wind direction changes from north to west, and at station Zavižan from southeast to northwest earlier, between 11 and 12 hours (9 and 10 UTC). Changes in wind direction are consistent to passing of an atmospheric front.

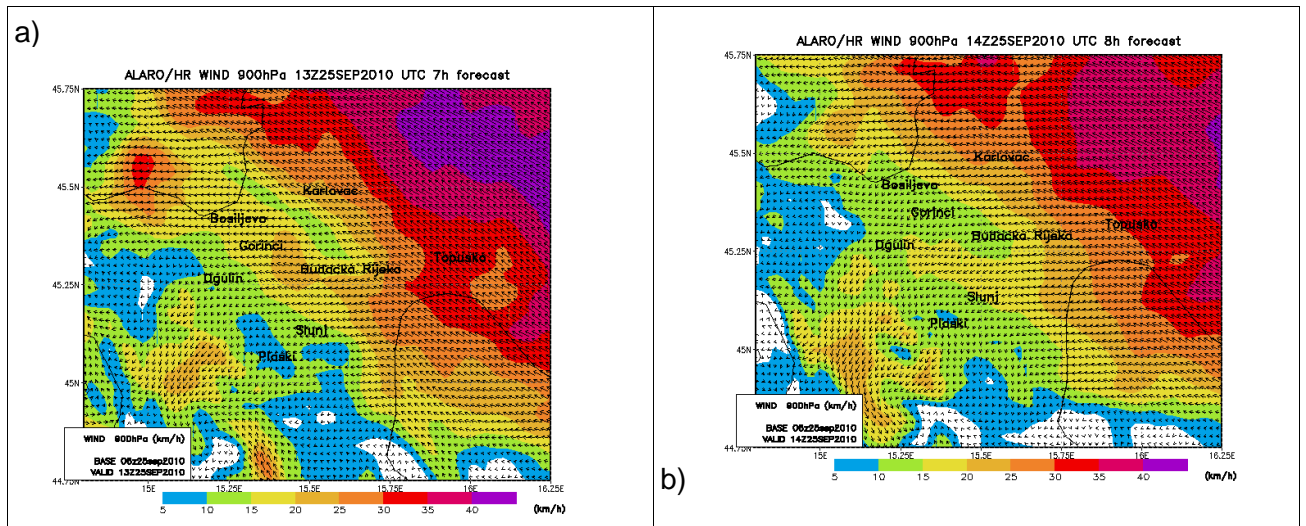
Image 18 Wind speed (shaded) and direction (arrows) at a surface of 900 hPa (aprox. 1 km above the ground) obtained by model Aladin with 2 km horizontal resolution, for 15 (a) and 16 (b) hours LT (13 and 14 UTC) on September 25th 2010.

Prognostic wind field at an altitude of 900 hPa isobaric surface (Image 18), which is situated at an altitude of 1 km, indicate that the wind was strong south-eastern northwest of the area of Budačka Rijeka; over Budačka Rijeka has weakened, and southwest of Budačka Rijeka was weak and changeable. That also points to the convergence of wind field in the observed area.

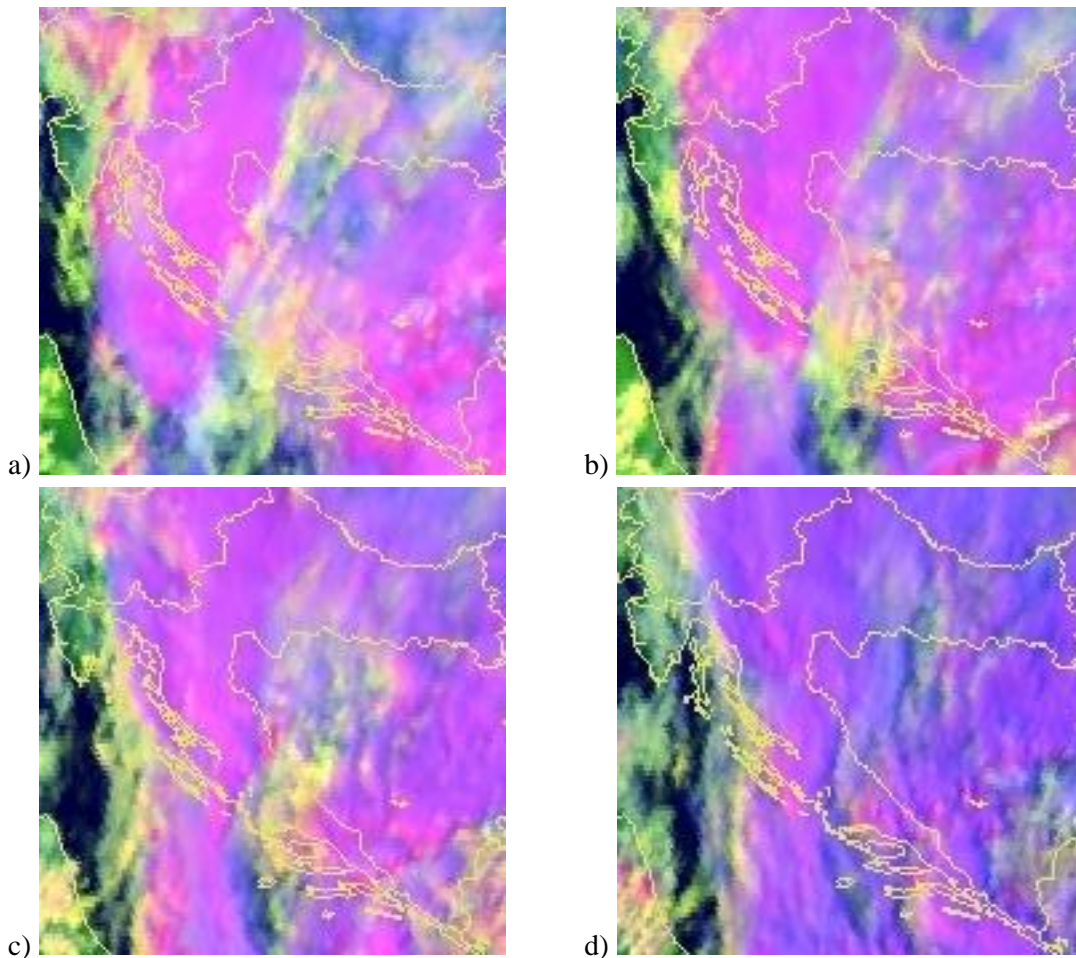
Image 20 Sattelite images of visible cloudiness at 13 hours (a), 14 hours (b), 15 hours (c) and 16 hours (d) local time (11, 12, 13 i 14 UTC) on September 25th 2010.

On satellite images (Image 20) over a wider area of Budačka Rijeka surroundings also are present high and convective clouds which have a cold cloud top (pink). A thicker layer of frontal convective cloudiness is stretching over the northwest Croatia, Gorski Kotar and Lika. Convective cloudiness is also located over the area of Karlovac. Surrounding area near Budačka Rijeka is also covered by convective clouds.

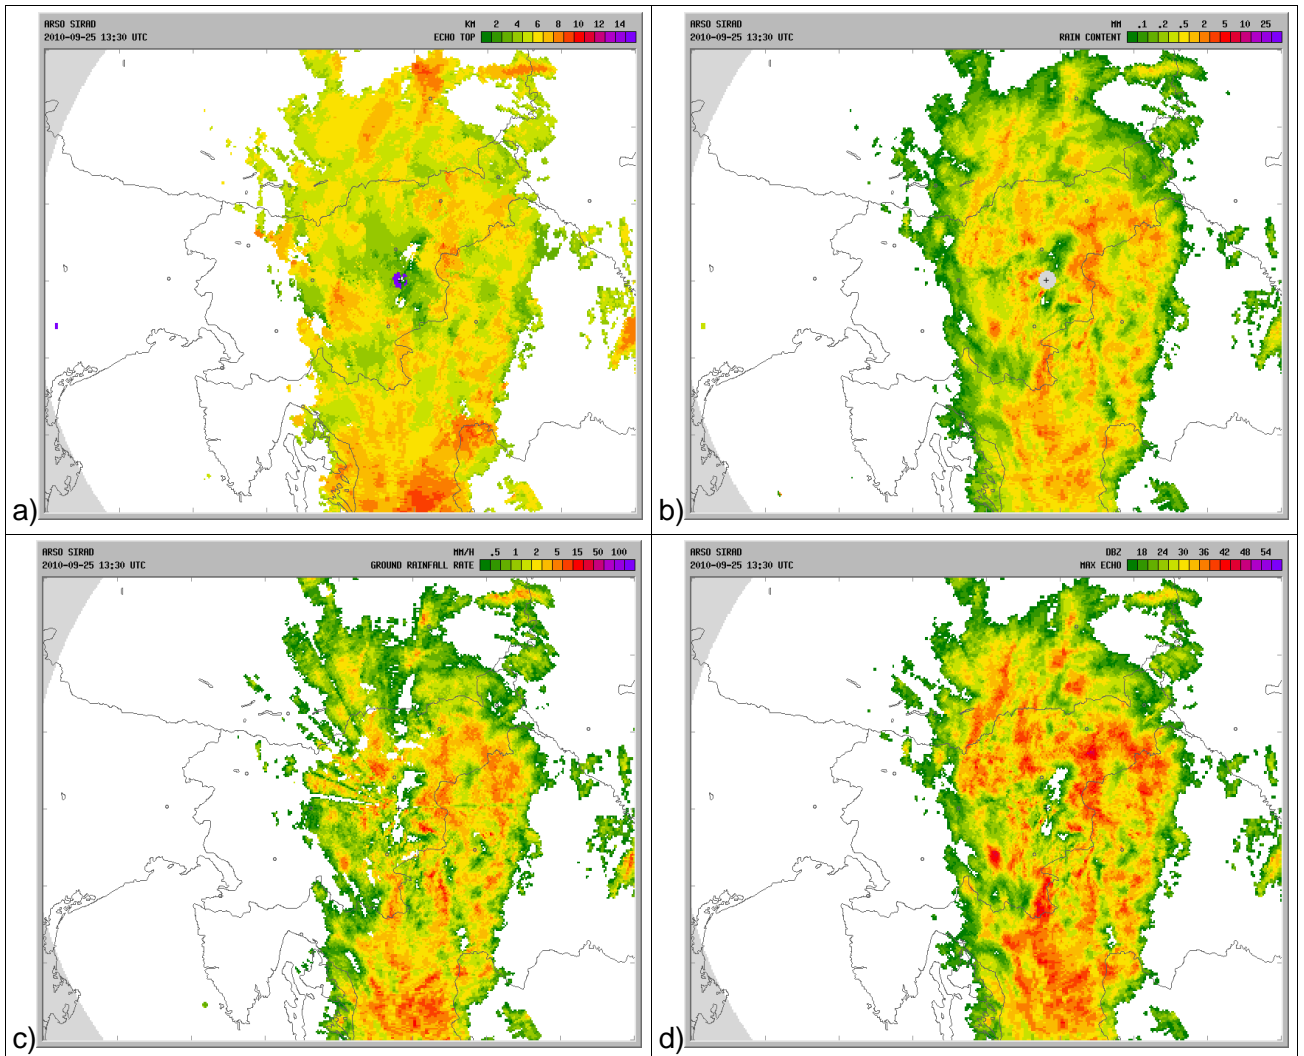
Image 21 The height of the cloud top (a), the amount of water in air (b), the intensity of precipitation at the ground (c) and the radar signal echo (d) measured on radar Lisca in Slovenia on September 25th 2010 at 15 hours and 30 minutes (13:30 UTC) .

Radar images show that in the area east of Budačka Rijeka, near Petrova Gora, between 15 and 16 hours (13 and 14 UTC) appears an area where there are no reflections (Image 21). This same area without reflection can be seen on images for radars Lisca and Bilogora (Image 24). This indicates the existence of holes in the clouds in the middle of the convective front that can occur due to strong vertical air flow downwards. At the same time, in the surrounding area there are convective clouds in which also strong vertical air flows exist. The bottom row of images on Image 24 shows the radial wind velocity at 2 km above the ground, calculated from the reflected glare measured at radar station Bilogora. On this image lack of reflection (marked by circle) can also be seen.

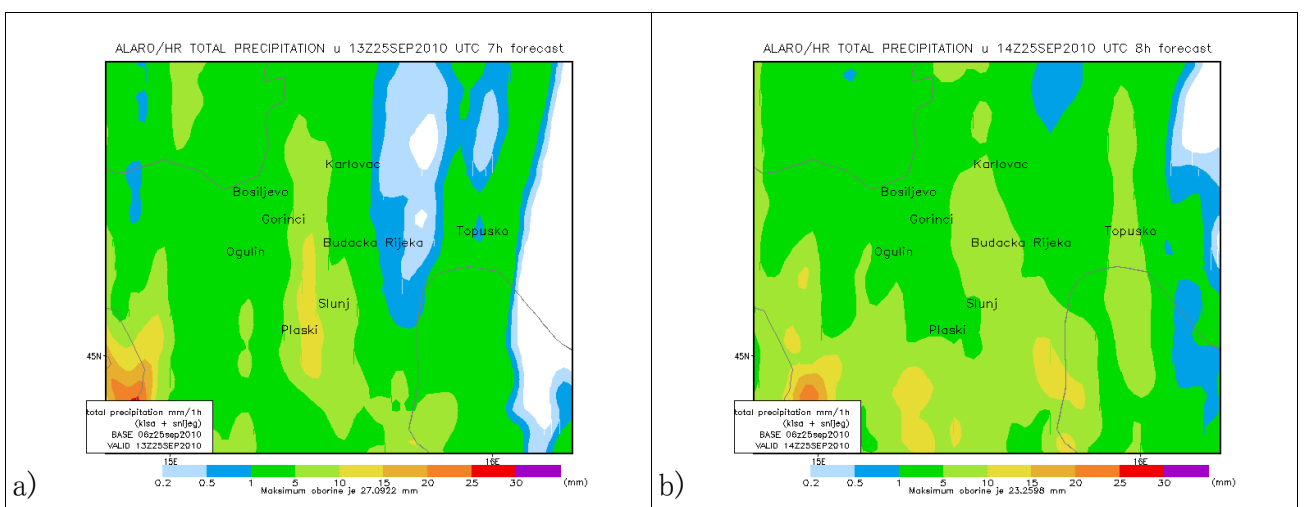
Image 22 Total precipitation calculated by model Aladin for the period 14-15 h (a) (12-13 UTC) and 15-16 h (b) (13-14 UTC) on September 25th 2010.

Field of precipitation resulting by model Aladin (Image 22) shows that, at the observed period from 14-15 hours (12-13 UTC), the rain was falling in intensity around 1 mm/h (Image 22a) and the next hour has increased to almost 5 mm/h (Image 22b). Such an increase in the

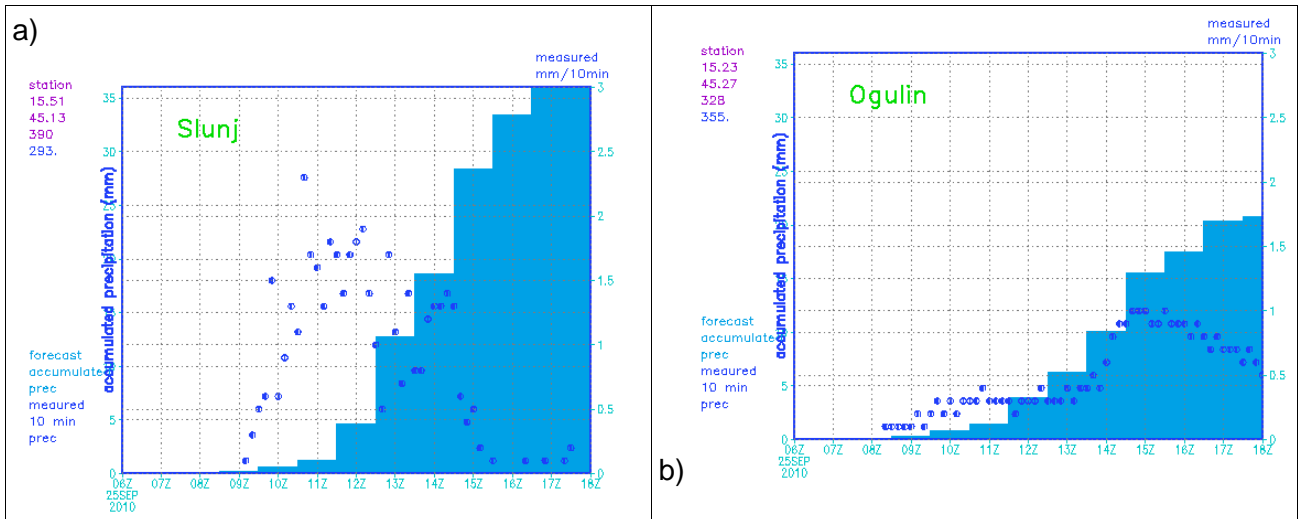
Image 23 Accumulated precipitation resulting by model Aladin (blue columns) and measured 10 minute precipitation (dark blue dots) at stations Slunj (a) and Ogulin (b) from 8-20 hours (6 to 18 UTC) on September 25th 2010.

intensity of precipitation was recorded also at the automatic station in Ogulin where, up to 16 hours, precipitation had the intensity of 0.3mm/10 min (1.8mm / h, blue dots in Image 23b), and then increased to 1mm/10min (6mm/h). Automatic station in Slunj recorded significantly higher measured intensity of precipitation (Image 23a), from 1-2 mm/10min (6-12 mm/h). Ombrograf in Karlovac recorded precipitation intensity of 8.8mm/h. Model Aladin predicted a higher intensity of precipitation in Slunj than Ogulin (blue columns in Image 23). In the fields of forecasted precipitation (Image 22) an area of decreased intensity of precipitation east of Budačka Rijeka can be seen, in accordance with the radar images (Image 21) obtained from measurements of echo on radar stations.

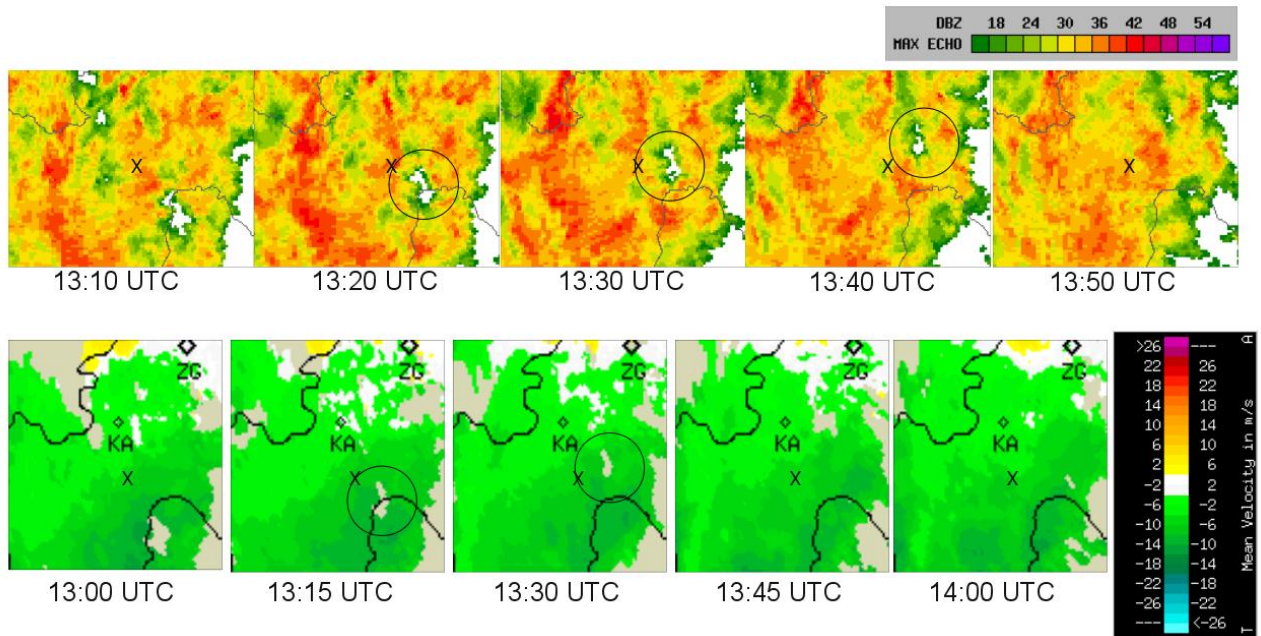
Image 24 Maximum reflection recorded on radar Lisca in Slovenia (top row of the images) and the radial velocity at 2 km above the ground was recorded on radar Bilogora in Croatia (bottom row of the images). Below the images is indicated in which period the cloud has been scanned. Beside the images, scales of reflectivity and velocity are shown.

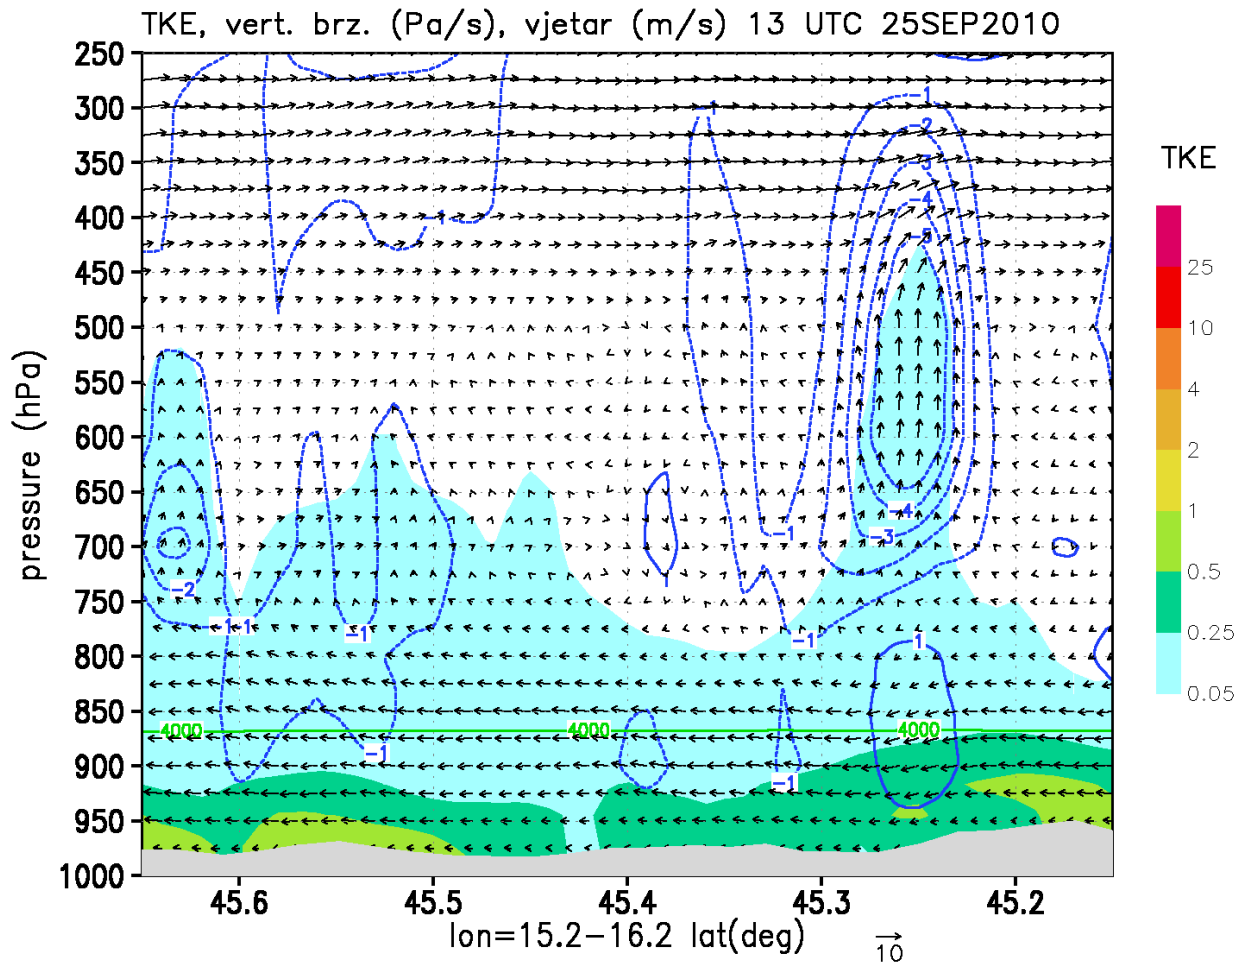
Image 25 The results of simulation by model Aladin: Cross-section by height (vertical axis is the pressure, from 1025-250 hPa) from point (lon= 15.2, lat = 45.65) to point (lon= 16.2, lat = 45.15) on September 25th 2010 at 15 hours local time (13 UTC), shows the turbulent kinetic energy (shaded), vertical velocity (blue isolines, unit Pa/s, positive velocity is downward, shown in full lines, negative velocity is upwards, shown as dotted lines), vectors show the wind parallel to the cross-section as a horizontal component and the vertical velocity as the vertical component. Also, the altitude of the flight is shown as the purple line. The height of the terrain in the model is shown in gray at the bottom of the image.

Image 25 shows turbulent kinetic energy, vertical wind speed and direction. Turbulent kinetic energy is shown shaded in color, vertical velocity is expressed in Pa/s, positive values are downward and displayed as full isolines, and negative values are upward and shown as dotted lines. Vectors show the wind parallel with the cross-section as the horizontal component and vertical velocity as the vertical component. The length of the arrow is proportional to the intensity of air flow. Image 25 shows ascending motion at an altitude of 700-400 hPa (3-7 km) and an increase of turbulent kinetic energy in this area. Maximum turbulence was recorded in the lee of Petrova Gora, in the layer from the ground to 900 hPa (1 km). The mountain wave has not originated.

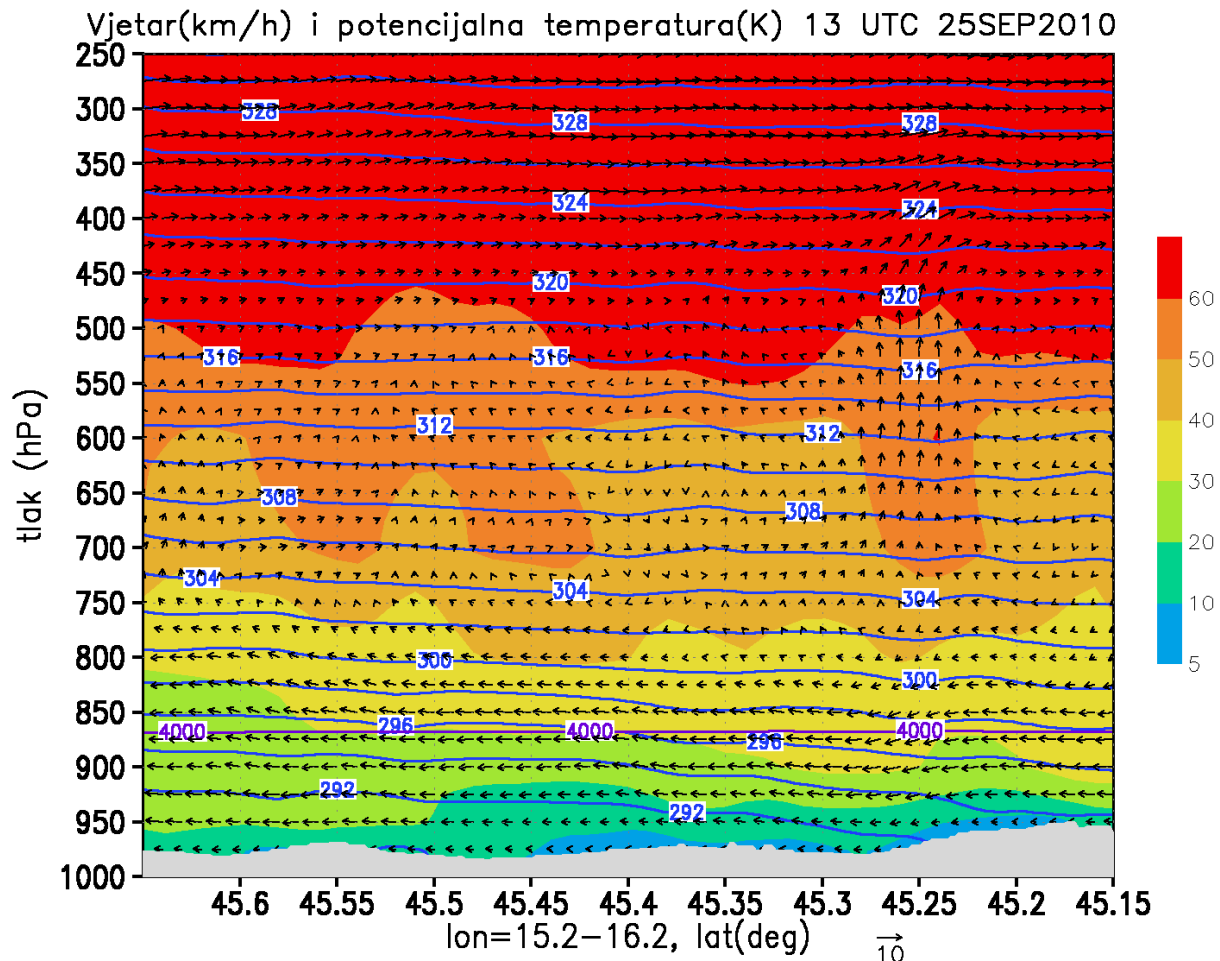
Image 26 Results of simulation by model Aladin: Cross-section by height (vertical axis is the pressure, from 1025-250 hPa) from point (lon= 15.2, lat = 45.65) to point (lon= 16.2, lat = 45.15) on September 25th 2010 at 15 hours local time (13 UTC), displays wind speed (shaded) and direction (vectors) and potential temperature (blue isolines). Also, flight altitude of 4000 feet is shown as the purple line. The height of the terrain in the model is shown in gray at the bottom of the image.

Image 26 shows wind speed and direction and potential temperature. Wind speed is shown shaded in color, potential temperature is shown in blue isolines, wind direction is shown in arrows as in Image 25. Vertical flow in Image 26 is expressed as omega (units Pa/s). Speed of the upwelling of 1 Pa/s at 900 hPa level (approximately 1000 m) corresponds to the vertical speed of about 4 km/h (1.1 m/s). Maximum turbulent kinetic energy at an altitude of 4000 feet is below 0.25 m²/s². This shows that the velocity in turbulent vortexes was below 1.8 km/h

(0.5 m/s). Modeled mean horizontal component of wind velocity at the same altitude is from 20 to 40 km/h (Image 26). Therefore, we can conclude that on the flight altitude, modeled vertical and turbulent motions were weaker than the horizontal flow of air.

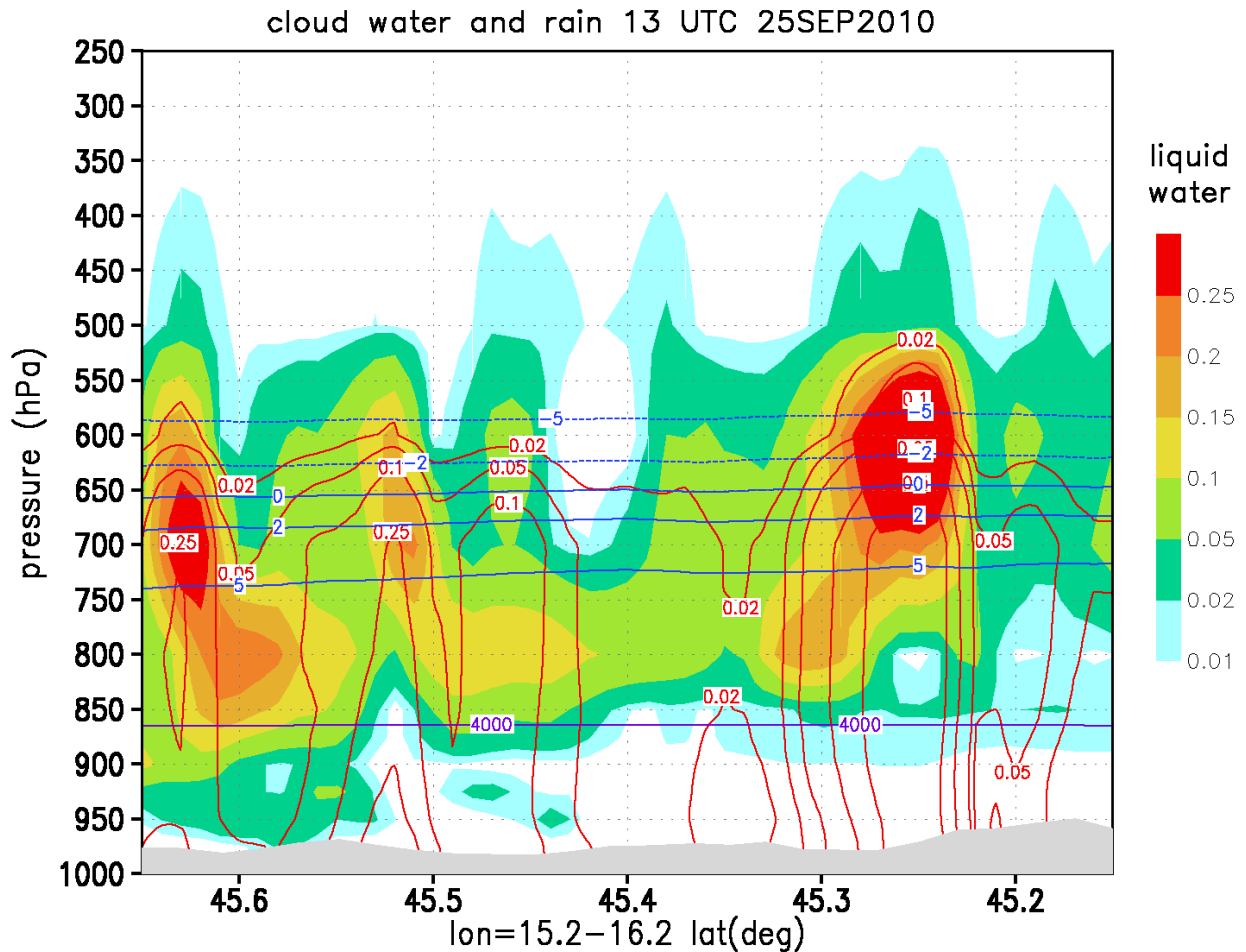
Image 27 Results simulation by model Aladin: Cross-section by height (vertical axis is the pressure, from 1025-250 hPa) from point (lon= 15.2, lat = 45.65) to point (lon= 16.2, lat = 45.15) on September 25th 2010 at 15 hours local time (13 UTC). The image shows the water in the clouds (* 10⁻³ liquid water content - shaded), rain (red isolines), temperature (blue isolines, the positive is shown as full lines, negative is shown as dotted lines). Also, flight altitude of 4000 feet is shown as the purple line. The height of the terrain in the model is shown in gray at the bottom of the image.

Image 27 shows water in the clouds (cloud liquid water content) in g/kg shaded, rain in g/kg in red isolines, temperature in blue isolines, positive temperature is shown as full lines; negative temperatures are shown as dotted lines. All images also show flight altitude of 4000 feet as the purple line and the height of the terrain in gray at the bottom of the image. Cloud flooring is descending from east to west, so it is above the flight altitude in the east and below in the west (Image 27). This is consistent with the observed flooring height of Nimbostratus flooring and other clouds observed at the synoptic stations (Table 1).

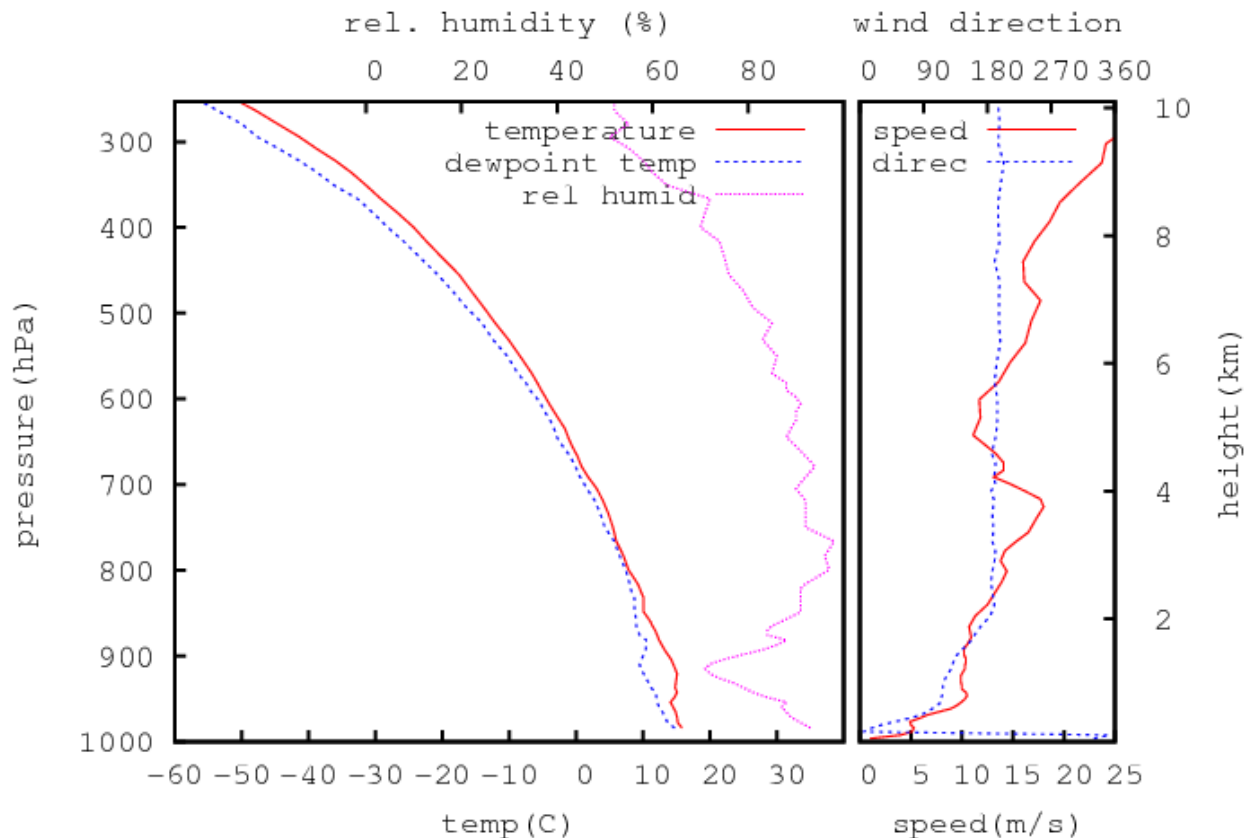
Image 28 Vertical profiles of air temperature and humidity, and wind speed and direction obtained by radio sounding measurement at station Zagreb - Maksimir at 14 hours (12 UTC) on September 25th 2010.

Measured vertical profiles of air temperature and humidity and wind speed and direction, shown in Image 28, was obtained from radio sounding measurements performed at 14 hours local time (12 UTC) on September 25th 2010 at location Zagreb-Maksimir. The profile shows a drop in temperature with height, interrupted with one temperature inversion (atmospheric layer in which the temperature increases with height) to about 950 hPa, where temperature increases with height by 1°C. Top of the temperature inversion is at 900hp. The air is saturated with water vapor and relative humidity reaches the minimum at the top of the temperature inversion. Above Zagreb, wind speed has increased with height up the temperature inversion layer where it reaches 10 m/s (36 km/h). Above the layer of temperature inversion, wind speed continues to increase up to 4 km height, where it reaches 18 m/s (65 km / h), then the wind speed drops to less than 70 km/h at 5 km, then increases again with height, and is greater then 90 km/h in the layer above 9 km. At flight altitude, the air temperature was well above 0°C, humidity 80%, and wind speed around 36 km/h.

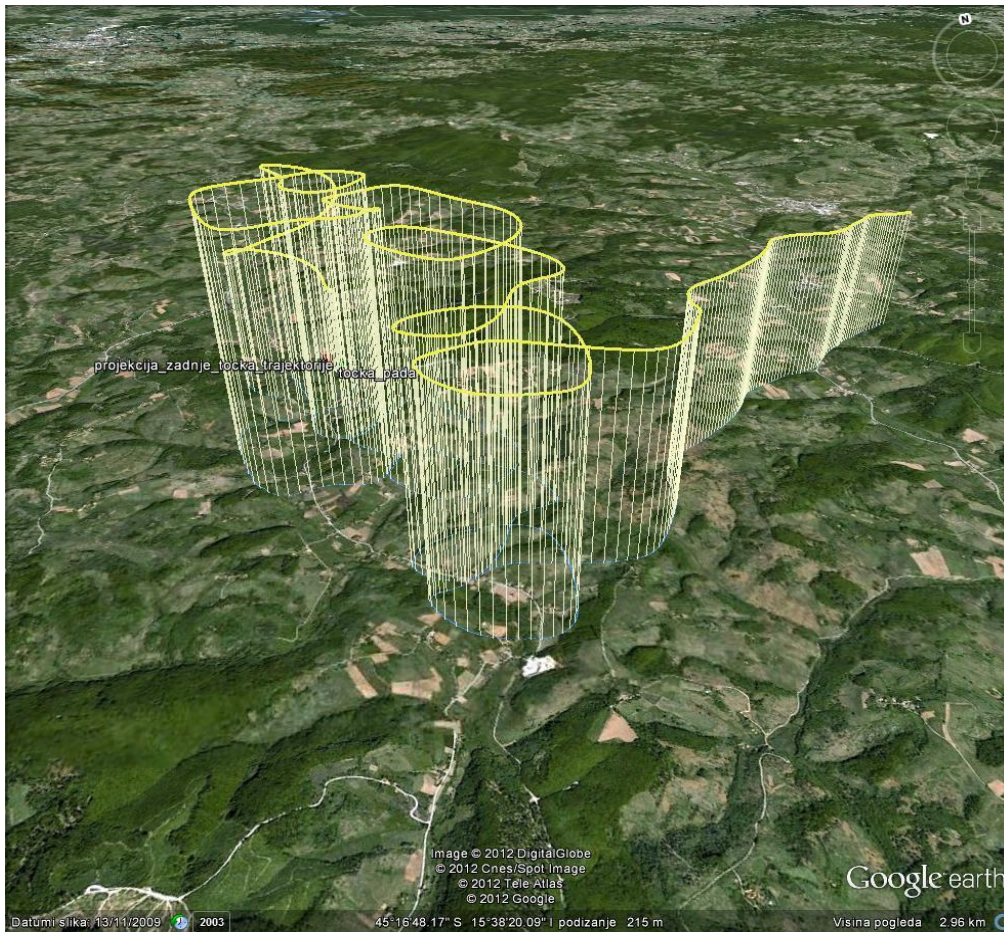
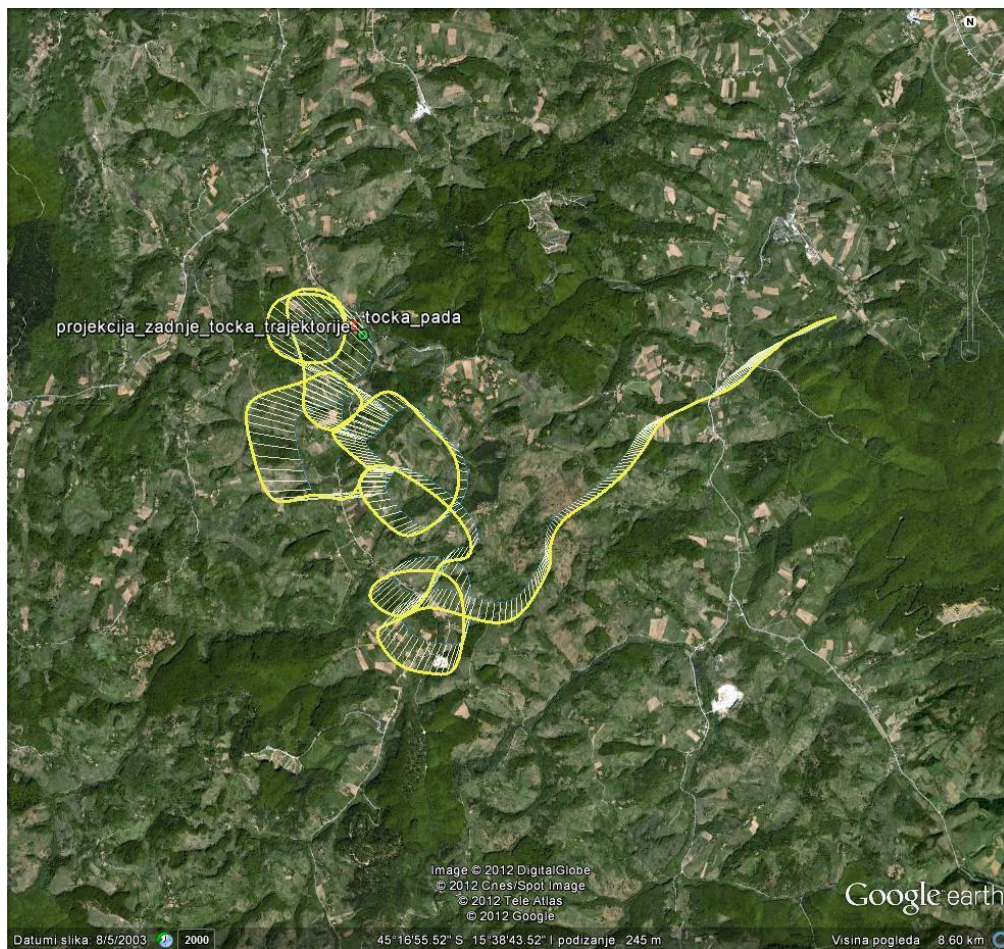
Image 29

The aircraft was found on September 25th 2010 at aprox 23:00 LT, near location Budačka Rijeka, area Kserov Potok. Altitude of the terrain is approx 958 ft.

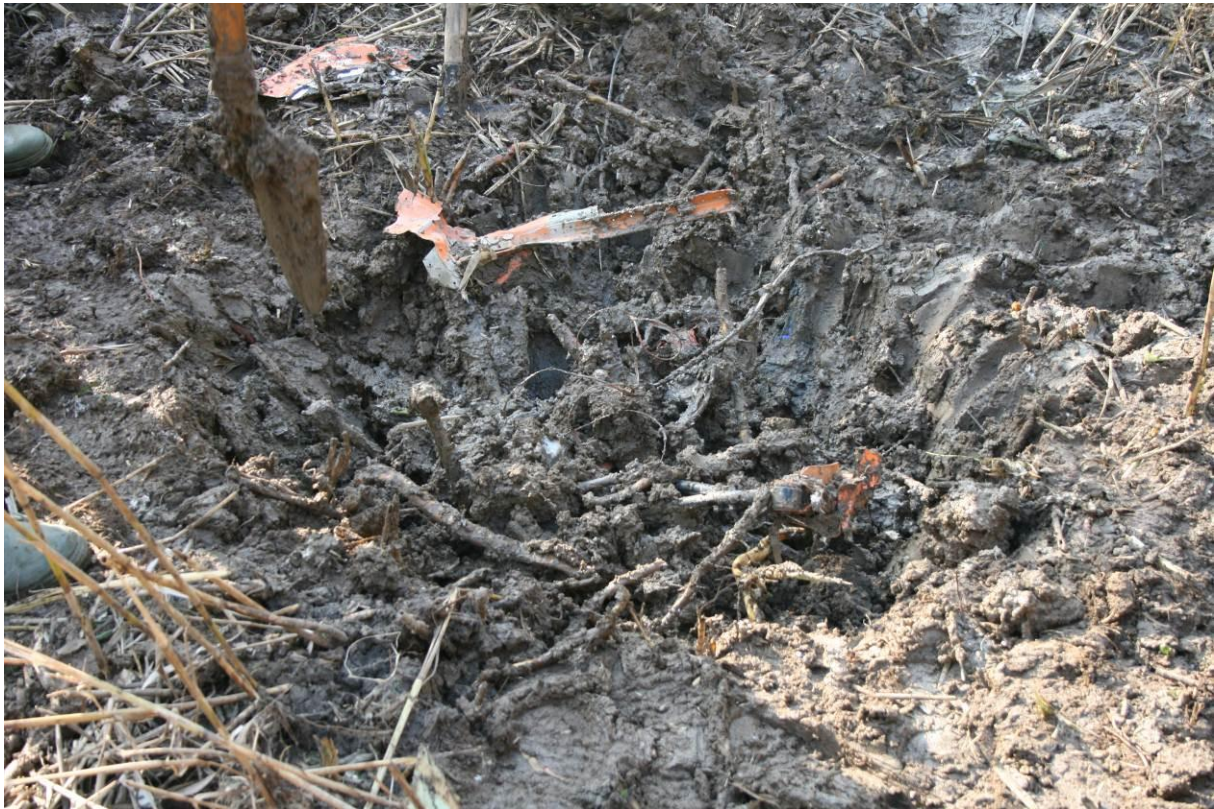
Image 35 Engine excavation

After the withdrawal of water, excavation of the engine was carried out. The engine was excavated on October 11th 2010.

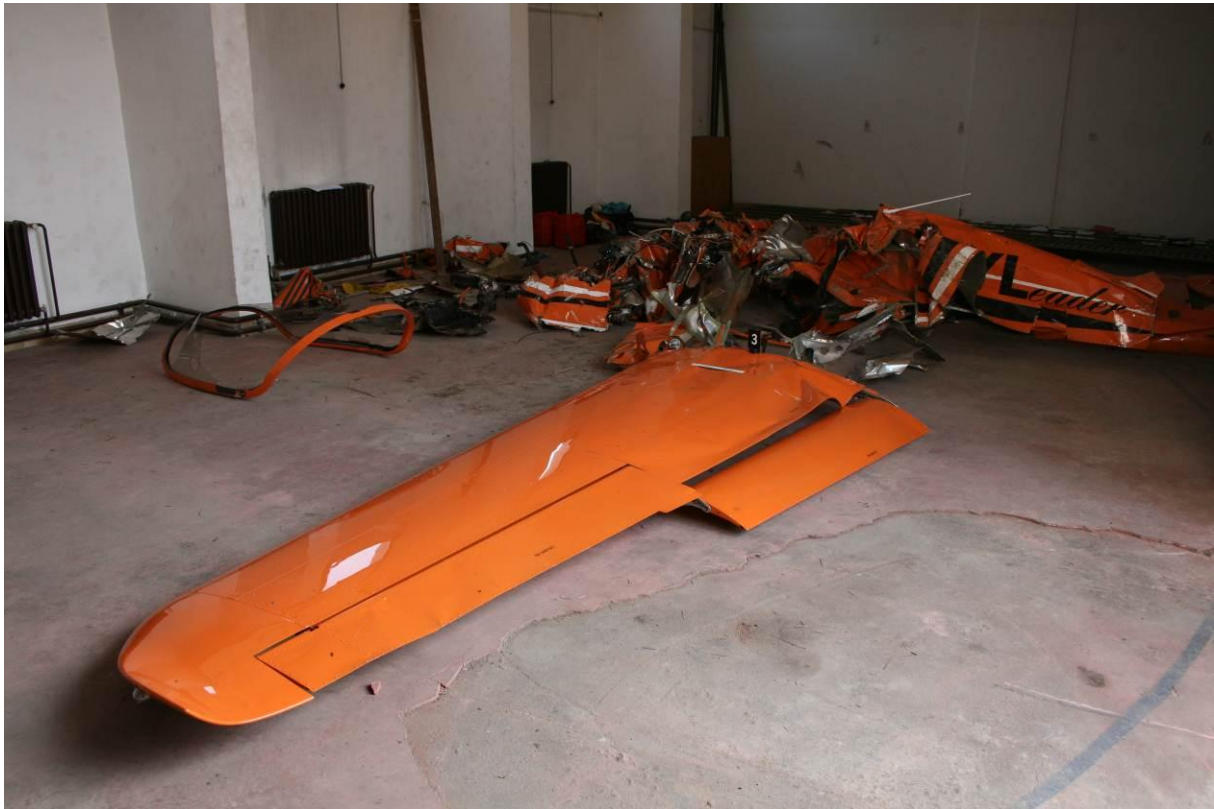
Image 37

On October 12th 2010, in the premises of Karlovac Police department in Erjavec, additional examination of the wreckage was conducted during which it was determined that the aircraft is missing the main left leg. During subsequent search of the terrain around the crash site, the left main leg was not found.

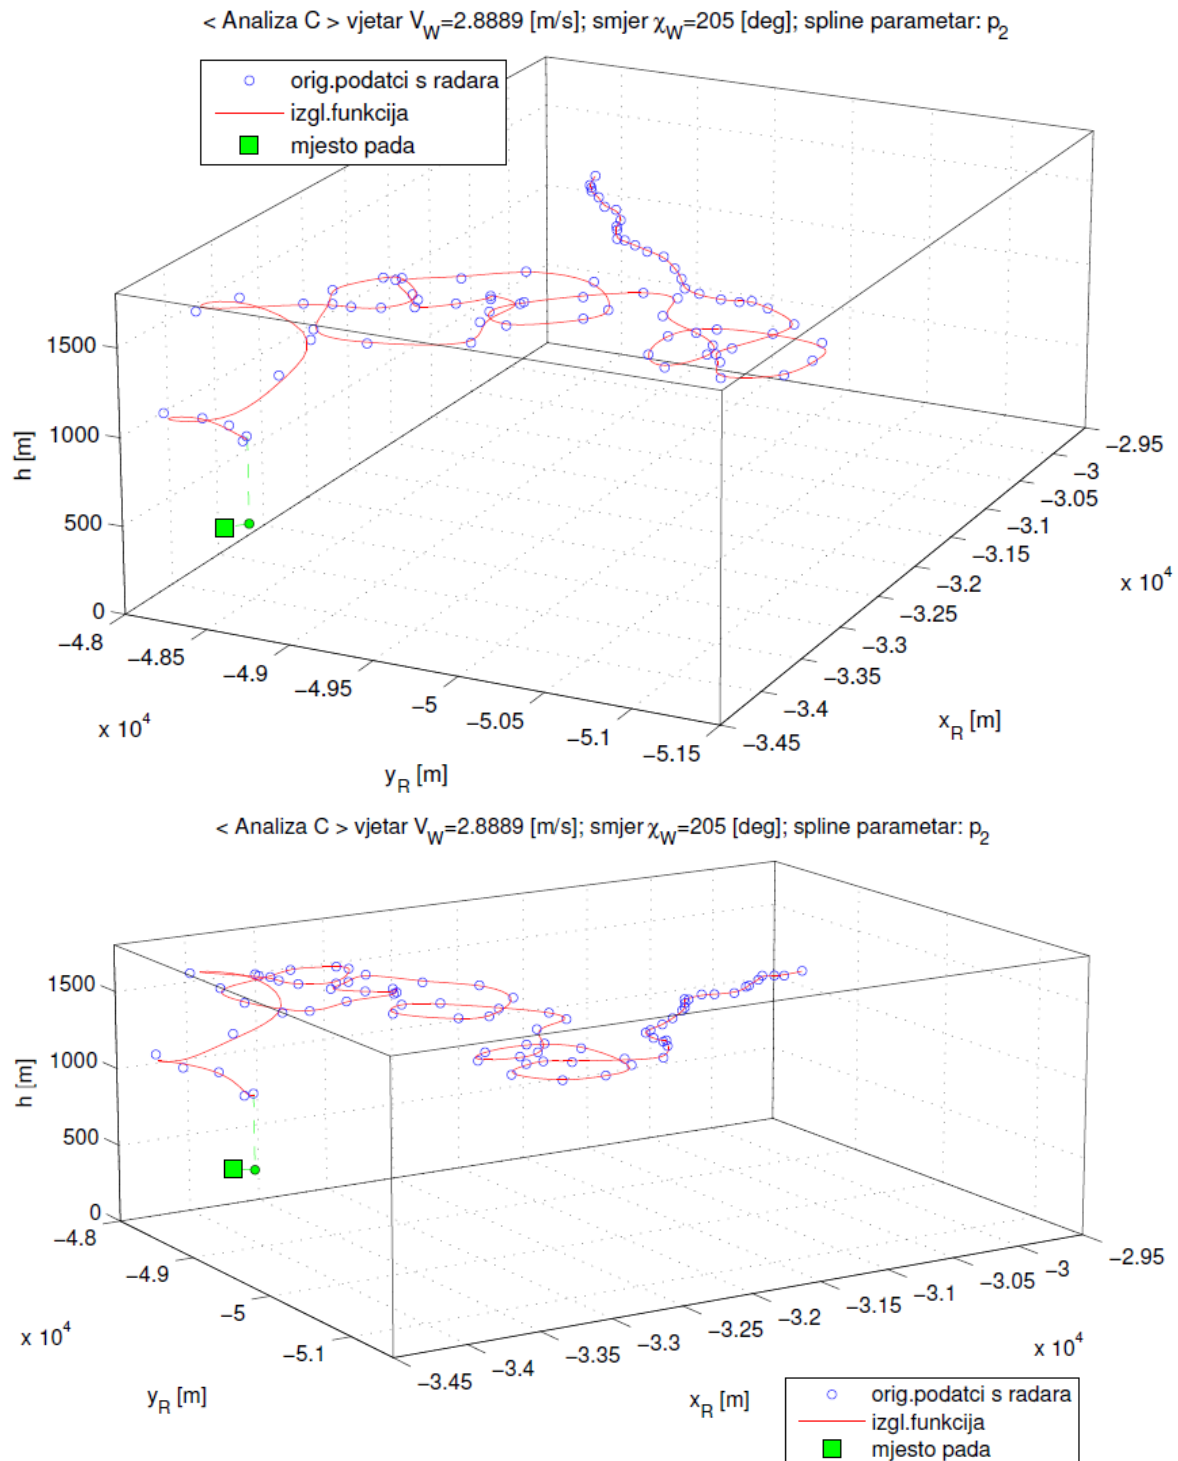
The analysis considered the flight between 12:06:41 ($t = 0$ s) to 12:13:11 ($t = 390$ s). Diagrams in Image 45 show the trajectory of the aircraft: blue circles indicate the original data for radar coordinates while the red line represents a smoothed curve of the aircraft (spline approximation). In addition, the location of the crash is drawn in the diagram (green cube).

- Aerodynamic speed (actual speed) takes the critical value: equal to or less than the speed of stall V_S at times $t= 100$ s and $t= 277$ s and values greater than the maximum speed V_{NE} at times $t= 158, 210, 245, 300, 345$ s. The exact estimate of aerodynamic speed cannot be done but based on the results and their explanations it can be concluded that the aerodynamic speed varied according to the diagram 46, by values between the curves C11 and C12.

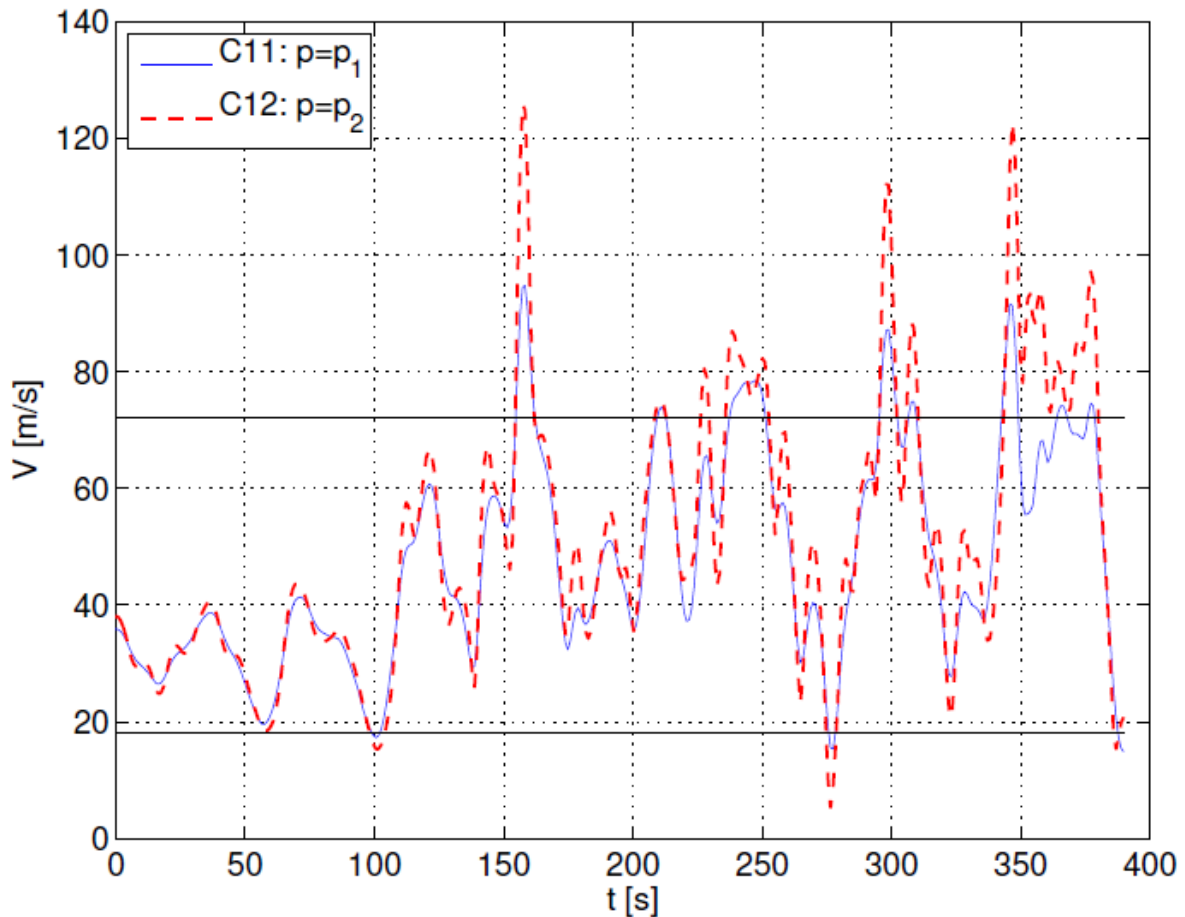
Image 46 Estimate of the aerodynamic speed V during the flight: border values
