**Aircraft Accident and Incident
Investigation Agency**
10002 Zagreb, Prisavlje 14

FINAL REPORT

OF AIRCRAFT SKYLEADER 500 ACCIDENT WHICH OCCURRED ON SEPTEMBER 25th 2010 IN THE AREA OF BUDAČKA RIJEKA

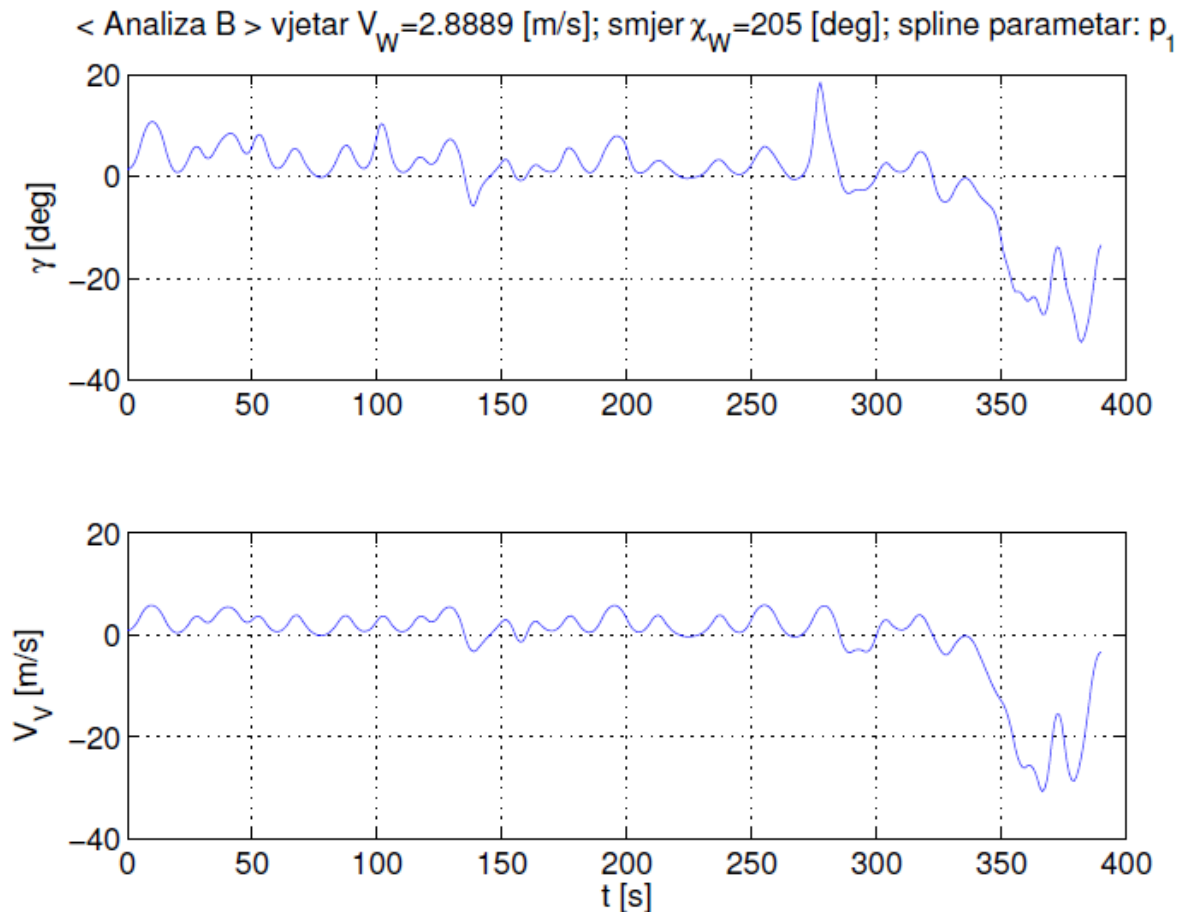
- Speed of climb reaches its maximum values several times (Image 47)

Image 47 Analysis B (B11): Climb angle and vertical speed changes per time

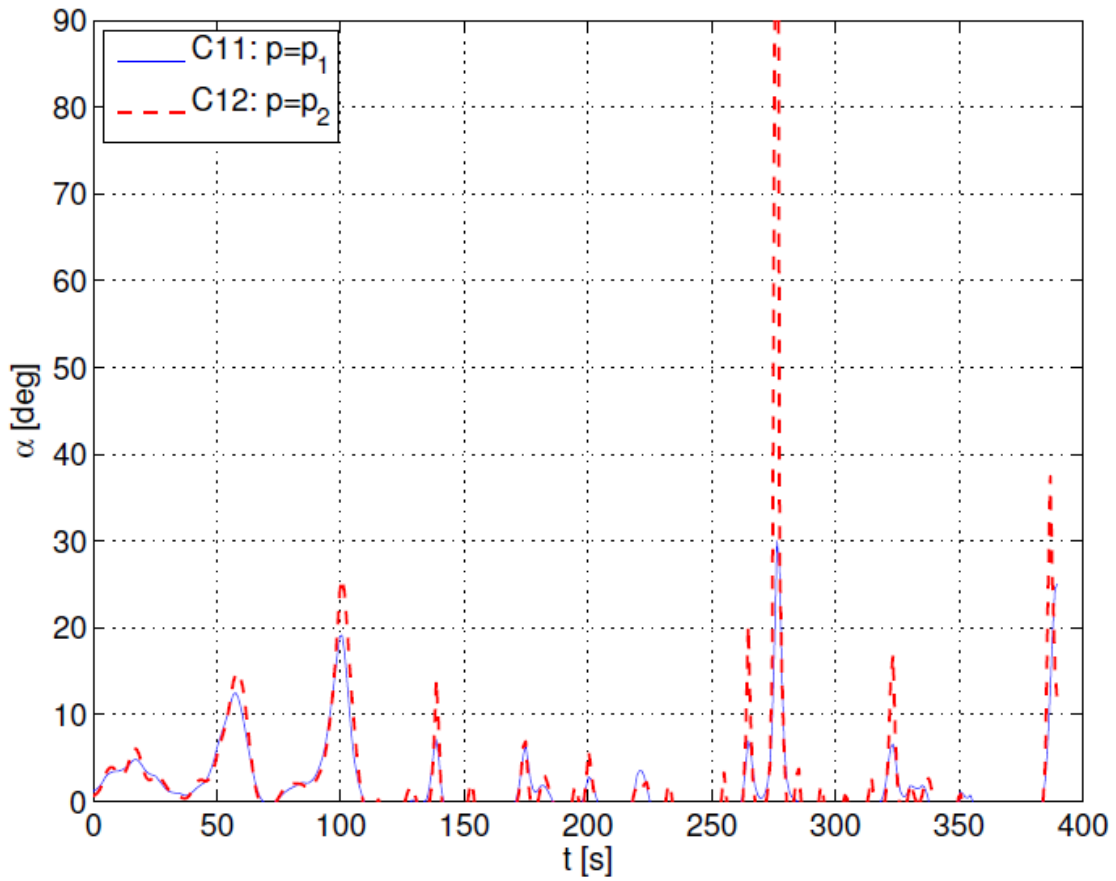
- Angle of attack in terms of critical values follows the aerodynamic speed - where it takes values around the stall. According to the results of the diagram 46, it is estimated that the attack angle takes values between curves C11 and C12.
- The load factor on several occasions takes very high values, even more than $n=4$ ($t = 350$ s). Based on the above analysis, load factor is estimated pursuant to diagram 49 where the probable values of the load factor are between curves C11 and C12. The maximum value of the load factor during the observed flight is $n= 2.5 - 4.5$.
- Based on the described analysis, the roll angle ϕ is estimated pursuant to diagram 50 where the values of the roll angle are between curves C11 and C12.
- Based on the described analysis, the pitch angle θ is estimated pursuant to diagram 51 where the probable values of the pitch angle are between curves C11 and C12.

Image 48 Estimate of the attack angle α during flight: border values

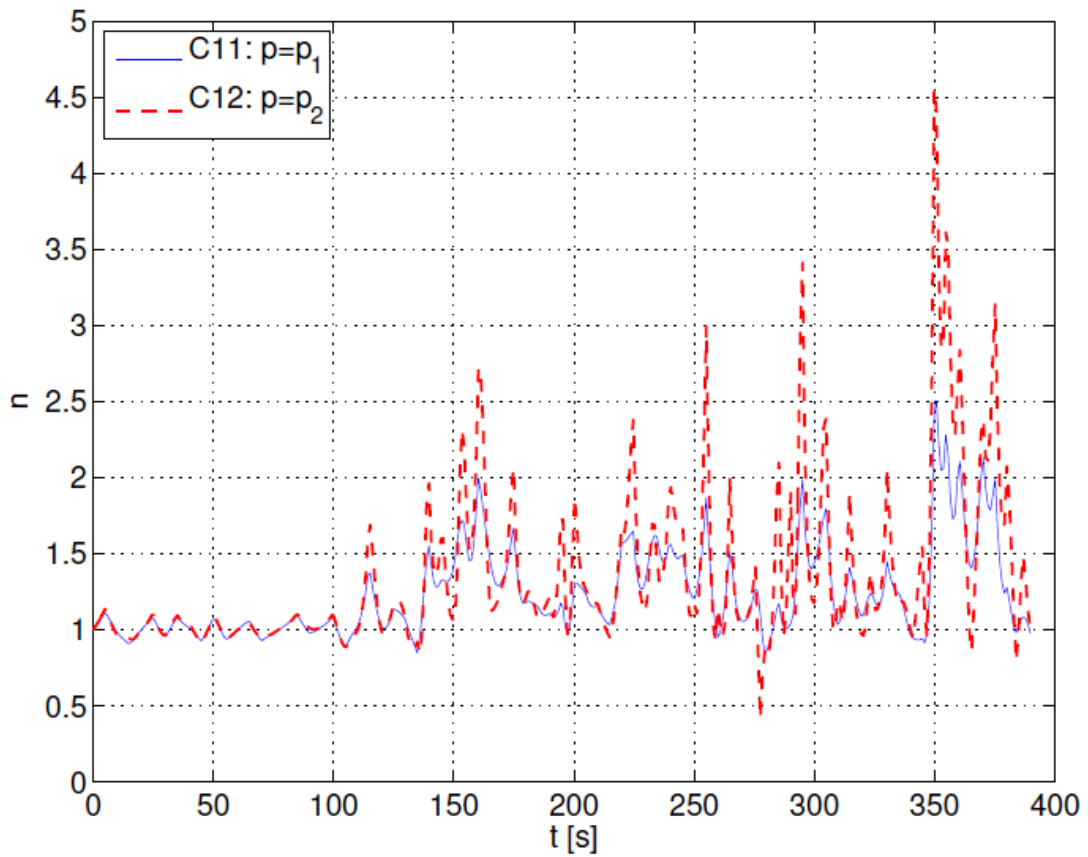
Image 49 Estimate of the load factor: border values

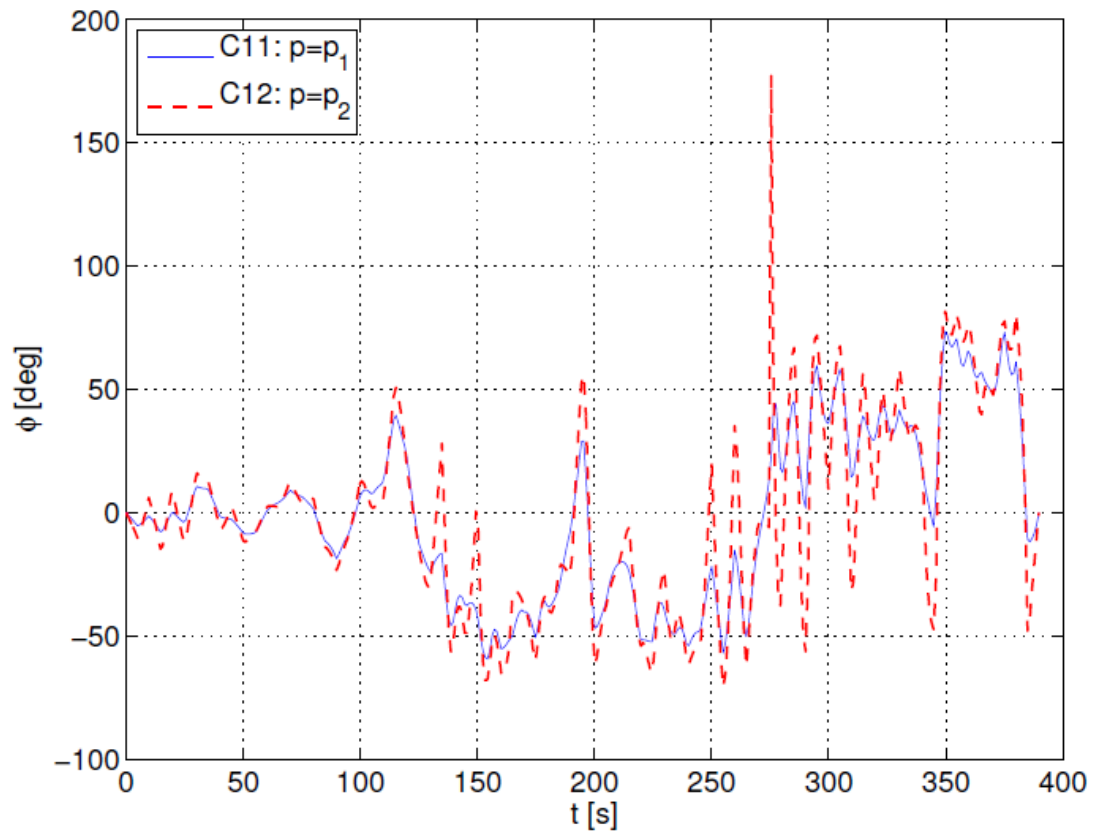
Image 50 Estimate of the roll angle ϕ during flight: border values

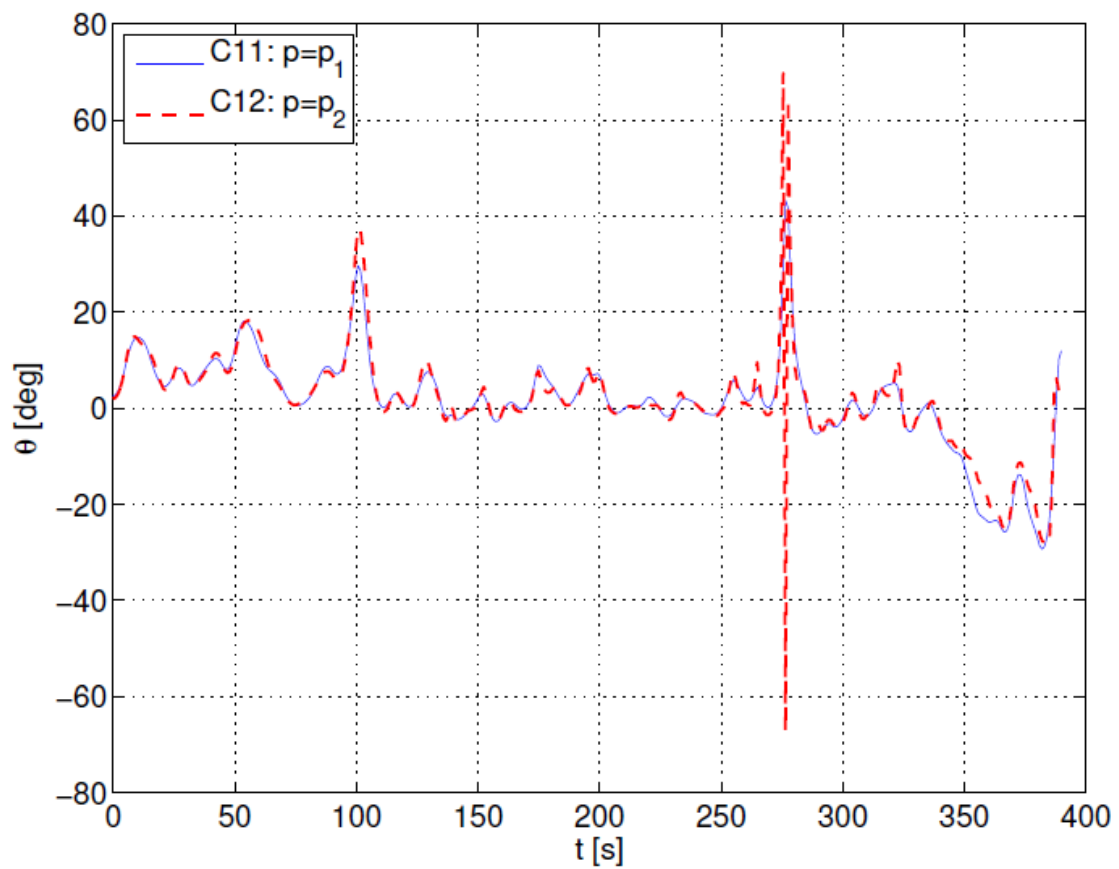
Image 51 Estimate of the pitch angle θ during flight: border values
